Sturgeon Bay

Aquatic Plant Management Plan

December 2019

Created by: Tim Hoyman, Brenton Butterfield, Emily Henrigillis, & Eddie Heath
Onterra, LLC
De Pere, WI

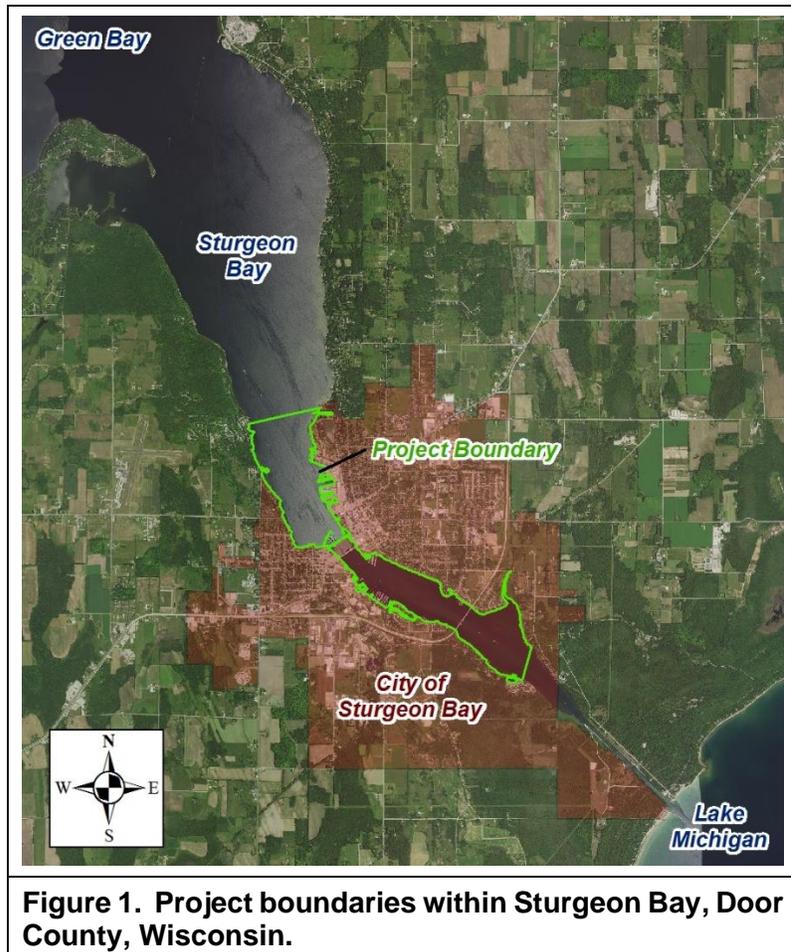
Figure 1. Project boundaries within Sturgeon Bay, Door County, Wisconsin.

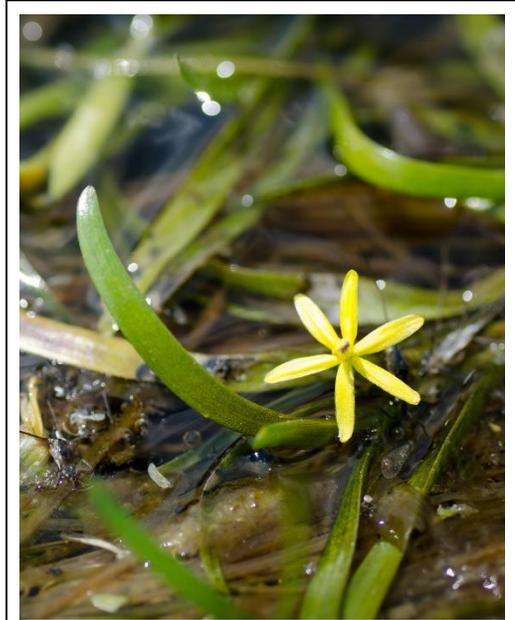
Photo 1. The native aquatic plant water stargrass found in Sturgeon Bay. Photo credit Onterra.

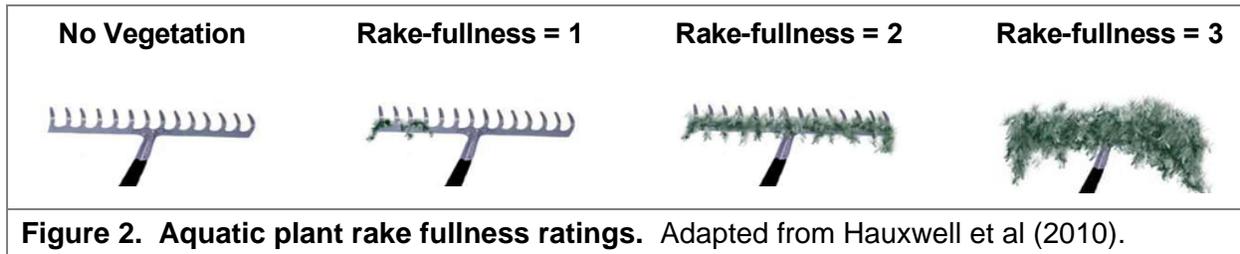
Figure 2. Aquatic plant rake fullness ratings. Adapted from Hauxwell et al (2010).

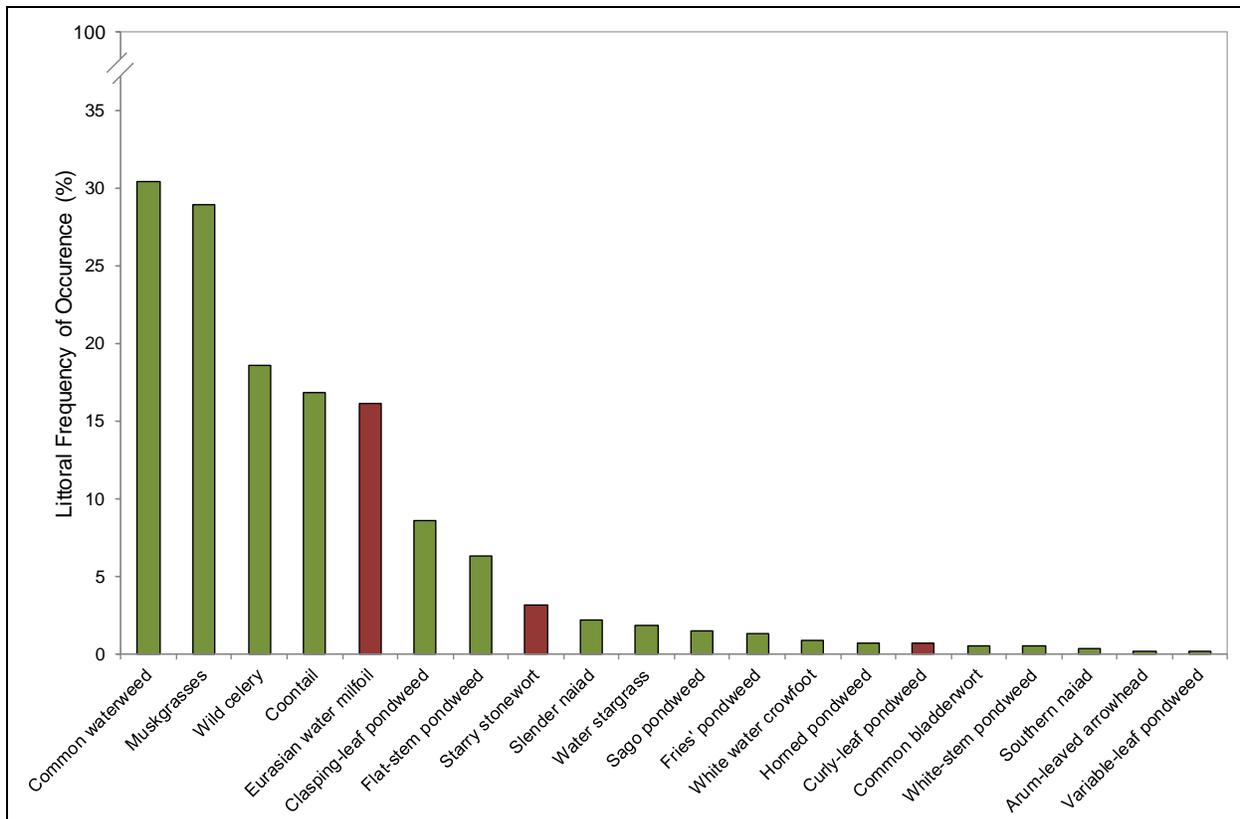
Figure 5. Littoral frequency of occurrence of aquatic plant species in Sturgeon Bay in August 2016. Exotic species indicated with red. Created using data from Onterra August 2016 point-intercept survey.

Coontail, arguably the most abundant aquatic plant in Wisconsin, was the fourth-most frequently encountered aquatic plant in Sturgeon Bay with a littoral frequency of occurrence of approximately 17% (Figure 5). Unlike most of the submersed plants found in Wisconsin, coontail does not produce true roots and is often found growing entangled amongst other aquatic plants. Because it lacks true roots, coontail derives most of its nutrients directly from the water (Gross et al. 2013). This ability in combination with a tolerance for low-light conditions allows coontail to become more abundant in waterbodies with higher nutrients. While coontail has the capacity to form dense beds which mat on the surface and can hinder recreation, the majority of the coontail located in Sturgeon Bay was found growing in 10.0 to 15.0 feet of water.

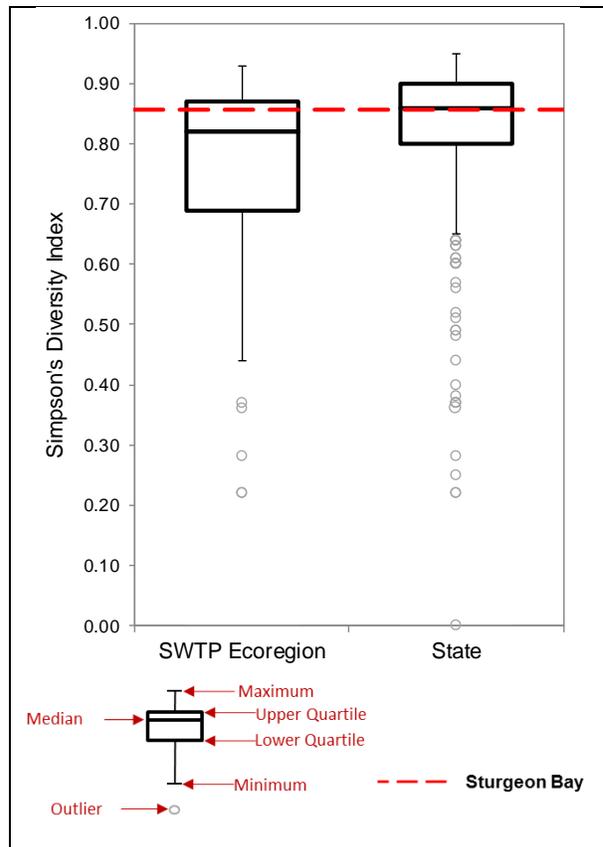
Figure 7. Sturgeon Bay aquatic plant community Simpson’s Diversity Index. SWTP = Southeastern Wisconsin Till Plain. Created using data from Onterra August 2016 point-intercept survey.

While a method for characterizing diversity values of fair, poor, etc. does not exist, lakes within the same ecoregion may be compared to provide an idea of how Sturgeon Bay's diversity value ranks. Using data collected by Onterra and WDNR Science Services, quartiles were calculated for 77 lakes within the SWTP Ecoregion (Figure 7). Using the data collected from the August 2016 point-intercept survey, Sturgeon Bay's aquatic plant community was found to have a Simpson's Diversity Index value of 0.86. In other words, if two individual aquatic plants were randomly sampled from Sturgeon Bay in 2016, there would be an 86% probability that they would be different species. Sturgeon Bay's species diversity value exceeds the median value for lakes within the SWTP ecoregion and is even with the median diversity value for lakes throughout Wisconsin.

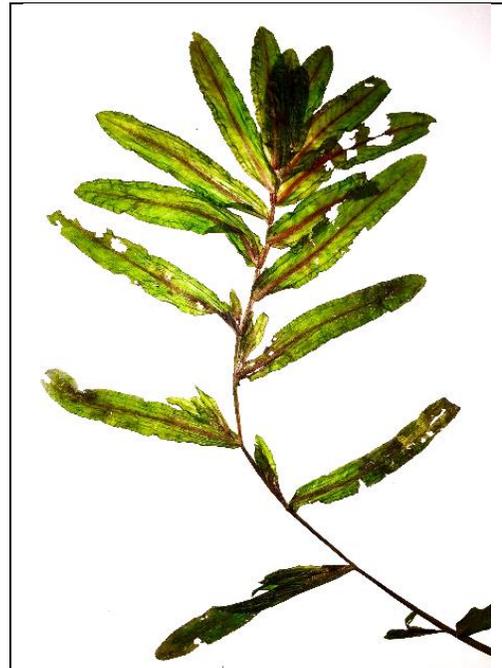
Photo 2. Curly-leaf pondweed, a non-native, invasive aquatic plant. Photo credit Onterra.

Curly-leaf pondweed (Photo 2) is a European exotic first discovered in Wisconsin in the early 1900's that has an unconventional lifecycle giving it a competitive advantage over our native plants. Curly-leaf pondweed begins growing almost immediately after ice-out and by mid-June is at peak biomass. While it is growing, each plant produces many turions (asexual reproductive shoots) along its stem. By mid-July most of the plants have senesced, or died-back, leaving the turions in the sediment.

The turions lie dormant until fall when they germinate to produce winter foliage, which thrives under the winter snow and ice. It remains in this state until spring foliage is produced in early May, giving the plant a significant jump on native vegetation. Like other invasive plants, curly-leaf pondweed can become so abundant that it hampers recreational activities within the lake. Furthermore, its mid-summer die back can cause algal blooms spurred from the nutrients released during the plant's decomposition.

Because of its odd life-cycle, a point-intercept survey was conducted early in the growing season on June 20, 2016 to gain an understanding of the distribution of curly-leaf pondweed within the study area of Sturgeon Bay when it was at its peak growth. Curly-leaf pondweed was the second-most frequently encountered aquatic plant during the June point-intercept survey with a littoral frequency of occurrence of approximately 25%. Figure 9 illustrates the distribution of CLP in Sturgeon Bay as determined from the point-intercept survey. This plant is widespread and abundant throughout most of the study area, with the exception of deeper areas and the northeastern portion of the study area. It was most abundant between 6.0 and 17.0 feet of water, but was also observed growing in some of the marinas. While CLP is widespread, the majority (78%) of the point-intercept locations containing CLP had a CLP rake fullness rating of 1, indicating that in most areas it is not overly dense. During the August point-intercept survey, CLP had a littoral frequency of occurrence of <1%, indicating that the majority of the population had died back by this time.

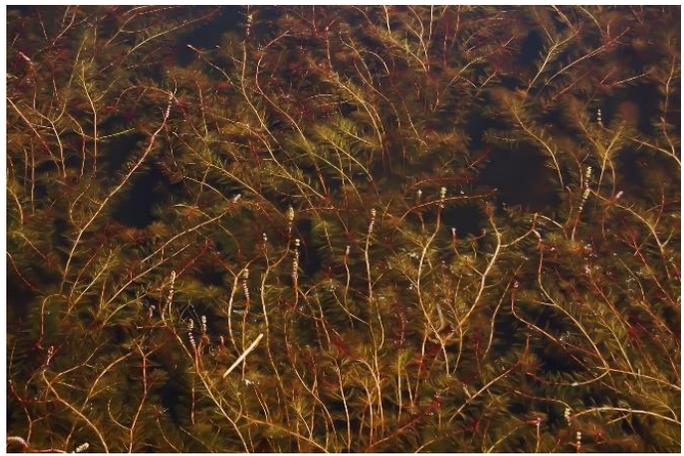
Photo 3. Eurasian watermilfoil, a non-native, invasive aquatic plant. Photo credit Onterra.

Eurasian watermilfoil (Photo 3) is an invasive species, native to Europe, Asia and North Africa, that has spread to most Wisconsin counties. Eurasian watermilfoil (EWM) is unique in that its primary mode of propagation is not by seed. It actually spreads by shoot fragmentation, which has supported its transport between lakes via boats and other equipment. In addition to its propagation method, EWM has two other competitive advantages over native aquatic plants: 1) it starts growing very early in the spring when water temperatures are too cold for most native plants to grow, and 2) once its stems reach the water surface, it does not stop growing like most native plants, instead it continues to grow along the surface creating a canopy that blocks light from reaching native plants. Eurasian water-milfoil can create dense stands and dominate submergent communities, reducing important natural habitat for fish and other wildlife, and impeding recreational activities such as swimming, fishing, and boating.

Unlike CLP, EWM reaches its peak growth in mid- to late-summer, and assessments are usually completed in July through September to capture populations at their peak. Figure 10 illustrates the distribution of EWM in the study area of Sturgeon Bay as determined from the point-intercept

survey completed by Onterra. During this survey, EWM had a littoral frequency of occurrence of approximately 16%, making it the fifth-most frequently encountered aquatic plant. It was most abundant between 4.0 and 14.0 feet of water. Total rake fullness data indicate that approximately 84% of the point-intercept sampling locations that contained EWM had an EWM total rake fullness rating of 1. Like CLP, while EWM is widespread throughout the study area, in most locations it is not overly dense. Onterra ecologists did note EWM growing within some of the marinas.

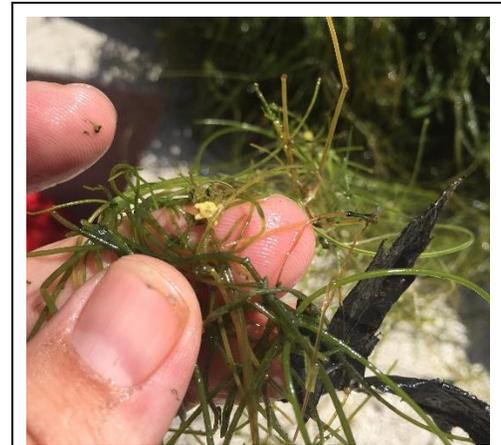
Photo 4. Starry stonewort, a non-native, invasive macroalgae.
Photo credit Onterra.

Starry stonewort (*Nitellopsis obtusa*; SSW; Photo 4) is a non-native, invasive macroalgae that was first observed in the United States in 1978 within the St. Lawrence River. It was recently discovered in a southeastern Wisconsin lake in 2014, and has since spread to six lakes within three counties in southeastern Wisconsin. The discovery of starry stonewort in Sturgeon Bay in 2016 marks the first record of its occurrence in Lake Michigan.

Like other invasive species, starry stonewort has been shown to quickly dominate aquatic plant communities, in some cases growing to nuisance levels and hindering recreation. During the August 2016 point-intercept survey on Sturgeon Bay, SSW had a relatively low littoral frequency of occurrence of approximately 3%. Figure 11 illustrates that SSW is widespread within the study area, but it was most frequently encountered within the southern portion of the study area. Starry stonewort was most abundant between 6.0 and 10.0 feet in Sturgeon Bay. Since its discovery in Sturgeon Bay, the WDNR has verified the presence of Starry Stonewort in Green Bay near Brussels, Fish Creek, and Little Sturgeon Bay.

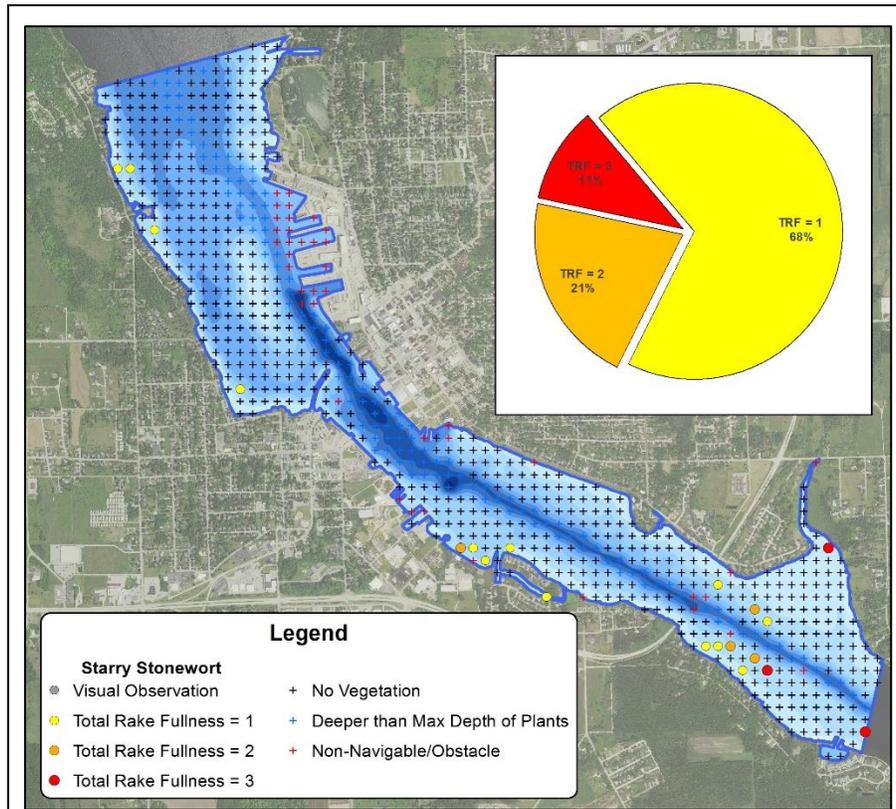
Figure 11. Distribution of starry stonewort in Sturgeon Bay in August 2016. Created using data from Onterra August 2016 point-intercept survey.

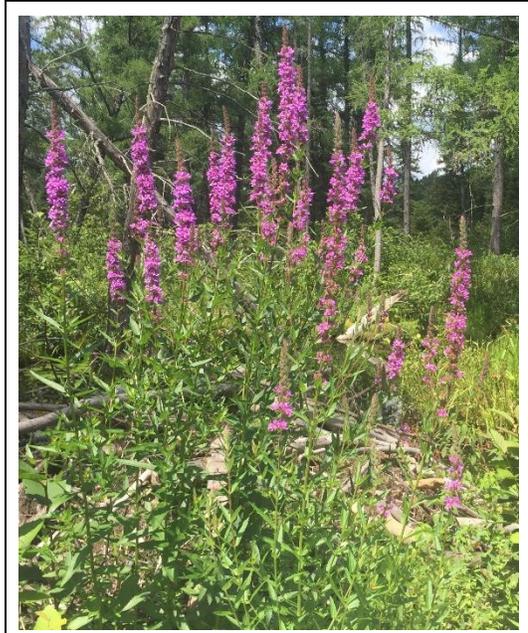
Photo 5. Purple loosestrife, a non-native, invasive wetland plant.
Photo credit Onterra.

Purple loosestrife (Photo 5) is a perennial herbaceous plant native to Europe and was likely brought over to North America as a garden ornamental. This plant escaped from its garden landscape into wetland environments where it is able to out-compete our native plants for space and resources. First detected in Wisconsin in the 1930's, it has now spread to 70 of the state's 72 counties. Purple loosestrife largely spreads by seed, but also can vegetatively spread from root or stem fragments.

Numerous purple loosestrife occurrences were located growing along portions of Sturgeon Bay's shoreline (Map 2). All of these occurrences were comprised of a single or few plants, and no large monotypic colonies were observed. There are a number of effective control strategies for combating this aggressive plant, including herbicide application, biological control by native beetles, and manual hand removal.

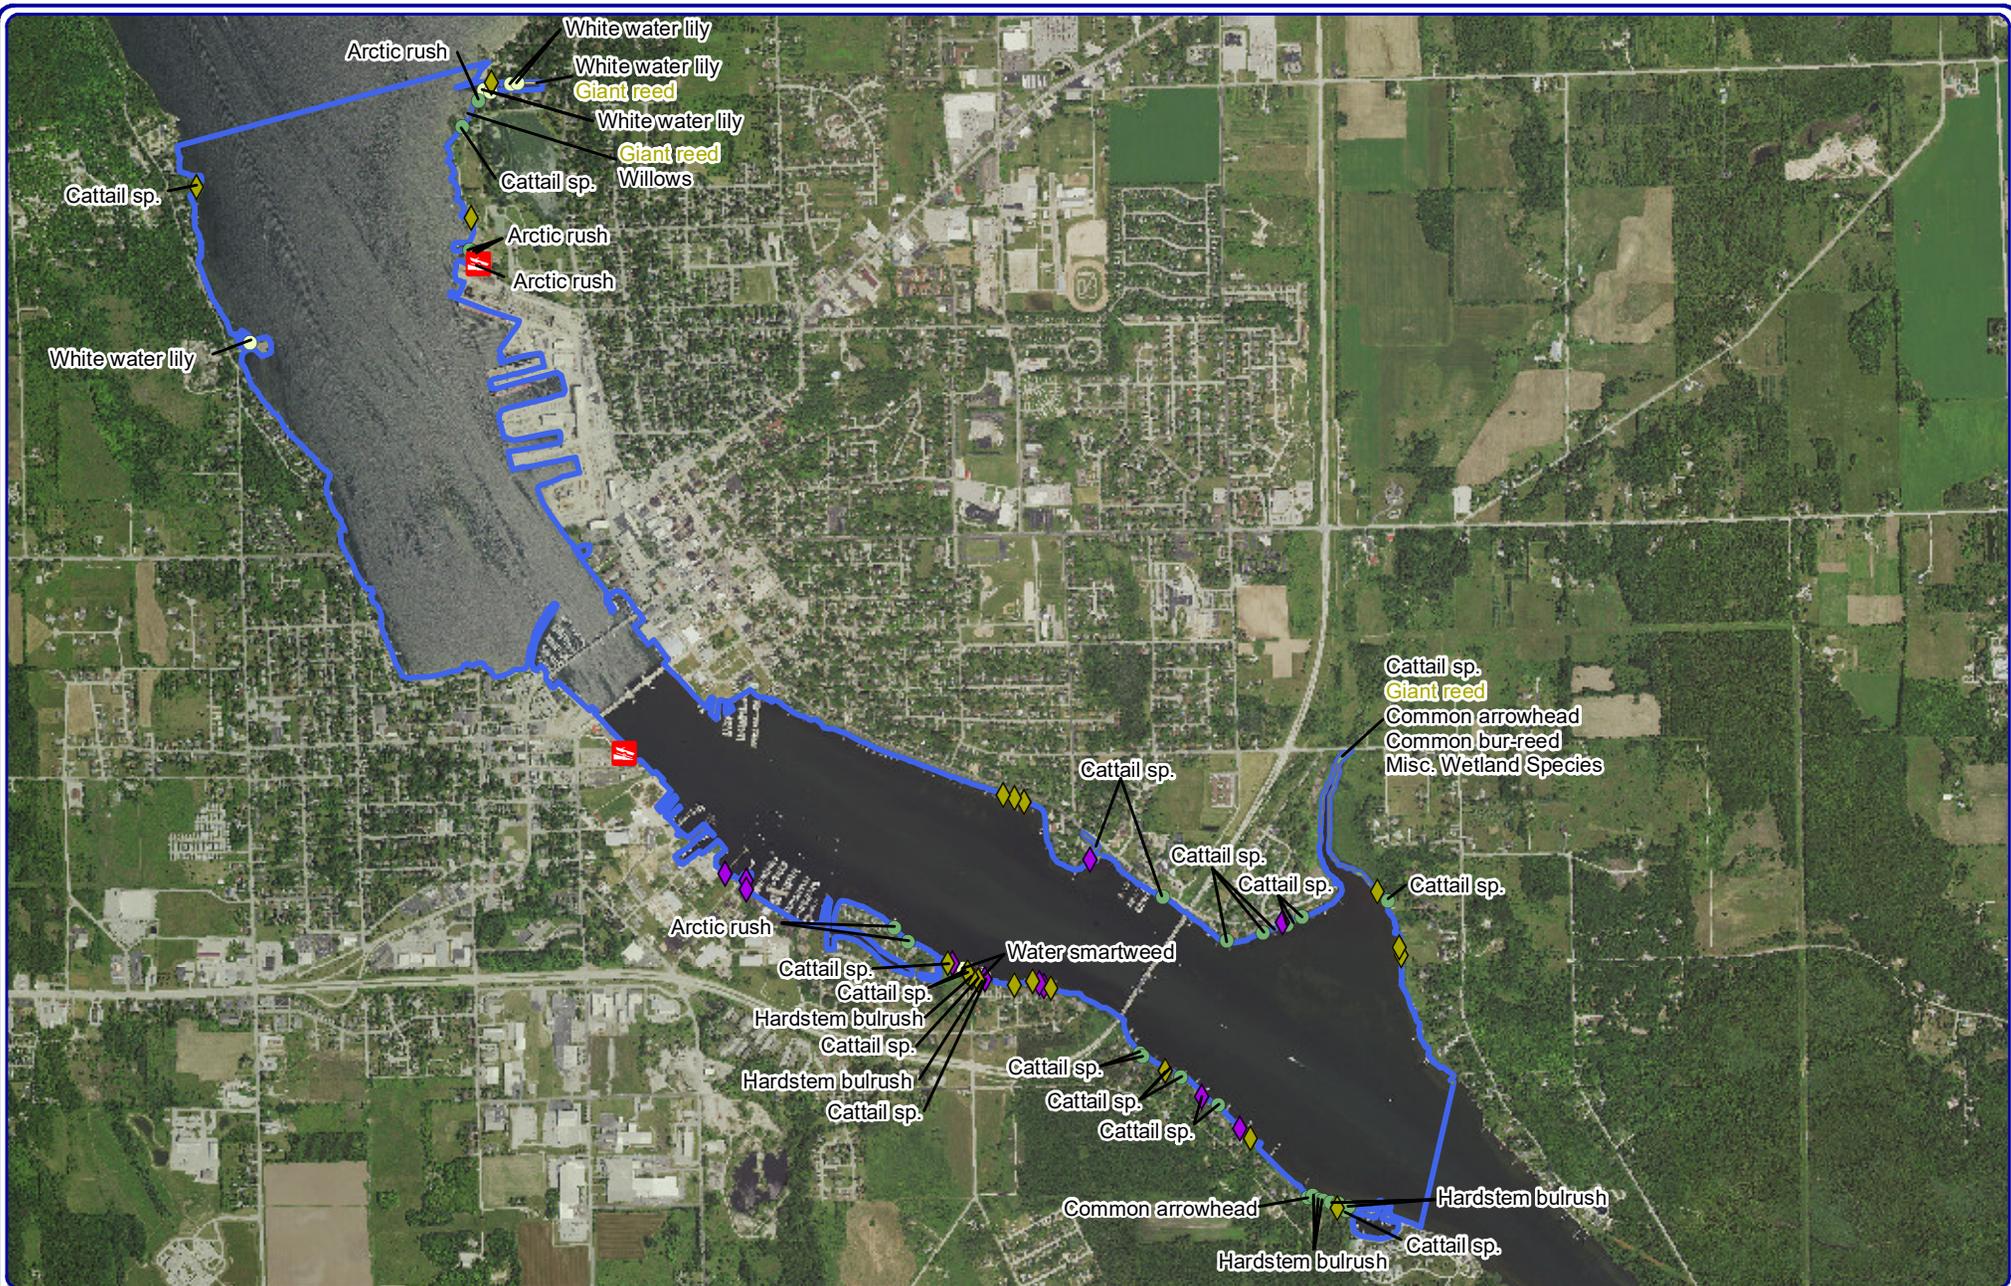
Map 2
Sturgeon Bay
 Door County, Wisconsin
Emergent & Floating-Leaf
Aquatic Plant Communities

Small Plant Community	Large Plant Community	Exotic Plant Community
● Emergent	Emergent	◆ Purple Loosestrife
● Floating-Leaf	Floating-Leaf	◆ Giant Reed
● Mixed Emergent & Floating-Leaf	Mixed Emergent & Floating-Leaf
