Bird Lake

Bird Lake AIS Monitoring and Water Clarity Report

Field Date: July 6th, 2018
WBIC: 972000
Previous AIS Findings: None
New AIS Findings: None
Field Crew: Aubrey Nycz, AIS Project Leader and Jody Partin, AIS Project Assistant,
Oneida County Land and Water Conservation Department
Report By: Jody Partin

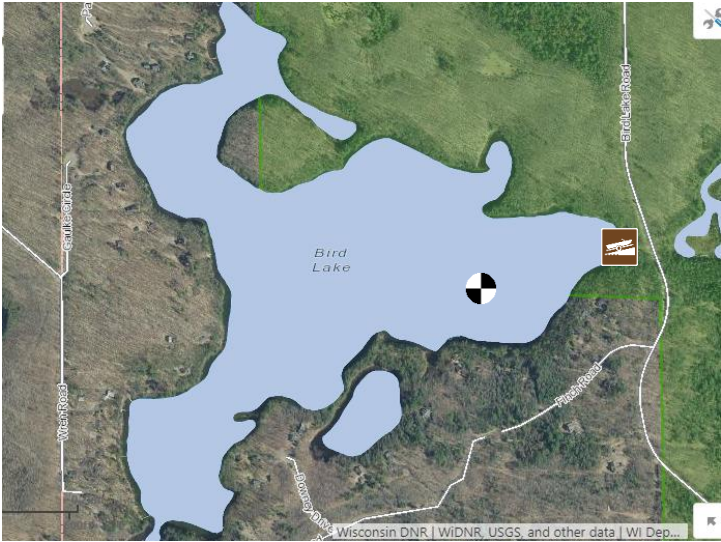
Figure 2. Map of Bird Lake with boat landing and location of Secchi disk reading labeled.

Secchi: The Secchi reading on this lake was 16.5 feet out of a 40 foot maximum depth. The water color was a yellowish color, and appeared clear when glancing across the lake.

Public boat landing
-

Deep hole & location of Secchi disk reading
