# Hixon Lake

## Hixon Lake AIS Monitoring and Water Clarity Report

Field Date: July 18<sup>th</sup>, 2018  
WBIC: 1568900  
Previous AIS Findings: None  
New AIS Findings: None  
Field Crew: Aubrey Nycz, AIS Project Leader, Tom Boisvert, AIS Project Assistant,  
Oneida County Land and Water Conservation Department  
Report By: Aubrey Nycz

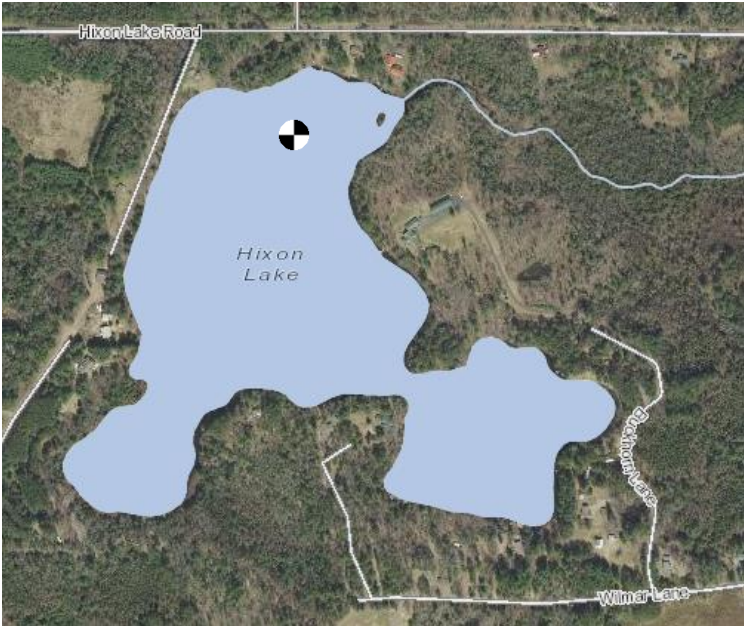
Figure 2. Map of Hixon Lake with location of Secchi disk reading labeled.

To observe the water clarity and quality of Hixon Lake, the AIS team went to the lake's deep hole, located on the north end of the lake. After locating the deep hole with our sonar unit, we used a Secchi disk to measure water clarity and a dissolved oxygen meter to measure water health. Oxygen is needed for a healthy fish population, and also for plants to respire at night. The measurements from the dissolved oxygen meter can tell us if the organisms in the lake would be under stress. Thankfully, both of these measurements were relatively average in nature, and there should be no concern for the health of Hixon Lake. The Secchi disk reading was 7 feet, and the dissolved oxygen readings can be found in table 2.

Secchi: The Secchi reading on this lake was 7 feet out of a 28 foot maximum depth. The water was a brownish color, and appeared clear when glancing across the lake.

Deep hole & location of Secchi disk reading
