# Langley Lake

## Langley Lake AIS Monitoring and Water Clarity Report

Field Date: July 18<sup>th</sup>, 2018  
WBIC: 1583500  
Previous AIS Findings: None  
New AIS Findings: None  
Field Crew: Aubrey Nycz, AIS Project Leader, and Thomas Boisvert, AIS Project Assistant, Oneida County Land and Water Conservation Department  
Report By: Thomas Boisvert

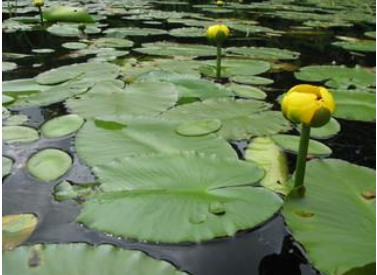
Common Name Scientific Plant Name	Description	Image
<p>Bullhead Pond Lily (Spatterdock)</p> <p><i>Nuphar variegata</i></p>	<p>An aquatic plant with heart-shaped leaves that can grow to be 15 inches long. This plant also has a yellow, cup-shaped flower. This plant is native.</p>
