McNaughton Lake

- Page 1: AIS Monitoring and Water Clarity
Report on August 16, 2018
- Page 6: AIS Monitoring and Water Clarity
Report of July 13, 2017
- Page 10: AIS Monitoring and Water Clarity
Report of August 14, 2014

McNaughton Lake AIS Monitoring and Water Clarity Report

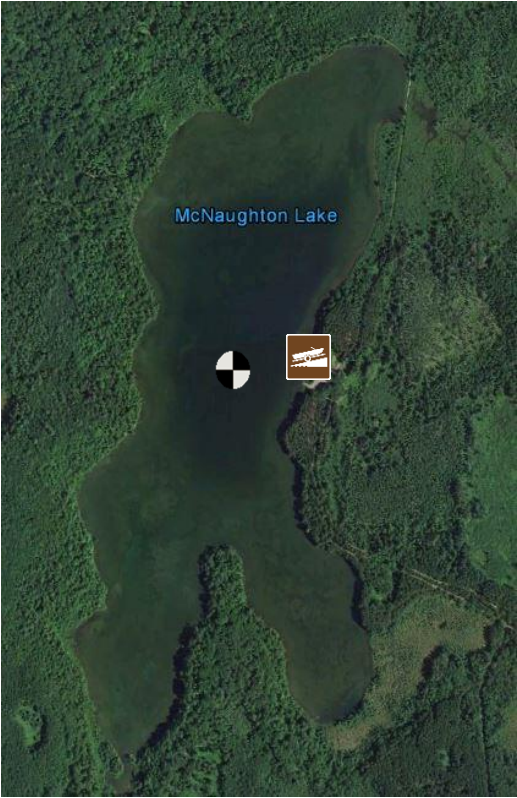
Figure 2. Map of McNaughton Lake with the location of Secchi disk reading labeled.

Public boat landing

Deep hole & location of Secchi disk reading

Secchi Disk Readings:
McNaughton - Deep Hole
Coordinates - Not Available

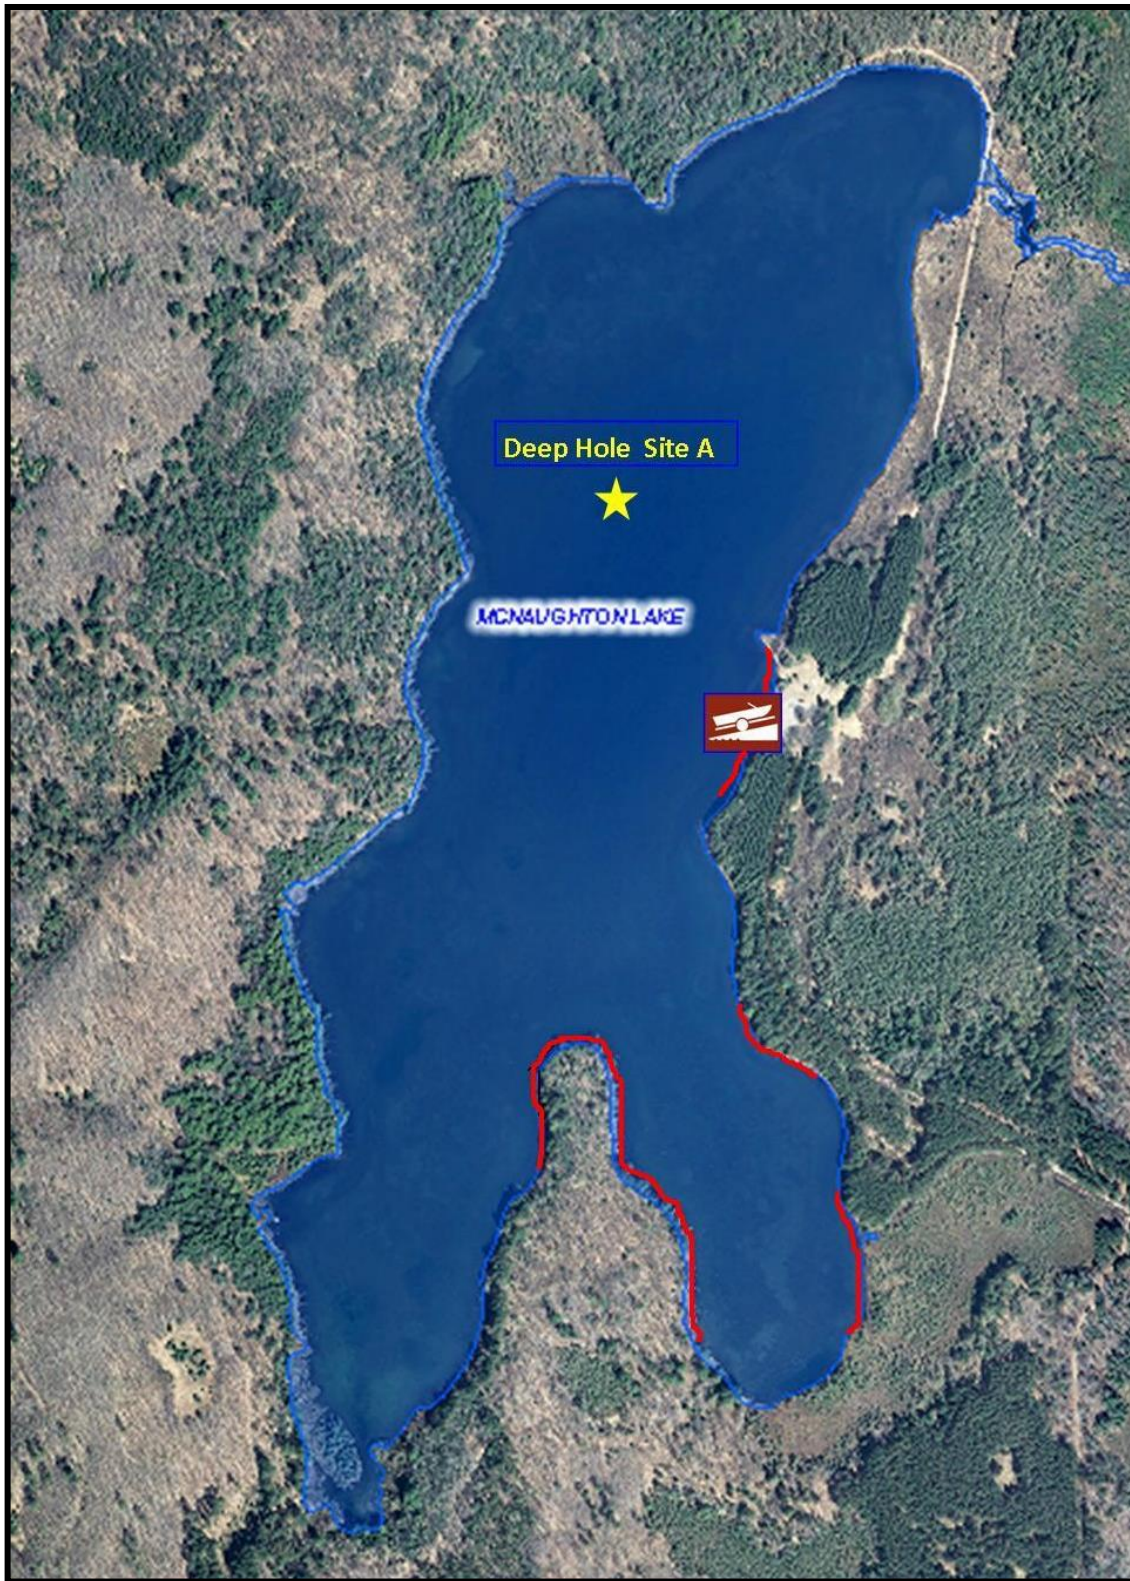
Figure 2. Map of McNaughton Lake's Deep Hole Site A and the locations monitored for AIS Presence/Absence.

The morning's blue sky and slight breeze made perfect conditions for monitoring the lake via the canoe. Using the depth finder and bathymetric map (**Figure 1**), I navigated the canoe to our monitoring location, which is located at the deep hole on the north end of the lake (**Figure 2**). There is an interesting "dead head" located directly at the deep hole. To prevent the canoe from moving while obtaining monitoring data, I pointed the bow of the canoe downwind, had Sara drop the anchor. I was in the stern and was able to keep the stern unwind by holding on to the dead head while Sara obtained a GPS point of our location and then collect Secchi, dissolved oxygen, and temperature readings (**Table 1**).

After data collection, we paddled to three locations on the lake to perform an AIS presence/absence check). The protocol for this process is to complete a visual inspection of the littoral zone along 100' of shoreline in each area. We choose to monitor the boat landing, and then two areas south of the boat landing (**Figure 2**). We visually inspected from the canoe, meandering the shoreline and via walking
