Sand Lake

Sand Lake AIS Monitoring and Water Clarity Report

Field Date: August 15th, 2018
WBIC: 1015800
Previous AIS Findings: None
New AIS Findings: None
Field Crew: Aubrey Nycz, AIS Project Leader, and Jody Partin, AIS Project Assistant,
Oneida County Land and Water Conservation Department
Report By: Jody Partin

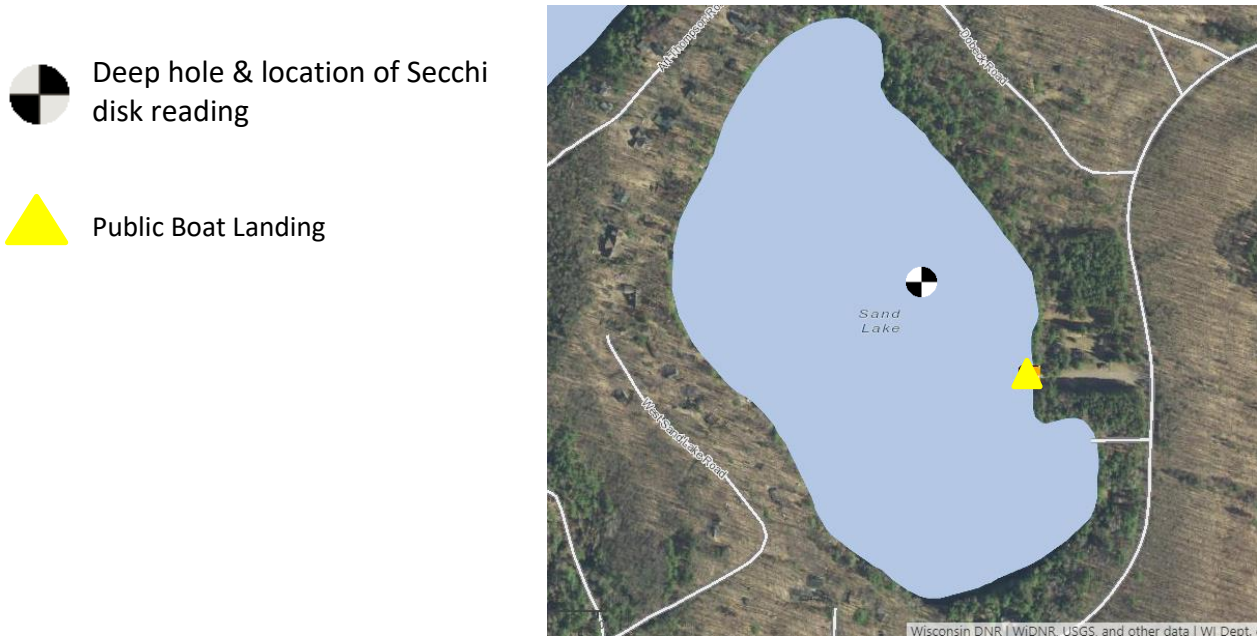
Figure 2. Map of Sand Lake with the location of the boat landing and Secchi disk reading labeled.

Secchi: The Secchi reading on this lake was 16 feet out of a 19 foot maximum depth. The water color was a blueish color and was clear when glancing across the lake.

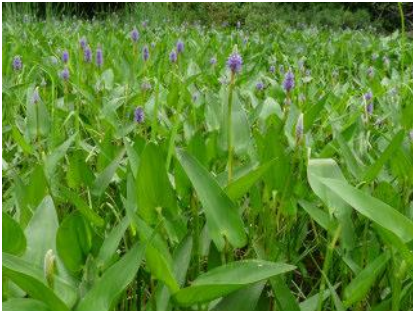
<p>Pickereel Weed <i>Pontederia cordata</i></p>	<p>An aquatic plant with thin, bright green leaves. Emergent leaves tend to be arrow shaped with 6 parted, blue flowers. This plant is native.</p>
