Page 1: AIS Monitoring and Water
Clarity Report of July 26th, 2018

Turtle Lake AIS Monitoring and Water Clarity Report

Field Date: July 26th, 2018
WBIC: 1587400
Previous AIS Findings: None
New AIS Findings: **Chinese Mystery Snail**
Field Crew: Aubrey Nycz, AIS Project Leader, and Thomas Boisvert, AIS Project Assistant, Oneida County Land and Water Conservation Department
Report By: Thomas Boisvert

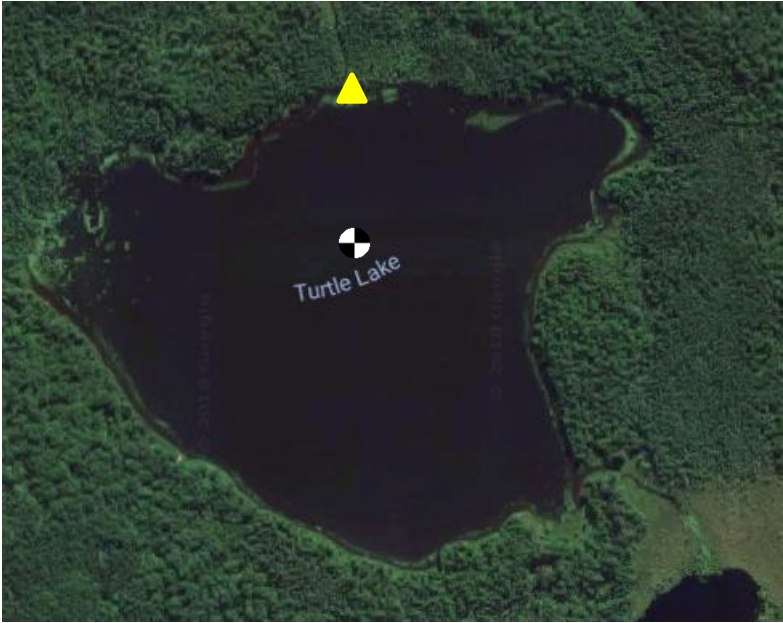
Figure 2. Map of Turtle Lake with the location of the Secchi disk reading labeled.

Deep hole & location of Secchi disk reading
- Secchi Disk Readings:
Turtle Lake - Deep Hole
Coordinates - Not Available
-

Public Boat Landing

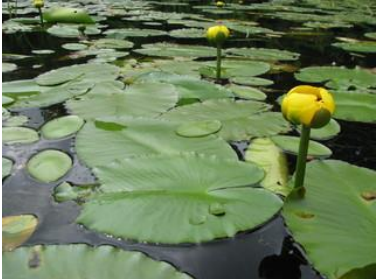
Common Name Scientific Plant Name	Description	Image
<p>Bullhead Pond Lily (Spatterdock)</p> <p><i>Nuphar variegata</i></p>	<p>An aquatic plant with heart-shaped leaves that can grow to be 15 inches long. This plant also has a yellow, cup-shaped flower. This plant is native.</p>
