# Beaver Creek Targeted Watershed Assessment: A Report to Restore Wisconsin Watersheds, 2020

*Watershed Report by the Bureau of Water Quality in support of the Clean Water Act.*

*Beaver Dam Watershed (UR03)  
Columbia and Dodge Counties  
HUC 12: 070900010903*

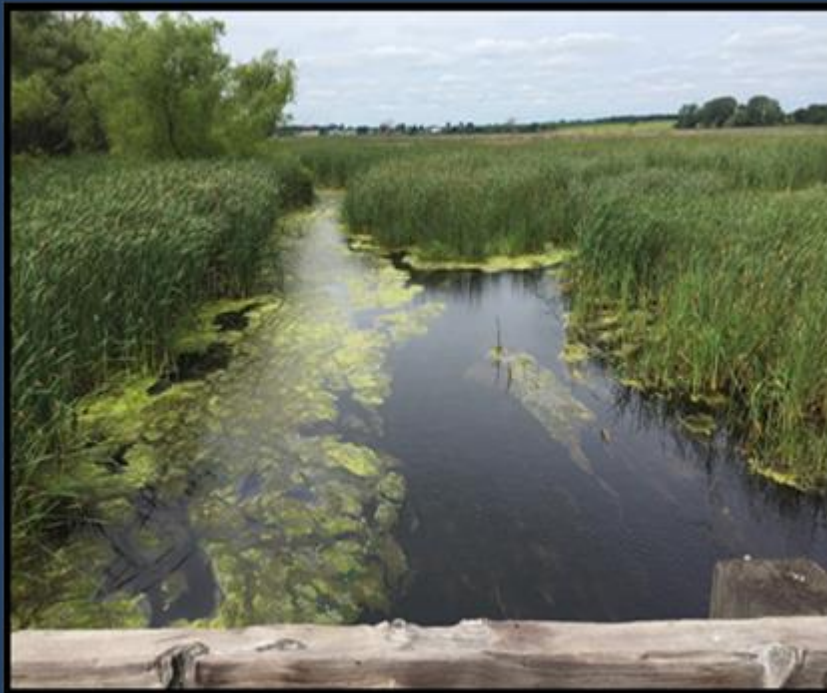
Beaver Creek looking upstream from CTH DG (downstream of Paradise Marsh)  
Photo by James Amrhein, Water Quality Biologist, South District

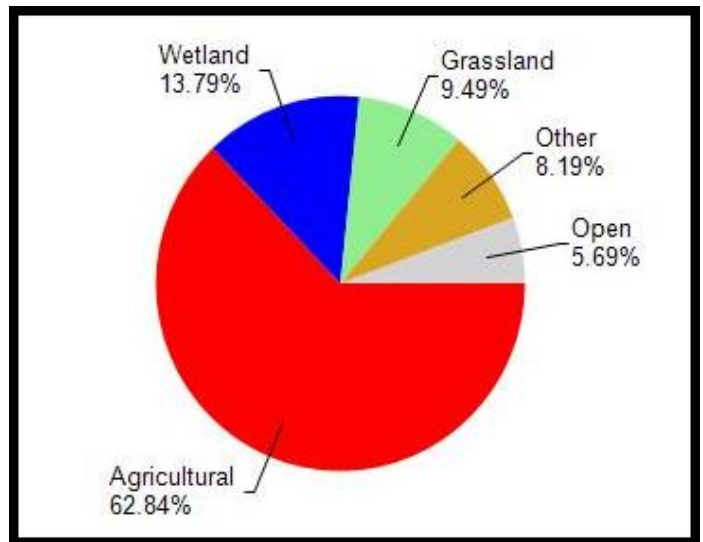
Figure 1: Land use in the Beaver Dam Watershed (WisLand2)

Most of the Beaver Creek Watershed is in cropland or pasture (Figure 1). The watershed also contains many wetlands and includes 2 state properties – the Paradise March Wildlife Area which encompasses 1800 acres and the Glacial Habitat Restoration Area which contains 380 acres.

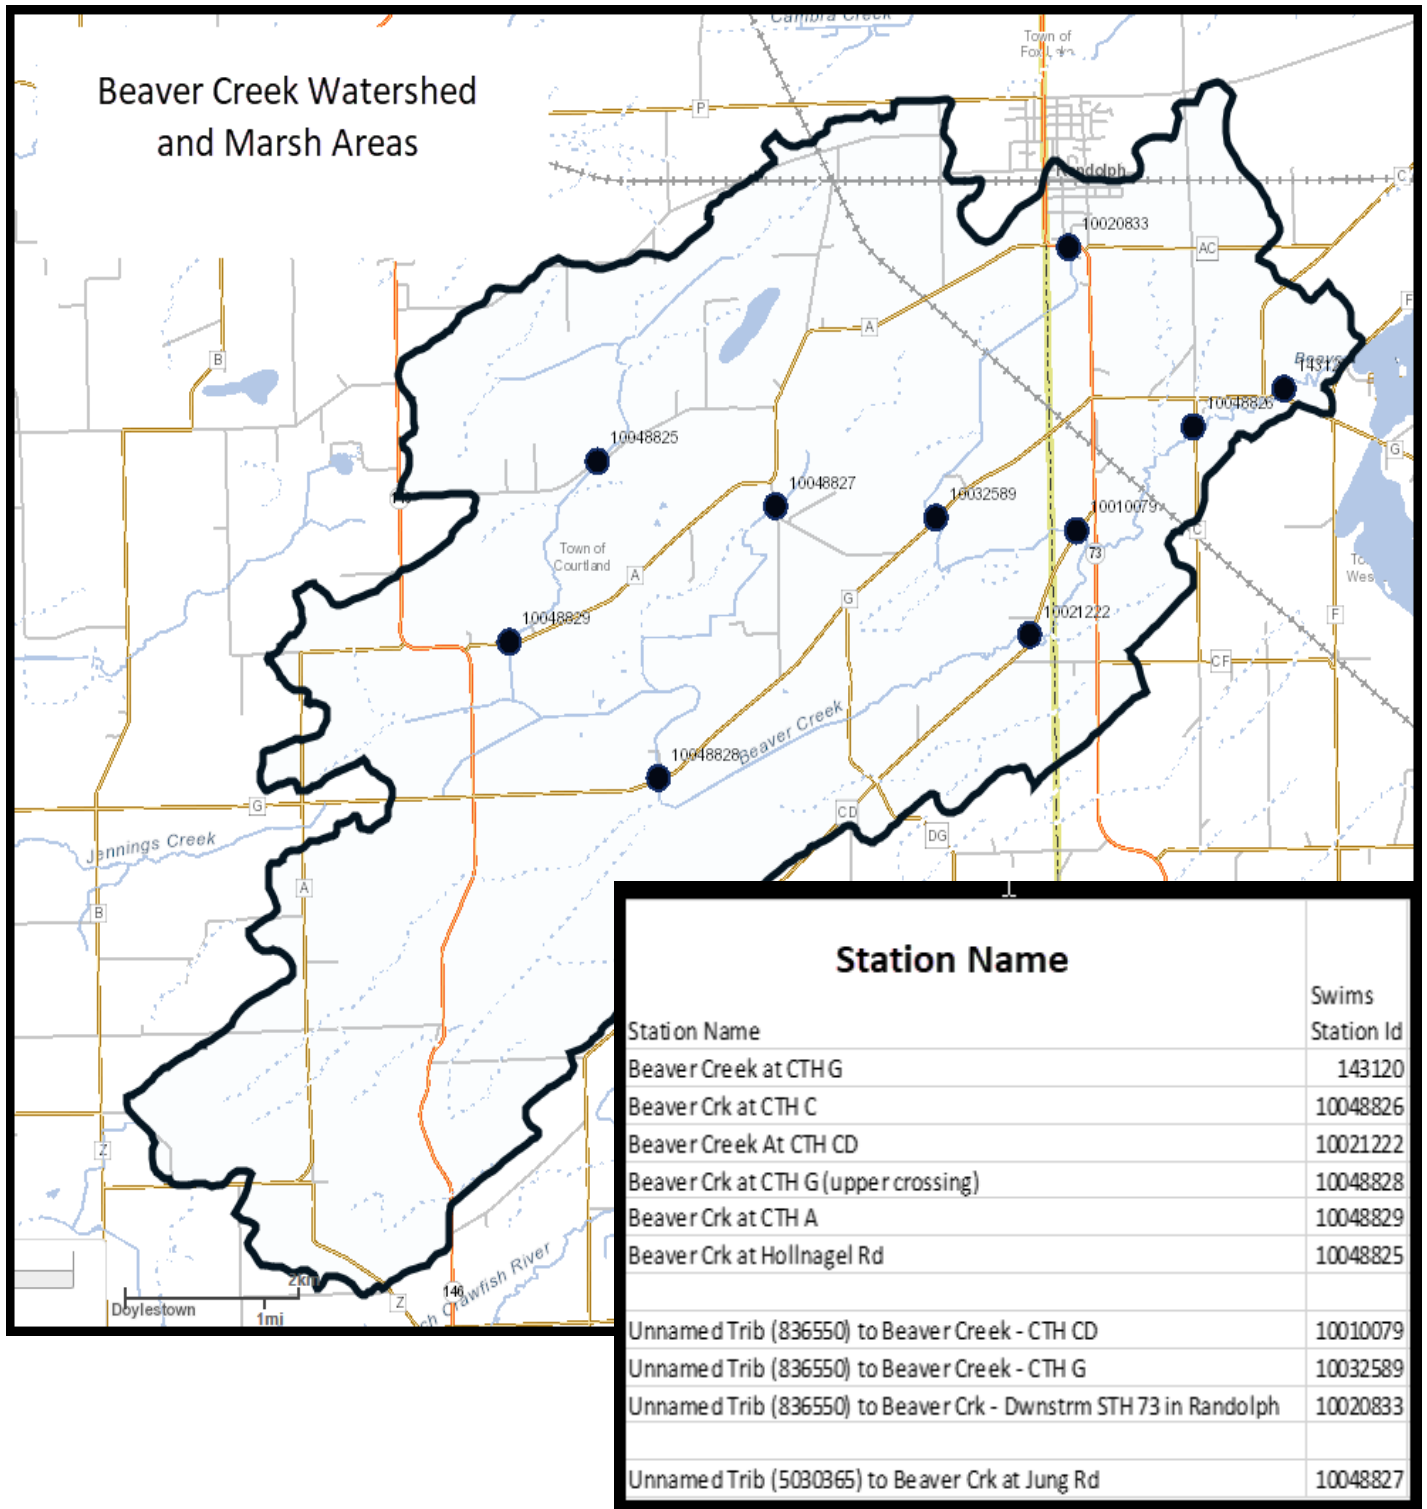
Figure 2: Sample Sites in the Beaver Creek Watershed 2017

The 2017 watershed survey was conducted by water resources biologists on 10 sites in the HUC 12 (Figure 2). Six sites were surveyed on Beaver Creek (WBIC = 836500), 3 on an unnamed tributary (WBIC = 836550) and 1 on another unnamed tributary (WBIC = 5030365).

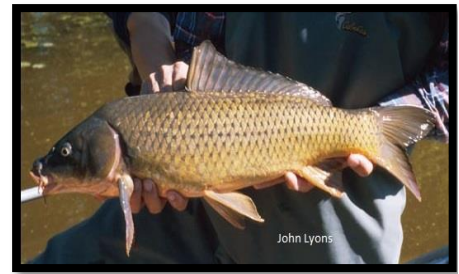
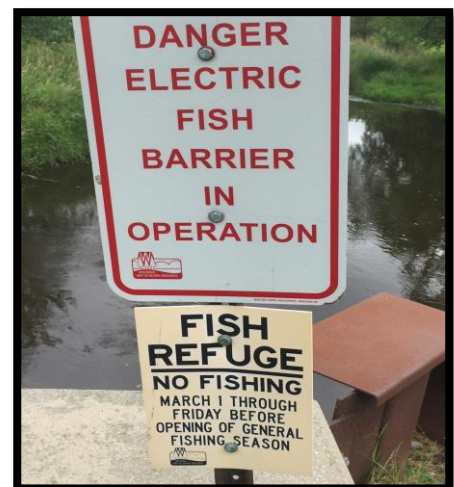
### Keep Out!

Common Carp (*Cyprinus carpio*) were identified as one of the factors limiting water quality of Beaver Dam Lake. To reduce carp populations in the lake, it is desirable to keep carp out of the wetland complexes of Beaver Creek where they prefer to spawn. An electrical barrier was placed across Beaver Creek at the (lower) CTH G crossing to prevent them from moving upstream into the marshes to spawn. Fisheries management operates the barrier annually. It is typically turned on in mid-to-late May, after northern pike, white sucker, and walleye have had an opportunity to move upstream and back downstream in the spring, but before the carp begin to spawn. It operates throughout the summer months and is turned off in the fall. It is hoped that reducing carp reproduction opportunities, as well as other methods to reduce carp populations in the lake will result in improved water quality.

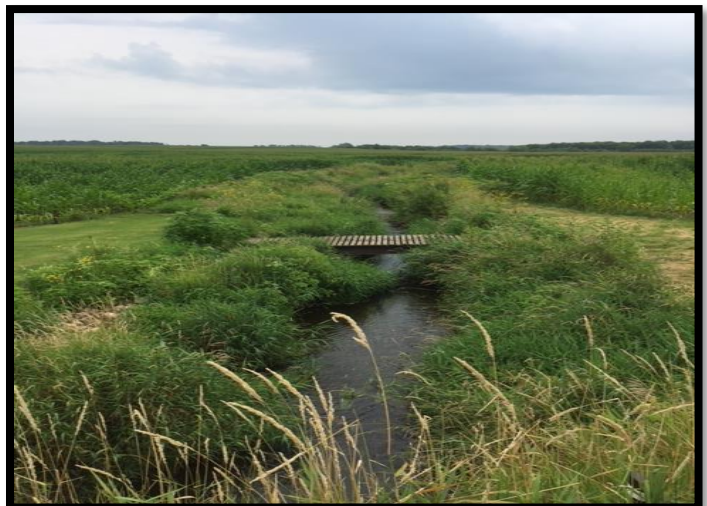
**Unnamed Tributary to Beaver Creek (836550)**

This 4.05-mile tributary to Beaver Creek, in the Beaver Dam River Watershed, falls in Columbia and Dodge Counties. This water is managed for fishing and swimming and is not considered impaired. Assessments during the 2020 listing cycle showed new bug sample data were in fair condition; however, a single fish sample was in poor condition. This water is currently considered in fair health and future monitoring is recommended.
