# Clark Lake Watershed, Door County Wisconsin Sensitive Area Report November 2006

Dates of Survey: April 2006 - August 2006

Authors: Darrin Hoverson and Nancy Turyk

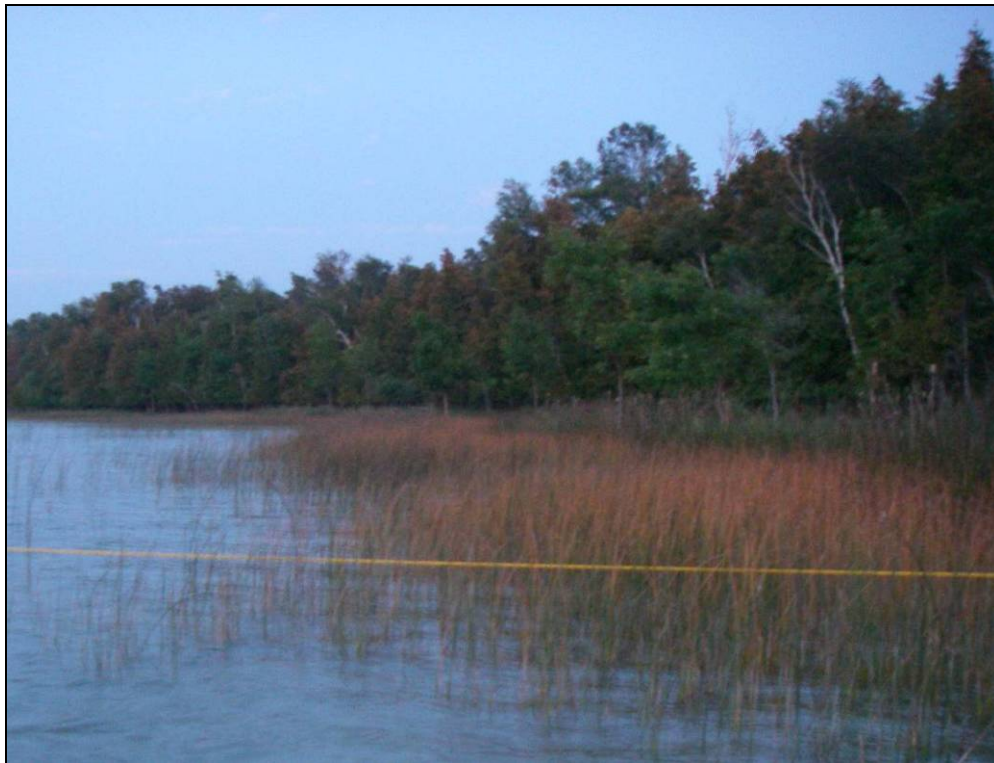
**Figure 3. View of S5**

Site **S5** is located on the south shore and is currently managed by the WIDNR as part of Whitefish Dunes State Park. S5 exhibited quality shoreline/shoreland habitat for wildlife with a mixture of wetland and upland plant species as well as fallen woody debris, lowland areas, and a strong hardstem bulrush community just off the shoreline. S5 is a large tract of shoreline in which many species of wildlife utilize for shelter, reproduction, and protection.

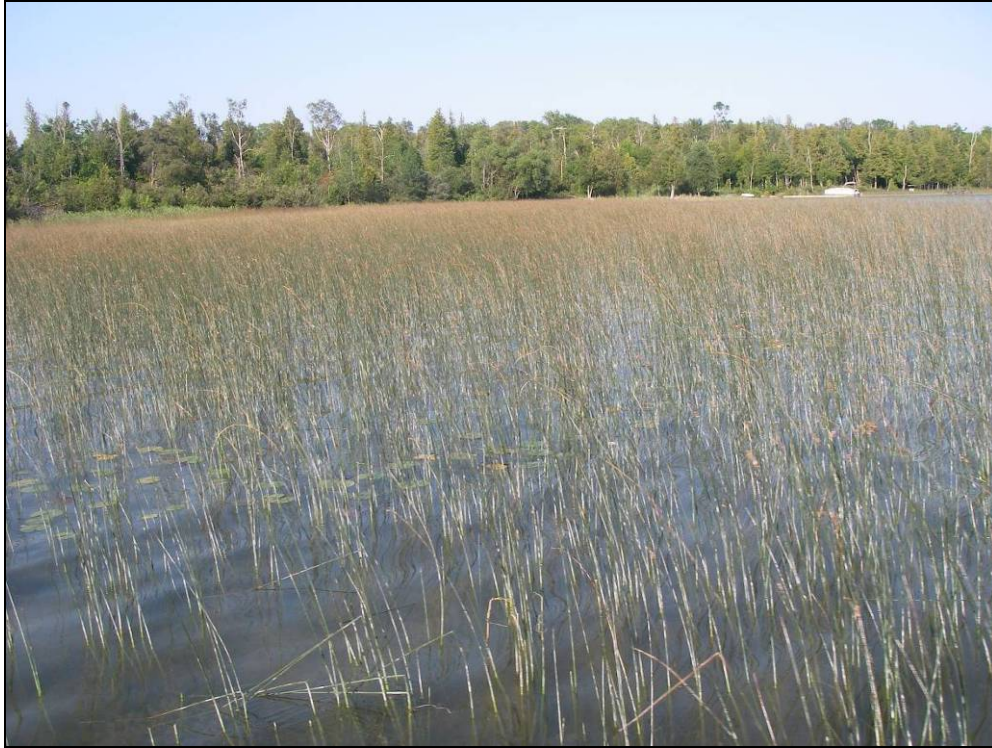
**Figure 4. View of S8**

Site **S8** is located on northeast corner of the east bay of Clark Lake. This shoreline exhibited one of the densest and healthiest hardstem bulrush stands

just adjacent to the shoreline with a variety of other aquatic plant species present. The shoreline is a large section of undeveloped lowland cedar swamp with a lot of blow down, woody debris, and habitat for wildlife.

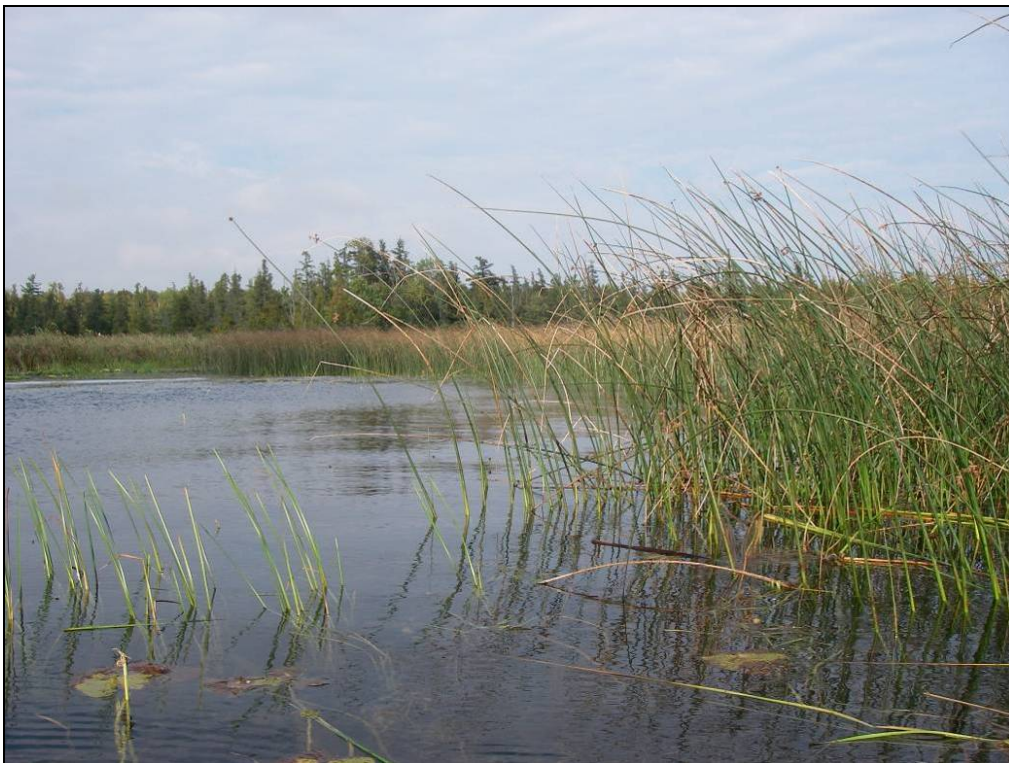
**Figure 5. View of S15**

Site **S15** is the shoreline adjacent to RC1 in the north bay of Clark Lake. This shoreline was characterized by lowland and white cedar swamp with a diverse and abundant plant community. Very dense and healthy hardstem bulrush stands just adjacent to the shoreline are what we consider some of the highest quality stands in Clark Lake. This shoreline included many groundwater discharge areas from which the groundwater originated further up in the white cedar swamp of RC3. S15 along with S16 both exhibit quality habitat for wildlife and is likely the shoreline with the least disturbance in Clark Lake.

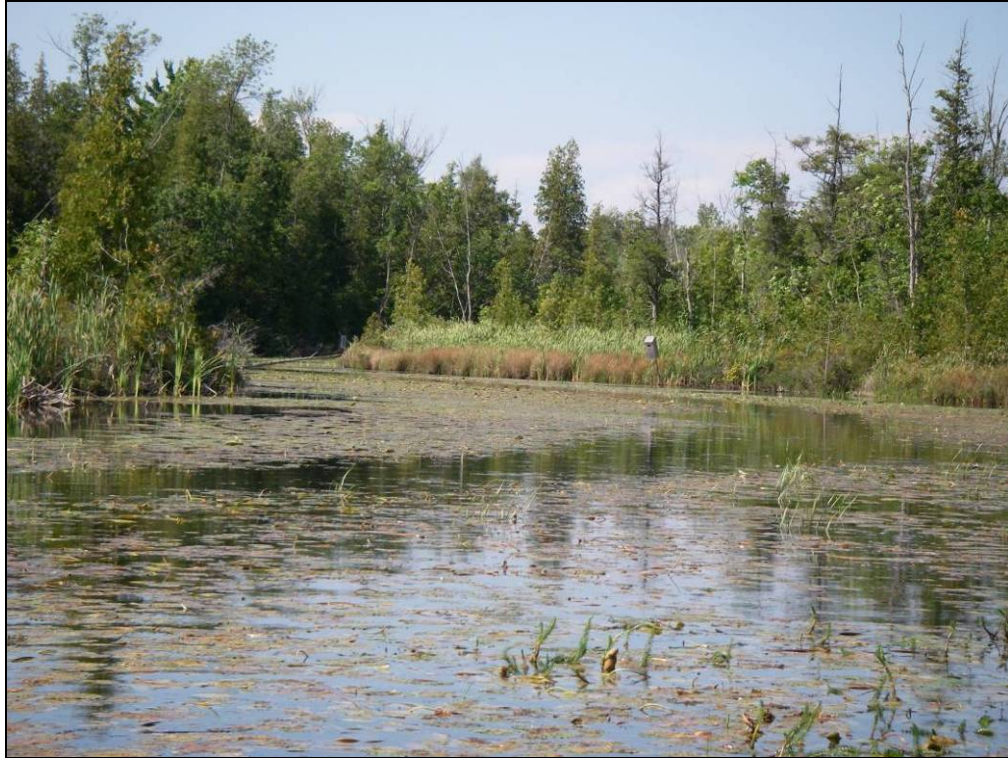
**Figure 6. View of S16**

Site **S16** is the shoreline adjacent to Logan Creek and in the region of RC3. This region had numerous direct groundwater discharge springs which are critical to the water quality/quantity entering Clark Lake. A healthy and diverse plant community exists within this region in and along Logan Creek. Many of these plant species are found only within Logan Creek (Hoverson and Turyk, 2006). S16 exhibits quality wildlife and fish habitat with ample lowland, vegetation, and fallen woody debris along the creek edge. As stated previously S16 along with S15 is likely the least disturbed shoreline in Clark Lake.

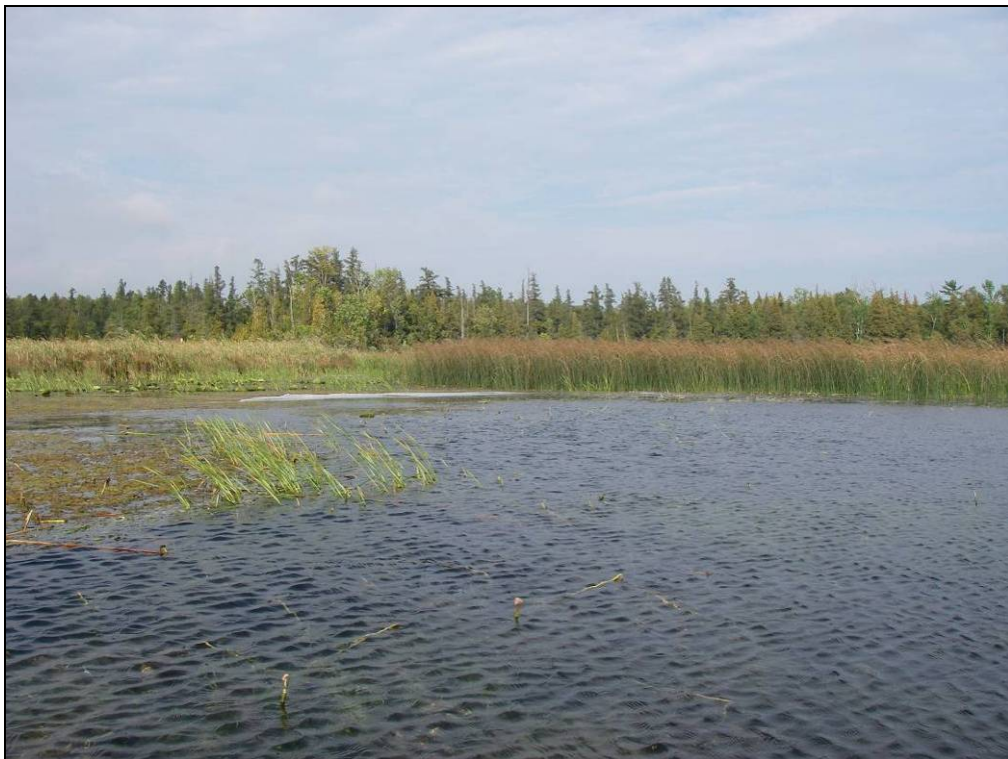
**Figure 7. View of RC1**

**RC1** is an in-lake location which is located at the mouth of Logan Creek and extends out into the north end of Clark Lake. This region is especially important to Clark Lake because it includes the most diverse and abundant plant community of the lake and the primary fishery/in-lake habitat (Aquatic Plant Survey, Hoverson and Turyk, 2006). Nineteen different plant species, many with high coefficients of conservancy or high in abundance colonize this area that is unlike any other location in the lake. Sensitive plants like wild rice (*Zizania palustris*) inhabit this area. Fish, insects, reptiles, amphibians, and many other wildlife species thrive in this region of the lake.

Sites RC1, RC2 and RC3 are the primary areas around Clark Lake that are essential for the health of the Clark Lake aquatic ecosystem. We recommend them for conservancy designation.

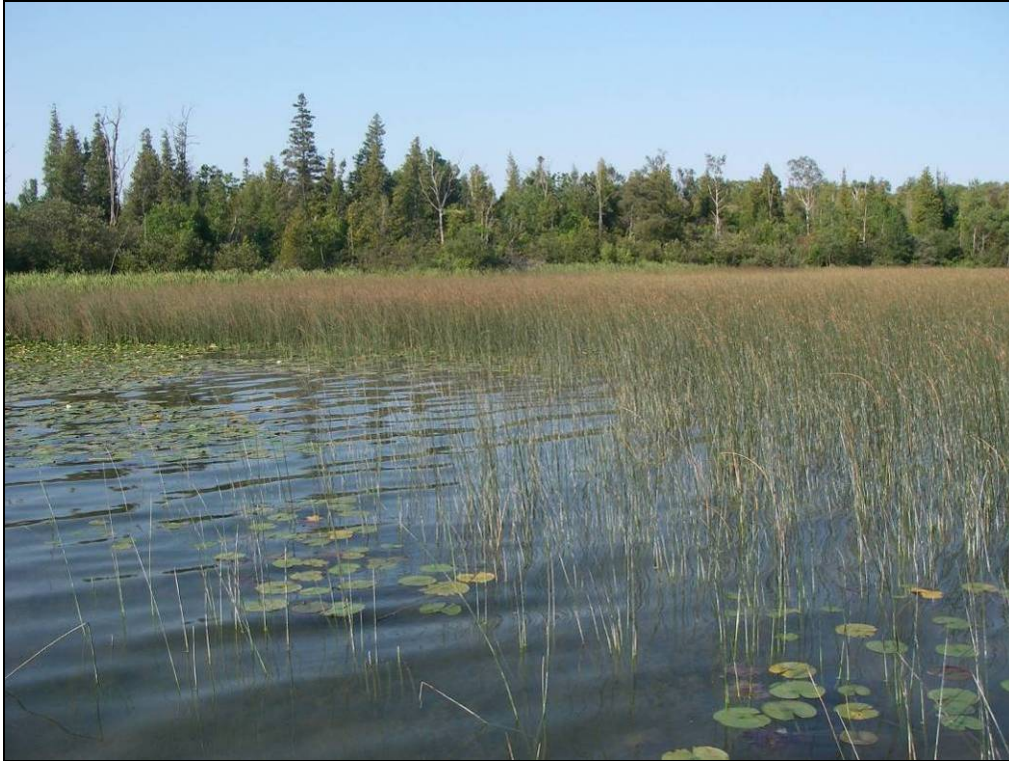
**Figure 8. View of RC2**

**RC2** is also a location of relatively high diversity and abundance in comparison to the rest of the lake. It is located in the north-east corner of the south-east bay. It includes a healthy hardstem bulrush community, little shoreline disturbance, and excellent habitat make it a candidate location to be recommended for conservancy.

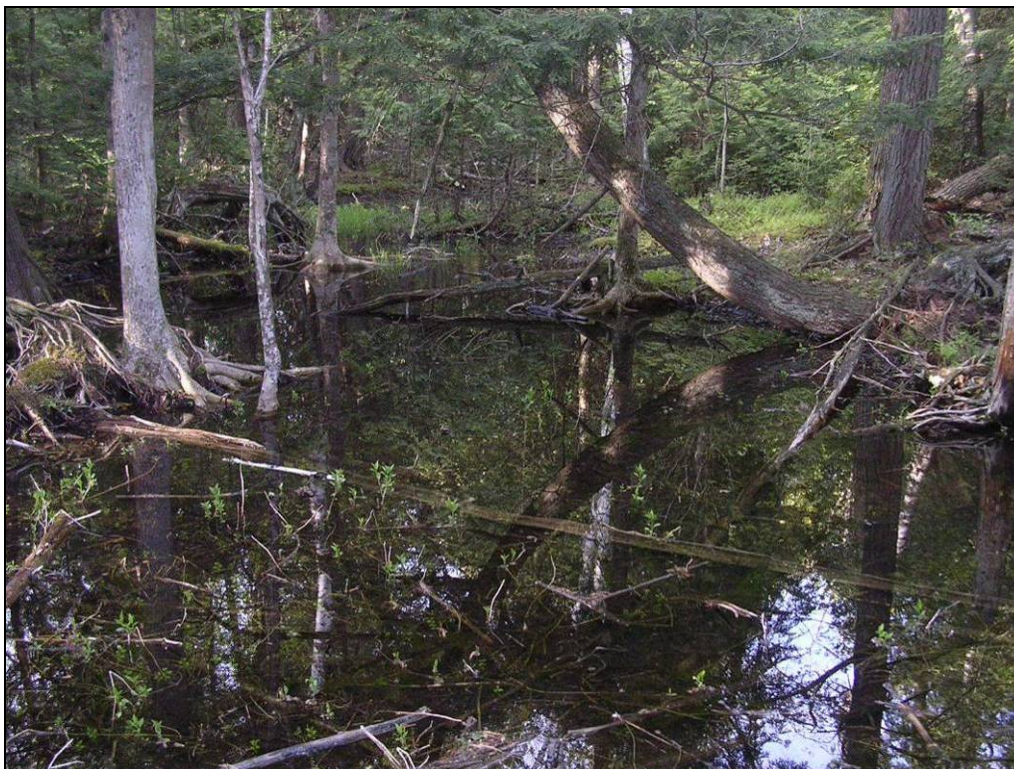
**Figure 9. View of RC 3**

**RC3** is the region surrounding Logan Creek including its healthy aquatic plant community and numerous groundwater springs within the region is also being recommended for conservancy. White Cedar (*Thuja occidentalis*) dominates

the vegetation adjacent to Logan Creek and Clark Lake, acting as shoreland buffer. Numerous fish species utilize the open creek area for reproduction and shelter, countless insects live amongst the fallen debris and riffles, as well as many other birds and wildlife use the area for nesting, feeding, and shelter. Areas of groundwater inflow are desirable locations for many species of fish spawning beds.

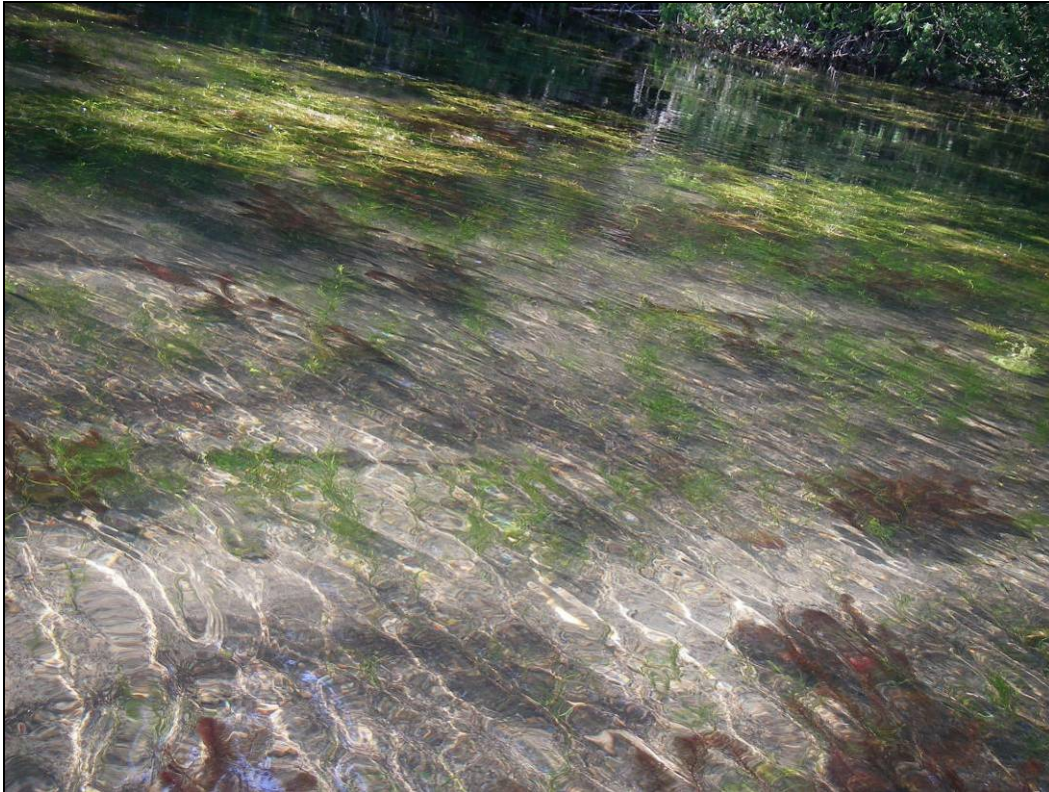
**Figure 17. Evidence of scouring of the Logan Creek creekbed.**

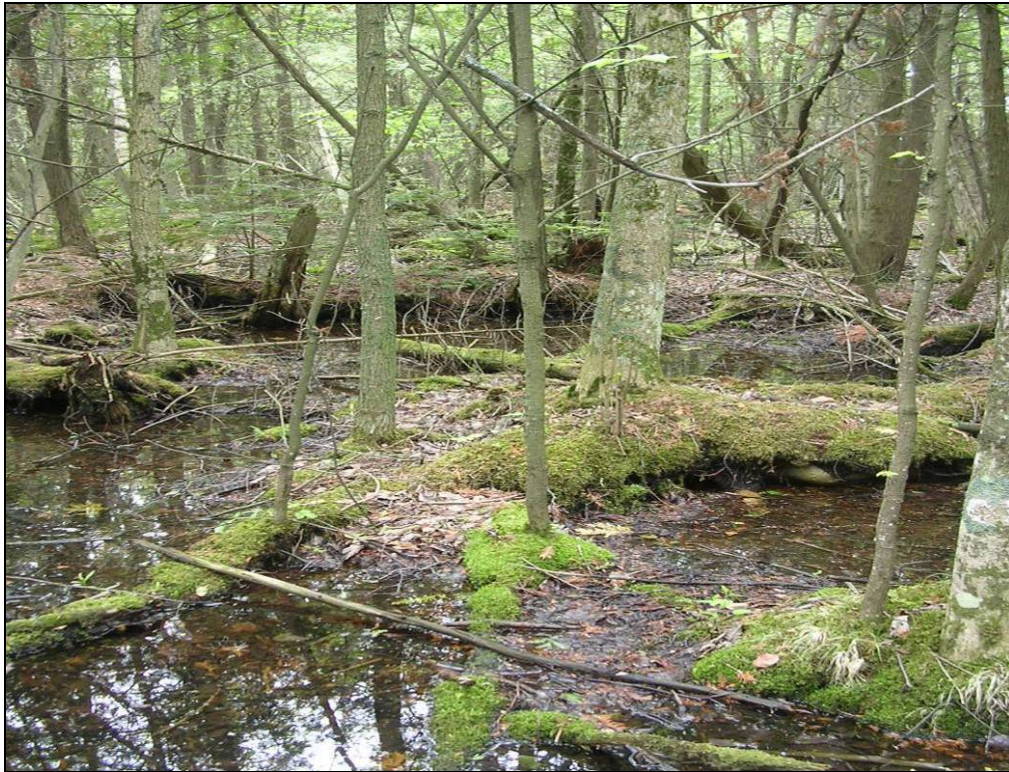
**Figure 19. White Cedar wetland surrounding much of Logan Creek**

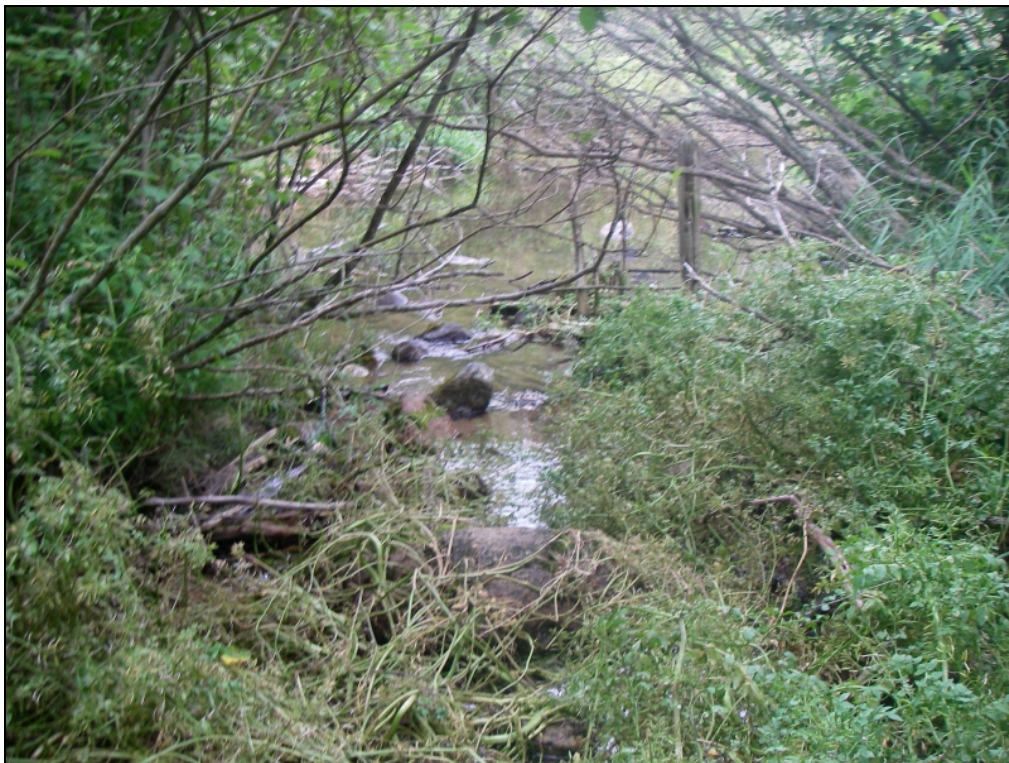
**Figure 20. Groundwater springs and water cress beds just north of Hwy 57**
