# Designation of Critical Habitat Lake Redstone, Sauk County, Wisconsin

**Donna Sefton & Susan Graham  
South Central Region  
Wisconsin Department of Natural Resources  
Fitchburg, Wisconsin  
Final Report  
January 5, 2009**

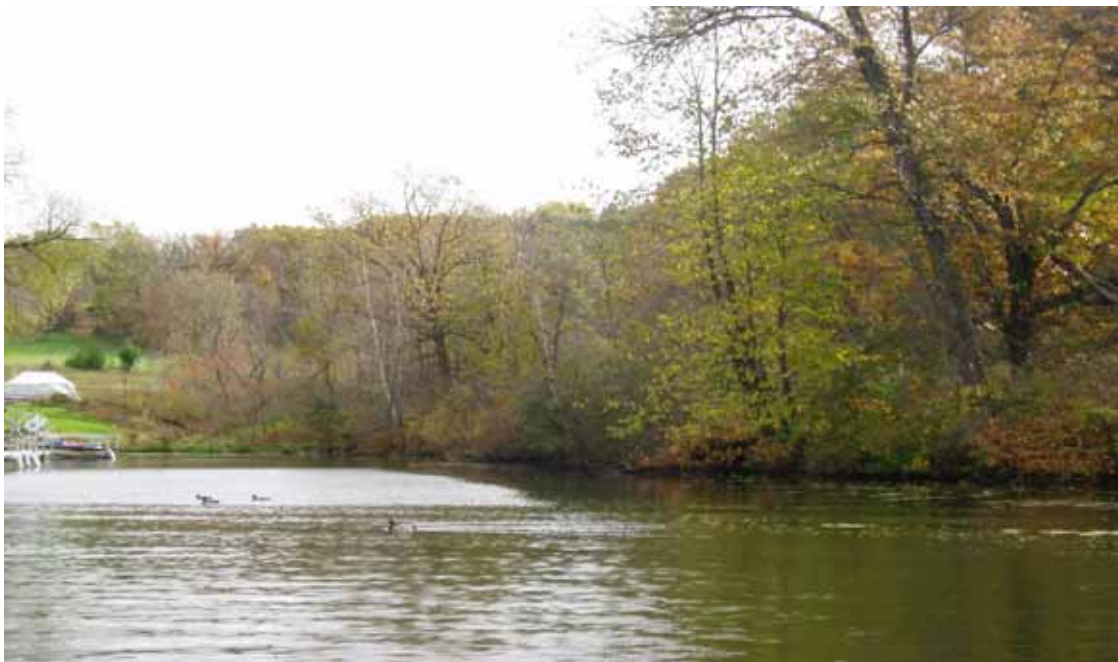
**Figure 14. Lake Redstone Critical Habitat 4.**

This Critical Habitat is the east inlet on the south edge of the northeast arm near Bob O Link Court (Figure 13). It is adjacent to Tanager Outlots 1 and 2. The shoreline at this Critical Habitat Area is 100% wooded, with trees and shrubs dominant and herbaceous cover abundant. Bracken fern and dogwood, along with willows, sugar maples and birch were noted on the slopes. Some snags were also present. Turtles and ducks were observed. Large woody cover from some fallen trees is present in the shallow water. This woody cover provides important habitat for fish and wildlife areas. A photo of the area is shown in Figure 14.

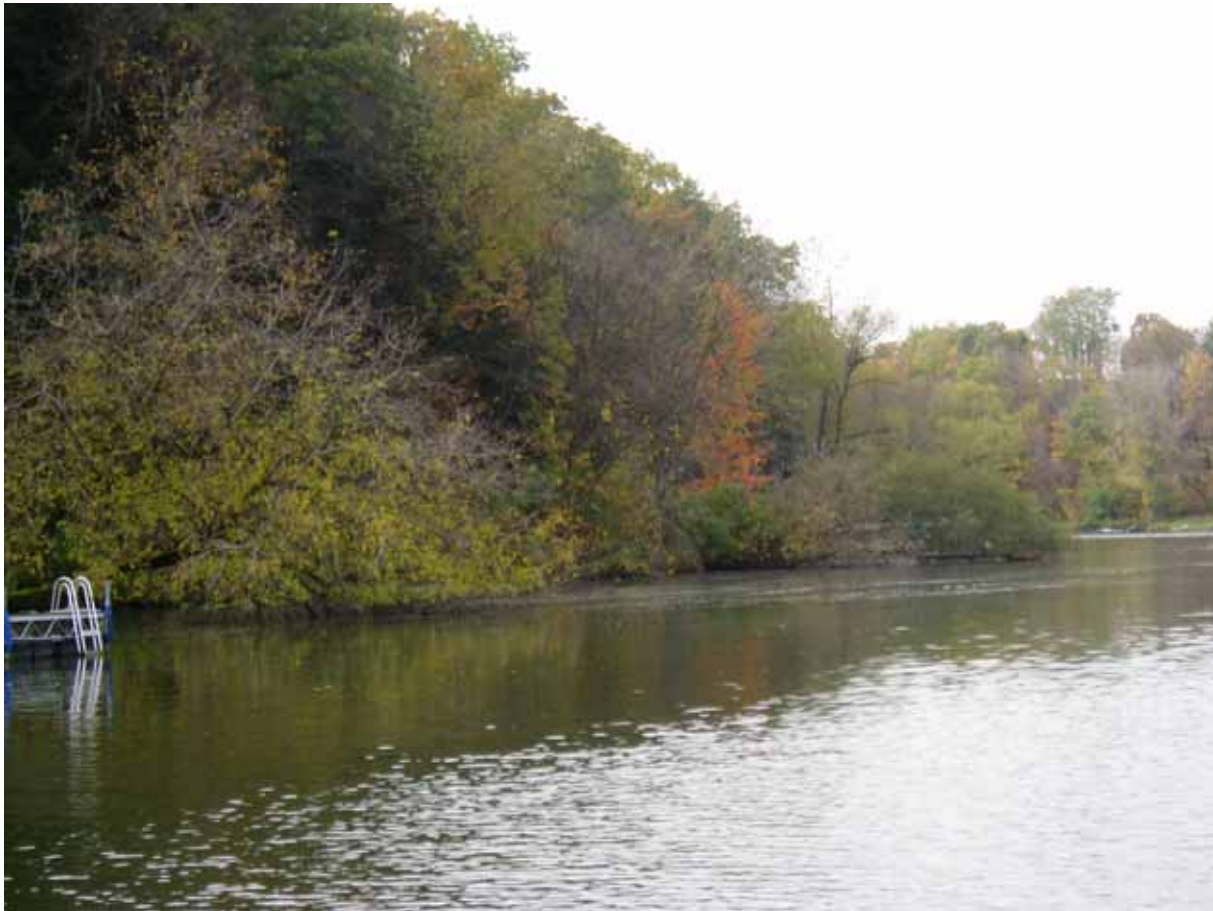
**Figure 16. Lake Redstone Critical Habitat 5.**

This Critical Habitat is located along the northern shore of the big point in the southeast portion of the Northeast Arm along East Redstone Drive (Figure 15). It is adjacent to the Public Access lot between Tanager Lot 28 and Swallow Outlot 1, and includes Swallow Outlot 1 and Lots 15-22. The shoreline at this Critical Habitat is composed primarily of trees, with very minimal development apparent. Trees overhanging the water provide a unique feature. Hemlocks, sugar maple and birch are found on top of the cliffs. A photo of the area is found in Figure 16.

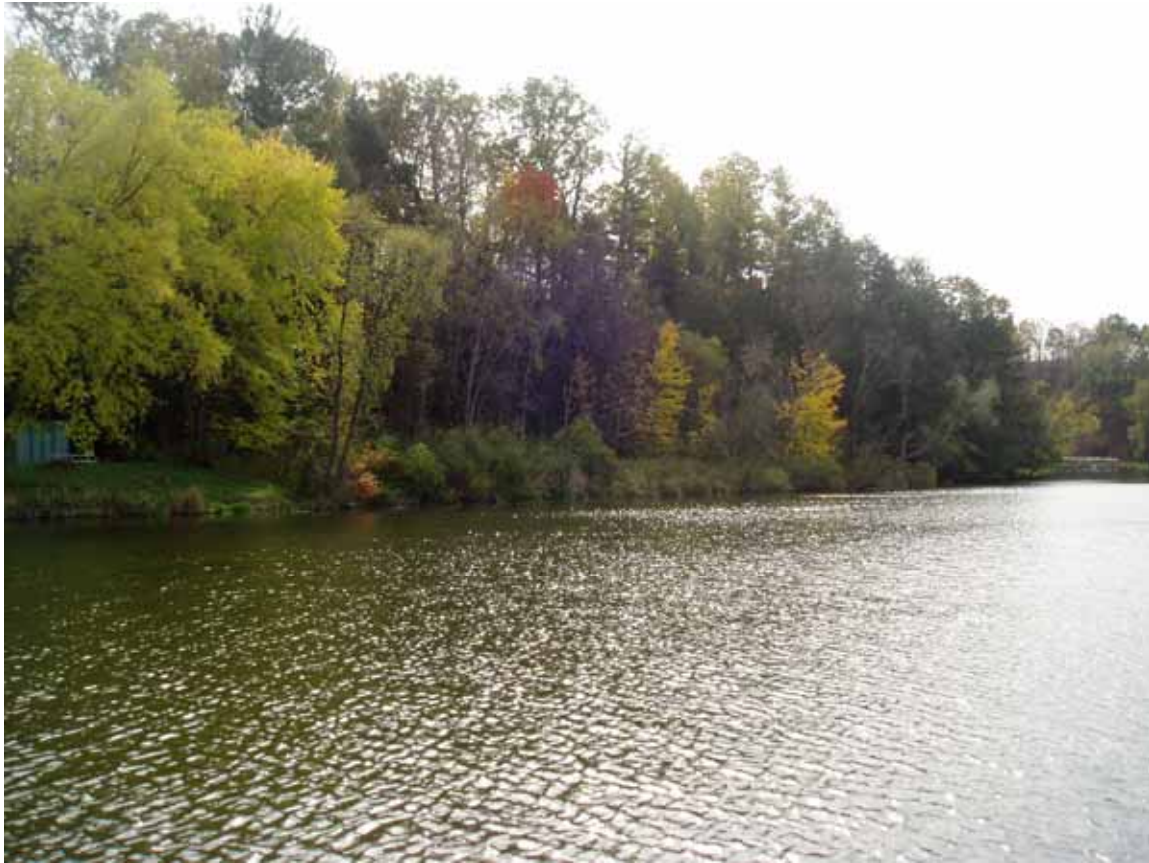
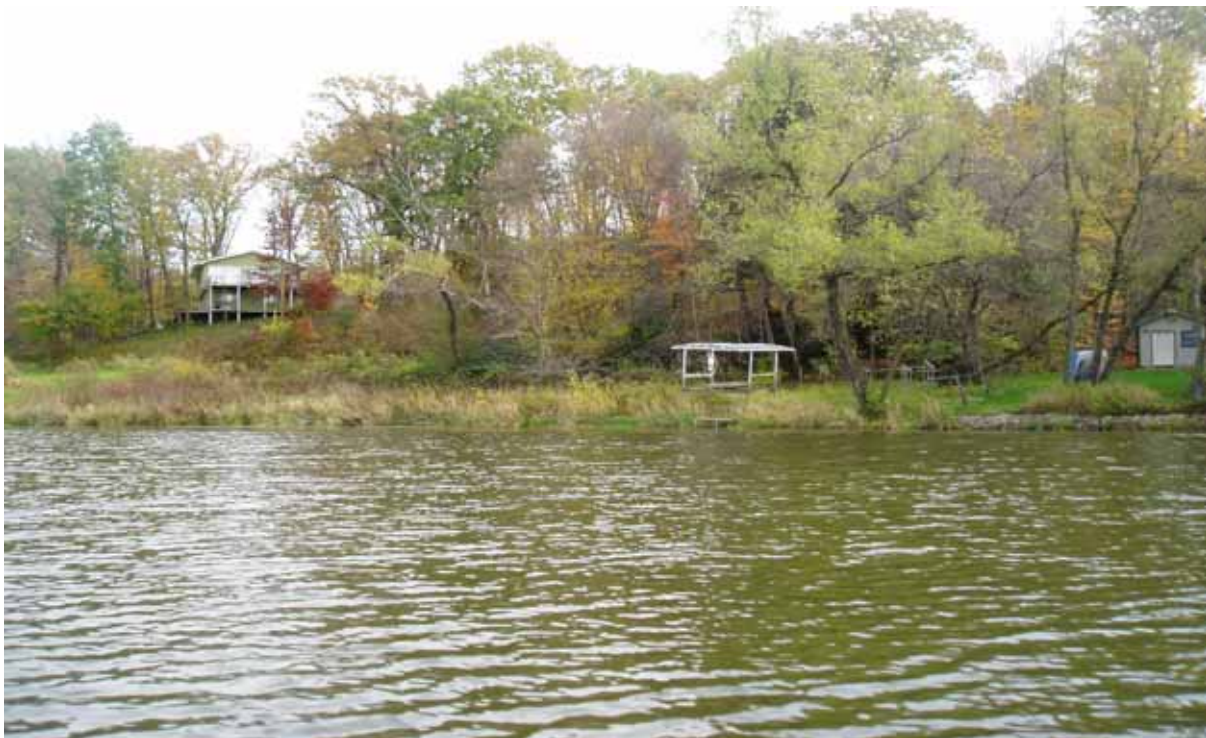
**Figures 22 and 23. Lake Redstone Critical Habitat 7.**

This site supports important near-shore terrestrial habitat, shoreline habitat and shallow water habitat. Large woody cover from some fallen trees is present in the shallow water. This woody cover provides important habitat for fish cover and wildlife resting areas. It is known to provide nursery, feeding areas and protective cover for panfish and crappies. Ducks were observed. Anglers were also observed. Photos of the area are found in Figures 22 and 23.

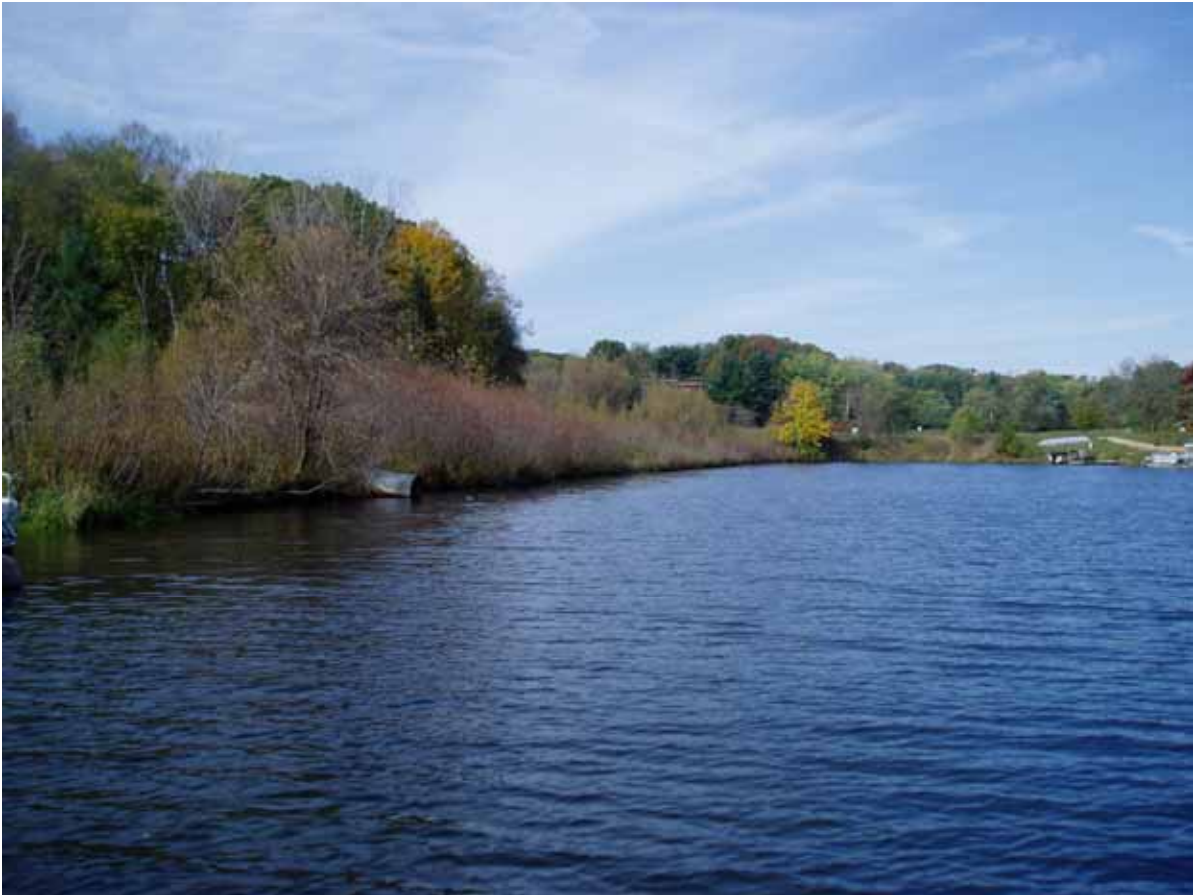
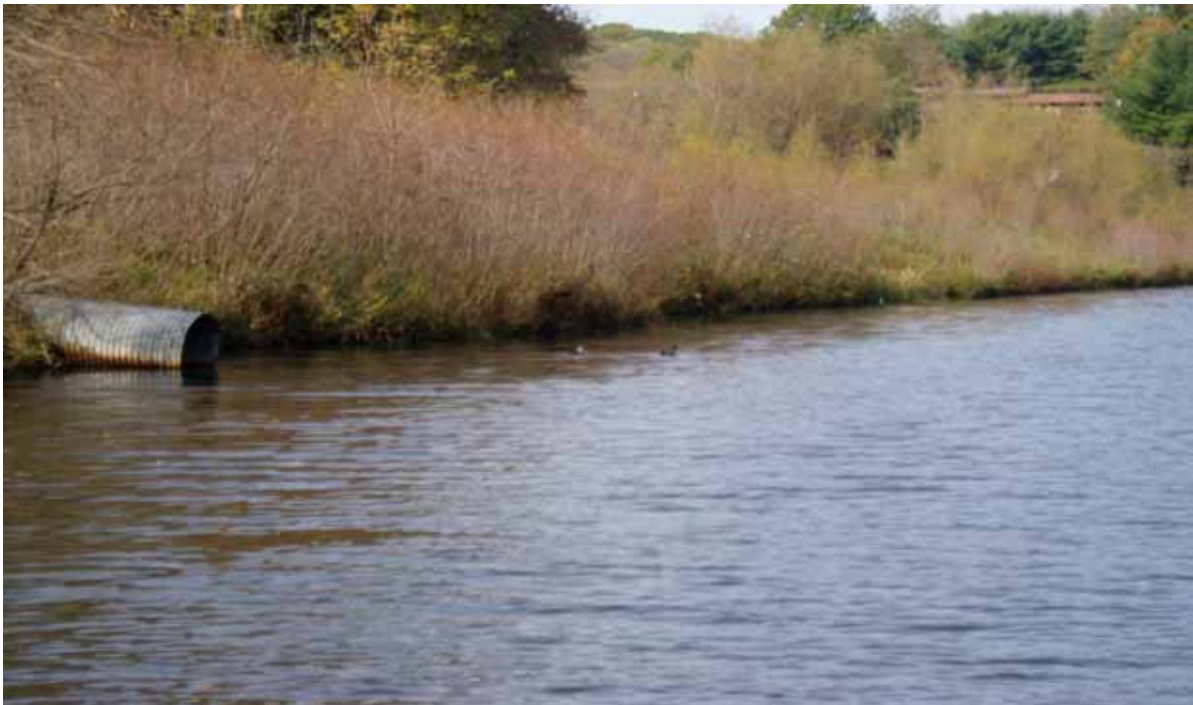
**Figure 43. Lake Redstone Critical Habitat 18.**

This Critical Habitat is the second long bay to the north off West Redstone Drive on the west-southwest side of the main lake (Figure 42). It is adjacent to Mourning Dove Lots 1-35 and Oriole Lots 30-44. It supports important shallow water and shoreland habitat. The shoreline on the southwest side of the bay is undeveloped, with old field, willow thickets, trees and other natural vegetation. White pines and sugar maples are found on the slopes. There is wetland and prairie on the west side of the bay. The flood in June, 2008 gouged out a significant gully before depositing a significant, sandy delta of sediment at the inlet. This filled in an area of this finger, but restoration of the site through dredging is currently being planned. The aquatic plants in this bay are not expected to change since the species present are fairly tolerant of disturbance. Figure 43 shows a photo of this area.

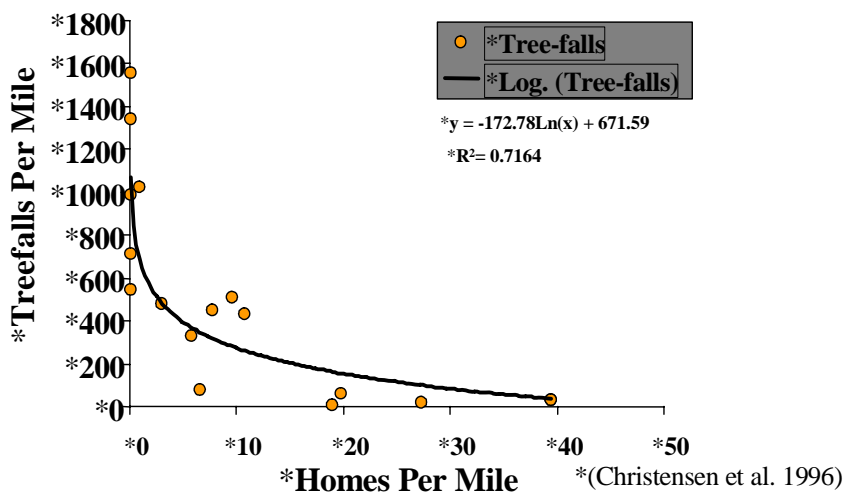
**Figure 4. Impacts of Residential Development on Treefalls into Lakes.**

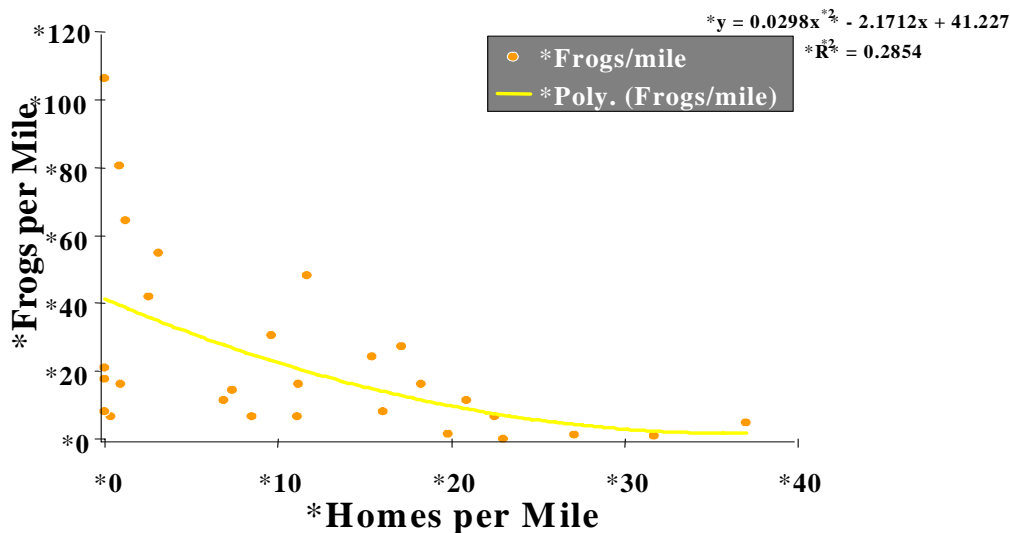
**Figure 6. Response of Green Frog Populations to Lakeshore Residential Development**
