POTATO LAKE BASELINE ANALYSIS

LAKE MANAGEMENT PLANNING GRANT

PHASE I REPORT

December 2005

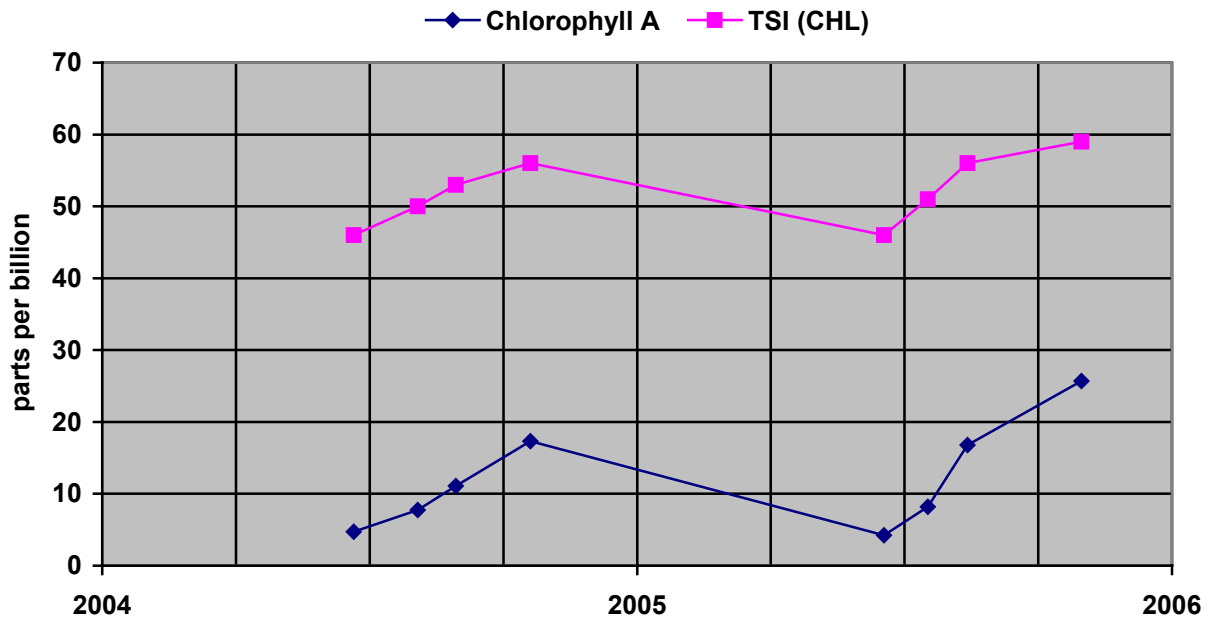
2004-2005	2004	2005
Average (ppb)	12	10.2	13.7
Median (ppb)	9.6	9.4	12.5
Range (ppb)	4.2-25.7	4.74-17.3	4.21-25.7
Average TSI	52.1	51.3	53
Median TSI	52.0	51.5	53
Range TSI	46-59	46-56	46-59

Chlorophyll a levels indicate mesotrophic conditions in the spring, but changing to eutrophic conditions in early summer with the first algae bloom. Algae blooms occurred in April, June, August and September during 2005. The average TSI value is 52 over the past two years, indicating a eutrophic state. The fall 2005 result was the highest so far.

Chlorophyll a: Average TSI chlorophyll a results ranged from 46 to 59 with an average of 52, which is eutrophic. Algae blooms occurred in April, June, August and September. The highest readings for 2004 and 2005 were during the fall.

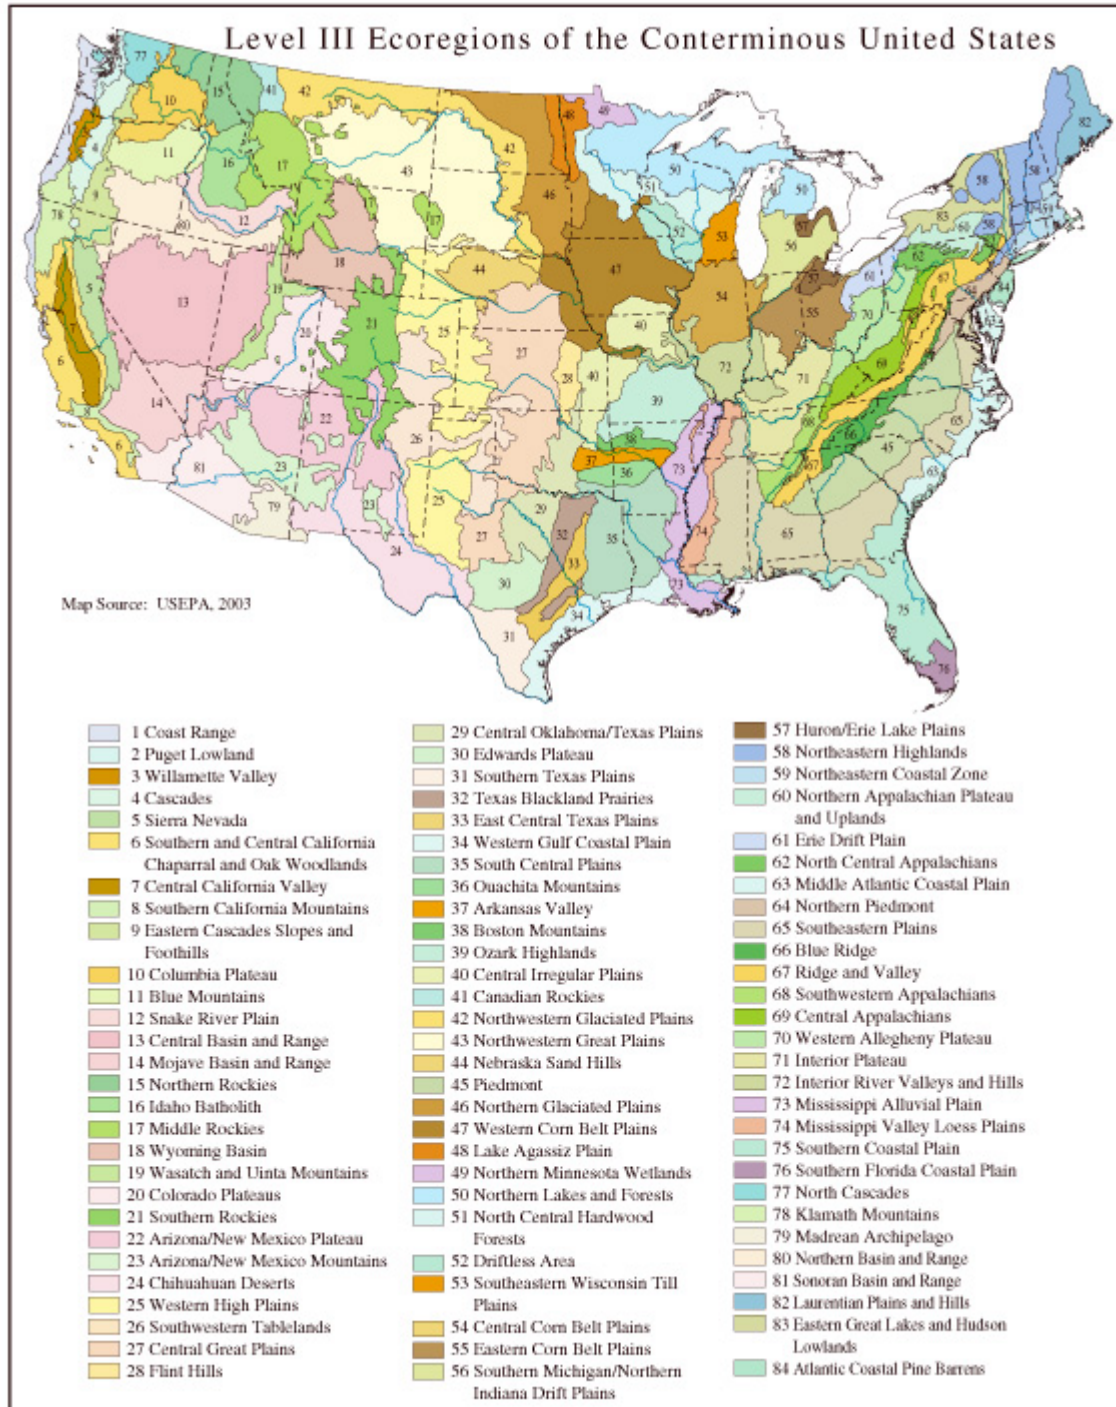
FIGURE 8
Potato Lake Ecoregion:
Northern Lakes and Forests

The Northern Lakes and Forests ecoregion parameter values according to Descriptive Characteristics of the Seven Ecoregions in Minnesota, by G. Fandrei, S. Heiskary, and S. McCollar, 1988, Minnesota Pollution Control agency were also used for comparison of Potato Lake’s values (see Figure 8). The typical values for Northern Lakes and Forests are listed below. Potato Lake contained higher total phosphorus, some chlorophyll a values exceeded the mean and maximum, and Secchi depths were on average shallower.
