Management of Aquatic Plants and Sediments in the Harmony Grove Channels

Harmony Grove Lake Protection and Rehabilitation District

April 5, 2007

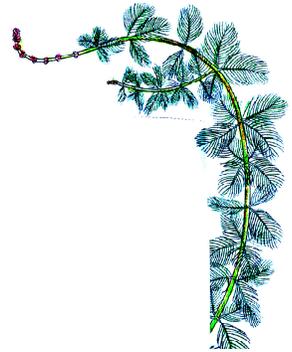
Eurasian watermilfoil

Eurasian Watermilfoil (*Myriophyllum spicatum*) produces long spaghetti-like stems that often grow up to the water's surface. Leaves are feather-like and resemble bones on a fish. 3-5 leaves are arranged in whorls around the stem, and each leaf contains 12-21 pairs of leaflets. At mid-summer small reddish flower spikes may emerge above the water's surface. Perhaps the most distinguishing characteristic though, is the plant's ability to form dense, impenetrable beds that inhibit boating, swimming, fishing, and hunting.

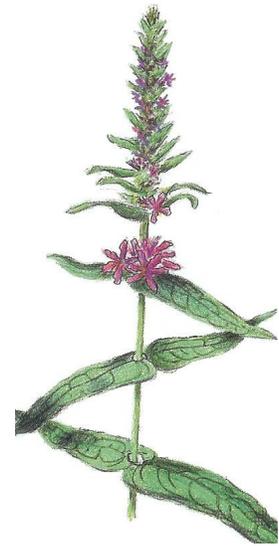
Purple Loosestrife

Purple loosestrife (*Lythrum salicaria*) forms bright purple flowers in a spike atop stems that reach 2 to 7 feet in height. Lance-shaped leaves are arranged oppositely along the stem. Purple loosestrife can be found in a wide variety of habitats from shallow water to moist soils. Like Eurasian watermilfoil it is a very aggressive plant that can displace many native wetland plants including cattails (*Typha spp.*). Purple loosestrife plants produce hundreds of thousands of tiny seeds. When purple loosestrife is cut, seeds stick to mowing equipment and are spread to new locations. This invasive plant causes significant economic damage by clogging waterways and irrigation canals. Unlike cattails, purple loosestrife has little food or cover value for wildlife (Borman et. al. 1997). When food and cover disappear, so do the species that depend on it.
