**Garners Creek Targeted Watershed  
Assessment: A Water Quality Report to  
Restore Wisconsin Watersheds, 2020**

***HUC: 040302040205, Monitored 2016***

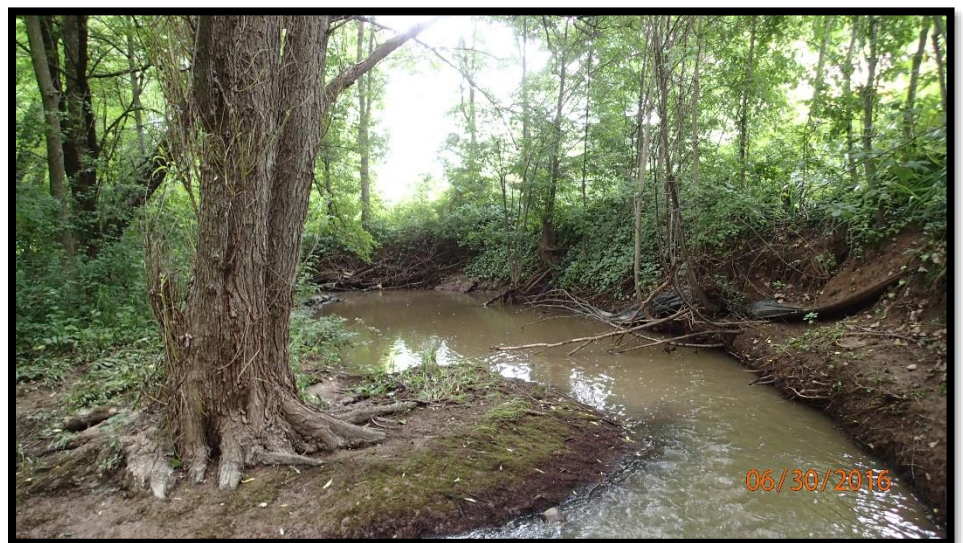
**Garners Creek at Brookhaven Drive. Photo by Andy Hudak, Wisconsin DNR, East District Biologist**

**Garners Creek Upstream Oakridge Drive Realignment, 2016. Photo by Andy Hudak, Wisconsin DNR, East District Biologist**

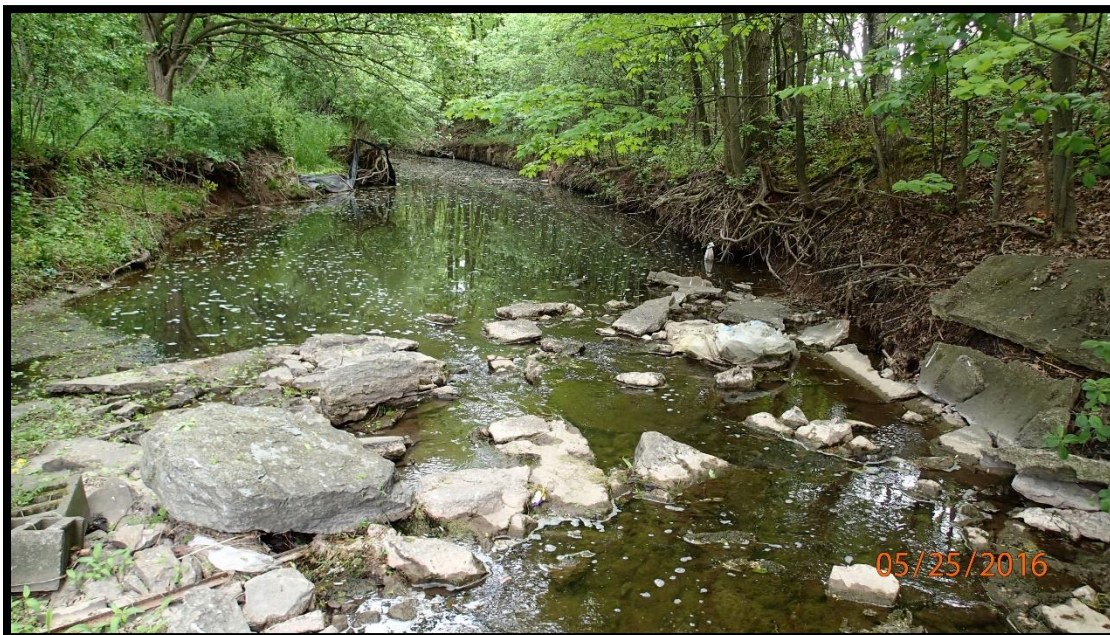
Unnamed Tributary to the Fox River Downstream of Pershing Road (concrete). Photo by Andy Hudak, Wisconsin DNR. East District Biologist

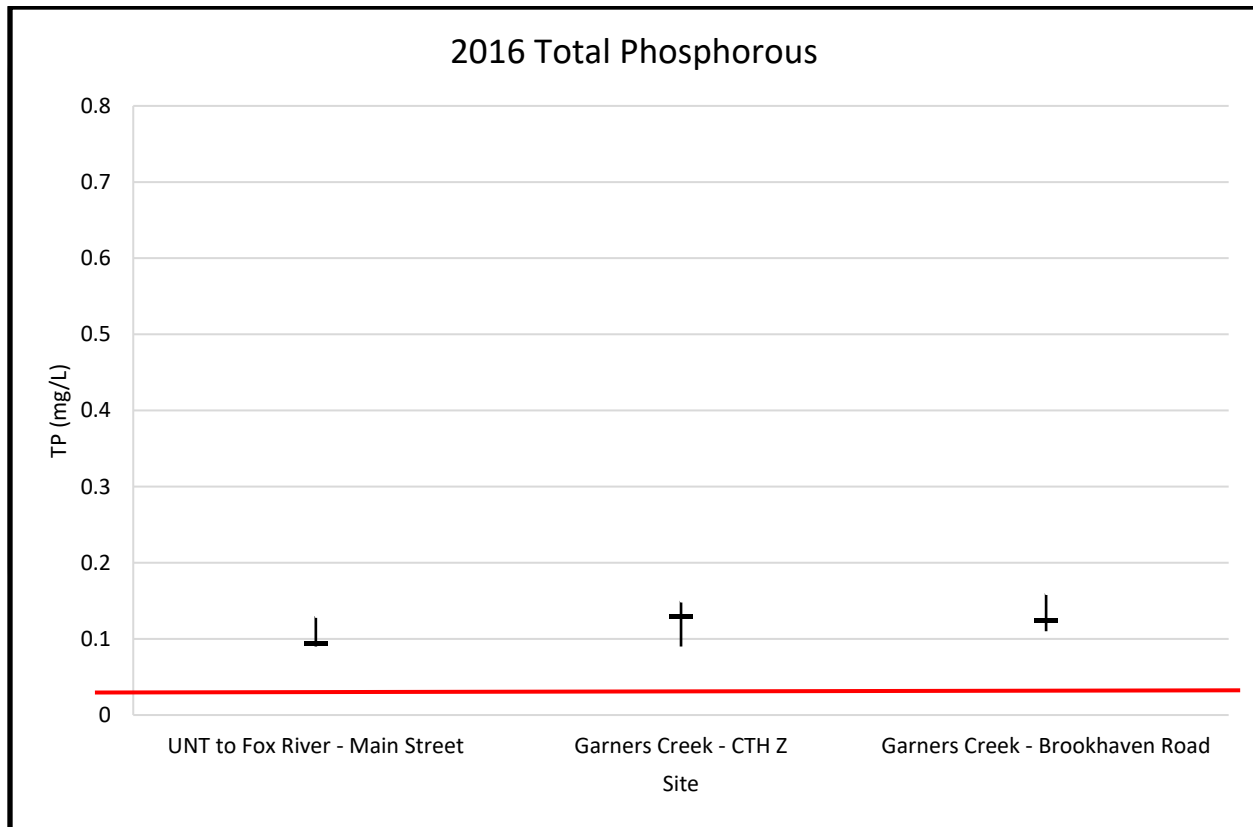
**Figure 6: Lower 90% confidence limit of Total Phosphorus concentrations in 2016 in the Garners Creek Watershed**

All inorganic chemistry samples were sent to the WISLOH in Madison for analysis. All sample sites for this project had an average TP concentration (mg/L) exceeding the NR 102 water quality criteria (WQC) for creeks and rivers of 0.075 mg/L (Table 3). Wisconsin Consolidated Assessment and Listing Methodology (WisCALM 2018) requires a parametric statistical approach to assess creek TP data against the applicable water quality criterion found in NR 102. This approach involves the calculation of a 90% confidence limit around the median of a TP sample dataset. If the lower 90% confidence limit (LCL) exceeds the criterion for TP, then that creek segment (assessment unit) is considered to exceed the criterion. The LCLs were calculated for each creek's TP samples (Table 3). Both locations on Garners Creek and the UNT to the Fox River had calculated LCLs that exceeded the water quality criterion for TP (Figure 6 and Figure 7).

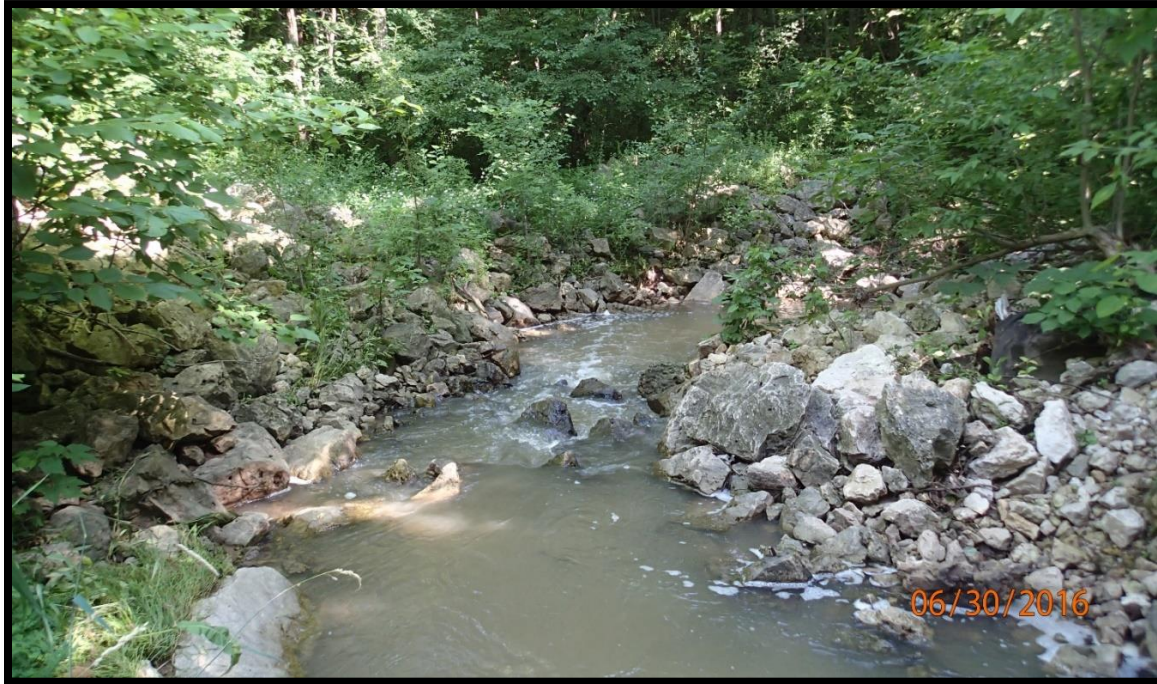
Garners Creek  
upstream of Oakridge  
Drive Realignment/  
CTH N.

A large comprehensive stream bank stabilization project had recently been permitted and constructed along the stream banks of Oak Ridge Drive on Garners Creek west of CTH N and south of CTH CE. **See Figure 5.** This segment of stream corridor was highly degraded with a dominance of bow elder, green ash, and buckthorn. Significant bank failure was occurring and had the potential for infrastructure damage to homes in the area.

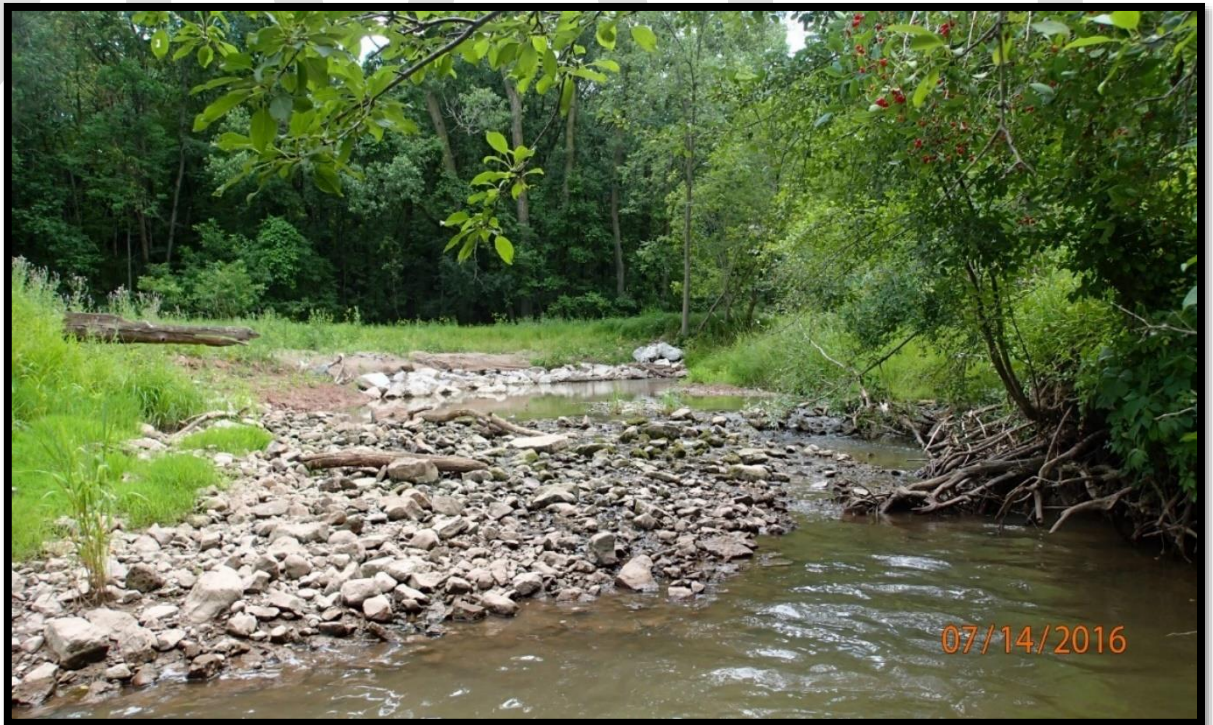
Garners Creek at  
County Highway Z.

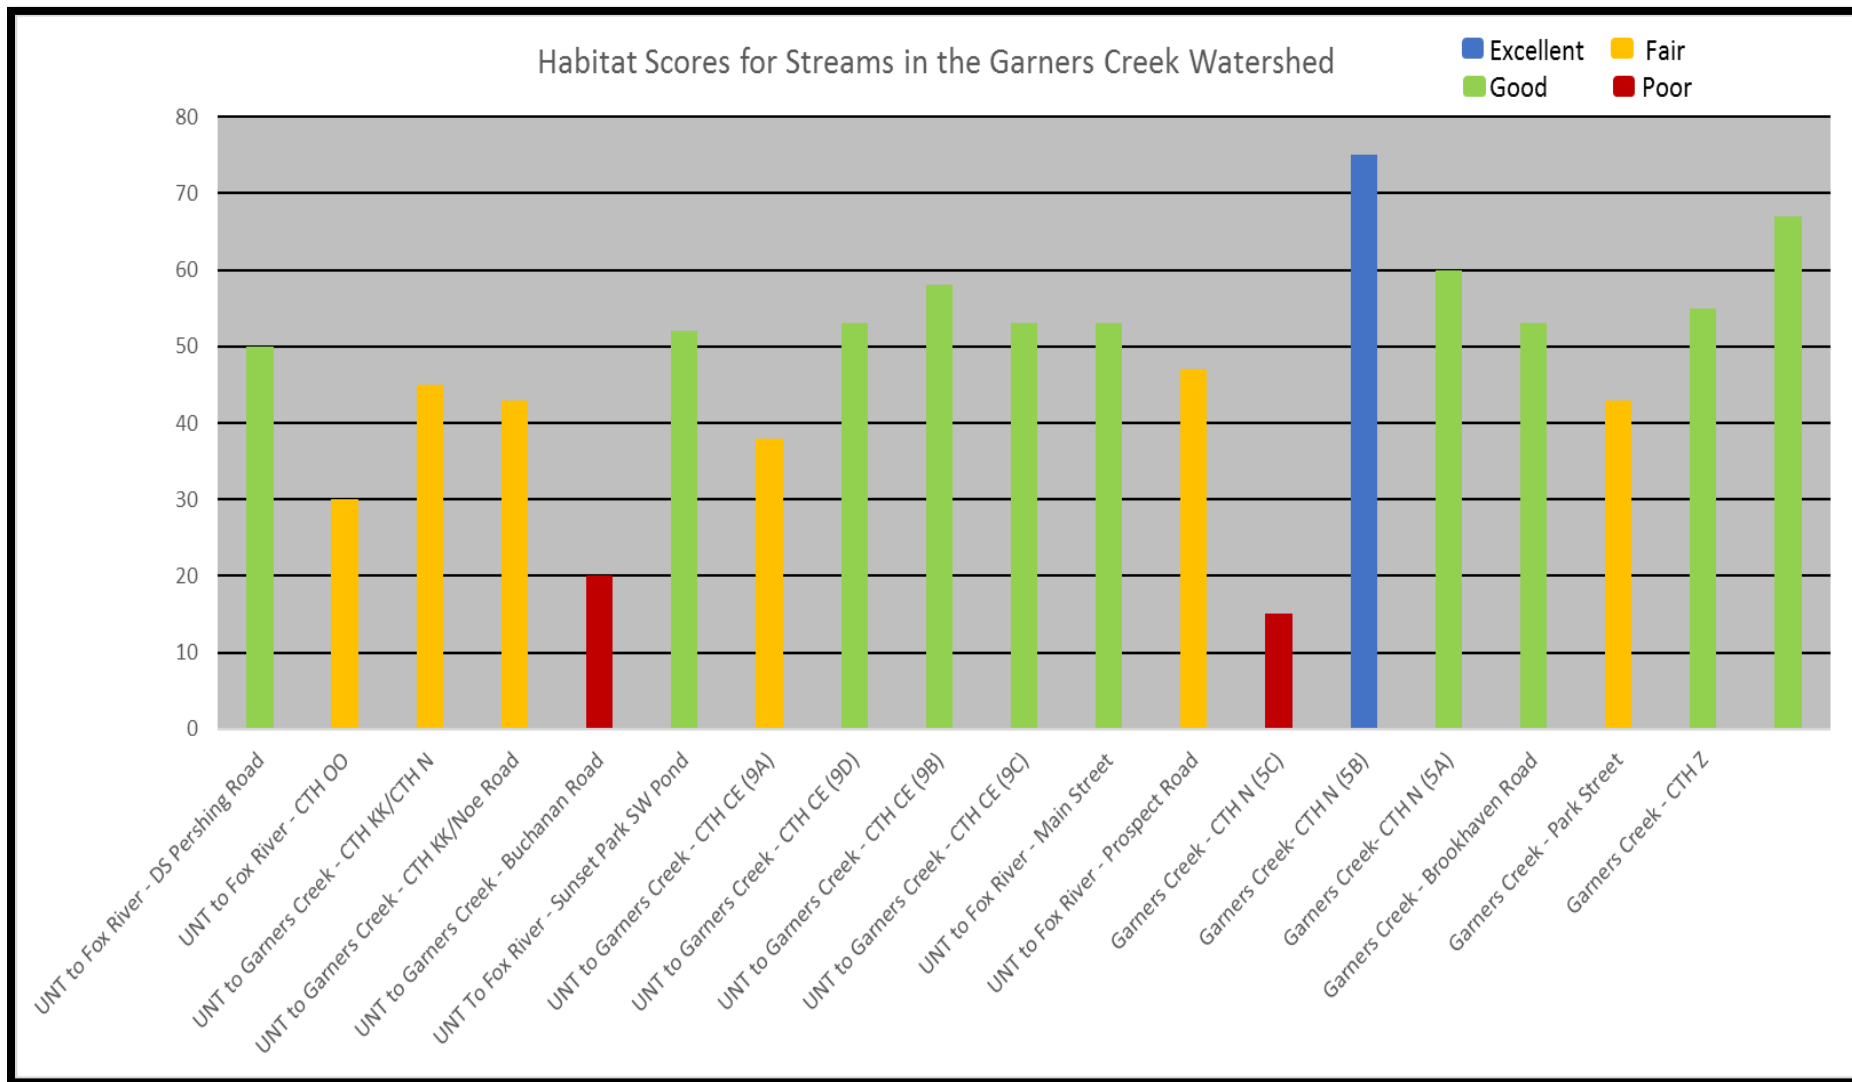
Figure 12: Habitat Index of Integrity scores and rating in the Garners Creek Watershed in 2016.

Quantitative habitat assessments evaluate a representative stream reach (35 X Mean Stream Width) for the quantity and quality of habitat for fish and compare the habitat to reference streams in Wisconsin. Based upon the assessment data collected during the 2016 surveys, a habitat rating was calculated for the 19 small streams less than 10m wide (Table 8, Figures 12 and 13). The habitat rating scores were relatively similar for all streams and half scored in the Fair range and half scored in the Good range. The greatest factor influencing the score and rating of Fair to Good is the undisturbed buffer width, bank erosion, the width to depth ratio, and riffle to riffle ratio. Cover for fish is largely absent from the stream.

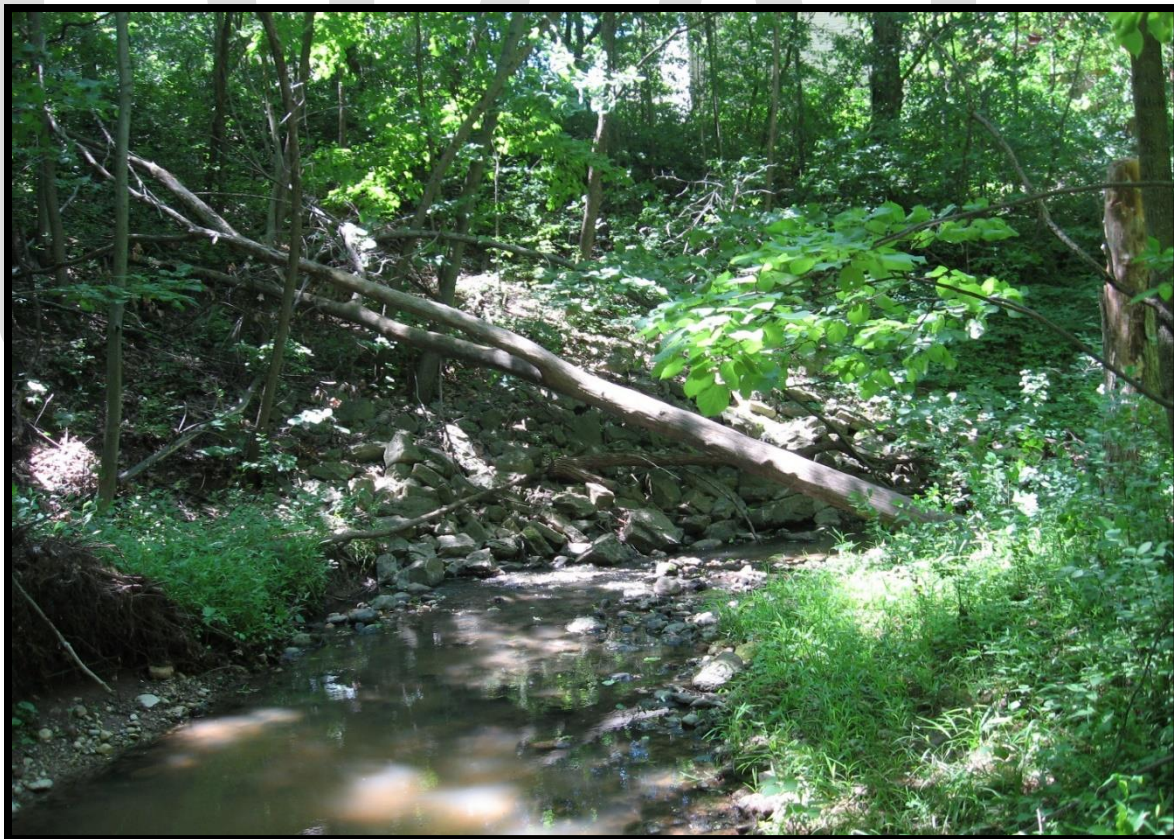
Overall habitat conditions were mostly in the fair to good category however these scores were likely bolstered by several metrics that were favorable in this watershed as observed by the biologist. The undisturbed buffer width was maintained at many locations as was the erosion score. Coincidentally the streams are highly entrenched in an urban landscape and set within valleys which limits the ability of development to encroach within the 10m buffers. There has also been extensive riprap installed throughout the watershed. It was noted this often occurred within the sample reach that seemingly artificially inflated the erosion score metric. In some locations, extensive streambank stabilization measures have been attempted to protect severely eroding banks only to deflect energy downstream leading to additional bank failures on unprotected banks. When looked at in a broader context, while a riprap protected bank may have corrected one bank erosion issue it often leads to the manifestation of increased downstream erosional issues.

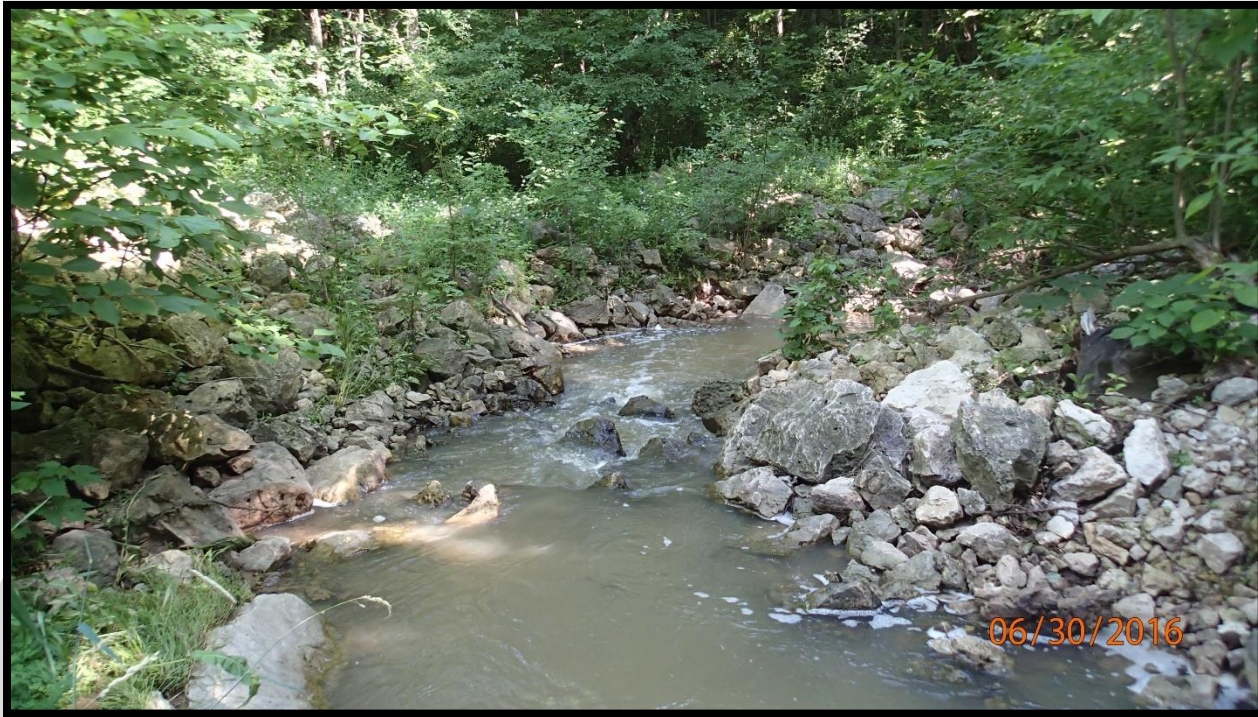
The installation of rock riprap also led to an apparent increase of the score to the metrics for riffle to rifle and width to depth ratio in some cases. It was often observed that rip-rap installation may have failed or been incorrectly installed which altered stream morphology indirectly falsely improving the habitat score.

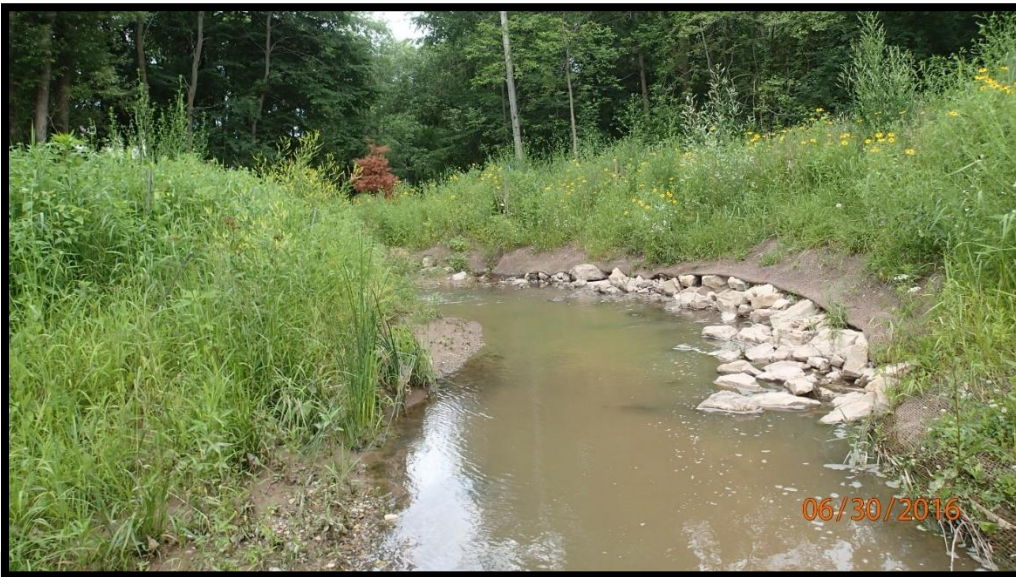
Integrated bank stabilization treatment with a rock toe.

The restored reach appeared to have benefited habitat scores not only in the stream within the restored reach but also extended benefits downstream. A significant 50-point increase in the FIBI score occurred within the restored reach and 30 points at the DS reach further supporting the evidence that the restored reach may have extended benefits downstream. The restored reach was the highest scoring reach surveyed in the watershed in 2016. The MIBI scores also improved in the restored reach and improved further in the downstream reach. It is difficult to determine the exact extent that the comprehensive stream restoration improved conditions in Garners Creek however, it is evident that aquatic habitat and overall conditions improved within and downstream of the restored reach providing ecosystem benefits for aquatic life.

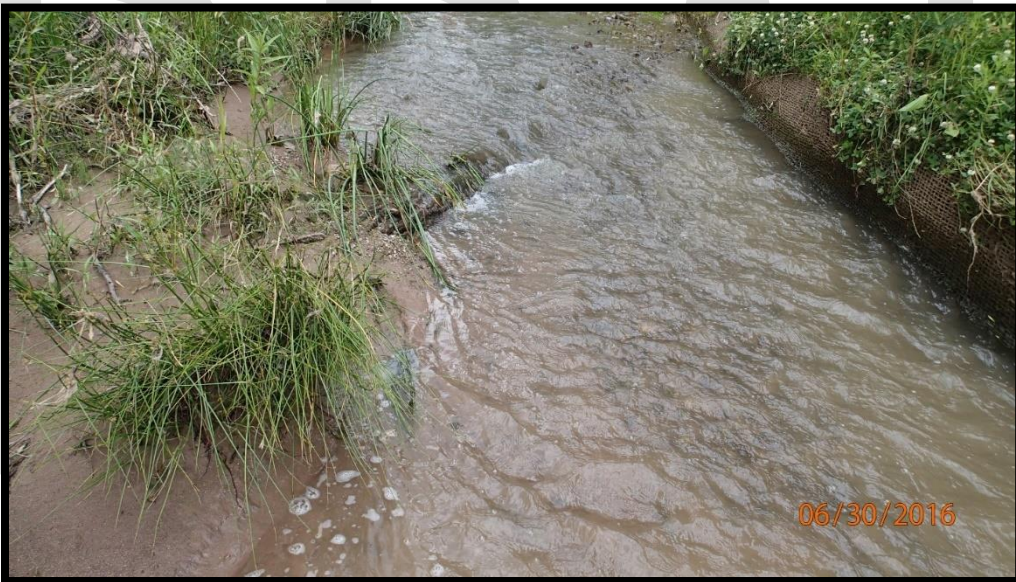
Cross log-vanes for habitat and sediment and stream feature improvements

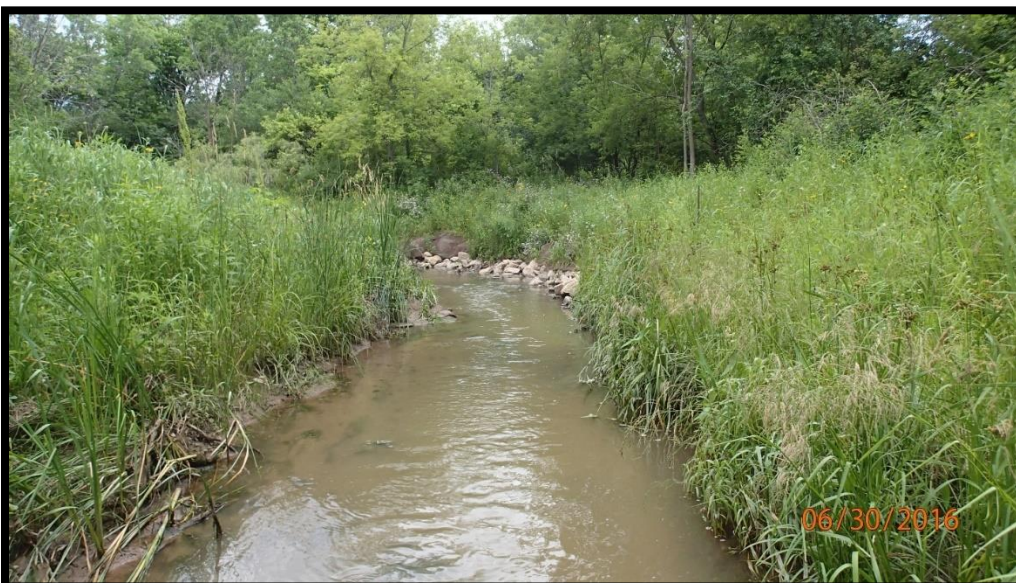
Slope and bank stabilization using vegetation with no hard armoring or toe protection

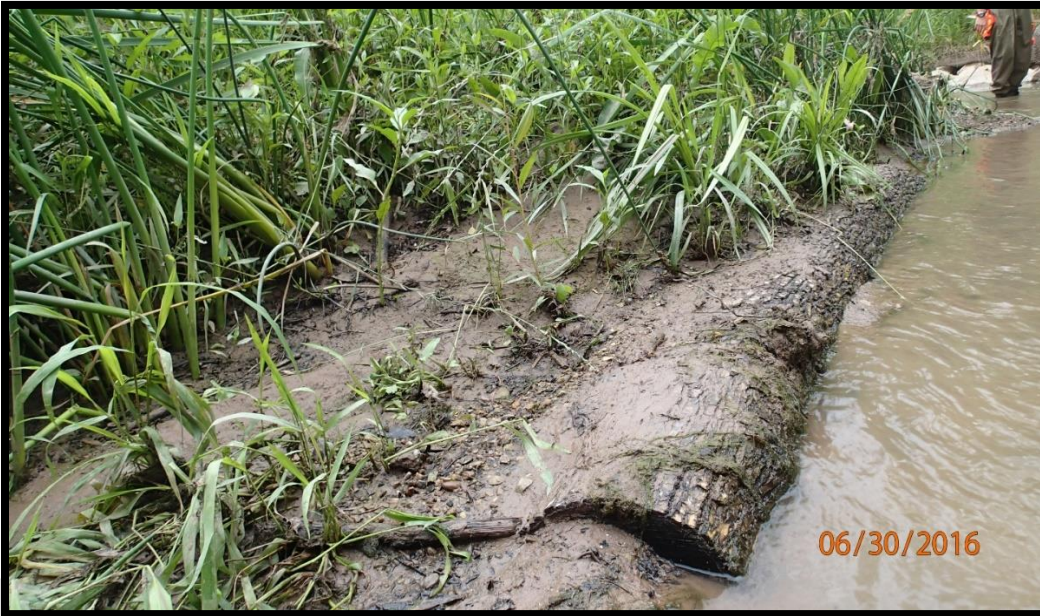
Log Vanes for sediment sequestration and bank stabilization

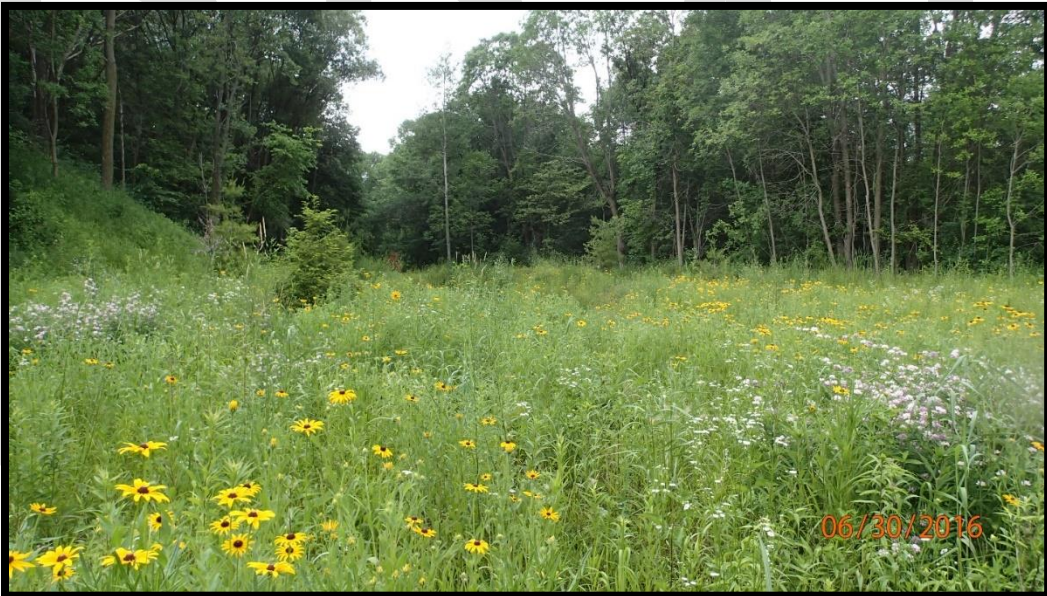
Riparian corridor vegetation management- previously Buckthorn dominated
