Big Carr Lake

Page 1: May 31, 2020 Aquatic Invasive Species Boat Launch and Shoreline Surveillance Monitoring Report

Big Carr Lake AIS Boat Launch and Shoreline Surveillance Monitoring Report

Big Carr Lake AIS Monitoring and Water Clarity Report

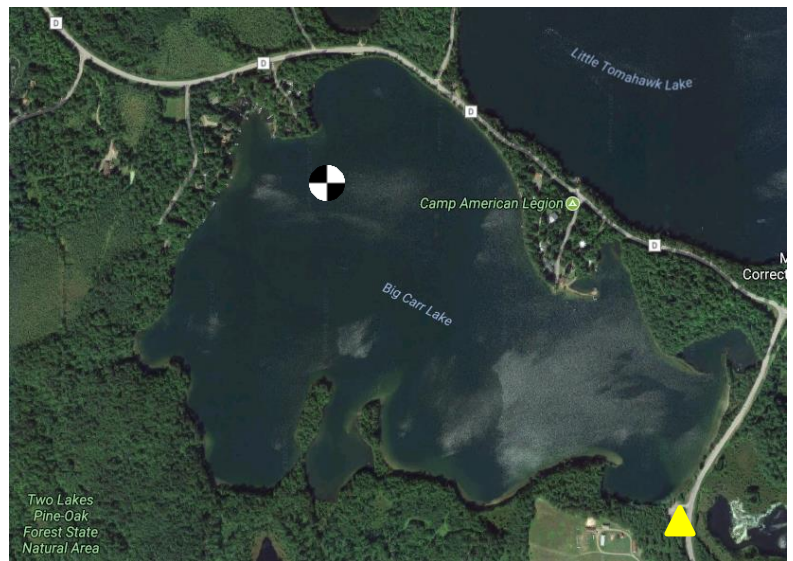
Figure 2. Map of Big Carr Lake with the location of the Secchi disk reading labeled.

Deep hole & location of Secchi disk reading

Public Boat Landing

Secchi: The Secchi reading on this lake was 8 feet out of a 75 foot maximum depth. The water color was a bluish color, and was clear when glancing across the lake.

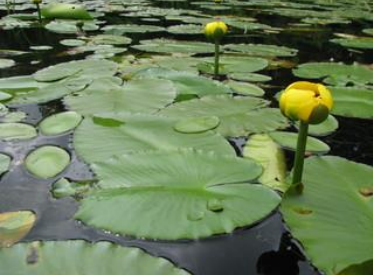
Common Name Scientific Plant Name	Description	Image
<p>Bullhead Pond Lily (Spatterdock)</p> <p><i>Nuphar variegata</i></p>	<p>An aquatic plant with heart-shaped leaves that can grow to be 15 inches long. This plant also has a yellow, cup-shaped flower. This plant is native.</p>

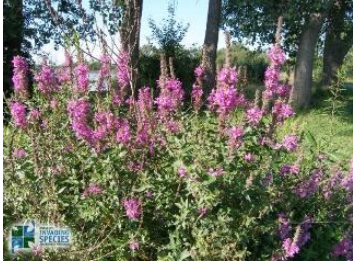
<p>Photo Credit: Jomegat's Weblog</p>
<p>Purple Loosestrife</p> <p><i>Lythrum salicaria</i></p>	<p>A flowering plant with a square or 6-sided stem and smooth leaves. Flowers tend to be a pinkish purple with 6 petals. This plant is invasive!</p>
