Upper East River Targeted Watershed Assessment: A Water Quality Plan to Restore Wisconsin Watersheds

HUC: 040302040301, Monitored 2017

EGAD #3200-2020-22 Wisconsin DNR Bureau of Water Quality

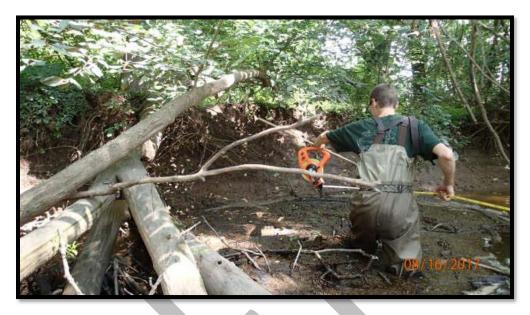
(Modified from Simonson, et al. 1994). Stations were no less than the minimum of 100 meters and no more than the maximum of 400 meters.

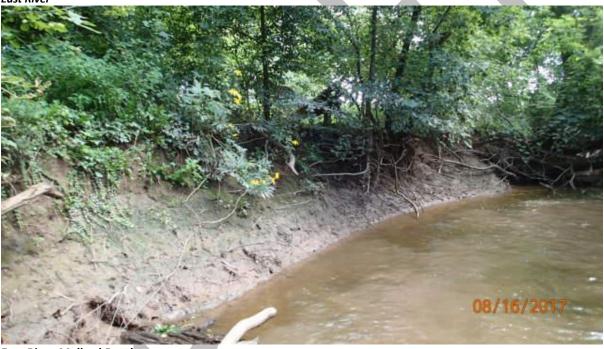
East River Mallard Road

The East River is a 42.25-mile long tributary stream to the Fox River. The segment of the East River within the Upper East River watershed is approximately 15.1-miles. Land-use in the watershed is predominantly agriculture changing to urban as the stream approaches the confluence with the Fox River. Agricultural land use along the East River corridor has significantly altered water quality and habitat throughout the upper portions of the watershed. The habitat scores rate good to fair along this entire segment of the East River and are maintained by intact riparian buffers, the width: depth ratio, and the diverse presence of riffles and bends. The overall habitat scores may seem acceptable, but segments of the East River continue to be heavily impacted by severe bank erosion, lack of fish habitat, and deposition of fine sediment. It was also noted that the quality of riparian areas were often times degraded, low quality forest cover types with little to no herbaceous understory and dominated by invasive species. Total Phosphorous concentrations near the pour point in 2017 and 2018 indicate Total Phosphorous concentrations exceed the State's water quality criteria for phosphorous and high suspended solids load continue to impair this stream. The East River originates and is verified as a warm headwater stream. As the stream flows north and picks up baseflow, it shifts to a cool-warm headwater. This general shift in natural community occurs within a zone between

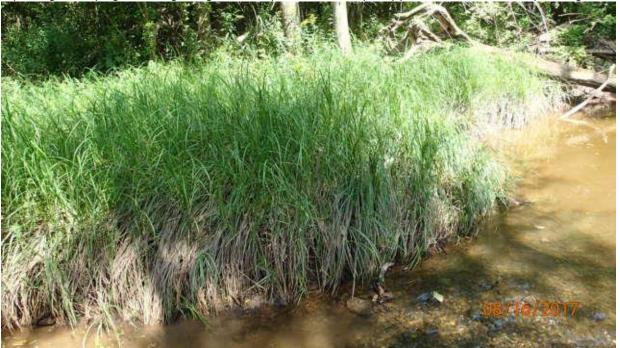
East River- Mill Road

Lamer-Clancy and Mill Road. The Fish IBI scores throughout the entire segment were within the good to Fair range with one excellent score observed. A shift in stream condition was noticeable near the change in natural community as noted by the biologist. Fewer fish species and the overall number of fish that were captured declined even though the scores and ratings were maintained. It was also noted that water clarity, bottom substrate composition, and bank condition all sharply declined near the Lamers-Clancy and Mill Road crossings. These observed changes are likely more than coincidental with a change in natural community and are linked to an increase in agricultural influences on water quality. The M-IBI scores were all within the fair range except for Mallard Road which was poor. It was consistent for the HBI scores that further downstream sites were impacted greater by organic loading and agricultural impacts which subsequently yielded scores in the fair to poor range.
