# Buffalo Lake

## Oneida County, Wisconsin

## Buffalo Lake AIS Boat Launch and Shoreline Surveillance Monitoring Report

## Buffalo Lake AIS Monitoring and Water Clarity Report

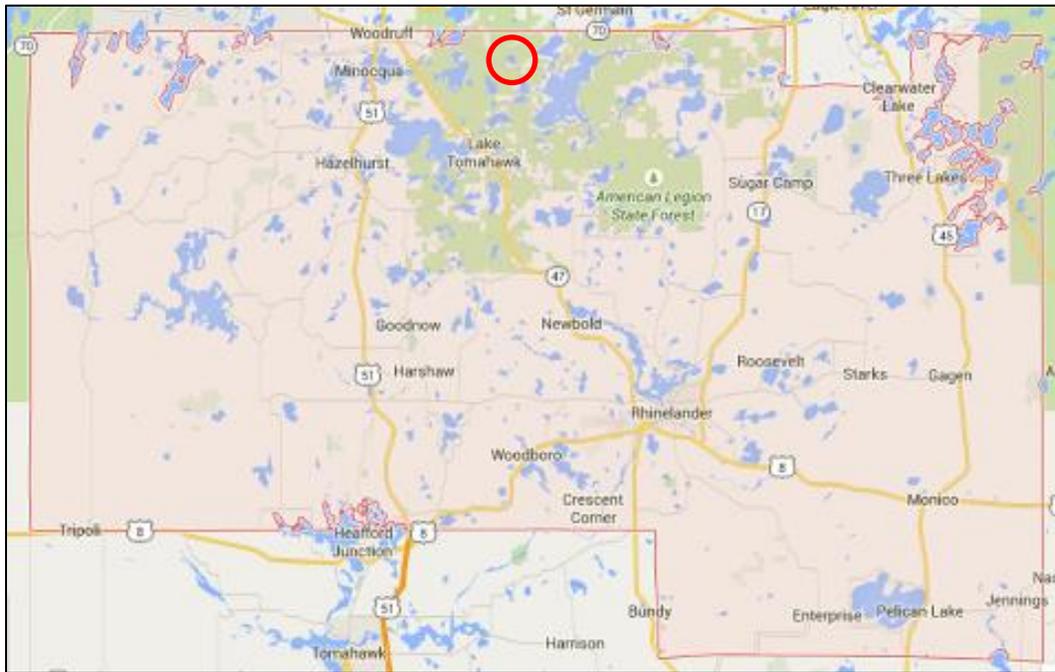
**Figure 2.** AIS Boat Launch and Shoreline Surveillance Monitoring Location.

On May 31, 2020, Aubrey Nycz, AIS Lead Project Assistant, visited the Buffalo Lake boat landing located off of Buffalo Lake Road, in Oneida County, to perform an AIS landing check (Figure 1). The main duties performed at AIS landing checks are to inspect shoreline vegetation, shallow aquatic vegetation, deeper aquatic vegetation (via rake), look for invasive animals, and replace old signs if needed. A GPS unit can be used to mark where the AIS check is performed, and to also mark invasive organisms if found. For today's landing check, I used the GPS on my phone to gather coordinates.

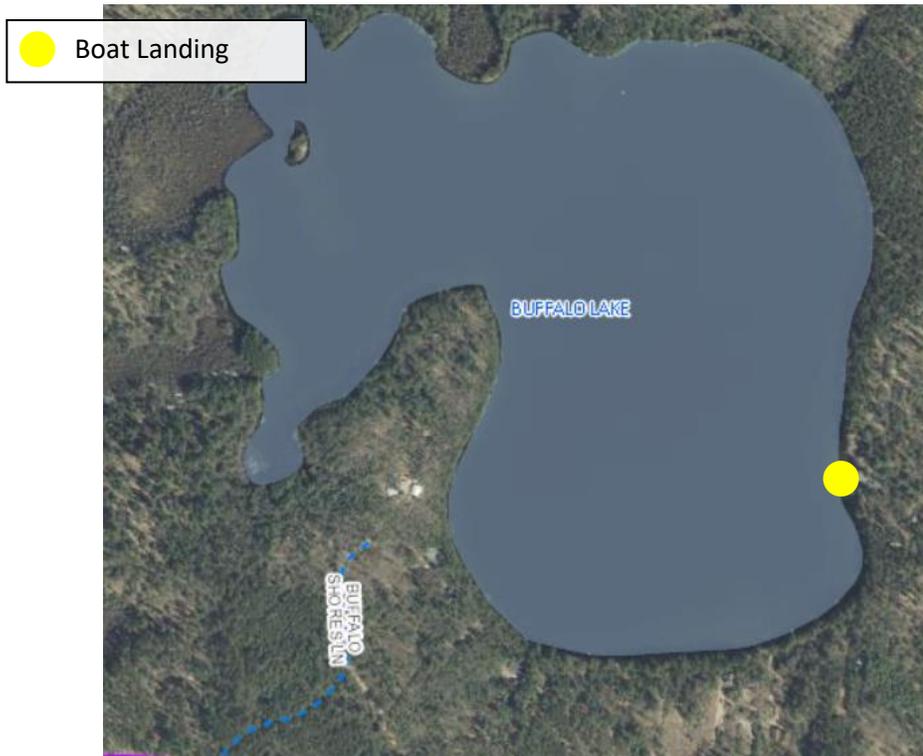
Buffalo Lake contains two kinds of invasive species. According to the Wisconsin Department of Natural Resources, Chinese Mystery Snails and Purple Loosestrife are already present in the lake. While monitoring at the boat landing, I observed three small purple loosestrife plants near the left-hand side of the boat landing. I noticed some beetle chew on these plants, so I left them there, and I plan to check on them in a couple of weeks.

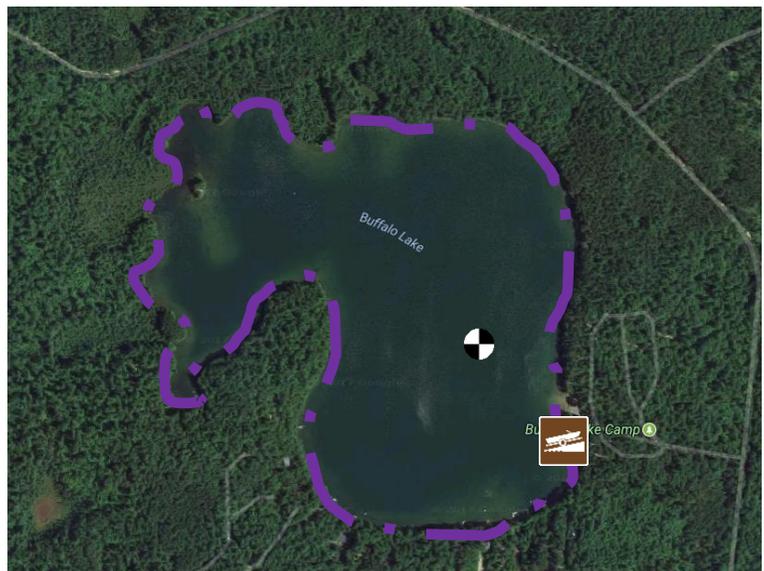
**Figure 2.** Map of Buffalo Lake with boat landing and location of Secchi disk reading labeled.

Deep hole & location of Secchi disk reading
- Secchi Disk Readings:  
Buffalo Lake - Deep Hole  
Coordinates - Not Available
-

Boat Landing
-

Purple Loosestrife

Purple Loosestrife was found along 80% of the shoreline on Buffalo Lake.

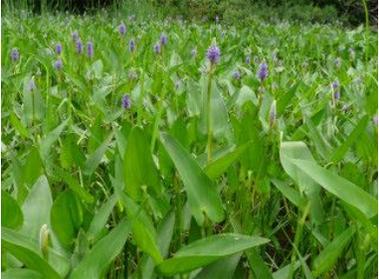
<p><b>Common Name</b> <b>Scientific Plant Name</b></p>	<p><b>Description</b></p>	<p><b>Image</b></p>
<p>Pickrel Weed <i>Pontederia cordata</i></p>	<p>An aquatic plant with thin, bright green leaves. Emergent leaves tend to be arrow shaped with 6 parted, blue flowers. This plant is native.</p>

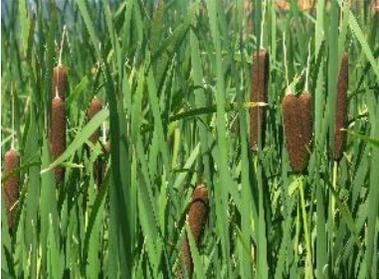
<p>Photo Credit: ediblewildfood.com</p>
<p>Broad-Leaf Cattail <i>Typha latifolia</i></p>	<p>An herbaceous plant with leaves greater than 12 mm wide. The pollen that this plant contains is shed in clusters of four grains. This plant is native.</p>

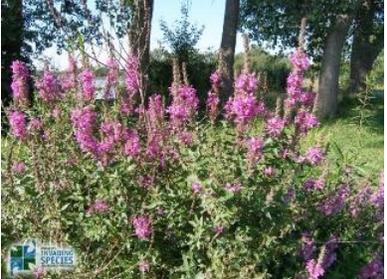
<p>Photo Credit: www.nwplants.com</p>
<p>Purple Loosestrife <i>Lythrum salicaria</i></p>	<p>A flowering plant with a square or 6-sided stem and smooth leaves. Flowers tend to be a pinkish purple with 6 petals. This plant is invasive!</p>

Aubrey and I did observe some Chinese Mystery Snails in Buffalo Lake, however, this invasive was already known to have been established here. Unfortunately we did find a new invasive species on Buffalo Lake. Aubrey and I noticed that Purple Loosestrife appeared to be taking over Buffalo Lake. Aubrey and I estimate that 80% of the shoreline is composed of Purple Loosestrife. This is very concerning, and the WDNR should consider high removal of Purple Loosestrife on the lake within the immediate years. While on the lake, Aubrey and I did clip all visible flowers and remove some of the larger patches.

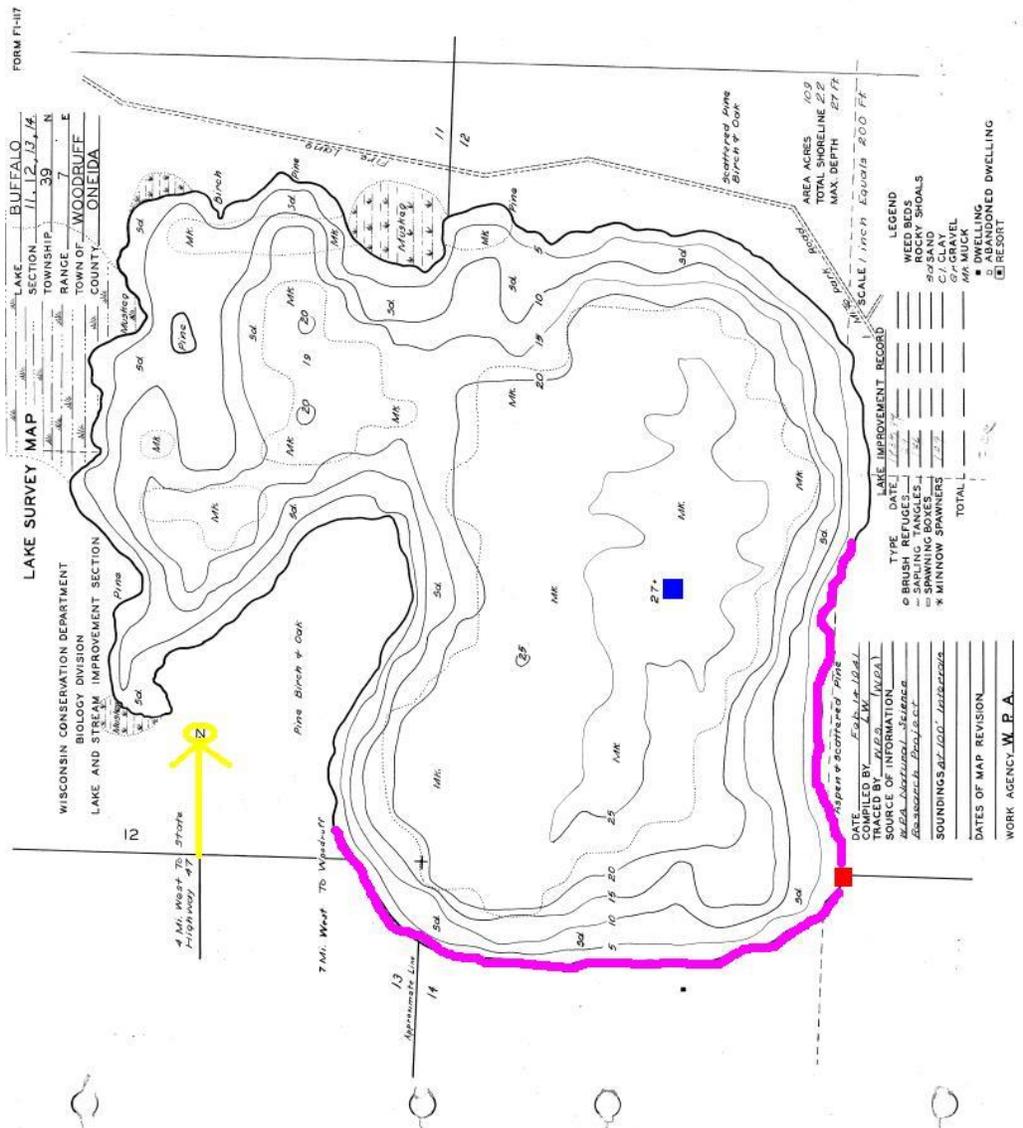
Stephanie and I monitored Buffalo Lake on Wednesday, August 13<sup>th</sup>. We accessed this lake from the public boat landing located on the campground along the eastern side of the lake. We navigated to the lake's deep hole (Figure 1), where we anchored at a depth of 20 feet. We used our GPS to map the coordinates of this location, and we recorded a Secchi disk reading of 11 feet.

**Figure 1.** Please note that we have flipped the Wisconsin Department of Natural Resources' contour map of Buffalo Lake so the north end of the lake is pointed upwards, as marked by the yellow arrow. Additionally, the red square marks the boat landing, the blue square marks the deep hole, and the pink lines represent areas of the shoreline where we visually monitored for the presence/absence of AIS.
