# Cunard Lake

## Oneida County, Wisconsin

## Cunard Lake AIS Boat Launch and Shoreline Surveillance Monitoring Report

## Cunard Lake AIS Monitoring and Water Clarity Report

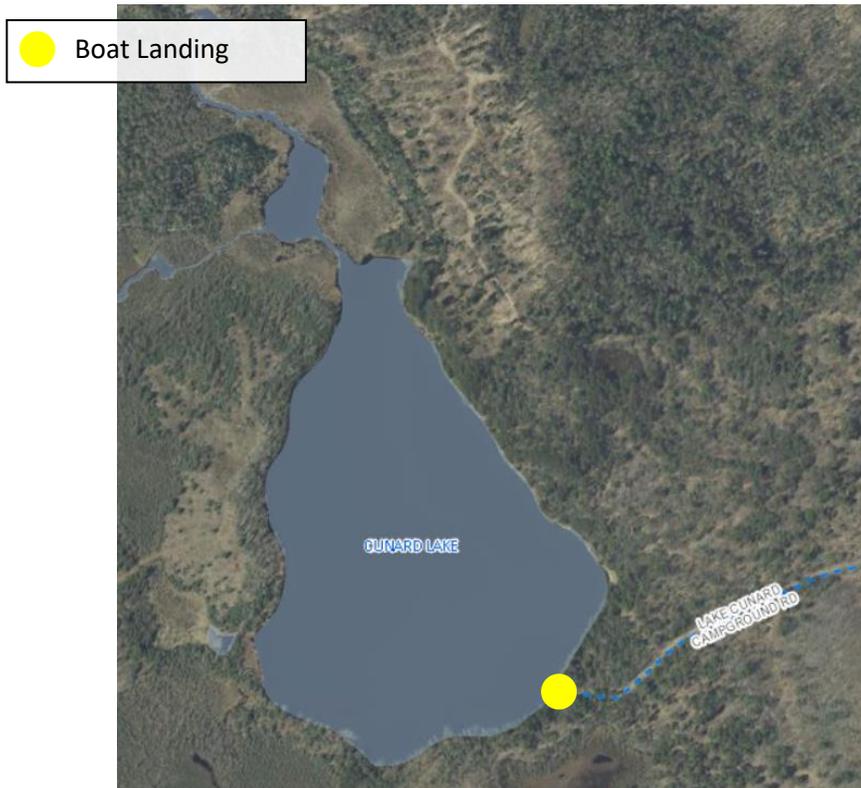
**Figure 2.** AIS Boat Launch and Shoreline Surveillance Monitoring Location.

On May 31, 2020, Aubrey Nycz, AIS Lead Project Assistant, visited the Cunard Lake boat landing located at the end of Cunard Campground Road, in Oneida County, to perform an AIS landing check (Figure 1). The main duties performed at AIS landing checks are to inspect shoreline vegetation, shallow aquatic vegetation, deeper aquatic vegetation (via rake), look for invasive animals, and replace old signs if needed. A GPS unit can be used to mark where the AIS check is performed, and to also mark invasive organisms if found. For today's landing check, I used the GPS on my phone to gather coordinates.

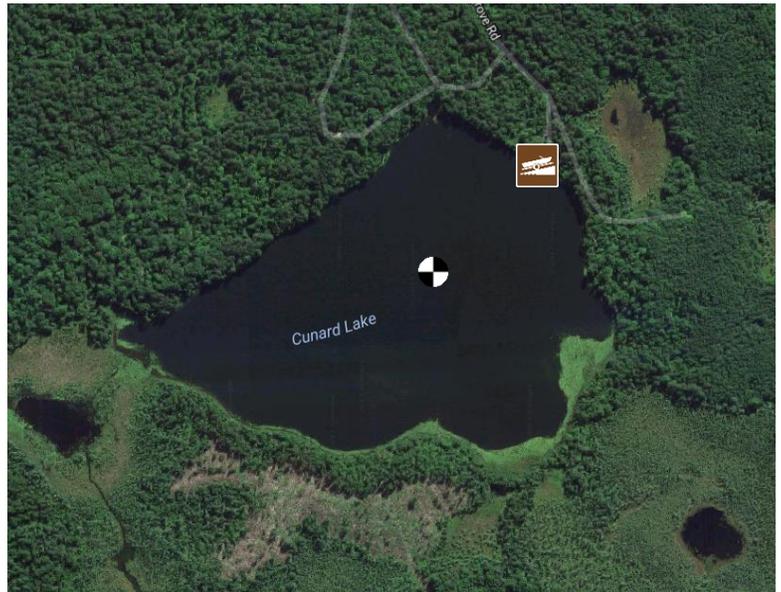
**Figure 2.** Map of Cunard Lake with boat landing and location of Secchi disk reading labeled.

To observe the water clarity and quality of Cunard Lake, Aubrey and I went to the deep hole towards the middle of the lake. After locating the deep hole with our sonar unit, we used a Secchi disk to measure water clarity and a dissolved oxygen meter to measure water health. Oxygen is needed for a healthy fish population, and also for plants to respire at night as well. The measurements from the dissolved oxygen meter can also tell us if the organisms in the lake would be under stress. Thankfully, both of these measurements were relatively average in nature, and there should be no concern for the health of Cunard Lake. The Secchi disk reading was 9 feet, and the dissolved oxygen readings can be found in table 2.

Public boat landing
  -

Deep hole & location of Secchi disk reading
- Secchi Disk Readings:  
 Cunard Lake - Deep Hole  
 Coordinates - Not Available

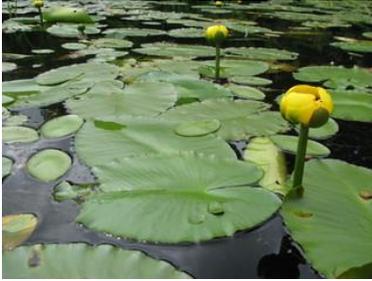
<p>Bullhead Pond Lily (Spatterdock)</p> <p><i>Nuphar variegata</i></p>	<p>An aquatic plant with heart-shaped leaves that can grow to be 15 inches long. This plant also has a yellow, cup-shaped flower. This plant is native.</p>

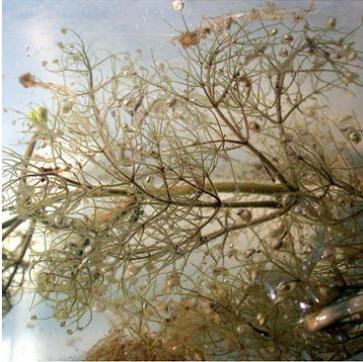
<p>Large Purple Bladderwort</p> <p><i>Utricularia purpurea</i></p>	<p>An aquatic plant with leaves containing small sacks that trap small invertebrates. This plant usually has unrooted stems that easily tangle with other plants. In the water, this plant tends to look cloudy or slimy. This plant is native.</p>
