Alva Lake

Alva Lake AIS Monitoring and Water Clarity Report

Field Dates: July 23rd, 2020
WBIC: 968100
Previous AIS Findings: Chinese Mystery Snail, Banded Mystery Snail
New AIS Findings: None
Field Crew: Aubrey Nycz, AIS Project Leader, and Rachel Cook, AIS Project Assistant,
Oneida County Land and Water Conservation Department
Report By: Rachel Cook

WBIC: 968100
Previous AIS Findings: None
New AIS Findings: Banded Mystery Snail, Chinese Mystery Snail
Field Date: September 9, 2015
Field Crew: Stephanie Boismenu and Sara Mills, AIS Project Assistants, Oneida County Land and Water Conservation Department
Report by: Sara Mills

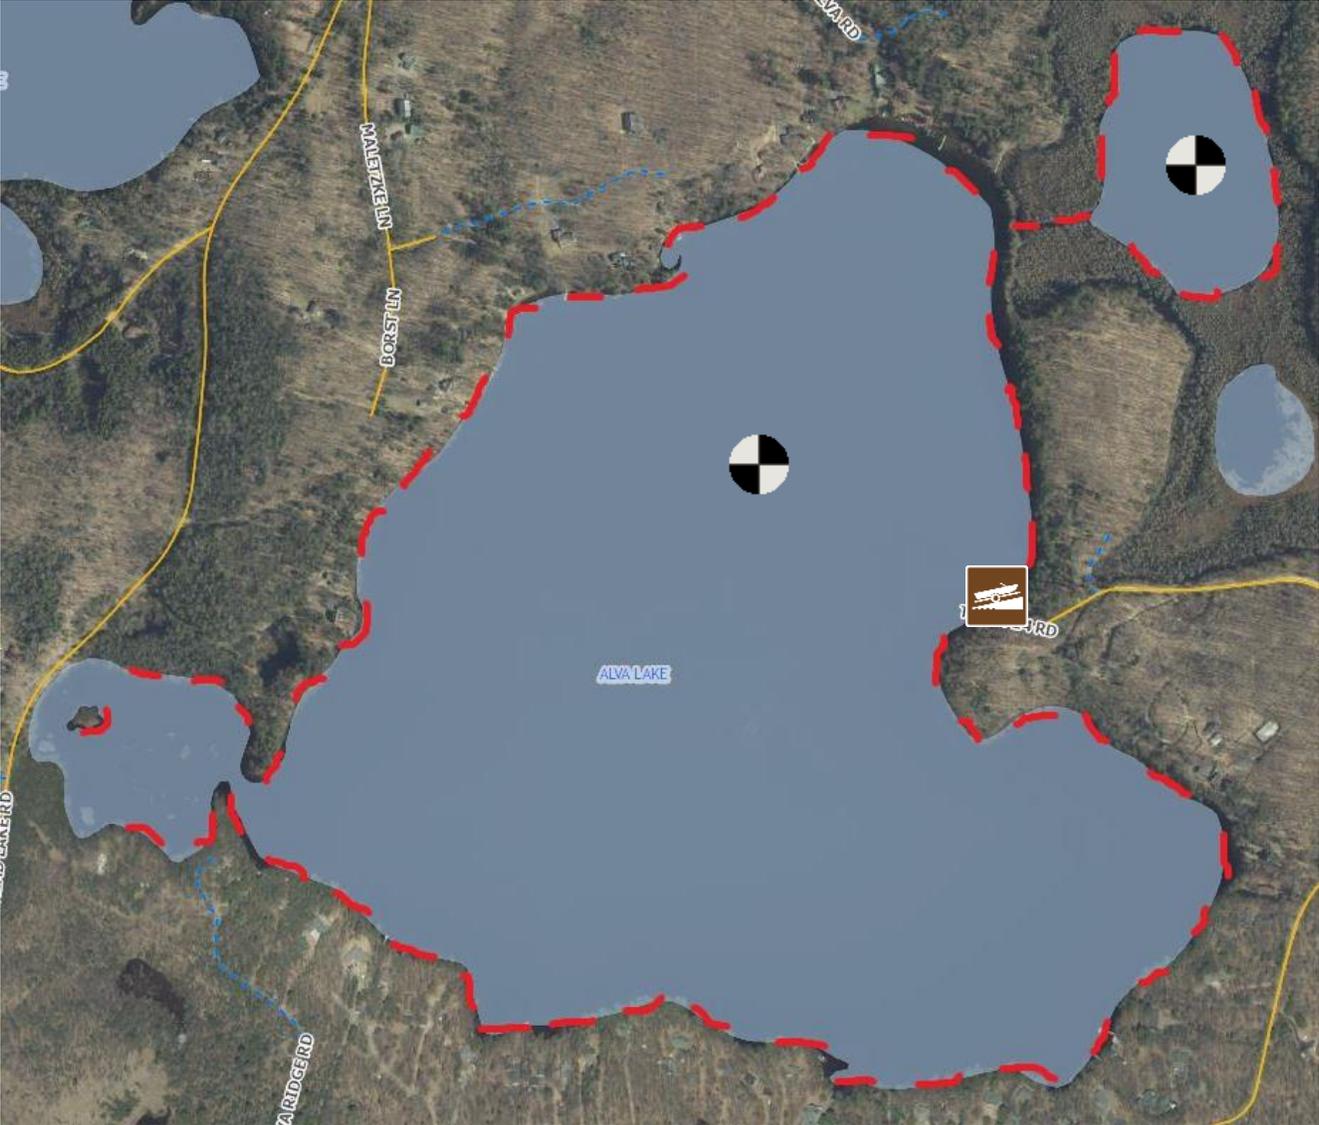
Figure 2. Map of Alva Lake with boat landing and location of Secchi disk reading labeled.

Deep holes & locations of Secchi disk readings

Monitoring path

Boat Landing

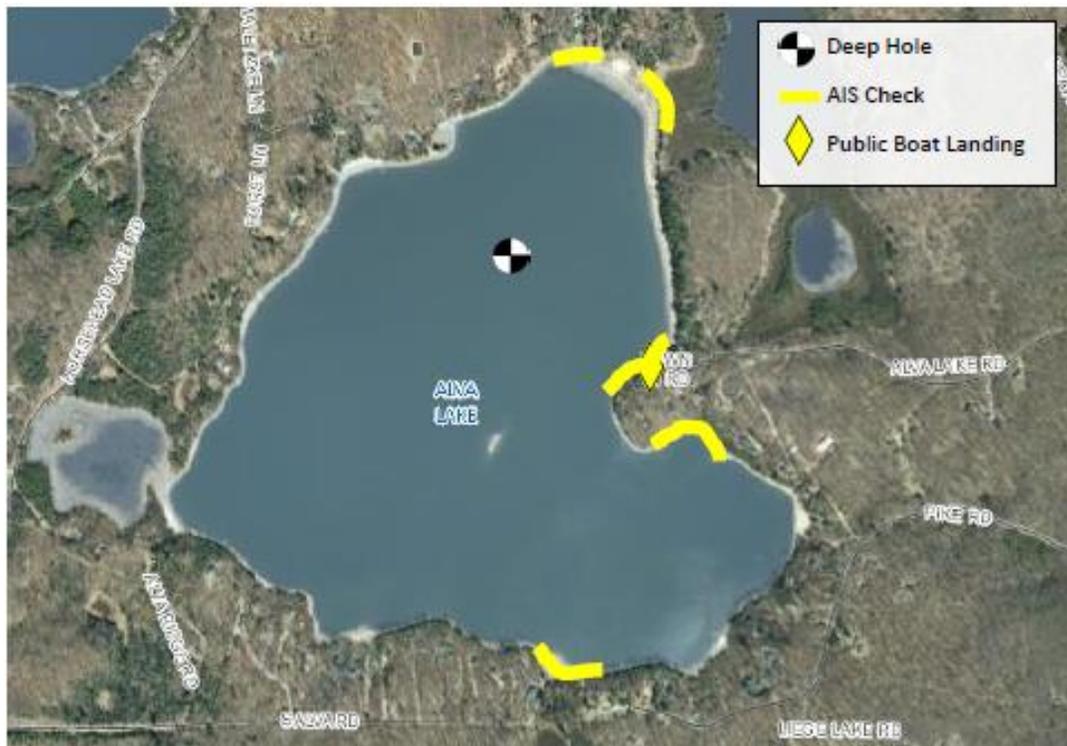
Figure 3. Map of Alva Lake with the deep hole, AIS checks, and public boat landing labeled.

Deep Hole GPS Coordinates: 45.71029644, -89.59135756

The conditions for lake monitoring were partly cloudy with wind at 12-13 mph. We entered the lake from a public boat landing (Figure 3). Using the bathymetric map (Figure 2) and the depth finder, Stephanie and I navigated as close as we could to the deep hole of the lake. Due to the high wind speeds, we could not find the deep hole of 43 feet. We dropped anchor to keep the canoe from drifting while taking the measurements. I collected a GPS location for our measurements, a Secchi disk reading for water clarity, and dissolved oxygen and temperatures for water quality (Table 1).

After data collection, we paddled to five locations of the lake shore to perform an AIS presence/absence check. The protocol for this process is to complete a visual inspection of the littoral zone along 100 feet of the shoreline in each area. We chose five areas around private landings, private docks with motorized watercrafts, and the public boat landing (Figure 3). For the five locations of AIS presence/absence checks, we meandered the shoreline via walking along the shoreline, looking through vegetation, and checking under and around solid surfaces. In addition to
