Bolger Lake AIS Monitoring and Water Clarity Report

Field Dates: August 5th, 2020
WBIC: 973000
Previous AIS Findings: Chinese Mystery Snail
New AIS Findings: None
Field Crew: Aubrey Nycz, AIS Project Leader, and Rachel Cook, AIS Project Assistant, Oneida County Land and Water Conservation Department
Report By: Rachel Cook

WBIC: 973000
Previous AIS Findings: None
New AIS Findings: Chinese Mystery Snails
Field Date: July 1, 2015
Field Crew: Stephanie Boismenu and Samantha Zommers, AIS Project Assistants, Oneida County Land and Water Conservation Department
Report By: Samantha Zommers

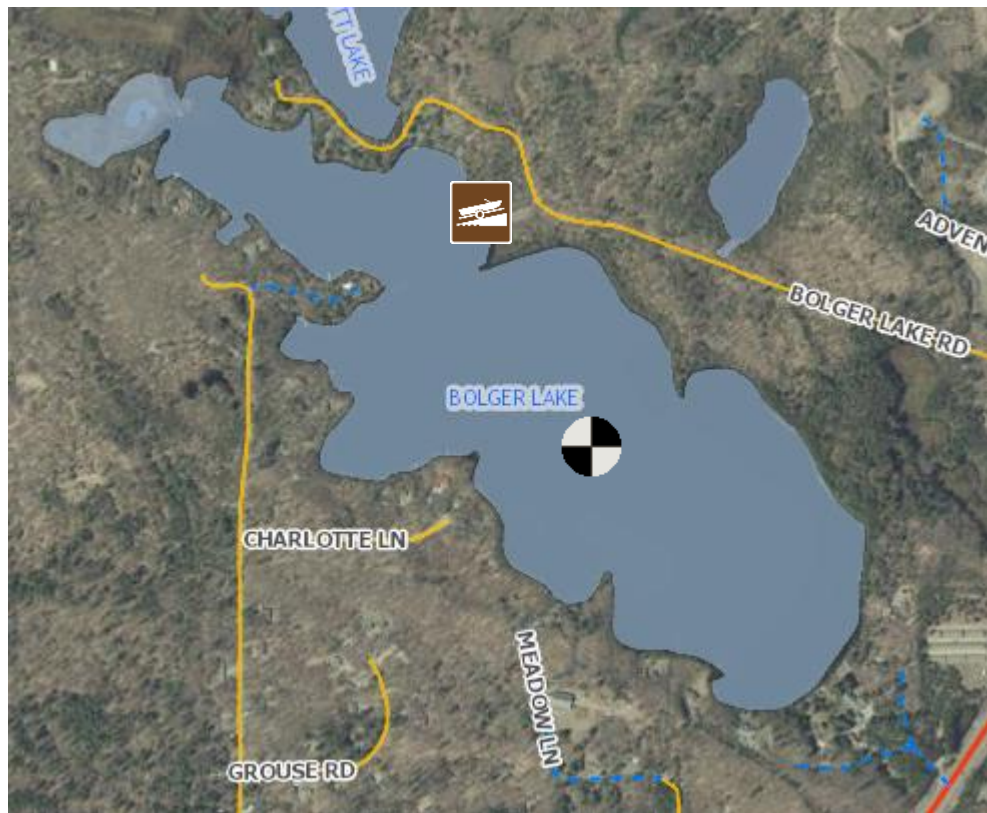
Figure 2. Map of Buffalo Lake with boat landing and location of Secchi disk reading labeled.

Secchi: The Secchi reading on this lake was 11 feet out of a 45 foot maximum depth. The water looked clear and dark blue in color, and the surface was a little wavy due to some wind.

Deep hole and location of Secchi disk reading
-

Boat landing

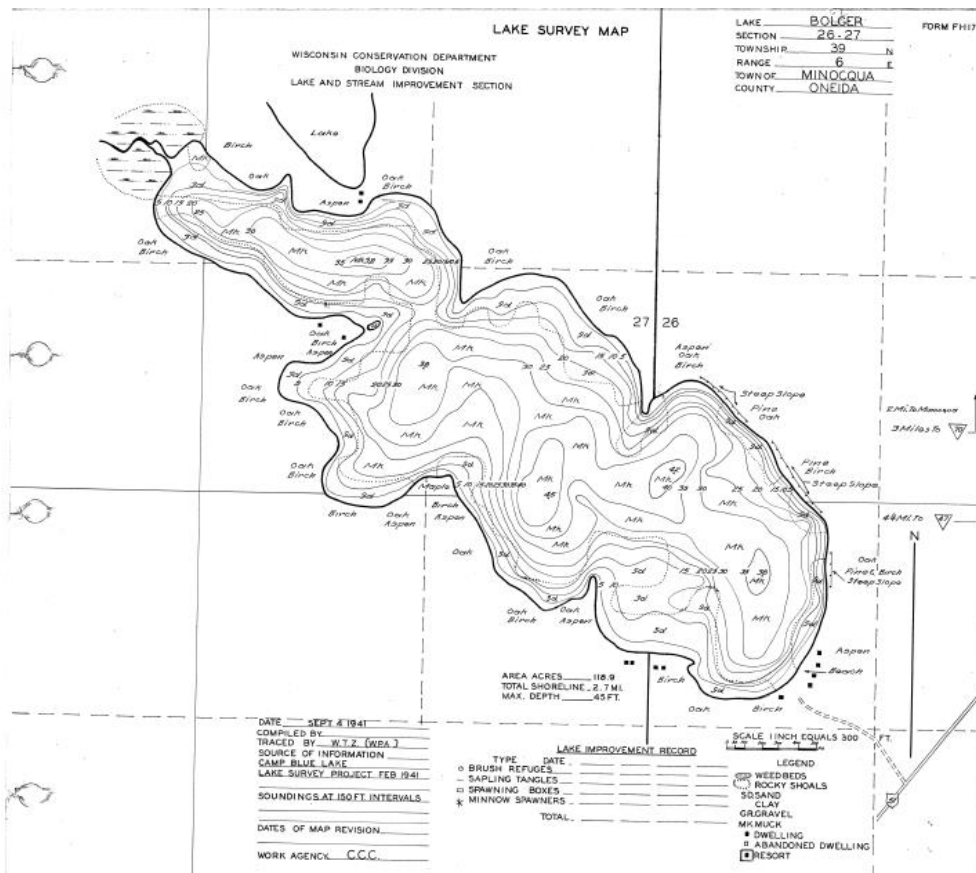
Figure 2. Bathymetric map of Bolger Lake in Oneida County, WI.

We entered Bolger Lake using the landing on Bolger Lake Road as seen on the map in Figure 3. Then using the bathymetric map (Figure 2) we found the deep hole in the lake to take water quality measurements. At this point we put down the anchor, took GPS coordinates, and obtained measurements on water clarity with the Secchi disk and the dissolved oxygen meter (Table 1).

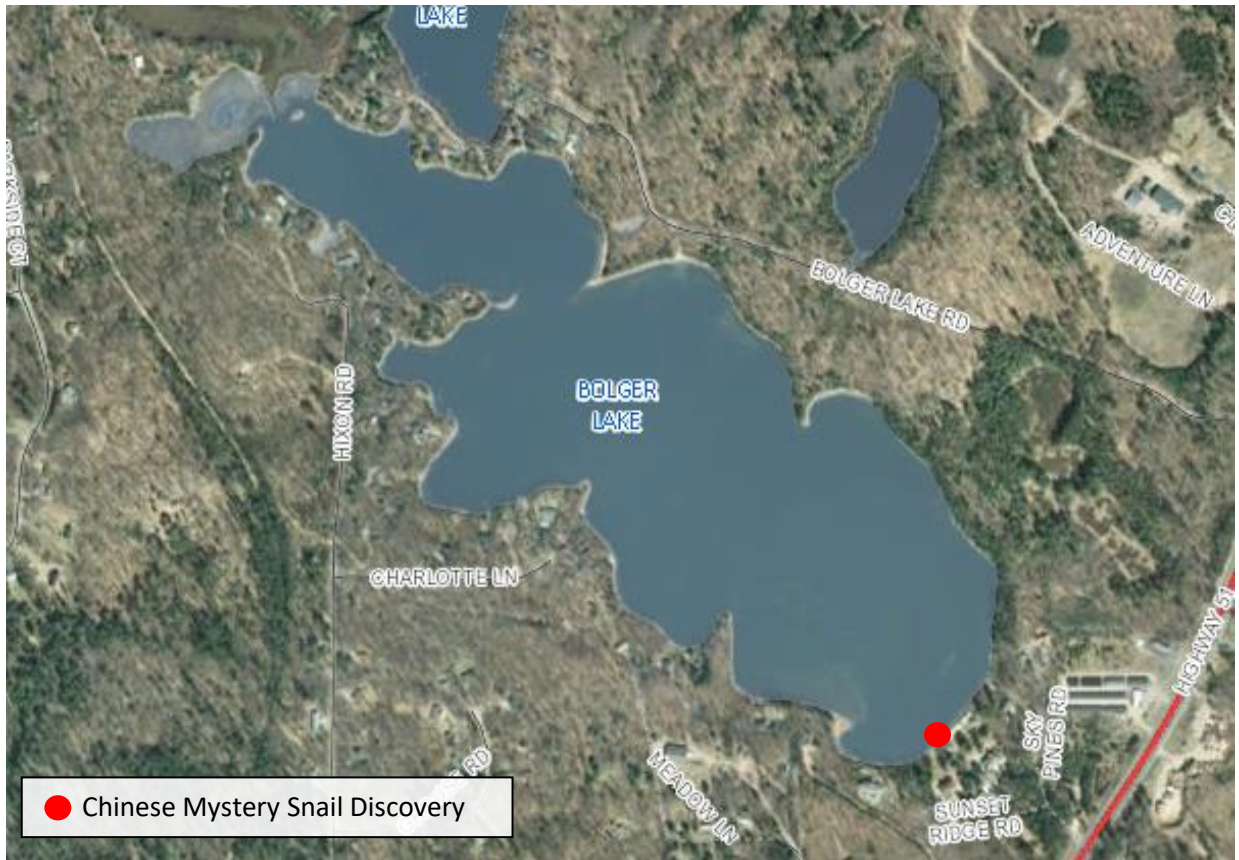
Figure 4. Map of Bolger Lake with new AIS discoveries.

Chinese mystery snails were newly discovered on the day of monitoring. There were both empty shells and live specimens found. GPS coordinates of the Chinese mystery snails can be seen in Figure 4.

Chinese Mystery Snail GPS Coordinates: 45.83769, -89.71366
