Page 1: AIS Monitoring and Water  
Clarity Report of August 12,  
2020

## **Sevenmile Lake AIS Monitoring and Water Clarity Report**

Field Dates: August 12<sup>th</sup>, 2020  
WBIC: 1605800  
Previous AIS Findings: Narrow-leaf cattail, Rusty Crayfish  
New AIS Findings: Chinese Mystery Snails  
Field Crew: Aubrey Nycz, AIS Project Leader, and Rachel Cook, AIS Project Assistant, Oneida County Land and Water Conservation Department  
Report By: Aubrey Nycz & Rachel Cook

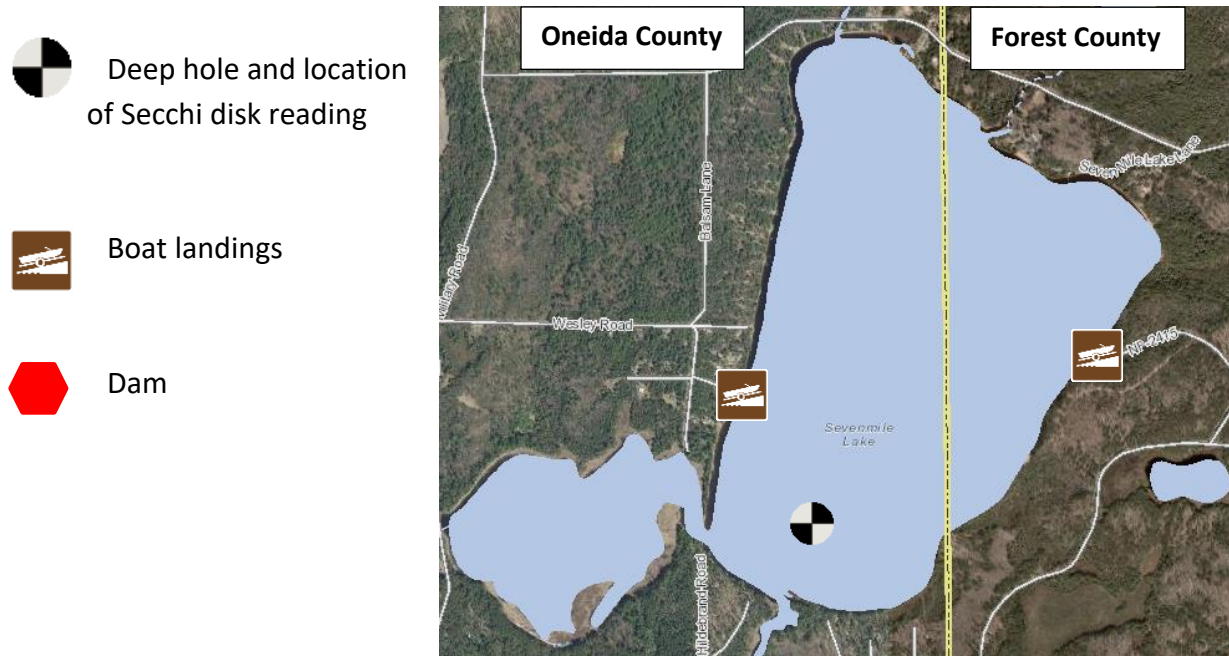
**Figure 2.** Map of Sevenmile Lake with boat landings, dam, and location of Secchi disk reading labeled. This lake is located in both Oneida and Forest Counties. The yellow line on the map separates the two counties. The western side of the lake is in Oneida County and the eastern side of the lake is in Forest County.
