Lake Management Plan for Big Round Lake, Polk County, Wisconsin

July 2004

Prepared by Steve McComas, Blue Water Science
with contributions from Wisconsin Department of Natural Resources,
St. Croix Chippewa Community, and the Big Round Lake Protection
and Rehabilitation District

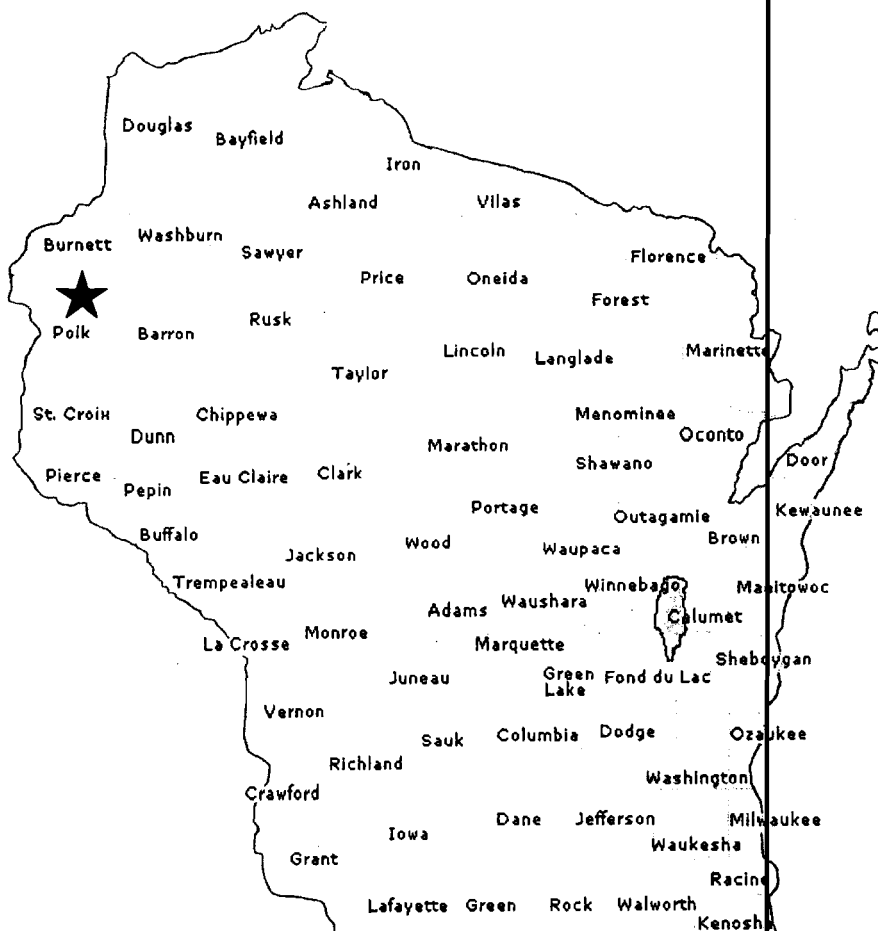
Figure 1. Big Round Lake is located in Polk County, Wisconsin.

Big Round Lake is located in Polk County, Wisconsin (Figure 1). Big Round Lake characteristics are shown in Table 1.

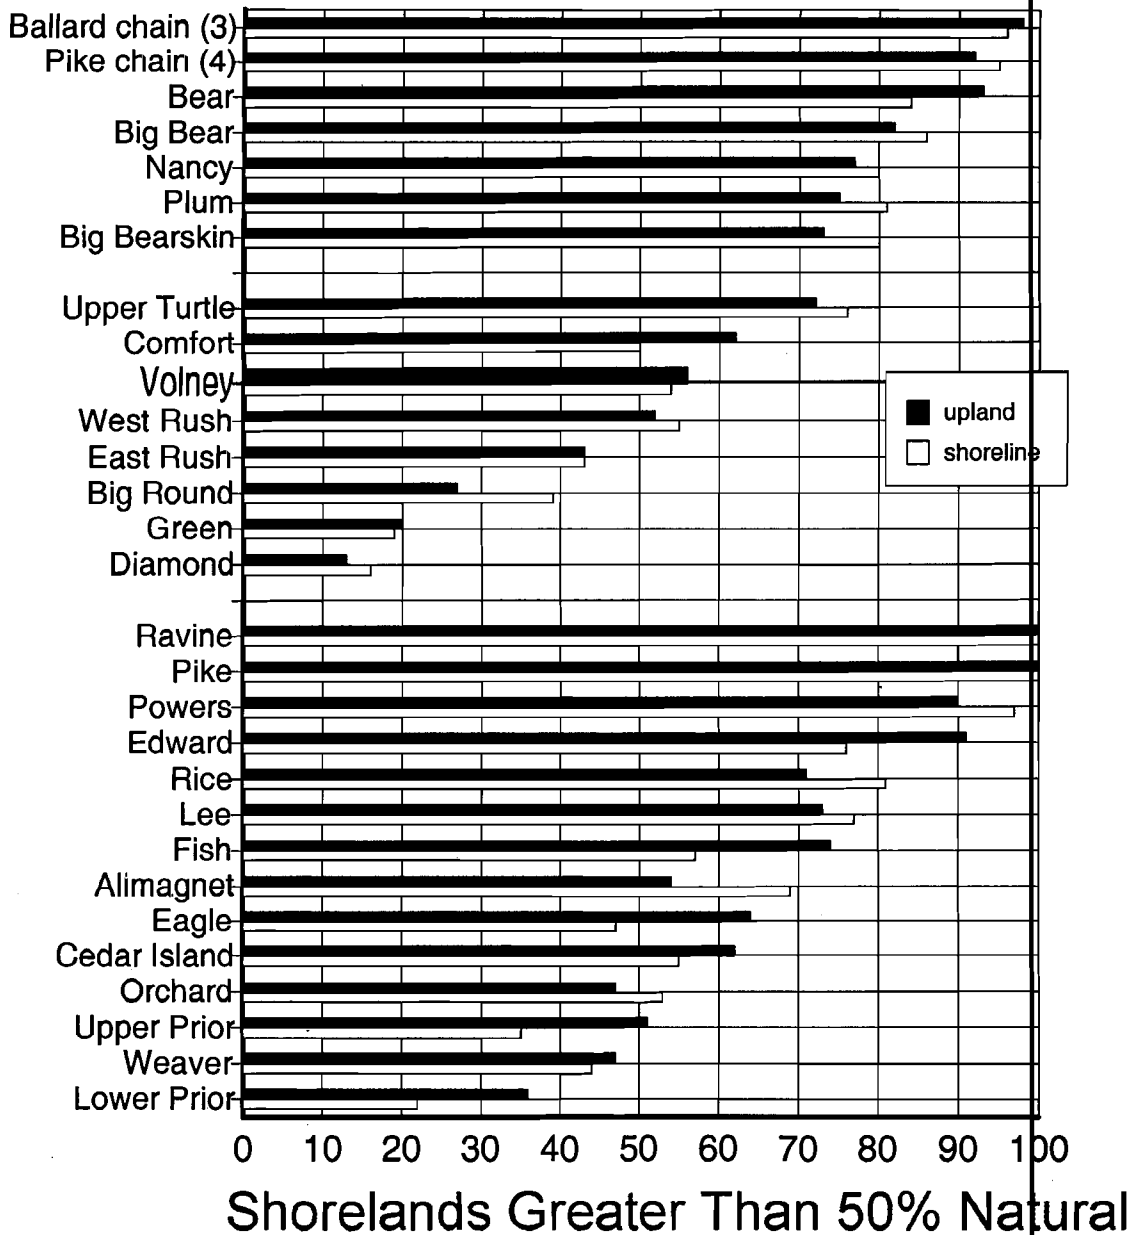
Figure 7. A summary of shoreland inventory results for lakes using an evaluation based on shoreland photographs. For each lake the percentage of shoreline and upland conditions with greater than 50% natural conditions is shown. The first tier of lakes are located in northern Wisconsin. The lower tier of lakes are in the Twin City Metropolitan area and are considered urban lakes. Although several lakes are “urban” lakes most of the shoreland is owned by the city and there is a high percentage of natural conditions. The middle tier of lakes are about an hour or two drive from the Twin Cities, and are not considered to be urban lakes, they are “country” lakes.

A comparison of Big Round Lake conditions to other lakes in Minnesota and Wisconsin is shown in Table 6 and in Figure 7.

Big Round Lake is a country lake. It’s natural shoreland conditions are slightly below average compared to the other country lakes in the middle tier.

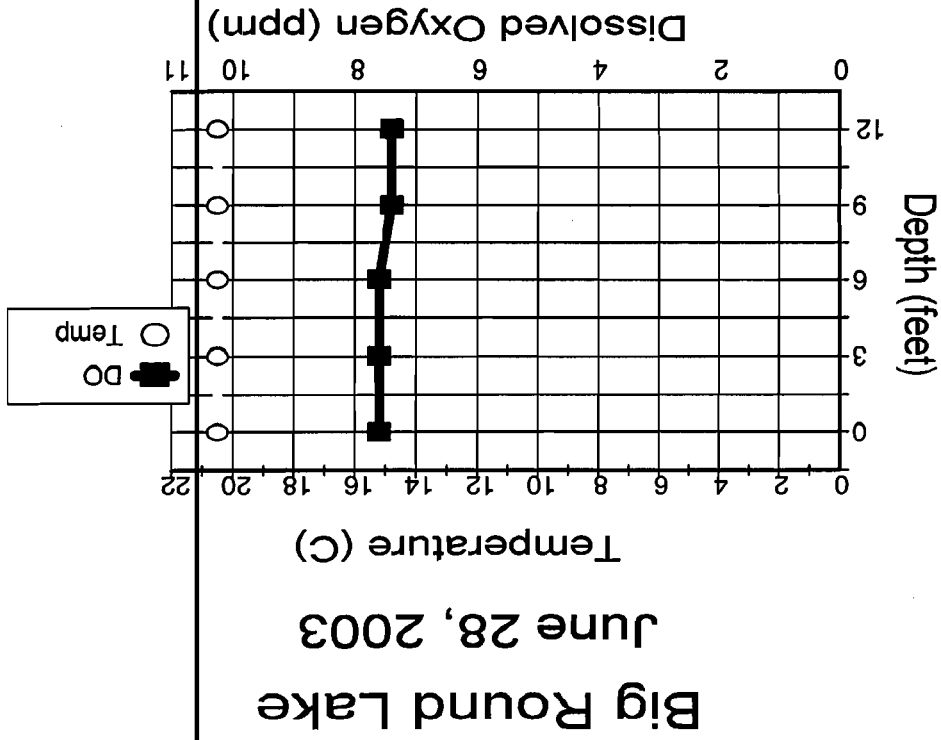
Figure 12. Dissolved oxygen (DO)/temperature profiles for June 28, 2003. Dissolved oxygen data are shown with squares and temperature with circles.

A profile was obtained each month from July and September, 2002. By examining the profiles, one can learn a great deal about the condition of a lake and the habitat that is available for aquatic life.

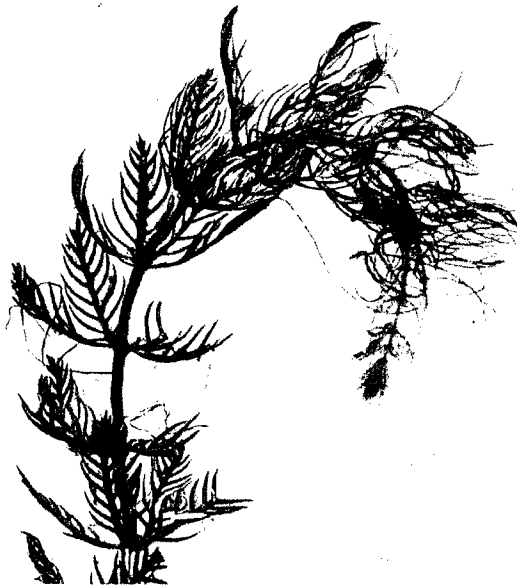
Northern watermilfoil (*Myriophyllum sibiricum*) is found in water depths to 10 feet.

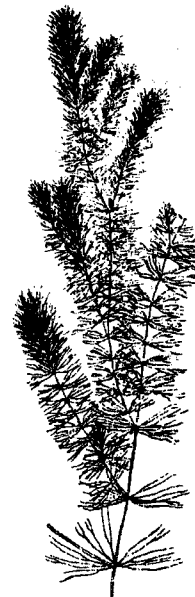
Coontail (*Ceratophyllum demersum*) is dominant in all water depths.

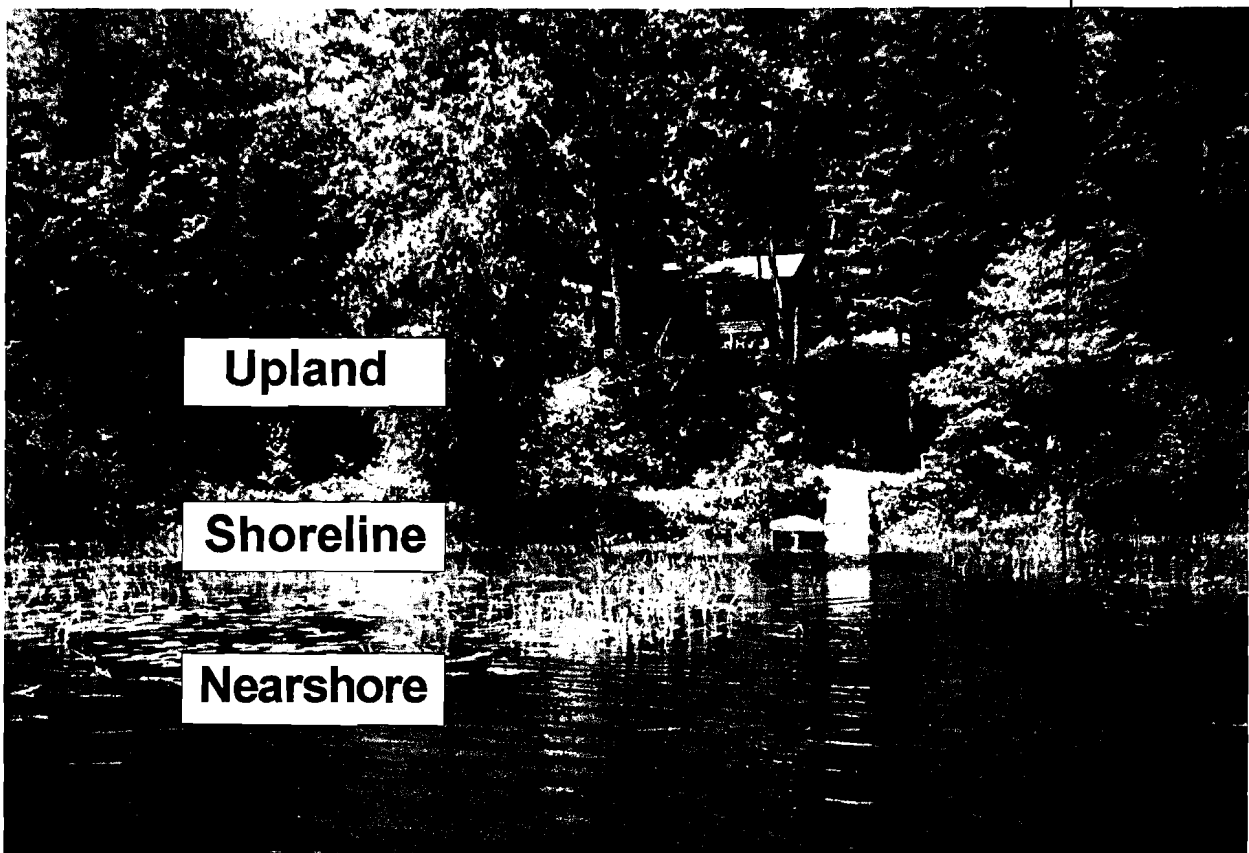
Figure 25. Cross section of the lake shoreland habitat.

The shoreland area is valuable for promoting a natural lake environment and a natural lake experience for lake users. The shoreland is defined as the upland area about 300 to 1,000 feet back from the shoreline, and out into the lake to about the end of your dock (Figure 25). A shoreland with native vegetation offers more wildlife and water quality benefits than a lawn that extends to the lake's edge. A summary of attributes and functions of native plants in the shoreland area is shown in Table 15.

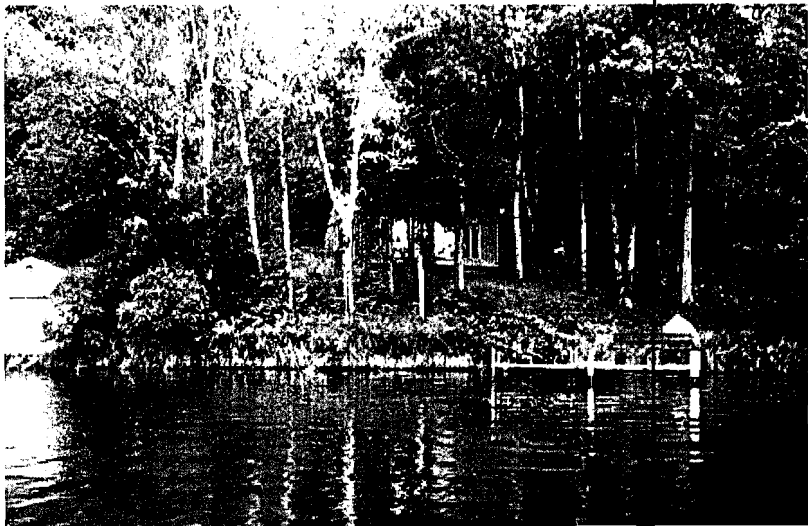
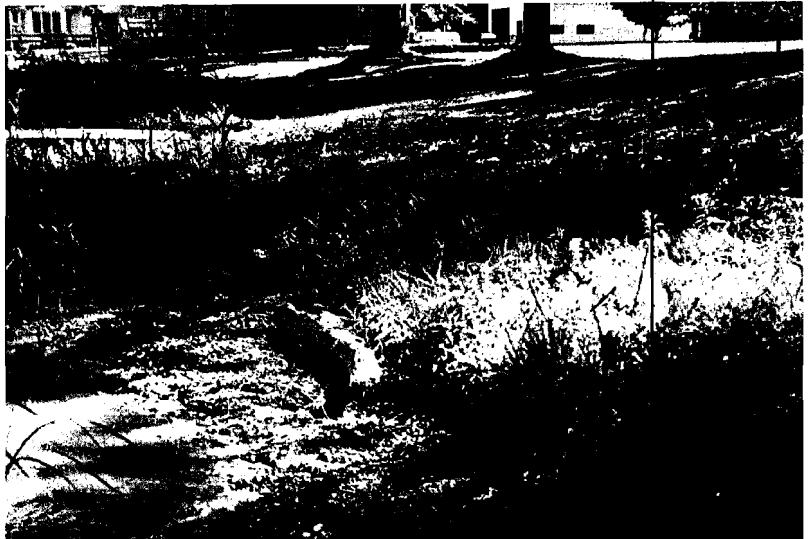
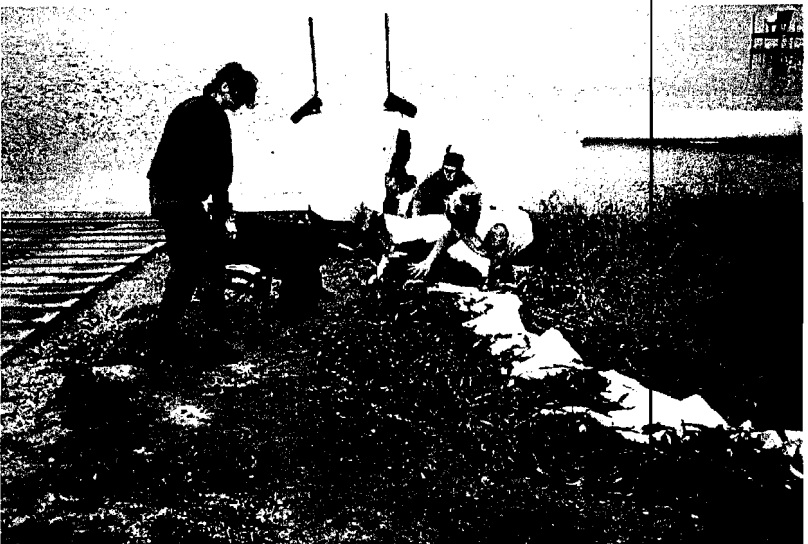
2. Accelerated Naturalization: To accelerate the naturalization, plant shrubs, wild flowers, or grasses into a shoreland area.

3. Restoration: This involves removing existing vegetation through the use of paper mats and/or mulching and planting a variety of native grasses, flowers, and shrubs into the shoreland area.

Figure 26. Examples of three shoreland management options.
