Lake Management Plan for Bear Lake, Barron County, Wisconsin

June 2007
Revised December 2007

Prepared by **Steve McComas, Blue Water Science**
with contributions from **Wisconsin Department of Natural Resources**
and the **Bear Lake Association**

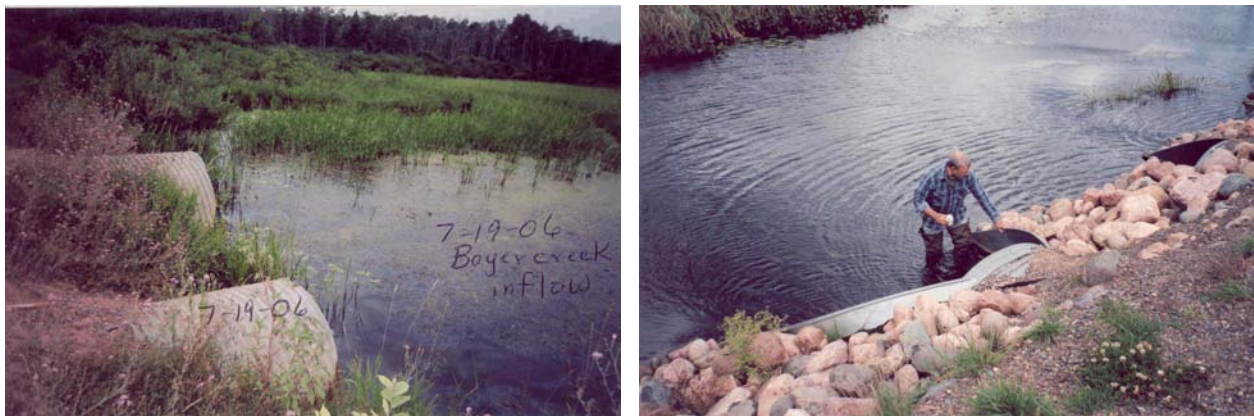
Figure 5. (Left) Boyer Creek inflow to Bear Lake on July 19, 2006. (Right) Bear Creek being sampled by Bob Moe on September 26, 2006 (photos by Dorothy Moe).

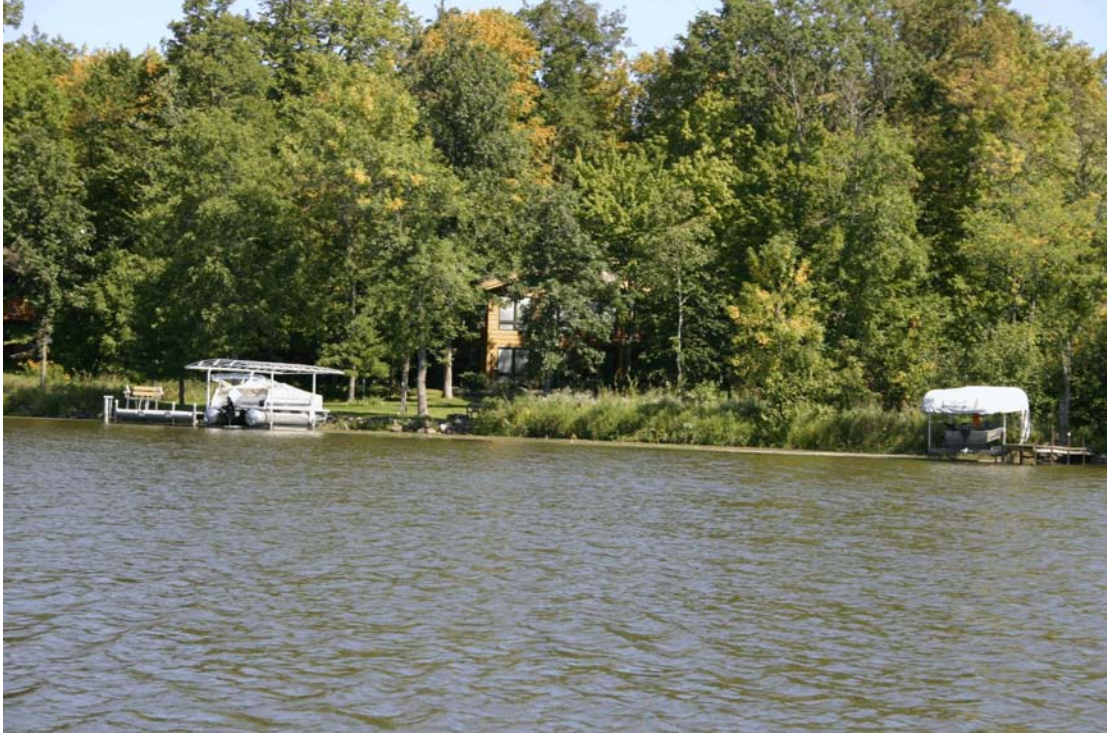
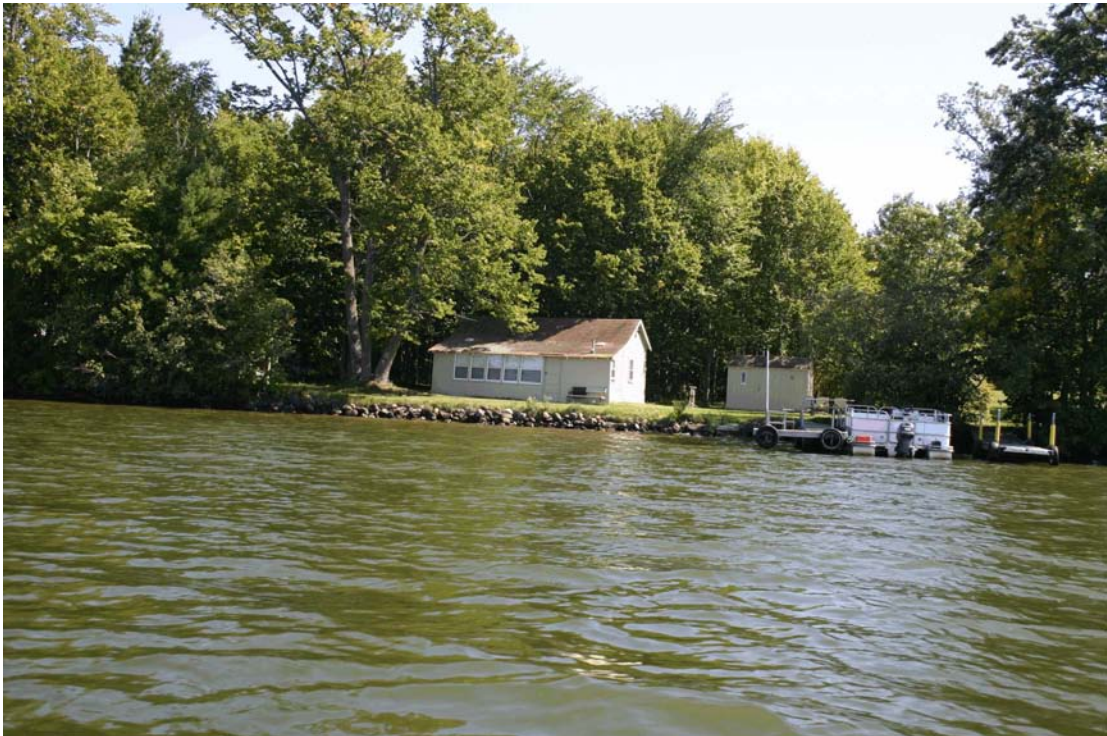
Figure 7. [top] This parcel would rate as having a shoreline with a buffer greater than 50% of the lot width and an understory with greater than 50% natural cover. [bottom] This parcel would not qualify as having a natural shoreline buffer greater than 50% of the lot width. Also understory in the upland area would be rated as having less than 50% natural cover.

For analysis, each photograph was evaluated by Blue Water Science staff for shoreline and upland conditions. Our criteria for natural conditions were the presence of 50% native vegetation in the understory and at least 50% natural vegetation along the shoreline in a strip at least 15 feet deep. Although the shoreline recommendations for new development is a 35-foot deep buffer, a 15-foot deep buffer is about the minimum needed to achieve some degree of runoff water quality treatment. We evaluated shorelines and uplands at the 75% natural level as well (Figure 7 illustrates the methodology).

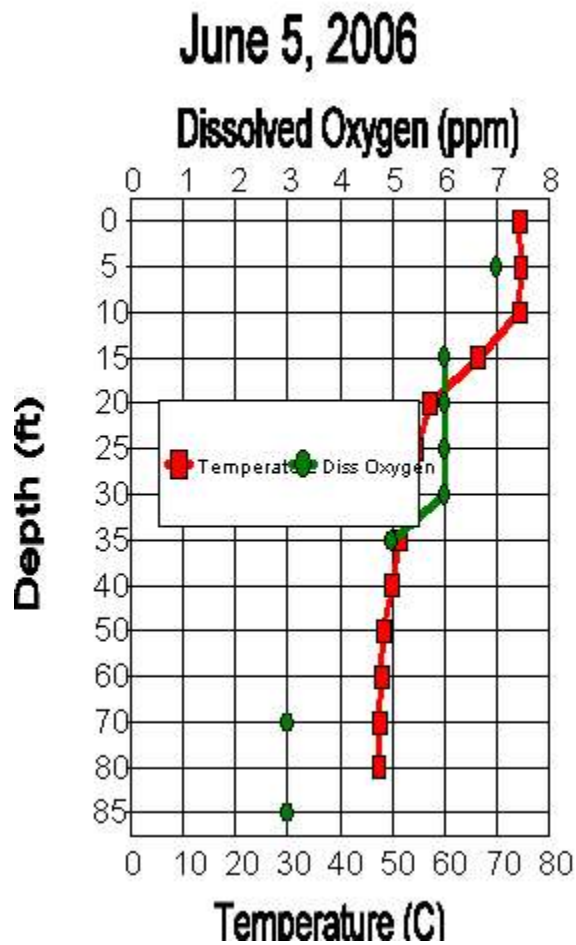
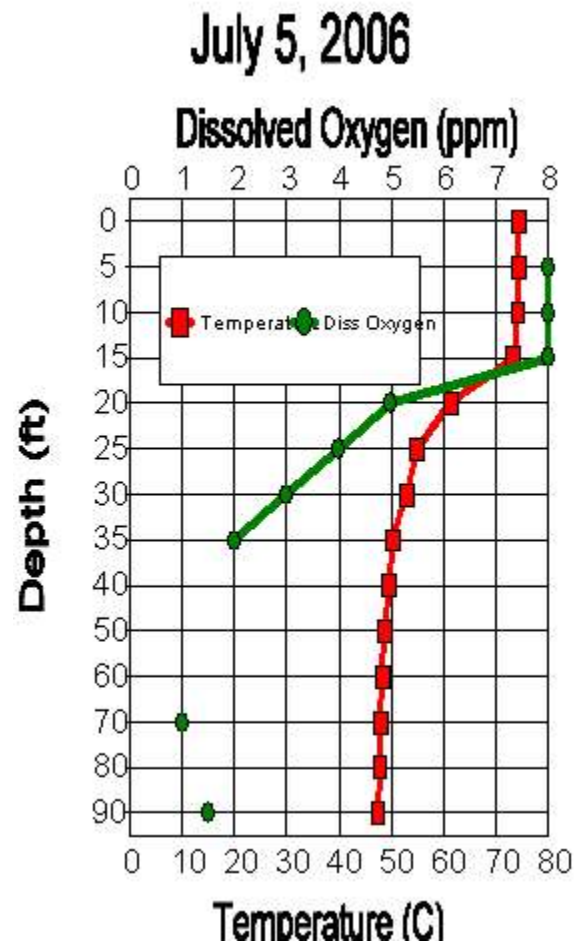
Figure 11. Dissolved oxygen and temperature profiles for Bear Lake in 2006.

Dissolved oxygen and temperature profiles have been acquired in 2005 and 2006. By examining the profiles, one can learn a great deal about the condition of a lake and the habitat that is available for aquatic life.

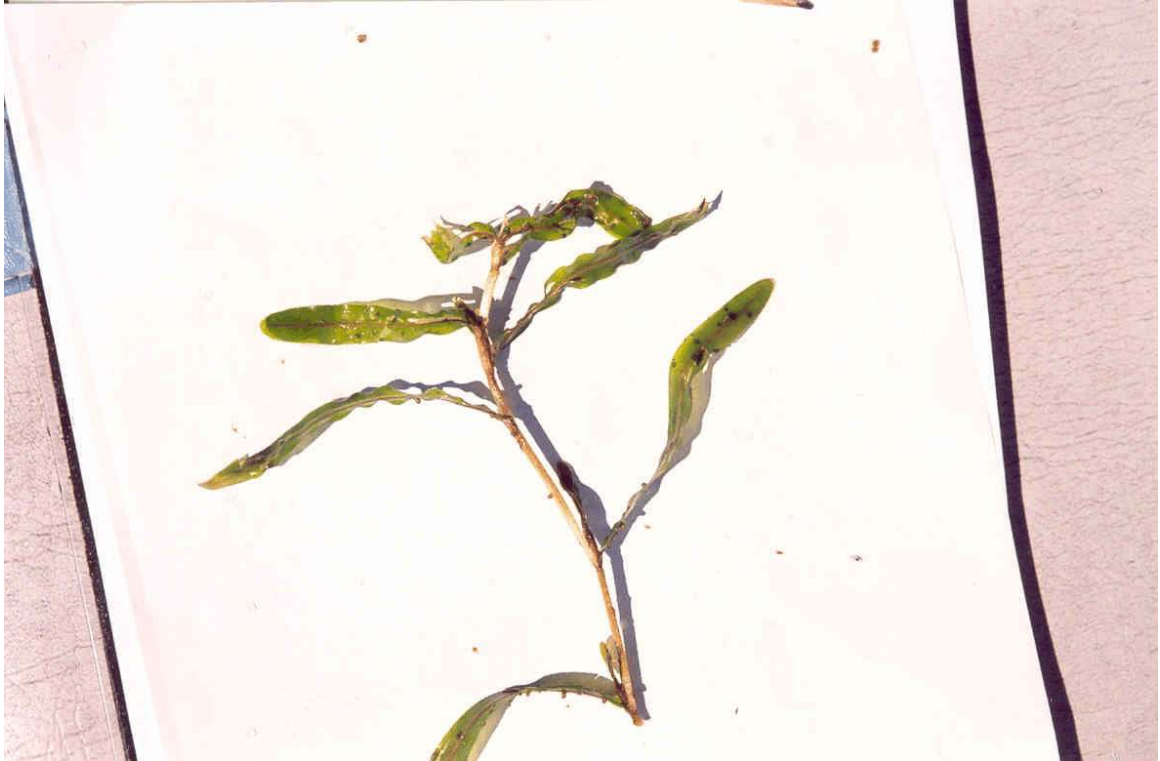
**Figure 20. [top] Curlyleaf was found at one location in May of 2006.
[bottom] Curlyleaf was more widespread in June of 2007 compared to May of 2006.**

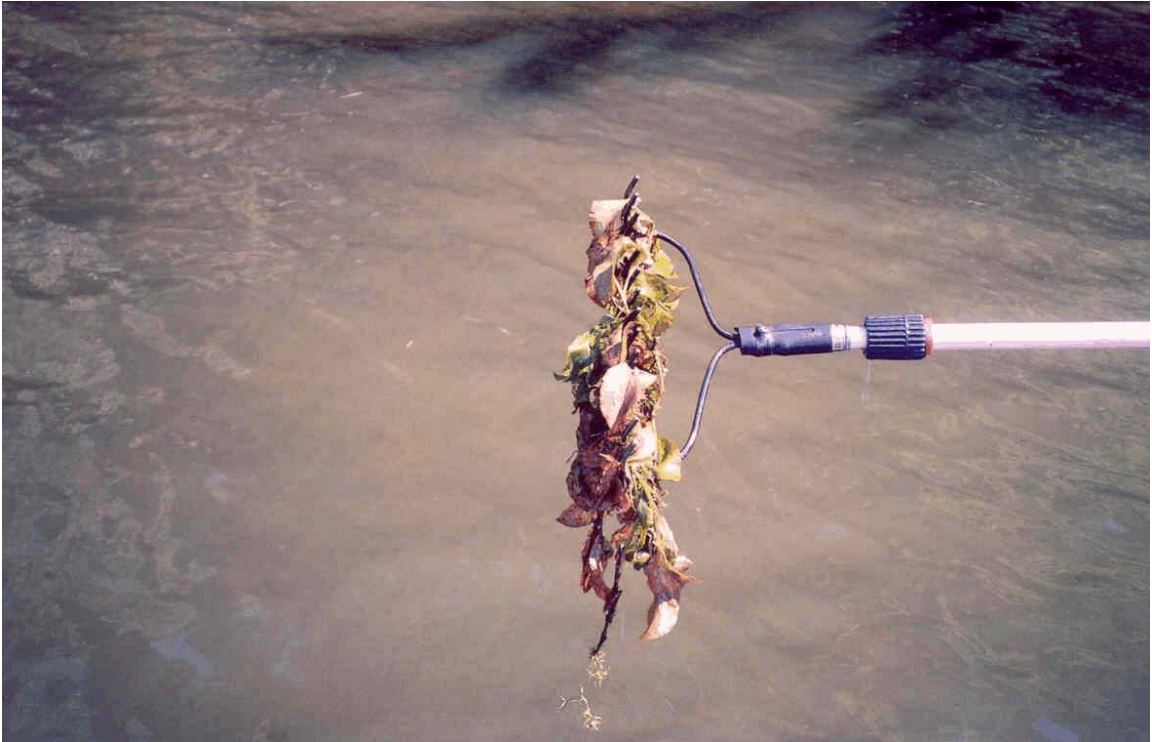
Figure 22. Largeleaf pondweed on a sample rake on August 15, 2006.

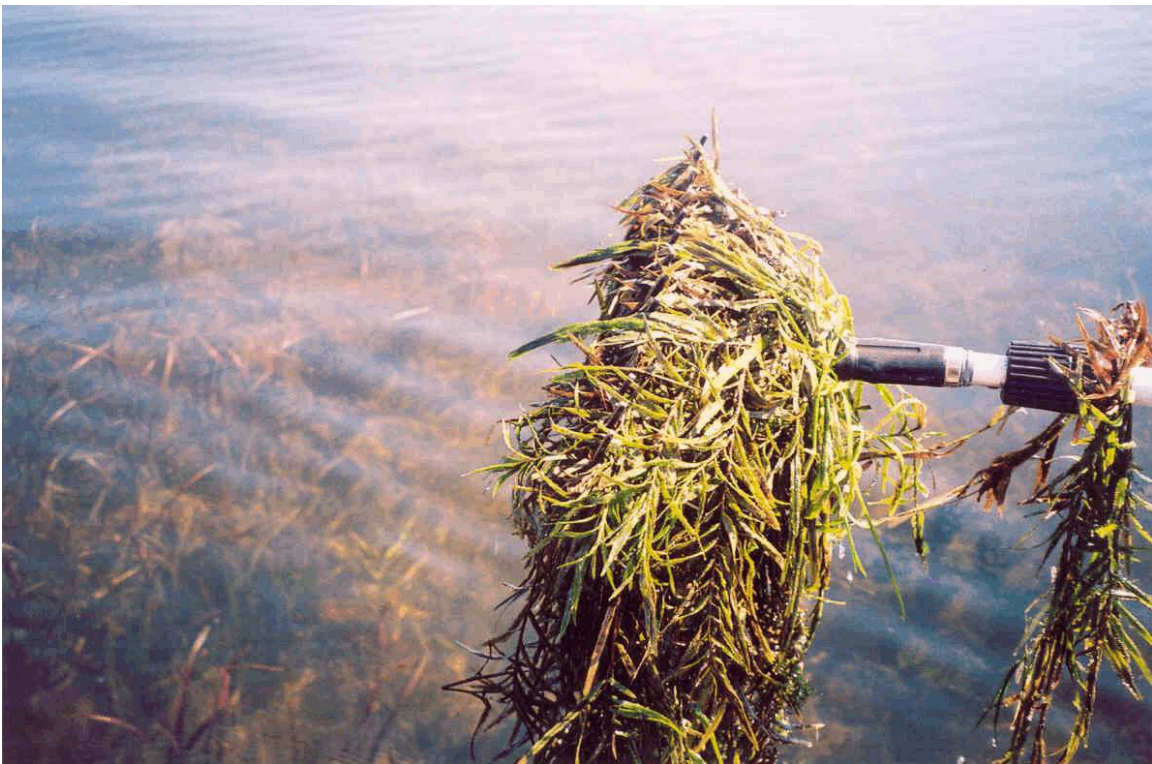
Figure 23. Fern pondweed was common in the August 15 Bear Lake aquatic plant survey.

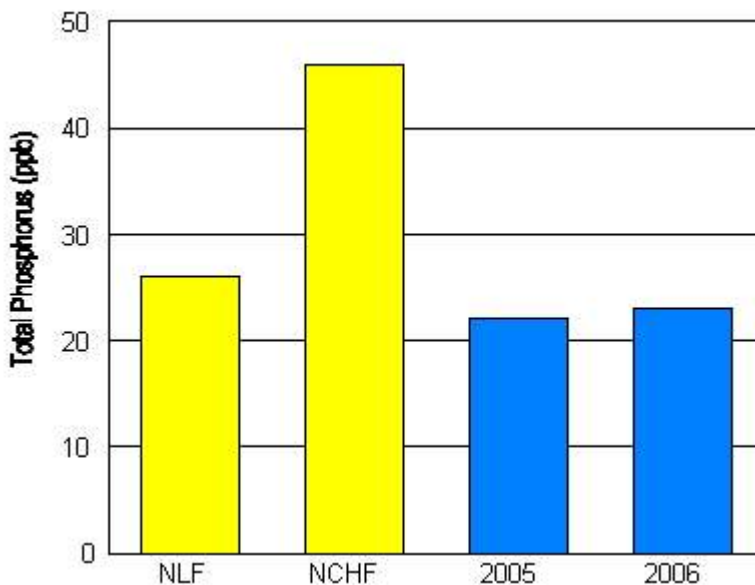
Figure 29. Comparison of total phosphorus (TP) conditions for Bear Lake in 2005 and 2006 to predicted conditions for a watershed and a lake the size of Bear Lake situated in the Northern Lakes and Forest (NLF) and the North Central Hardwood Forest (NCHF) ecoregion.

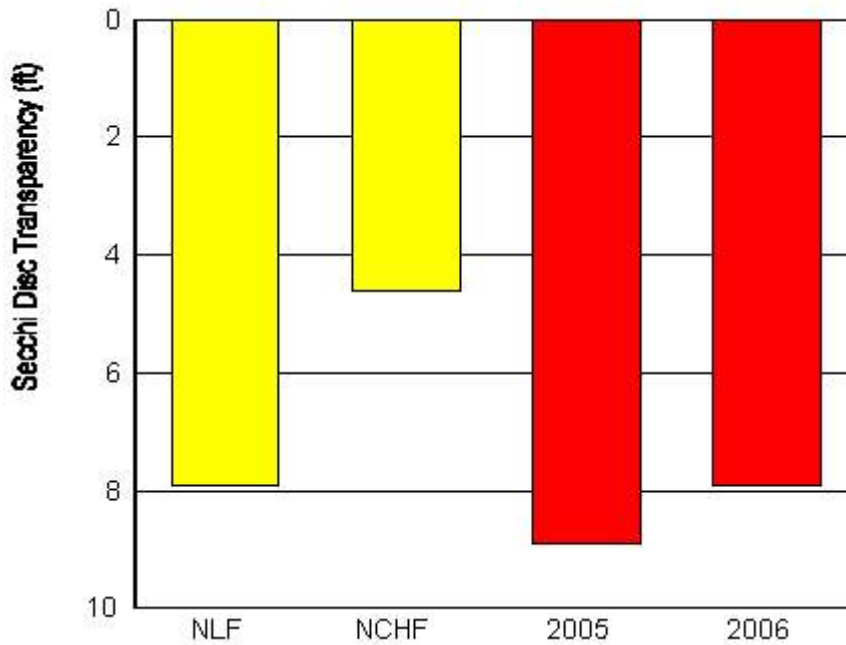
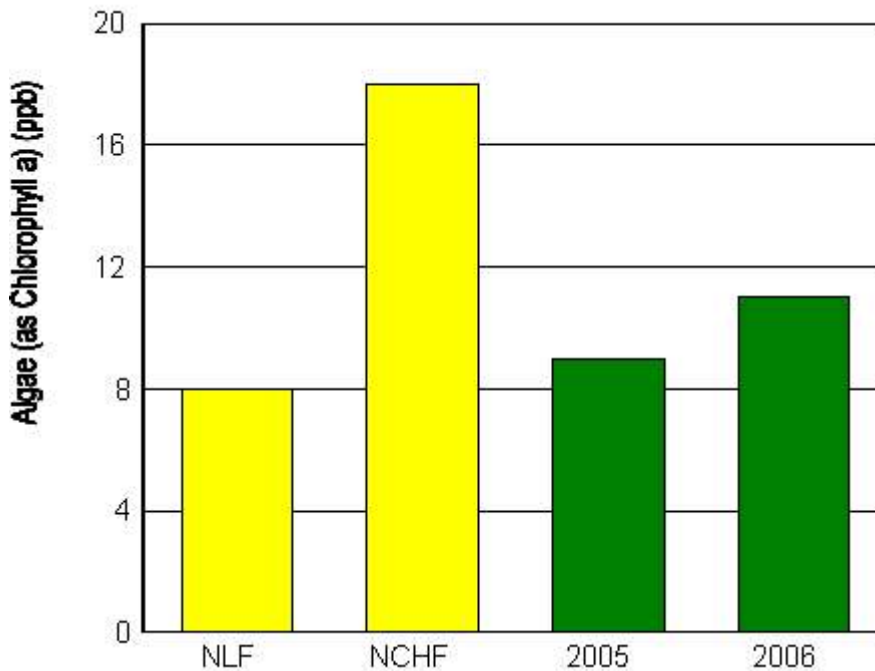
Figure 30. Comparison of Secchi disc transparency (meters) and algae (chlorophyll a – ppb) conditions for Bear Lake in 2005 and 2006 to predicted conditions for a lake the size of Bear Lake situated in the Northern Lakes and Forest (NLF) ecoregion and North Central Hardwood Forest (NCHF) ecoregion.

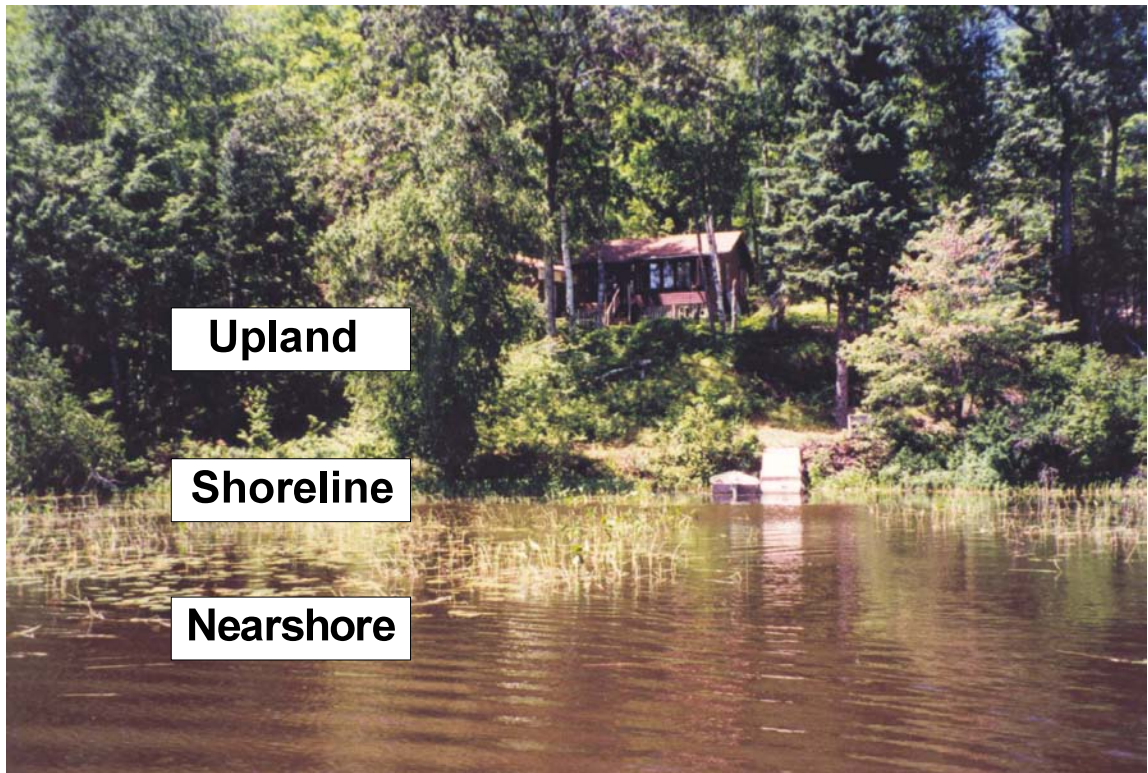
Figure 31. Cross section of the lake shoreland habitat.

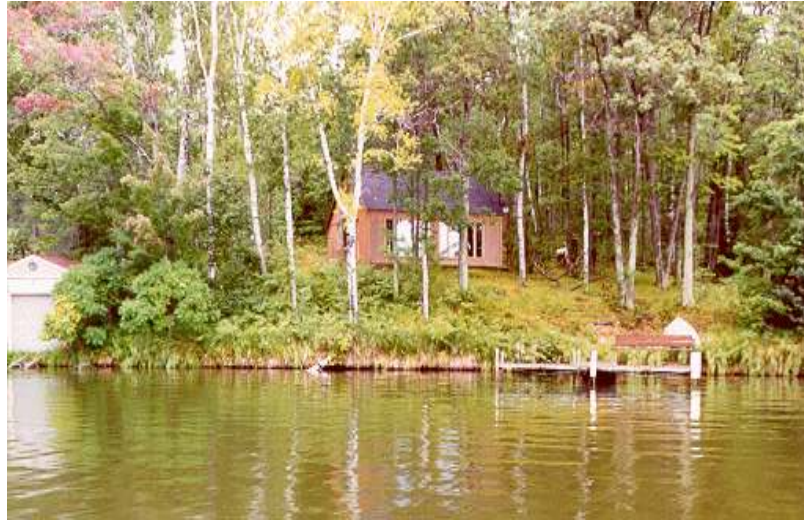
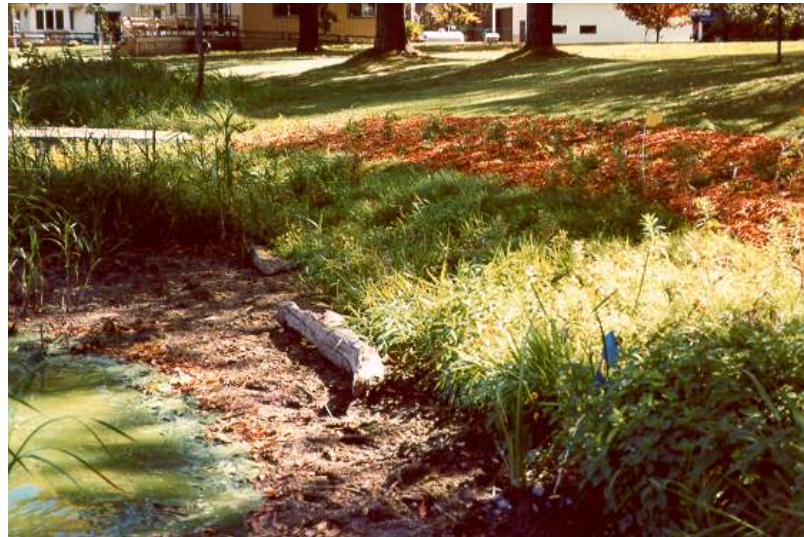
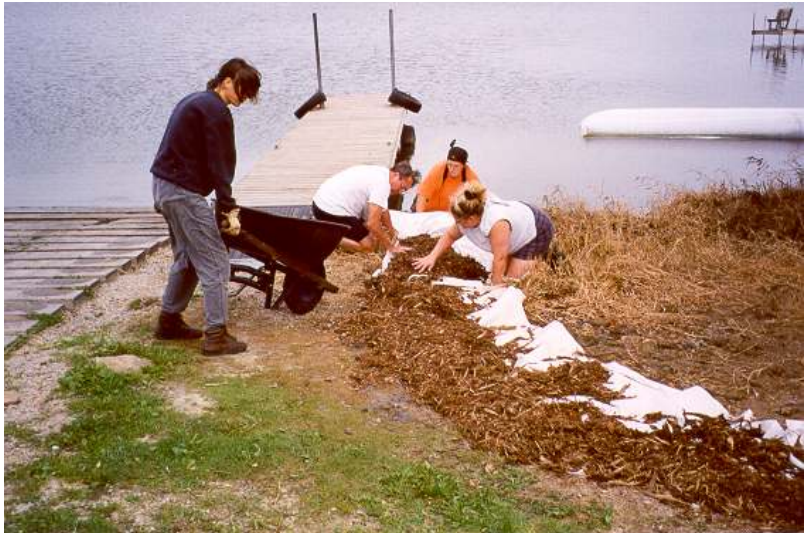
2. Accelerated Naturalization: To accelerate the naturalization, plant shrubs, wild flowers, or grasses into a shoreland area.

3. Restoration: This involves removing existing vegetation through the use of paper mats and/or mulching and planting a variety of native grasses, flowers, and shrubs into the shoreland area.

Figure 32. Examples of three shoreland management options.

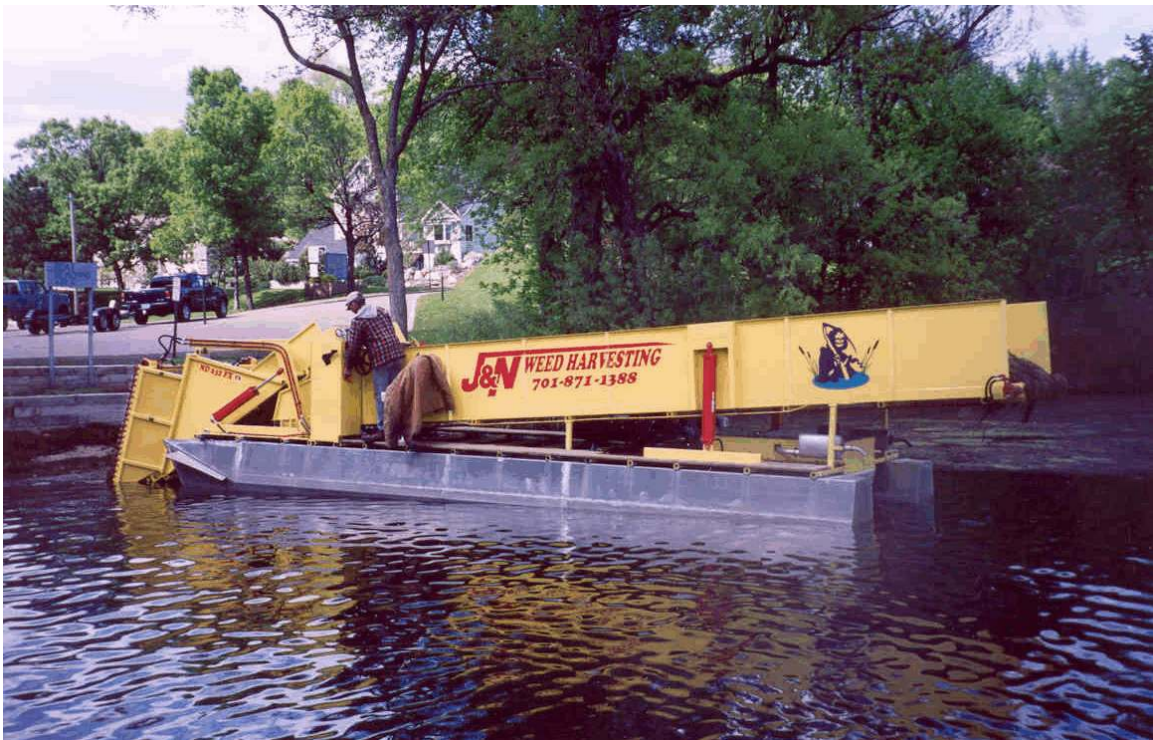
Figure 34. A mechanical harvester is a curlyleaf pondweed management option.
