**Aquatic Plant Management Plan for
the St. Croix Flowage, Douglas
County 2010 Addition**

2010 CLP/EWM AIS Education Project

Douglas County, Wisconsin

January 2011

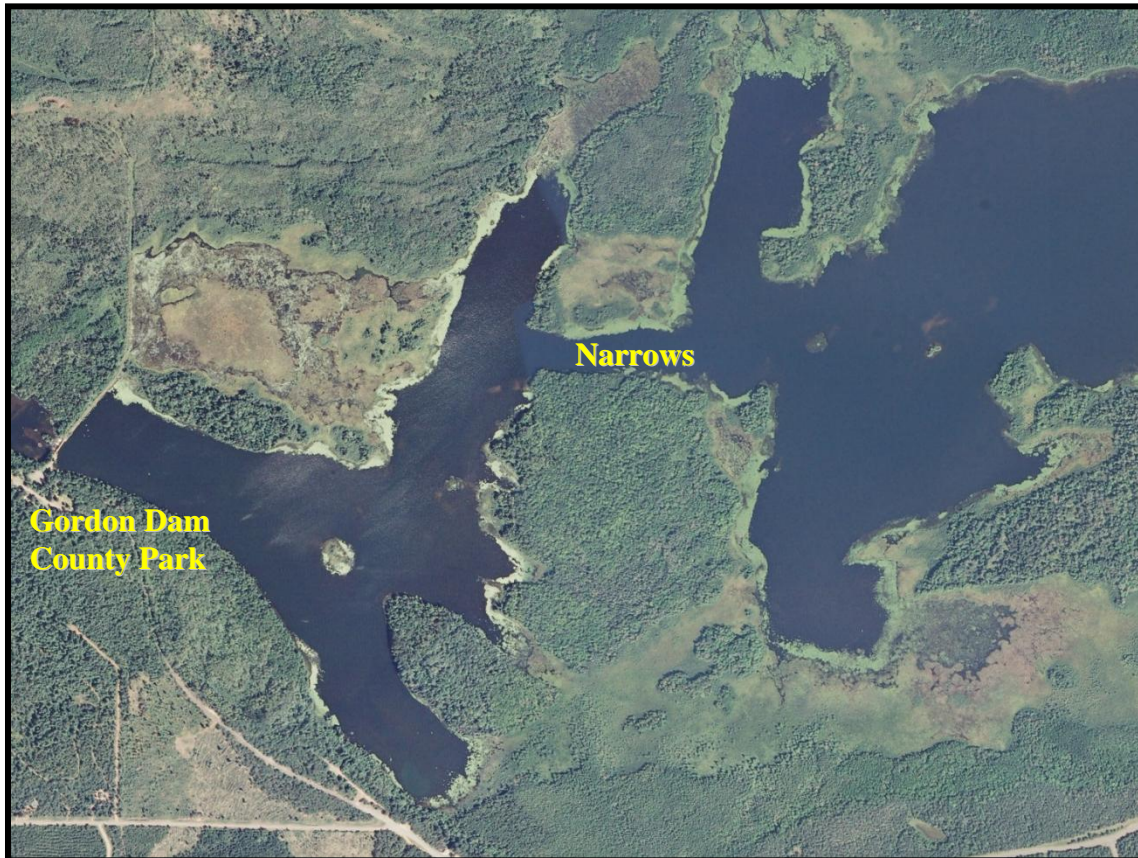
Figure 2 – Western Half of the St. Croix Flowage, Douglas County

In the 2009 APM Plan information about the level of curly-leaf pondweed (*Potamogetum crispus*) (CLP), another invasive non-native aquatic plant, present in the Flowage, particularly in the area near the “Narrows” (Figure 2), a natural restriction in the Flowage separating the western third of the Flowage from the main body of the Flowage was based on a 2007 survey completed by the University of Wisconsin-Stevens Point, and Citizen Lake Monitoring Network volunteer plant monitoring. No recommendations were made in the 2009 APM Plan to manage CLP except to complete additional point-intercept aquatic plant surveying and bed mapping in 2010 to better document the extent of CLP in this area of the Flowage. The 2010 point-intercept survey reduced the distance between the original point-intercept survey points by half and concentrated on an area beginning just east of the narrows and covering the entire area of the Flowage west of the Narrows to the dam. The 2010 survey identified CLP at a number of points within this area and mapped several small beds of CLP (Figure 3).

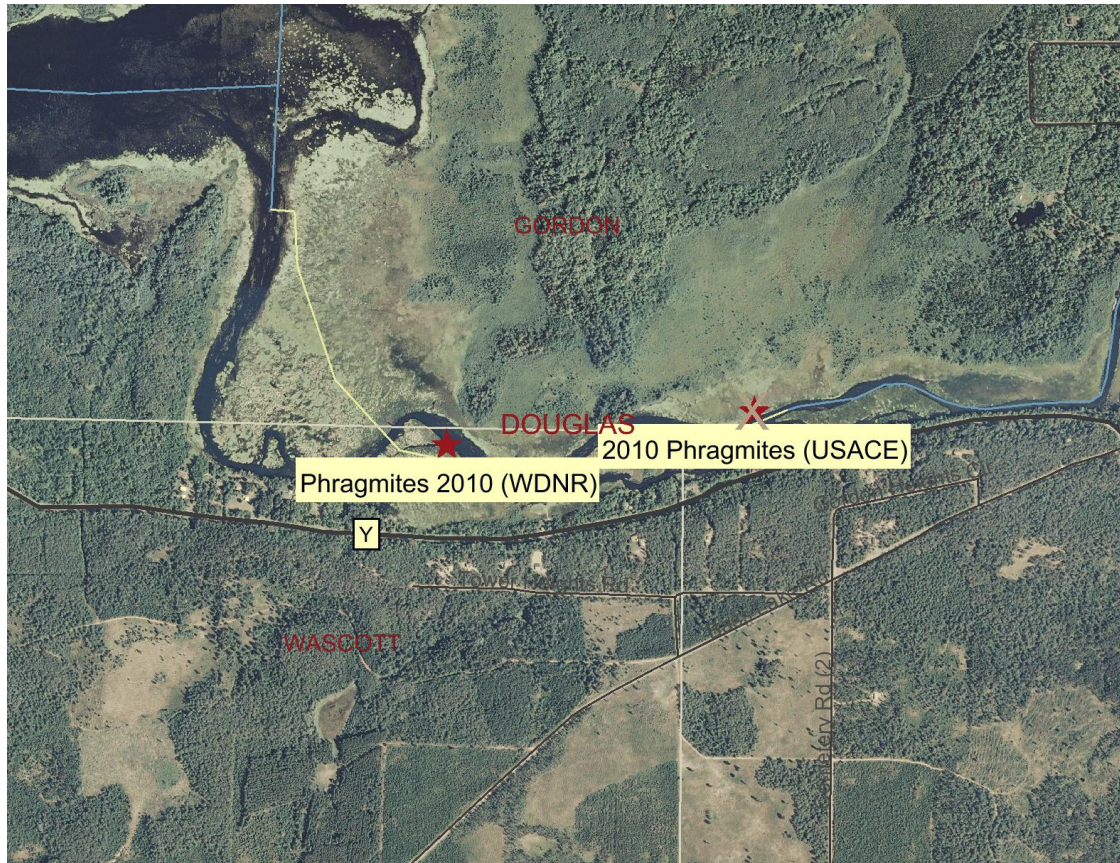
Figure 4 – 2010 *Phragmites australis* Locations

Giant reed grass (*Phragmites australis*) was mentioned in the 2009 APM Plan but at that time it was not known if it was present in the Flowage or not. Monitoring work completed in 2010 identified an area of giant reed grass along the shores of the St. Croix River on the east end of the Flowage (Figure 4).

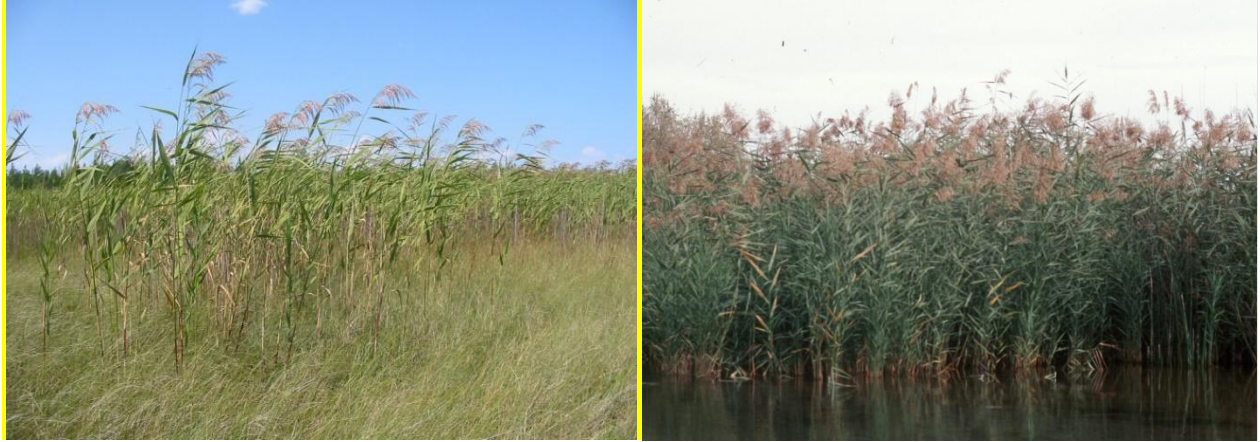
Figure 11 – Native (left) and Non-native (right) Phragmites

Native phragmites has low stem density and low seed viability. It has a slow rate of spread through runners and seeds. Seed heads are shorter than those of non-native phragmites and not as robust (Figure 11). Non-native phragmites has high stem density and high seed viability. It spreads quickly by runners that can be up to 50-ft long (Figure 12), pieces of runners, and seeds. It has a tall robust seed head (Figure 11).

Native <i>Phragmites</i>	Non-native <i>Phragmites</i>
shorter total plant height in same habitat (4-8 ft)	taller (10-15 ft)
found in undisturbed sites	found in disturbed sites
leaves yellow-green and lighter	leaves blue-green and darker
static, thin distribution w/other plants present	dense and spreading distribution, mono-typical
green to red stems may have small round spots	green stems with yellow leaf nodes with black patches, no spots
leaf sheaths readily fall off in the fall leaving smooth stems	leaf sheaths remain attached in the fall

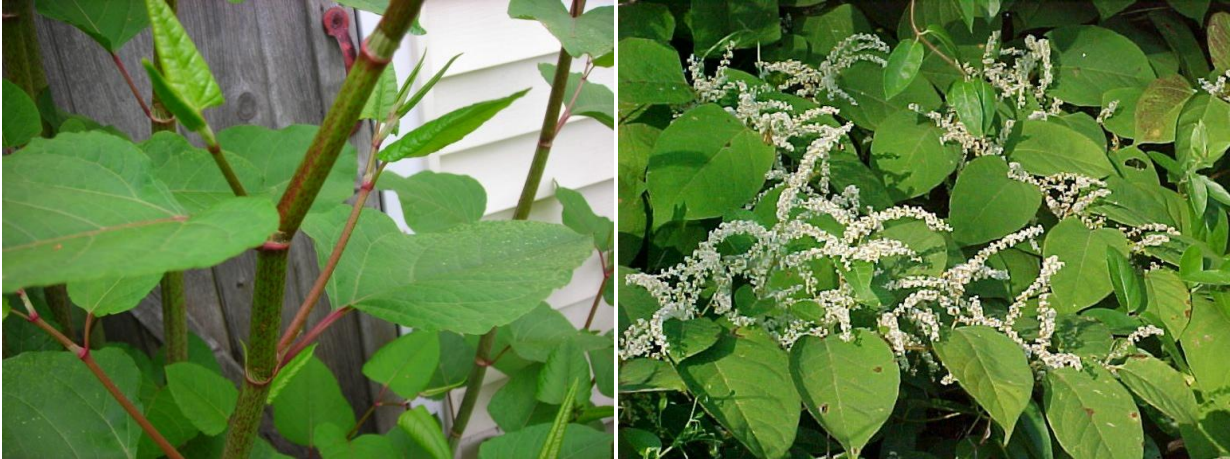
Figure 13 – Japanese Knotweed

Knotweeds are robust, bamboo-like perennials introduced from Asia that are spreading throughout the Great Lakes states. The main species is Japanese Knotweed. Knotweed grows in dense stands 6-12-ft tall. Its stems are hollow, green to reddish in color and bamboo-like. Its leaves are bright green, broad, egg or heart shaped, with a pointed tip. Small white flowers in branched spray appear July through August (Figure 13).

Dormant in winter, the dead reddish brown stems often remain standing. It emerges from root crowns in April and reaches full height in June. The heaviest concentrations of knotweed are usually along rivers and roads, but are also found in parks, backyards, along lake shore, in forests and on farms. Japanese knotweed reproduces occasionally by seed, but spreads primarily by extensive networks of underground rhizomes, which can reach 6 feet deep, 60 feet long, and become strong enough to damage pavement and penetrate building foundations. Controlling Japanese knotweed is difficult and requires persistence and diligence. It can be dug, cut, covered, chemically sprayed, or have herbicide injected into individual stems.
