SAND LAKE, BARRON COUNTY

2019 AQUATIC PLANT MANAGEMENT SUMMARY REPORT WDNR WBIC: 2661100

Prepared by: Heather Wood, Lake Management Assistant & Dave Blumer,
Lake Educator

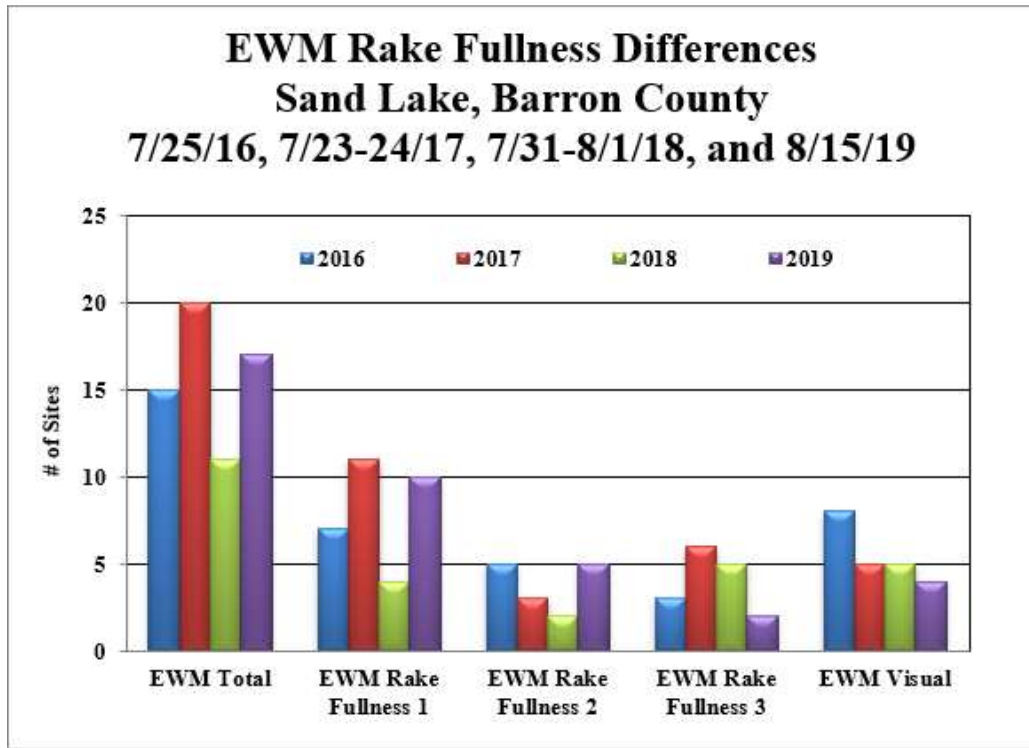
Significant differences = * $p < 0.05$, ** $p < 0.01$, *** $p < 0.001$

Figure 1: Comparison of EWM Density and significant changes from 2016, 2017, 2018, and 2019 (Berg, 2019)

In 2019, EWM was found in the rake at 17 sites (3.60% of points with vegetation), and it contributed 0.90% of the total relative frequency. Two points were rated a rake fullness of 3, five points a 2, and ten points a 1 for a mean rake of 1.53. EWM was also recorded as a visual at four points. Just as in each year since 2016, none of the changes in rake fullness were significant. Similarly, the overall decrease in mean density, and the increase in distribution were not significant (Figure 1)

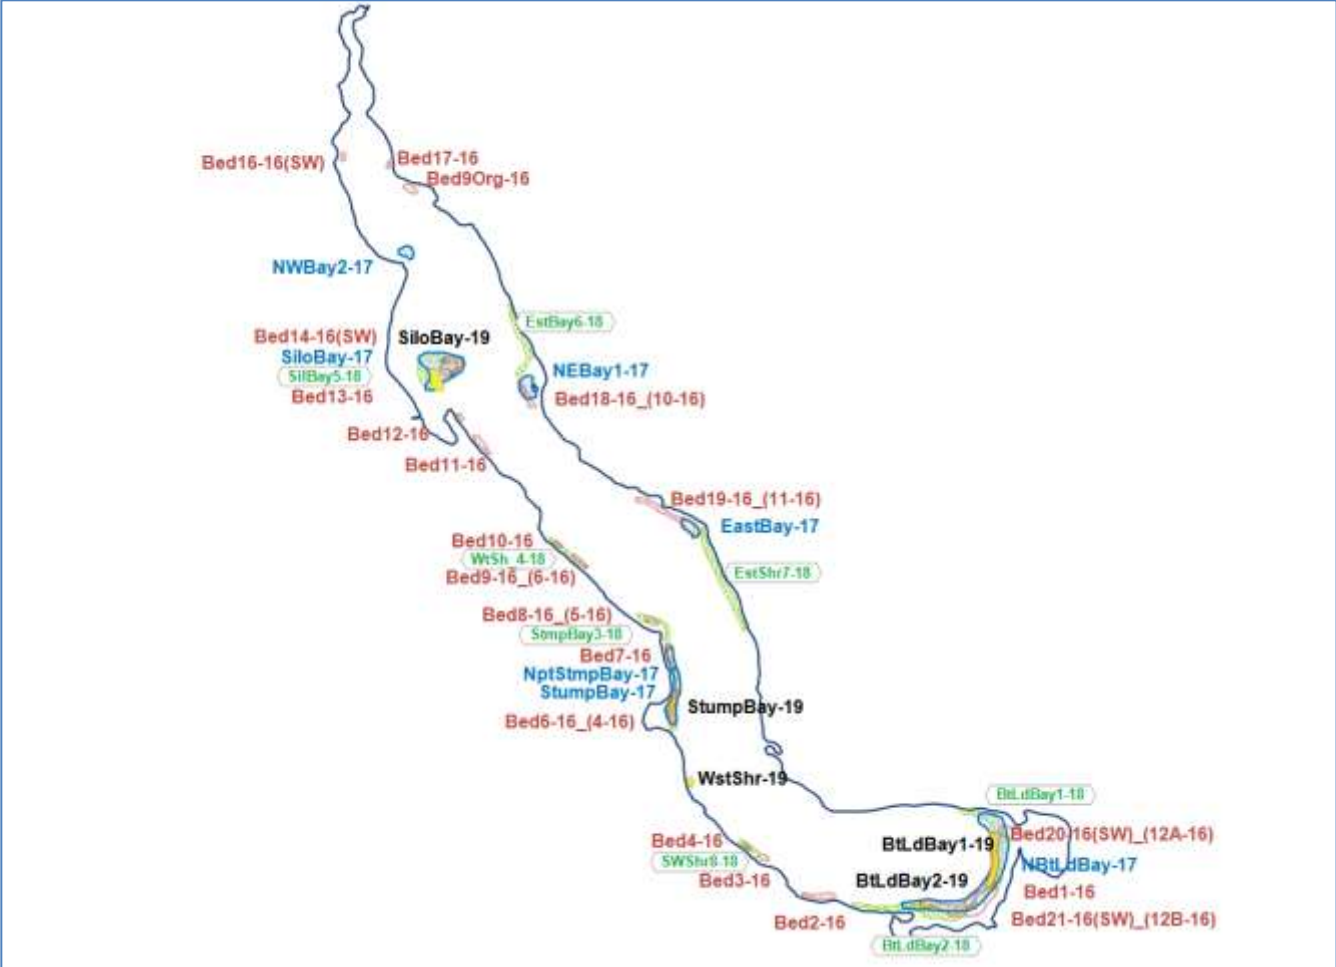
Figure 3: 2016, 2017, 2018, and 2019 chemical treatment areas

That said, EWM continues to be difficult to manage along the deep water edges of the littoral zone. It is these areas that are basically being treated every year (Figure 3).

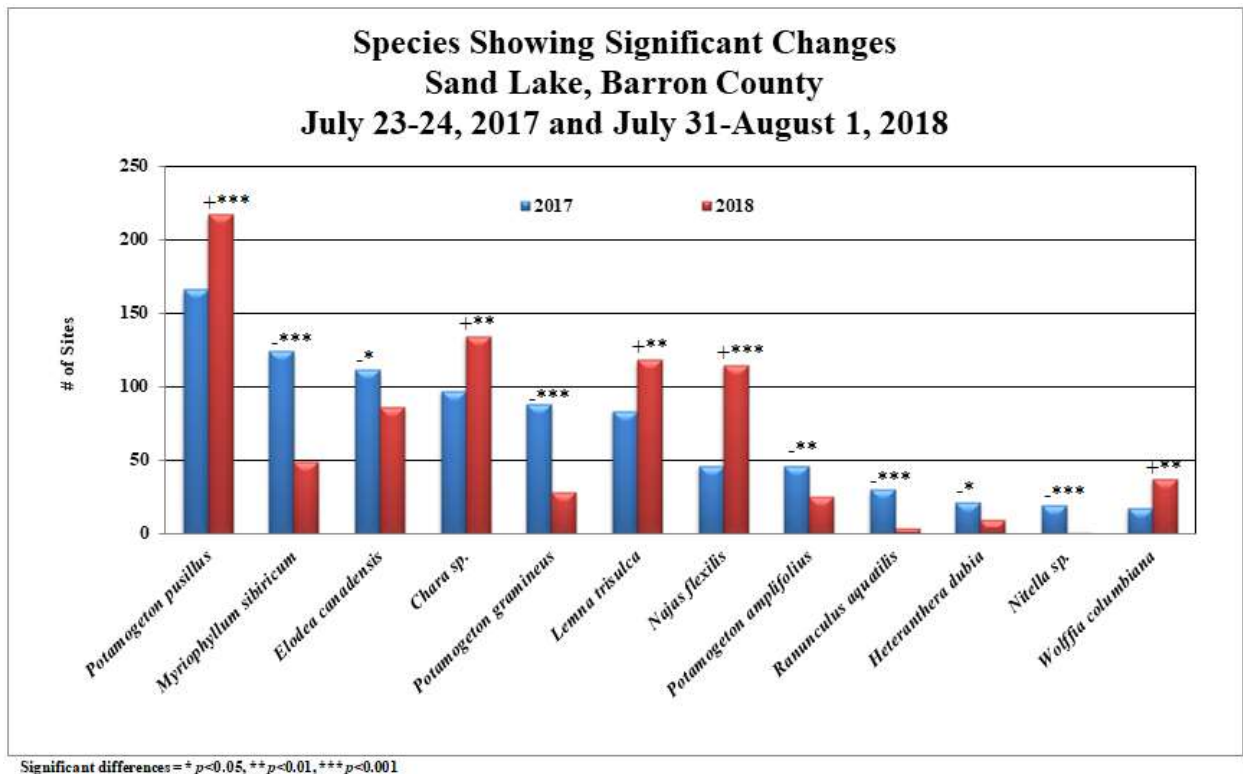
Figure 11: Species with a significant change from 2017 to 2018 (Berg, 2018)

From 2017 to 2018, 12 species experienced significant changes in distribution. Northern water-milfoil, Variable pondweed, White water crowfoot, and Nitella suffered highly significant declines; Large-leaf pondweed demonstrated a moderately significant decline; and Common waterweed and Water star-grass saw significant declines. Despite these

losses, highly significant increases were found in Small pondweed and Slender naiad; and moderately significant increases were found in Muskgrass, Forked duckweed, and Common watermeal (Figure 11).

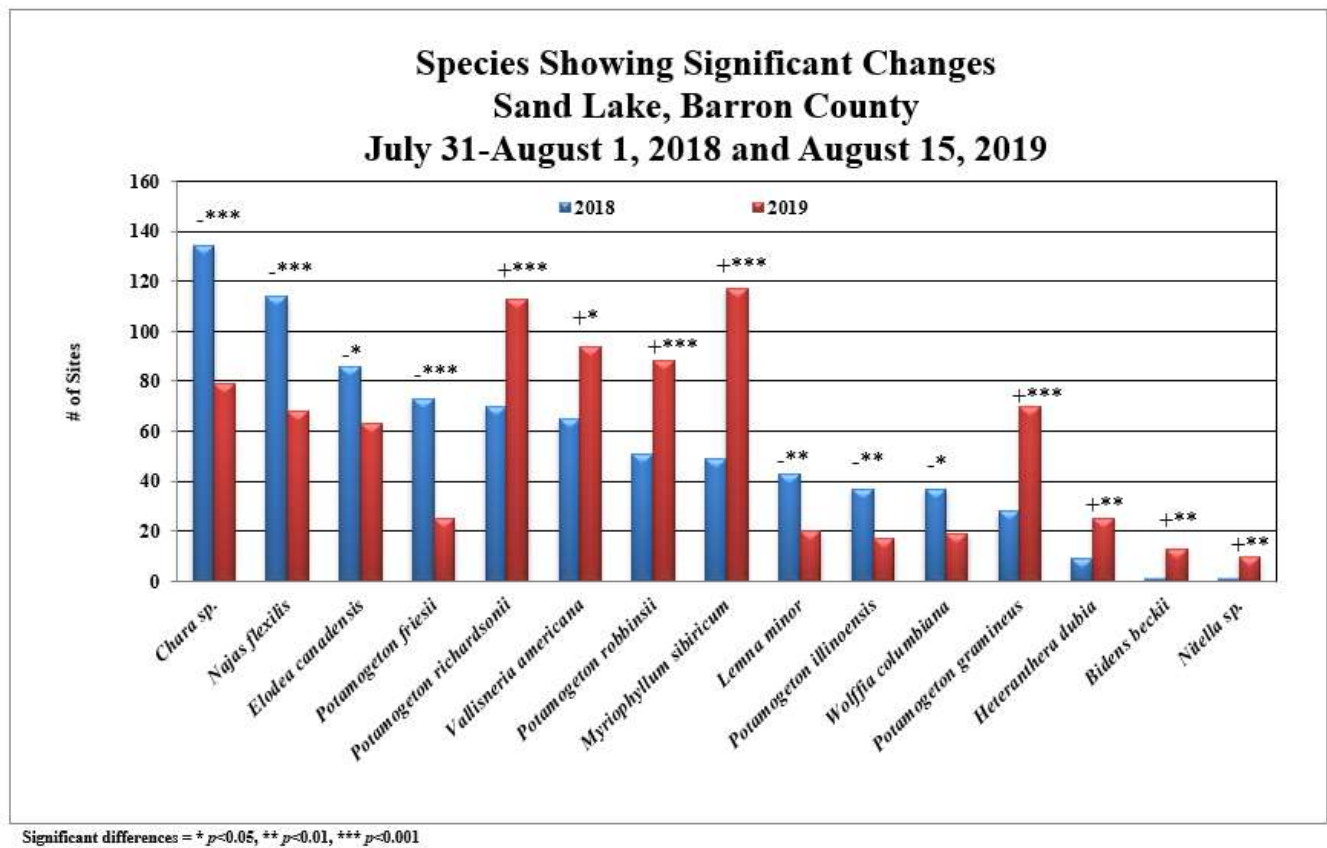
Figure 12: Species with a significant change from 2018 to 2019 (Berg, 2019)

From 2018 to 2019, 15 species experienced significant changes in distribution. Highly significant declines were found in Muskgrass, Slender naiad, and Fries' pondweed; moderately significant declines in Small duckweed and Illinois pondweed; and Common waterweed and Common watermeal had significant declines. Alternatively, Claspingleaf pondweed, Fern pondweed, Northern water-milfoil, and Variable pondweed all demonstrated highly significant expansions; Water star-grass and Water marigold both showed moderately significant increases; and Wild celery had a significant increase (Figure 12).
