Note: Methodology, explanation of analysis and biological background on Benson Lake studies are contained within the Manitowish Waters Chain of Lakes-wide Management Plan document.

8.13 Benson Lake

An Introduction to Benson Lake

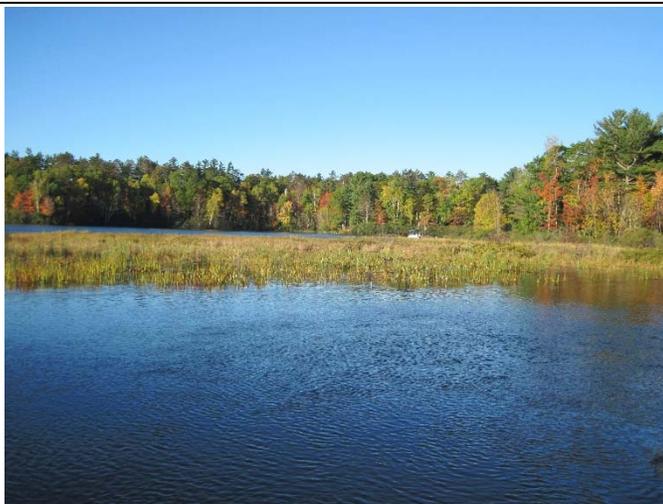
Photo 8.13. Benson Lake, Vilas County

Primarily sandy and rocky substrate observed during the 2017 point-intercept survey. The lake has abundant emergent and floating-leaf communities (Photo 8.13).

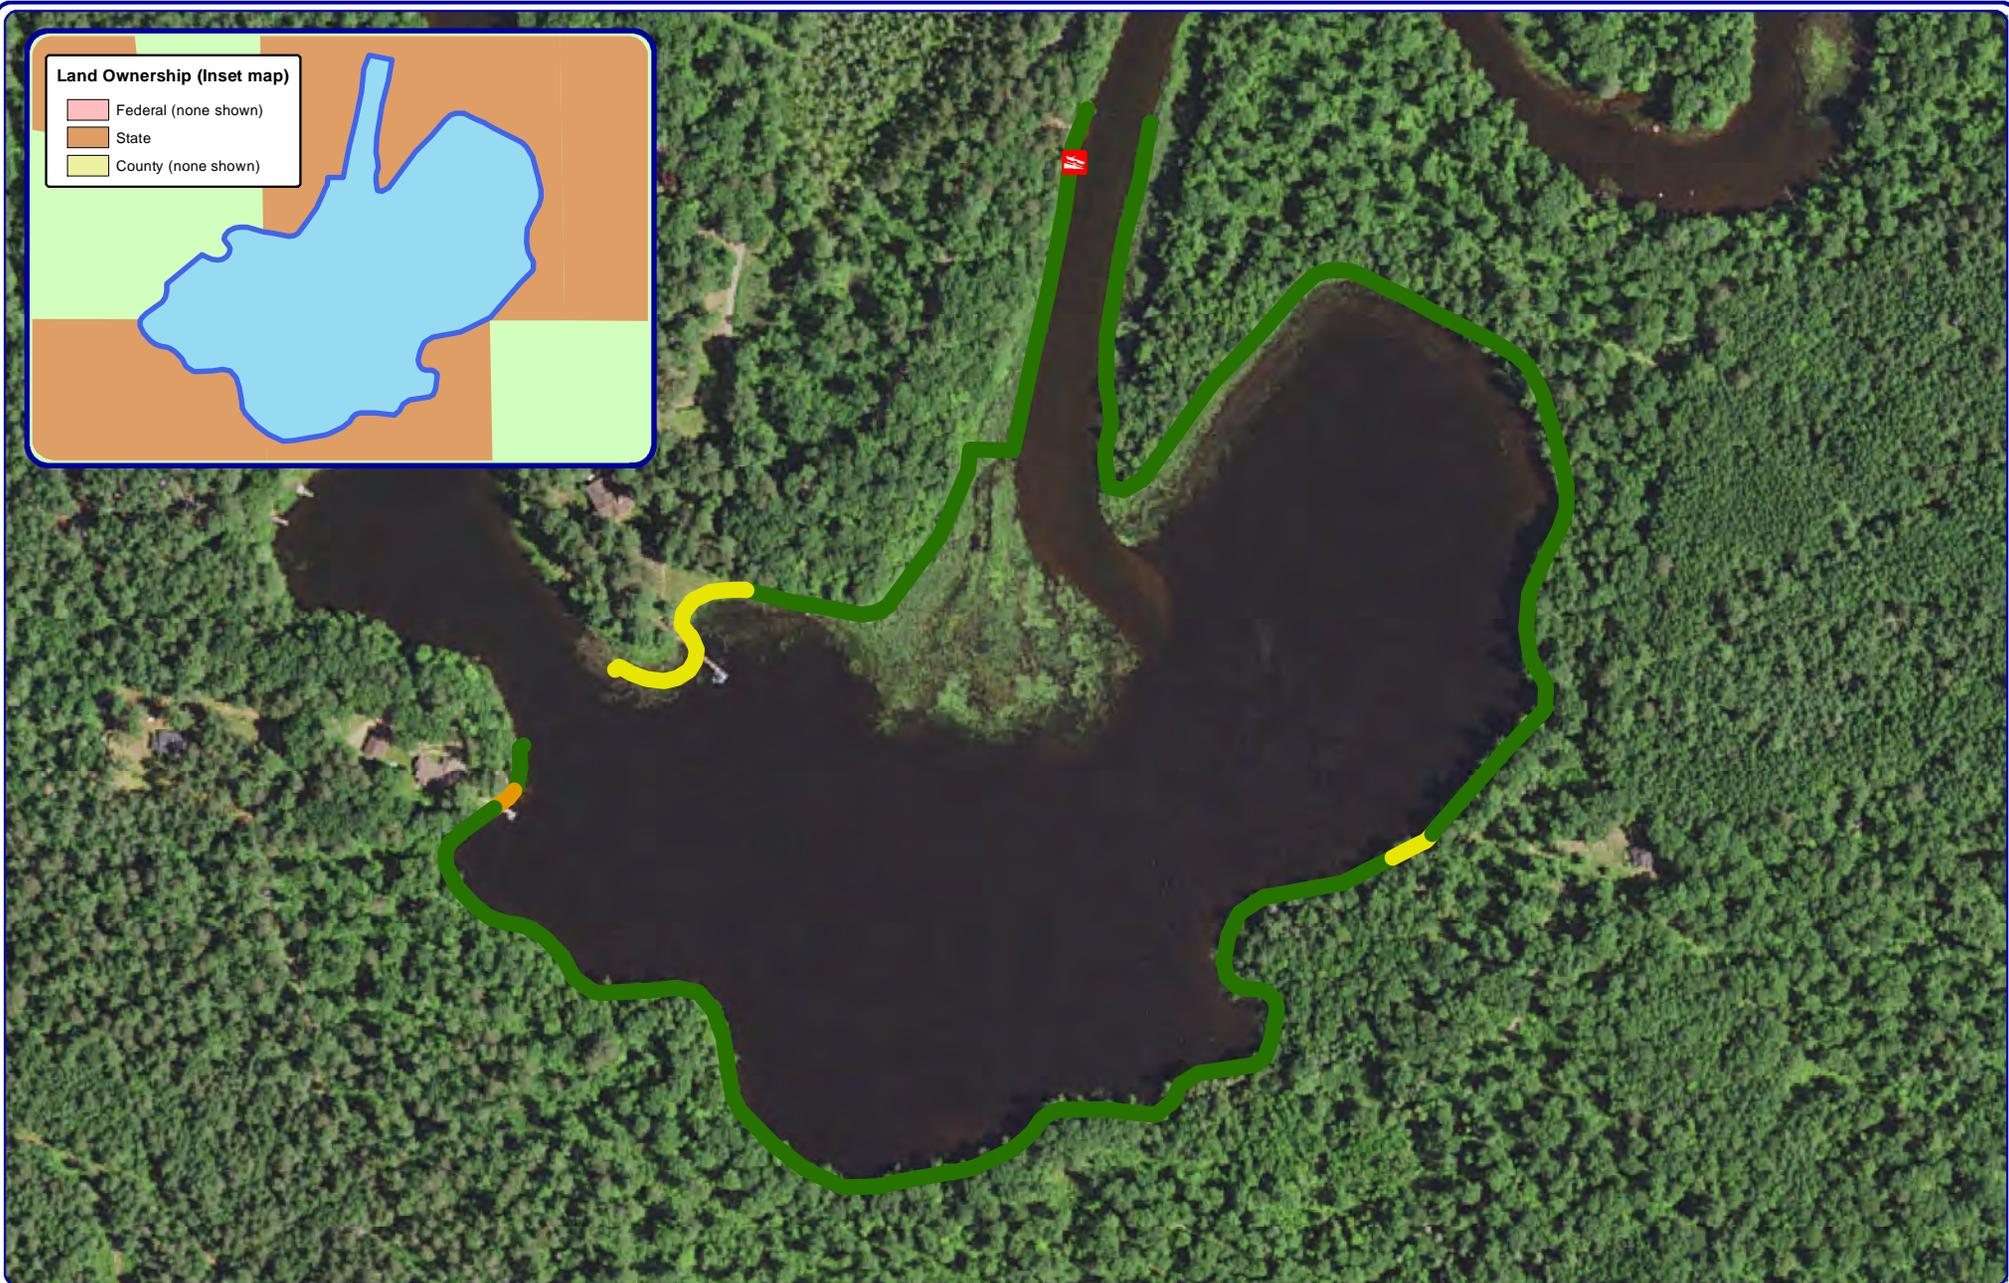
Map 1
 Benson Lake
 Vilas County, Wisconsin
**2017 Shoreland
 Condition**

As mentioned previously in the Chain-wide Shoreland Condition Section, one of the most sensitive areas of the watershed is the immediate shoreland area. This area of land is the last source of protection for a lake against surface water runoff, and is also a critical area for wildlife habitat. In fall of 2017, Benson Lake's immediate shoreline was assessed in terms of its development. Benson Lake has stretches of shoreland that three of the five shoreland assessment categories. In all, 1.1 miles of natural/undeveloped and developed-natural shoreline were observed during the survey (Figure 8.13.3-1). This constitutes about 93% of Benson Lake's shoreline. This shoreland types provide the most benefit to the lake and should be left in their natural state if at all possible. During the survey, less than one tenth of a mile of developed-unnatural shoreline (1%) was observed. If restoration of the Benson Lake shoreline is to occur, primary focus should be placed on this shoreland area as they currently provide little benefit to, and actually may harm, the lake ecosystem. Benson Lake Map 1 displays the location of these shoreline lengths around the entire lake.
