## 8.1 Rest Lake

### An Introduction to Rest Lake

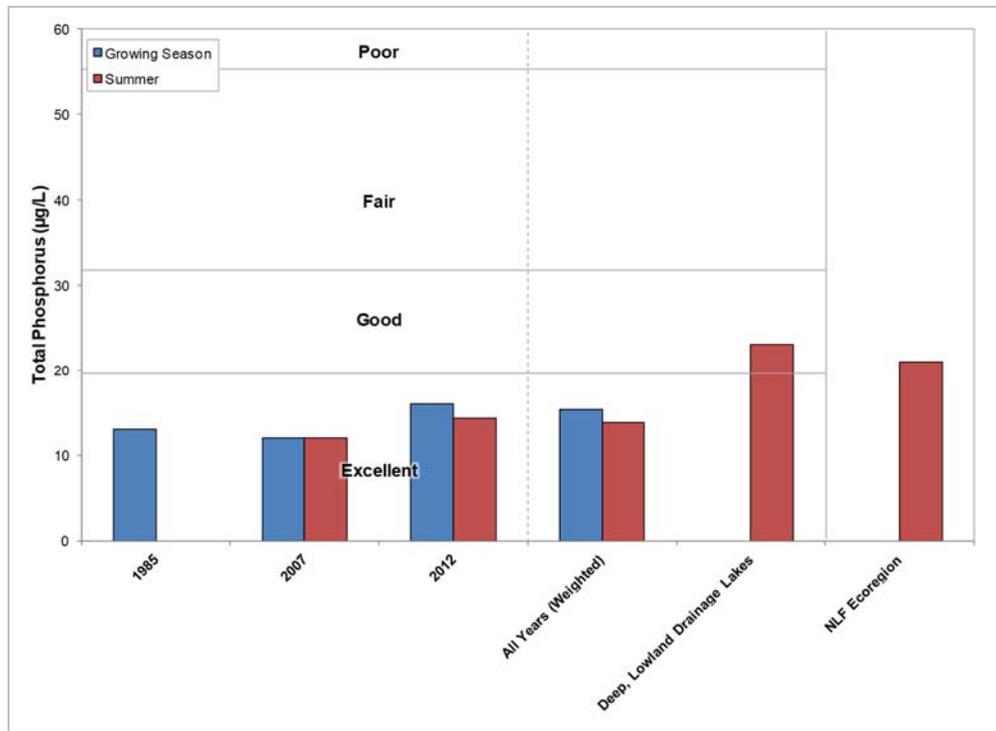
**Figure 8.1.1-1. Rest Lake, state-wide deep, lowland drainage lakes, and regional total phosphorus concentrations.** Mean values calculated with summer month surface sample data. Water Quality Index values adapted from WDNR PUB WT-913.

Unfortunately, very limited data exists for two water quality parameters of interest – total phosphorus and chlorophyll-*a* concentrations. In 2012, average summer phosphorus concentrations (14.3 µg/L) were less than the median value (23.0 µg/L) for other deep, lowland drainage lakes in the state (Figure 8.1.1-1). The values measured through this management planning process are similar to several data points which were collected in years past. A weighted value from all available data ranks as *Excellent* for a deep, lowland drainage lake.

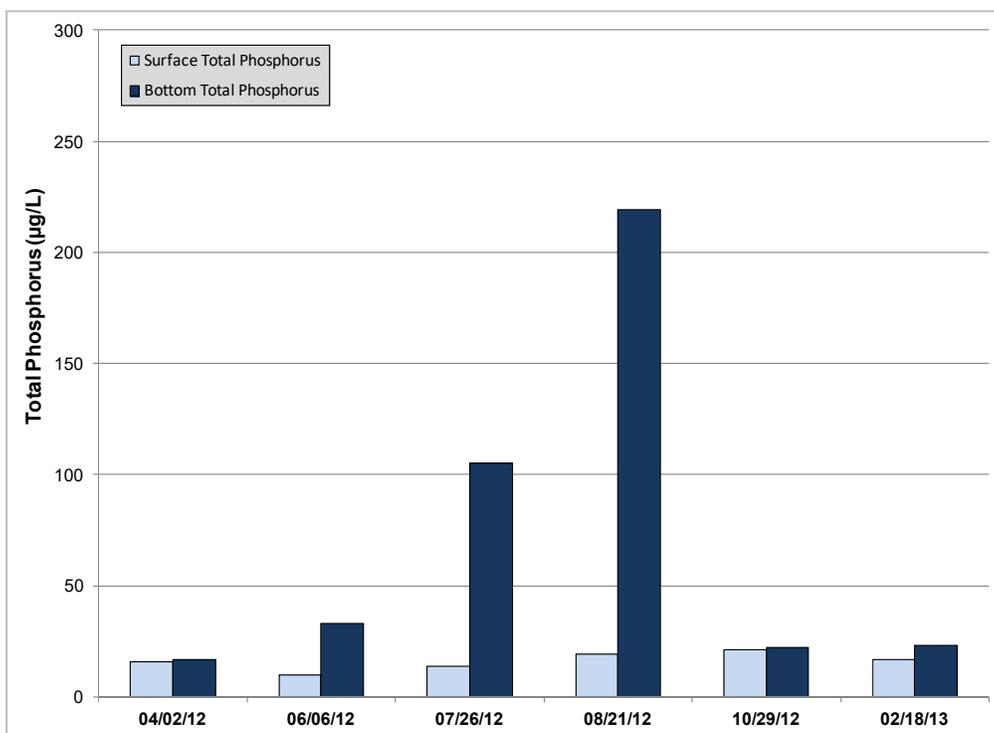
**Figure 8.1.1-2. Rest Lake surface and bottom total phosphorus values, 2012-2013.** Anoxia was observed in the hypolimnion of the lake during July and August sampling visits.

Total phosphorus surface values from 2012 are compared with bottom-lake samples collected during this same time frame in Figure 8.1.1-2. As displayed in this figure, on several occasions surface and bottom total phosphorus concentrations were similar. However, on some occasions, namely during July and August of 2012, the bottom phosphorus concentrations were much greater than the relatively low surface concentrations. During these periods, anoxic conditions were recorded near the bottom of the lake through measurement of dissolved oxygen (refer to Figure 8.1.1-6 and associated text). This is an indication of hypolimnetic nutrient recycling, or internal nutrient loading, which is a process discussed further in the Manitowish Waters Chain of Lakes-wide document. While this process may be contributing some phosphorus to Rest Lake's water column, the impacts of nutrient loading are not apparent in the lake's overall water quality; as previously mentioned, Rest Lake's surface water total phosphorus values are slightly lower than the median value for comparable lakes in Wisconsin.

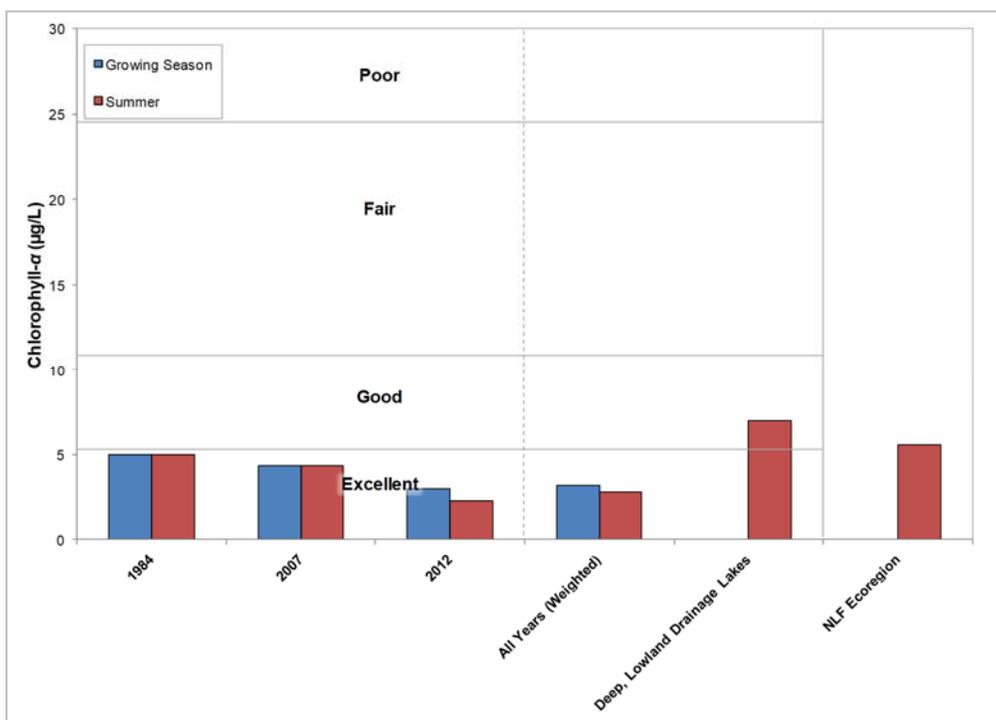
**Figure 8.1.1-3. Rest Lake, state-wide deep, lowland drainage lakes, and regional chlorophyll-a concentrations.** Mean values calculated with summer month surface sample data. Water Quality Index values adapted from WDNR PUB WT-913.

Similar to what has been observed with the total phosphorus dataset, summer average chlorophyll-*a* concentrations (2.3 µg/L) were less than the median value (7.0 µg/L) for other lakes of this type (Figure 8.1.1-3). These values are comparable to several historical values that have been collected on Rest Lake.

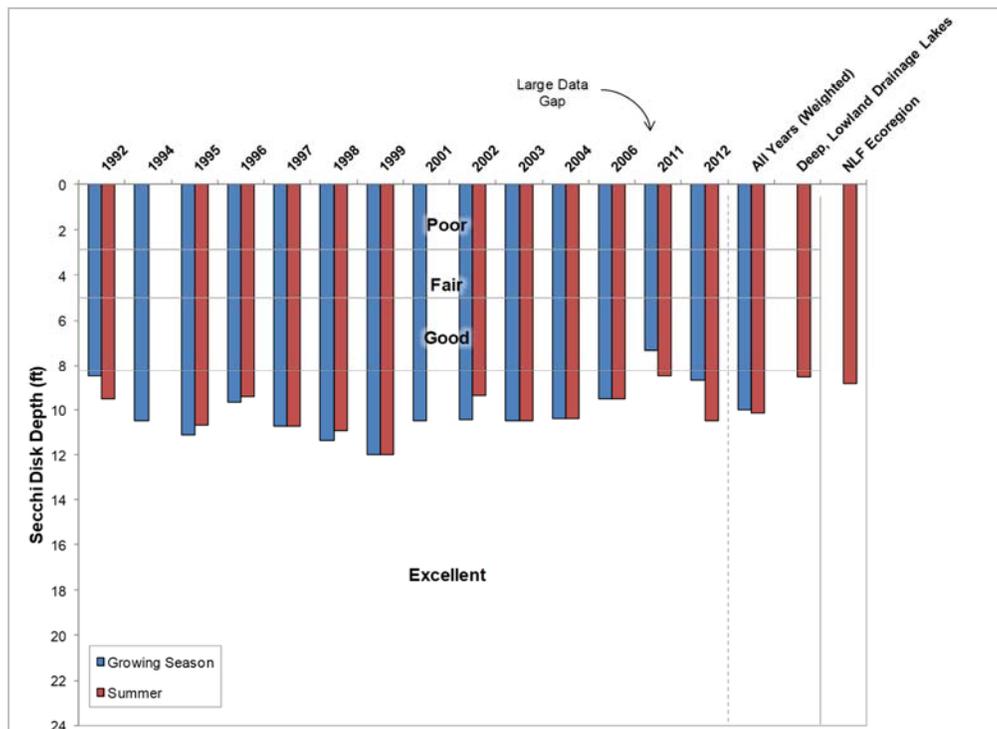
**Figure 8.1.1-4. Rest Lake, state-wide deep, lowland drainage lakes, and regional Secchi disk clarity values.** Mean values calculated with summer month surface sample data. Water Quality Index values adapted from WDNR PUB WT-913.

From the examination of nearly two decades worth of intermittent Secchi disk clarity data, several conclusions can be drawn. First, the clarity of Rest Lake’s water can be described as *Excellent* in most years (Figure 8.1.1-4). A weighted average over this timeframe is greater than the median value for other deep, lowland drainage lakes in the state as well as all lakes within the ecoregion. Secondly, there is very little variation seen in this data set indicating there is little reason to believe the water clarity has improved, or more importantly, gotten worse over this time period.

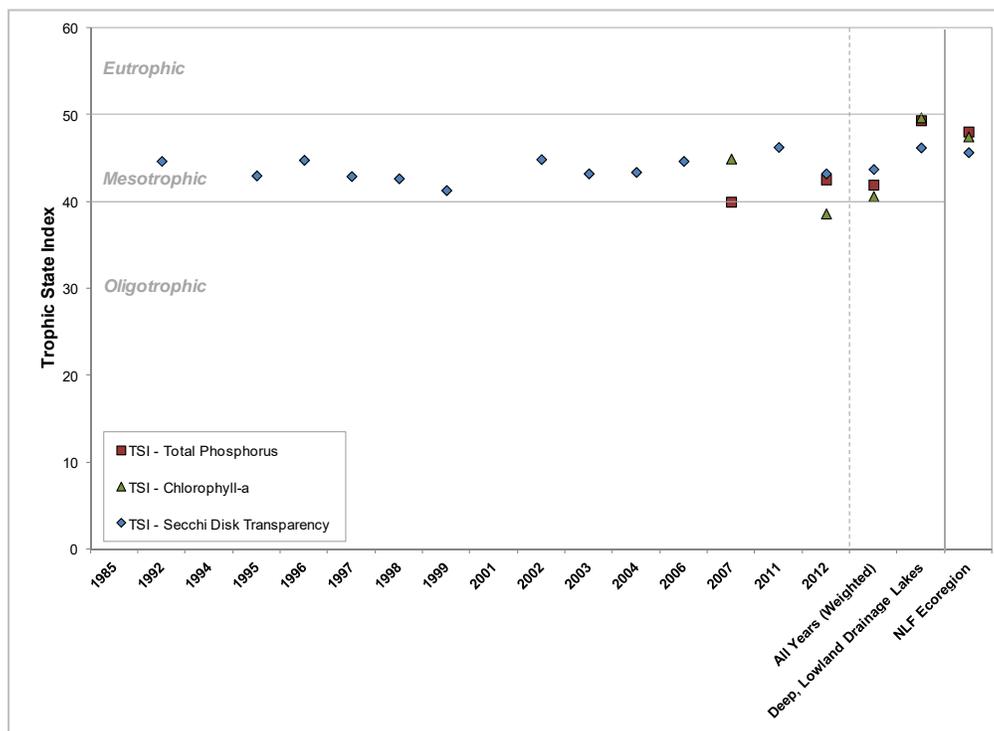
**Figure 8.1.1-5. Rest Lake, state-wide deep, lowland drainage lakes, and regional Trophic State Index values.** Values calculated with summer month surface sample data using WDNR PUB-WT-193.

The TSI values calculated with Secchi disk, chlorophyll-*a*, and total phosphorus values range in values spanning from lower mesotrophic to eutrophic (Figure 8.1.1-5). In general, the best values to use in judging a lake's trophic state are the biological parameters; therefore, relying primarily on total phosphorus and chlorophyll-*a* TSI values, it can be concluded that Rest Lake is in a mesotrophic state.

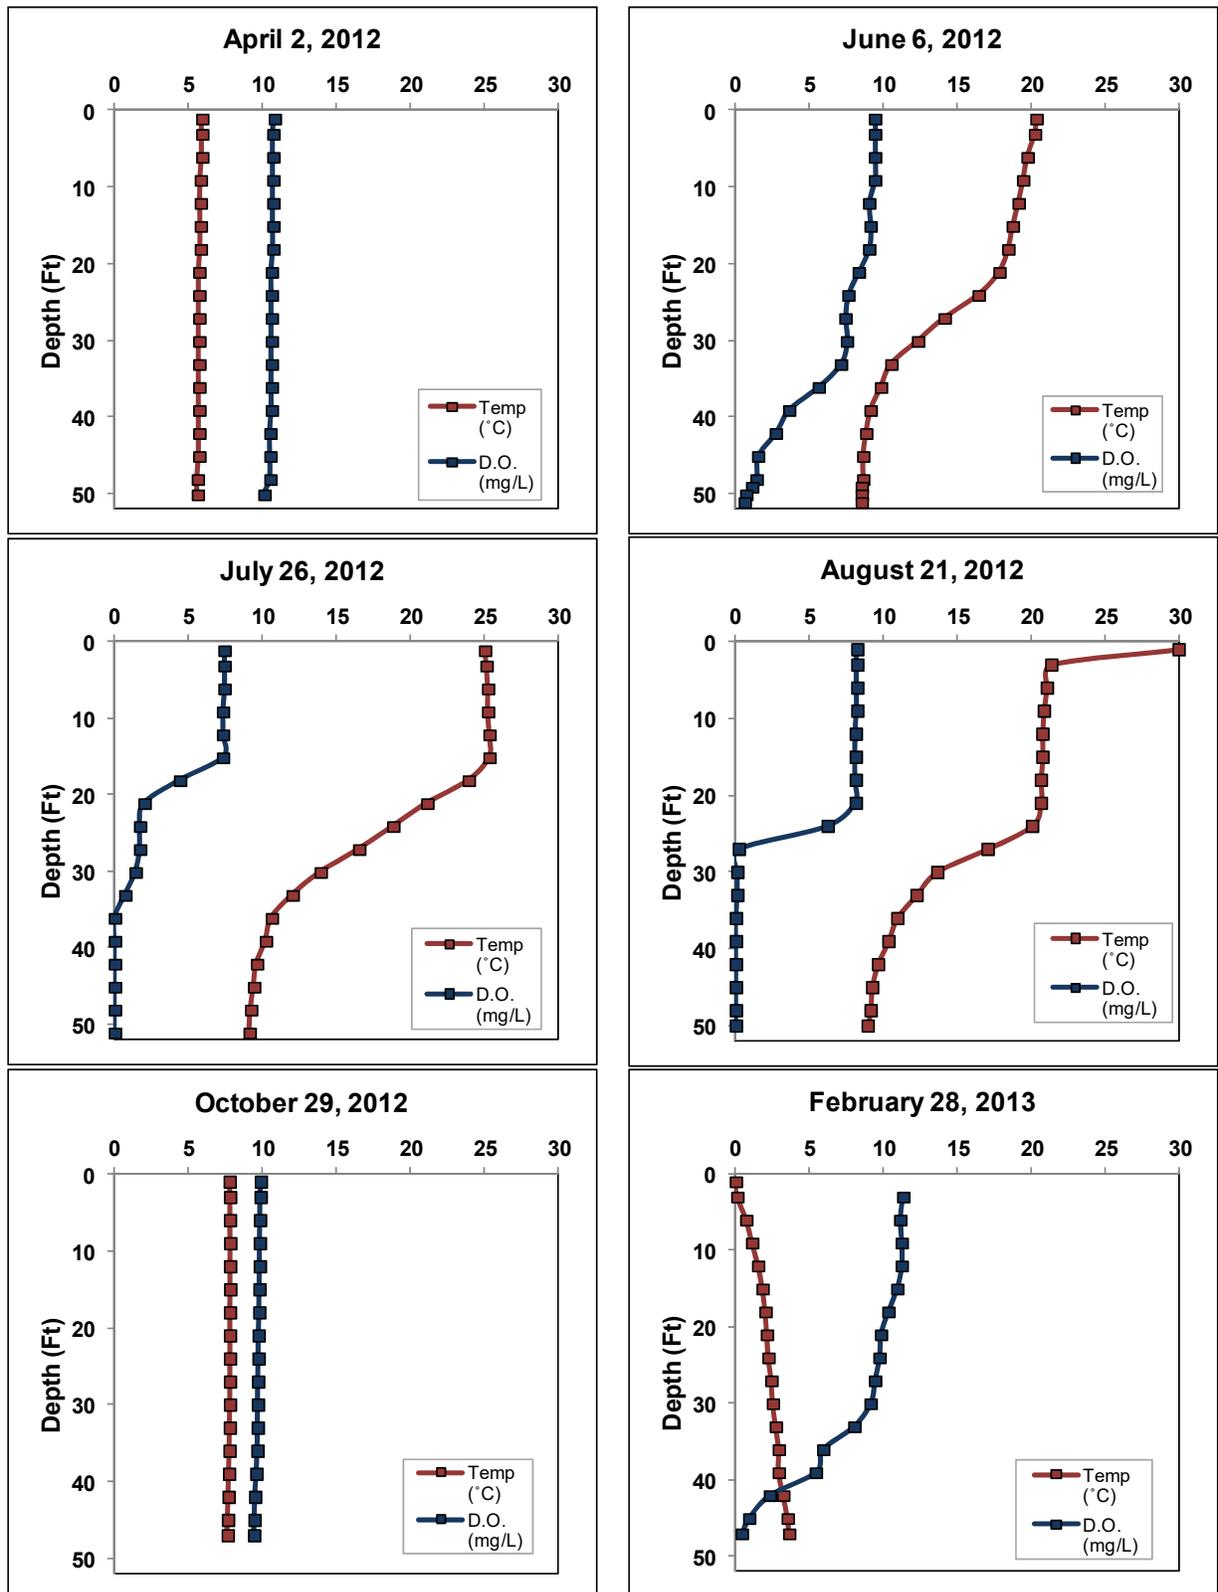
Figure 8.1.1-6. Rest Lake dissolved oxygen and temperature profiles.

Dissolved oxygen and temperature profiles were created during each water quality sampling trip made to Rest Lake by Onterra staff. Graphs of those data are displayed in Figure 8.1.1-6 for all sampling events.

Rest Lake mixes thoroughly during the spring and fall, when changing air temperatures and gusty winds help to mix the water column. During the summer months, the bottom of the lake becomes void of oxygen and temperatures remain fairly cool as they were in the spring months. This occurrence is not uncommon in deep Wisconsin lakes, where wind energy is not sufficient during the summer to mix the entire water column – only the upper portion. During this time, bacteria break down organic matter that has collected at the bottom of the lake and in doing so utilize any available oxygen.

The lake mixes completely again in the fall, re-oxygenating the water in the lower part of the water column. During the winter months, the coldest temperatures are found just under the overlying ice, while oxygen gradually diminishes once again towards the bottom of the lake. In February of

2013, oxygen levels remained sufficient throughout most of the water column to support most aquatic life in northern Wisconsin lakes.

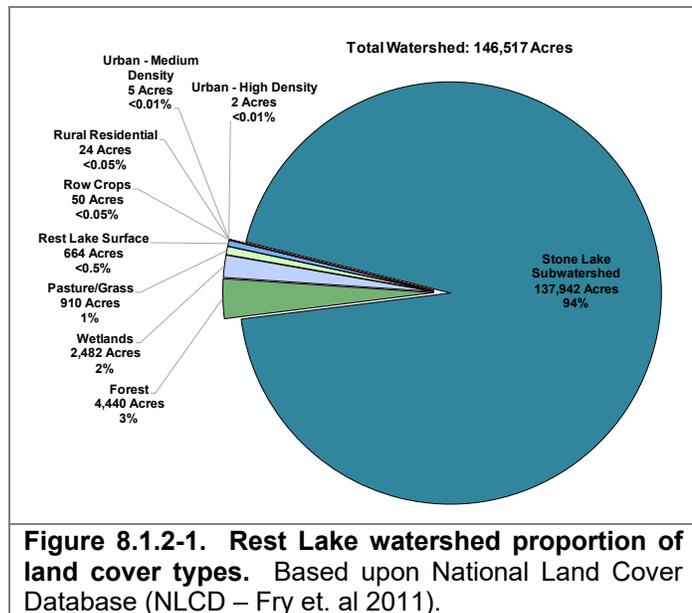
**Figure 8.1.2-1. Rest Lake watershed proportion of land cover types.** Based upon National Land Cover Database (NLCD – Fry et. al 2011).

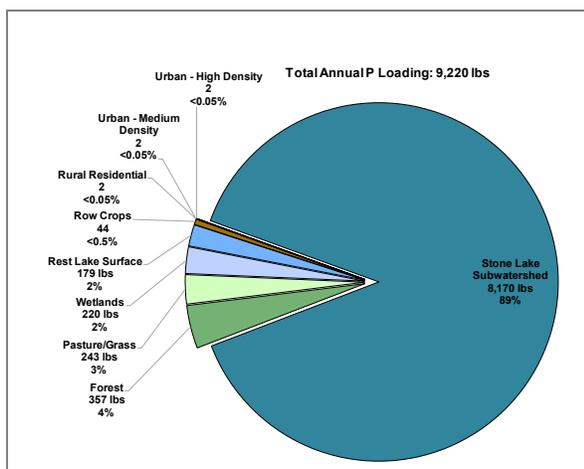
**Figure 8.1.2-2. Rest Lake estimated potential annual phosphorus loading.** Based upon Wisconsin Lake Modeling Suite (WiLMS) estimates.

Of the estimated 9,220 pounds of phosphorus being delivered to Rest Lake on an annual basis, approximately 8,170 pounds (89%) originates from the Stone Lake subwatershed, with next largest source being forest at 357 pounds (4%) pasture/grass at 243 pounds (3%), and the remainder being from various landuses and atmospheric inputs (Figure 8.1.2-2). Using the estimated annual potential phosphorus load, WiLMS predicted an in-lake growing season average total phosphorus concentration of 18 µg/L, which is similar to the measured growing season average total phosphorus concentration of 14 µg/L. This means the model works reasonably well for Rest Lake.

Because the large majority of the phosphorus that enters Rest Lake comes from the upstream Stone Lake, efforts to reduce phosphorus levels in Rest Lake should concentrate on reducing phosphorus inputs to the upstream lake.

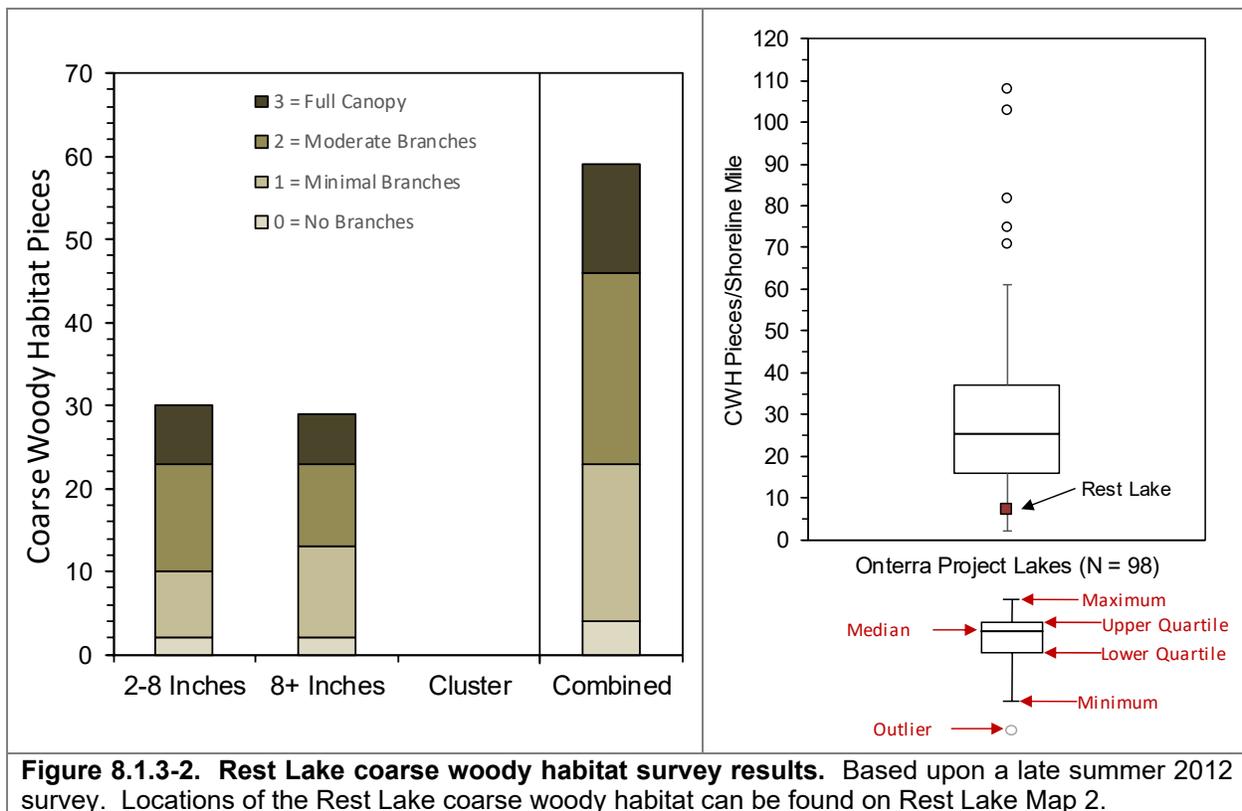
During this survey, 59 total pieces of coarse woody habitat were observed along 9.0 miles of shoreline (Rest Lake Map 2), which gives Rest Lake a coarse woody habitat to shoreline mile ratio of 7:1 (Figure 8.1.3-2). Only instances where emergent coarse woody habitat extended from shore into the water were recorded during the survey. Thirty pieces of 2-8 inches in diameter pieces of coarse woody habitat were found, twenty-nine pieces of 8+ inches in diameter pieces of coarse woody habitat were found, and no instances of clusters of coarse woody habitat were found.

Onterra has completed coarse woody habitat surveys on 98 lakes throughout Wisconsin since 2012, with the majority occurring in the NLF ecoregion on lakes with public access. The number of coarse woody habitat pieces per shoreline mile in Rest Lake falls well below the 25<sup>th</sup> percentile of these 98 lakes (Figure 8.1.3-2).

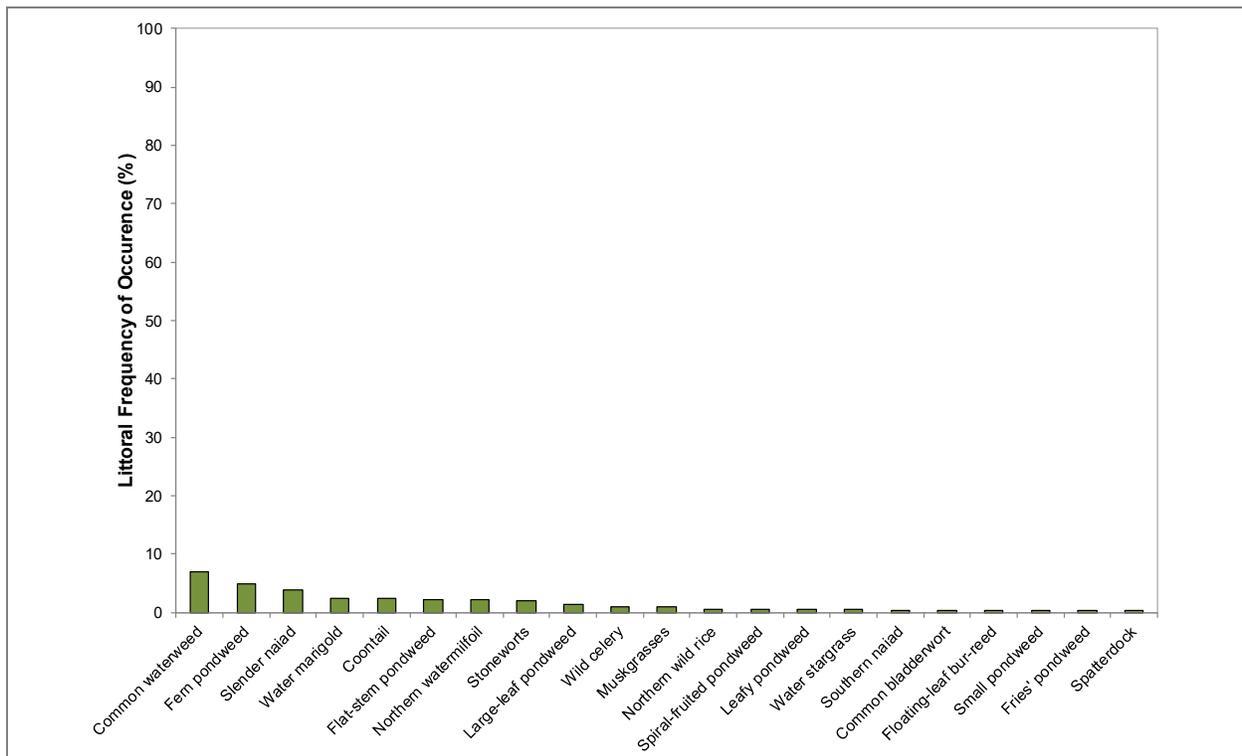
**Figure 8.1.4-1. Rest Lake aquatic plant littoral frequency of occurrence analysis.** Created using data from a 2012 point-intercept survey.

Figure 8.1.4-1 displays the littoral frequency of occurrence of aquatic plant species in Rest Lake from the 2012 point-intercept survey. Common waterweed, fern pondweed, and slender naiad were the three-most frequently encountered species in 2012. Common waterweed can be found in lakes throughout Wisconsin and North America. It is usually found growing in soft substrates, and possesses long stems with whorls of three, slender leaves. This species can tolerate and thrive in lakes with lower water clarity, and can often grow to nuisance levels forming large mats on the water’s surface. Common waterweed provides excellent structural habitat for aquatic organisms and is an important food source for animals such as muskrats.

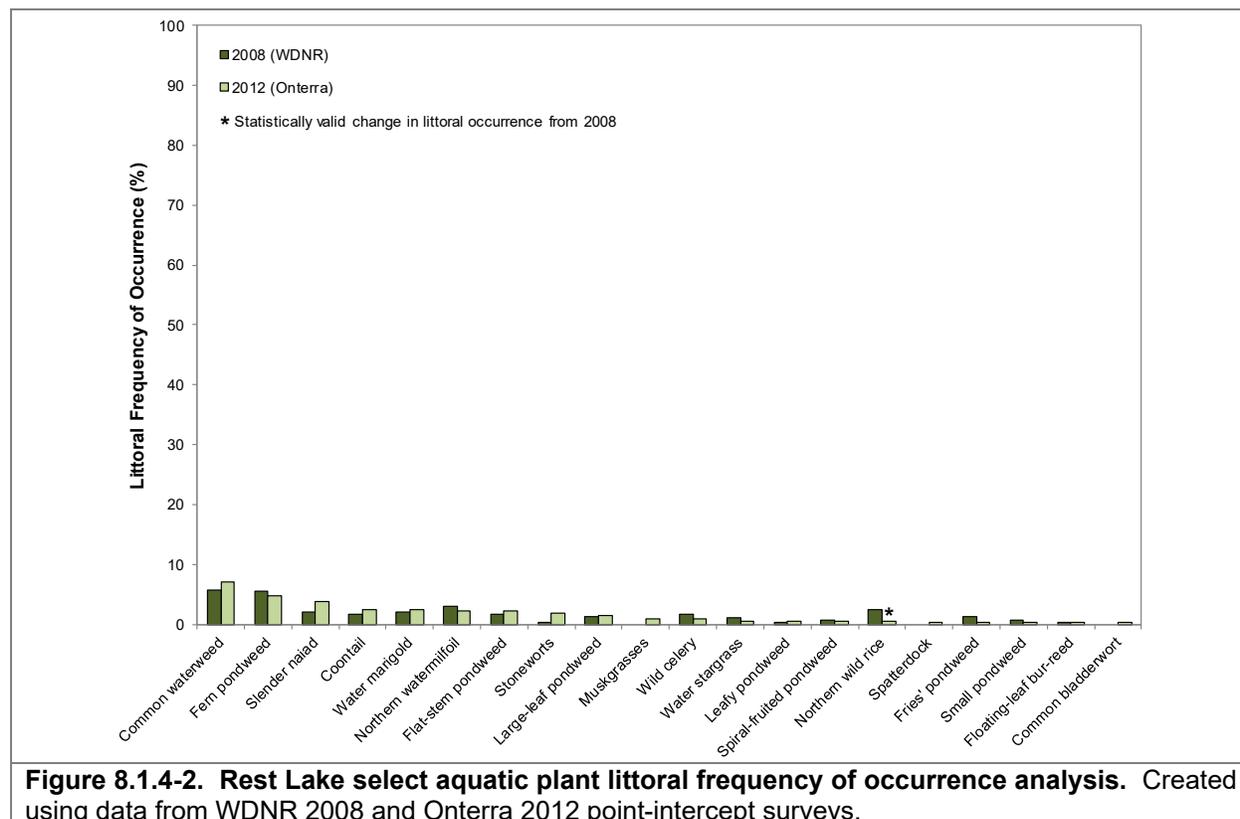
Figure 8.1.4-2 displays the littoral frequency of occurrence of select aquatic plant species from both the Onterra 2012 and WDNR 2008 point-intercept surveys. Like in 2012, common waterweed and fern pondweed were the most frequently encountered aquatic plants. As indicated on Figure 8.1.4-2, northern wild rice was the only aquatic plant species to exhibit a statistically valid reduction in its littoral occurrence from 2008 to 2012 (Chi-square  $\alpha = 0.05$ ). However, this is due to additional point-intercept sampling locations that were sampled in 2008 within the northwest bay of Rest Lake that were non-navigable due to dense northern wild rice in 2012. No

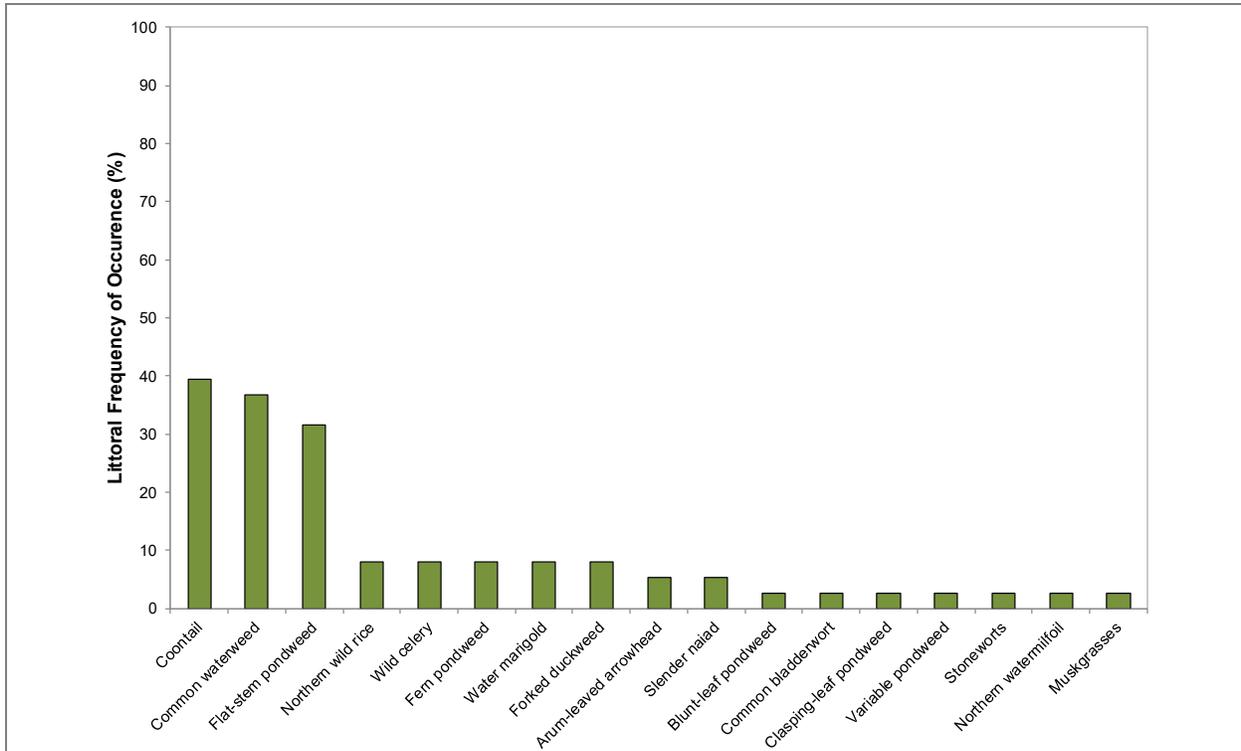
**Figure 8.1.4-3. Papoose Bay aquatic plant littoral frequency of occurrence analysis.** Created using data from a 2012 point-intercept survey.

The 2012 littoral frequency chart for Papoose Bay (Figure 8.1.4-3) illustrates that coontail, common waterweed, and flat-stem pondweed were the three-most frequently encountered aquatic plant species during the 2012 point-intercept survey. However, only about half of the point-intercept sampling locations were able to be sampled, the remaining were located in dense, emergent vegetation, mostly comprised of northern wild rice. Had these points been able to be sampled, these data would likely show that northern wild rice is the most dominant plant within Papoose Bay.

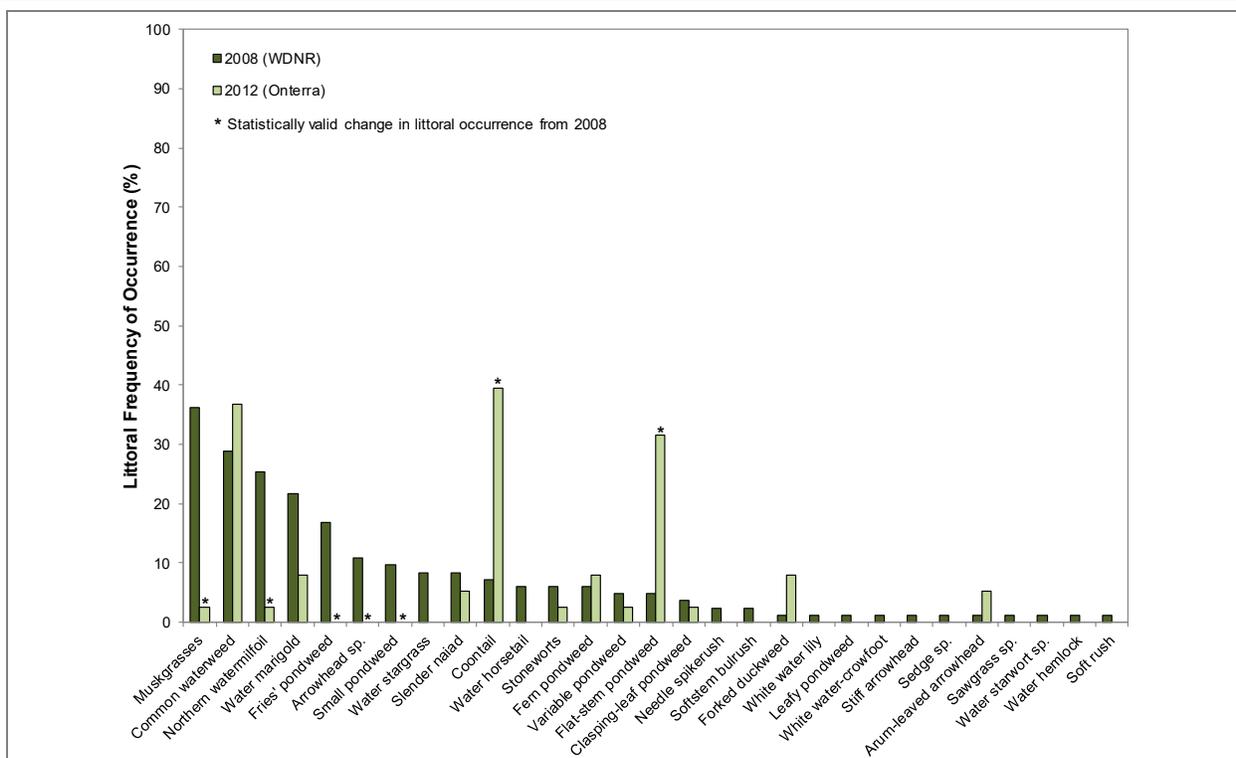
**Figure 8.1.4-4. Papoose Bay aquatic plant littoral frequency of occurrence analysis.** Created using data from WDNR 2008 and Onterra 2012 point-intercept surveys.

Figure 8.1.4-4 displays the littoral frequency of occurrence of aquatic plants from the 2012 and WDNR 2008 point-intercept surveys in Papoose Bay. As illustrate, a number of aquatic plants, including muskgrasses, northern watermilfoil, Fries’ pondweed, arrowhead sp., small pondweed, coontail, and flat-stem pondweed, saw statistically valid changes in occurrence from 2008 to 2012. While some of these may reflect natural community dynamics of Papoose Bay over time, these changes are likely due to the difference in the number of point-intercept locations sampled between 2008 and 2012. Nearly all the points (83) were able to be sampled in 2008, while less than half (38) were able to be sampled in 2012. As discussed in the chain-wide section, northern wild rice populations tend fluctuate naturally on an annual basis. It is likely that the northern wild rice in Papoose Bay was less dense in 2008 allowing surveyors to access areas that were non-navigable in 2012.

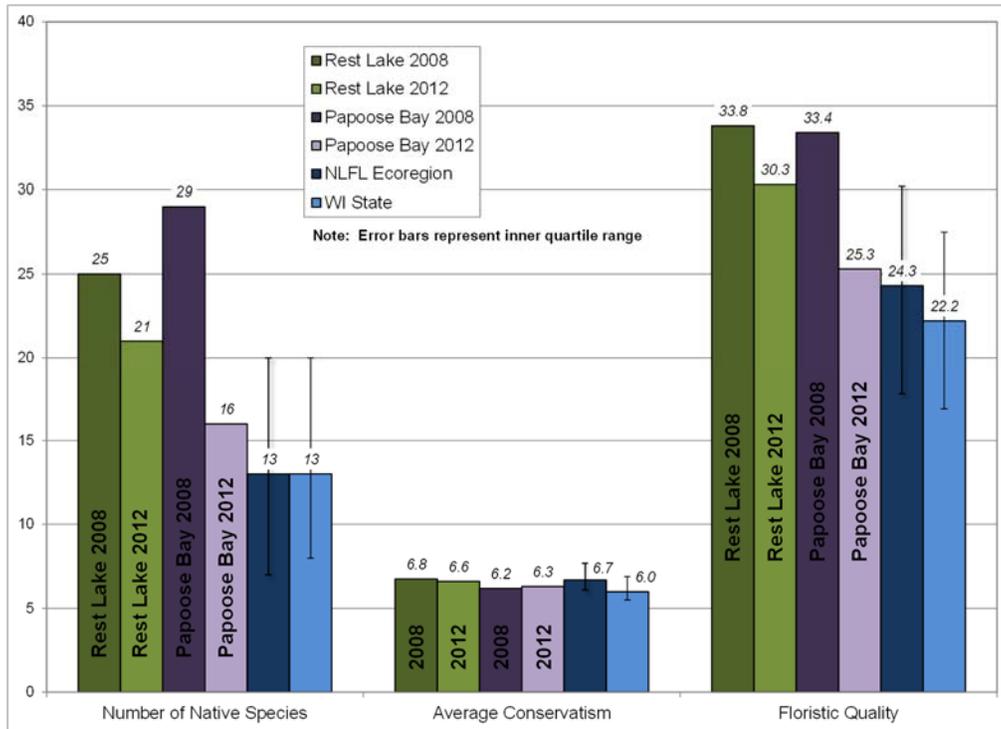
**Figure 8.1.4-5. Rest Lake and Papoose Bay 2008 and 2012 Floristic Quality Analysis.** Created using data from WDNR 2008 and Onterra 2012 point-intercept surveys. Analysis following Nichols (1999).

The average conservatism values decreased slightly in Rest Lake from 2008 to 2012, and increased slightly in Papoose Bay (Figure 8.1.4-5). The average conservatism values for Rest Lake and Papoose Bay in 2012 fall below the median value for lakes in the NLFL Ecoregion, but above the median for lakes throughout Wisconsin. The Floristic Quality Index values for both Rest Lake and Papoose Bay declined from 2008 to 2012, but both waterbodies were higher than the median values for lakes in NLFL Ecoregion and lakes in Wisconsin in 2012. These data indicate that the aquatic plant community of Rest Lake is of comparable quality to other lakes in NLFL Ecoregion and of higher quality than the majority of lakes in Wisconsin, and the plant community has changed little since 2008. The plant community of Papoose Bay is of comparable to slightly lower quality than other lakes in the NLFL Ecoregion but of higher quality than most of the lakes in Wisconsin.

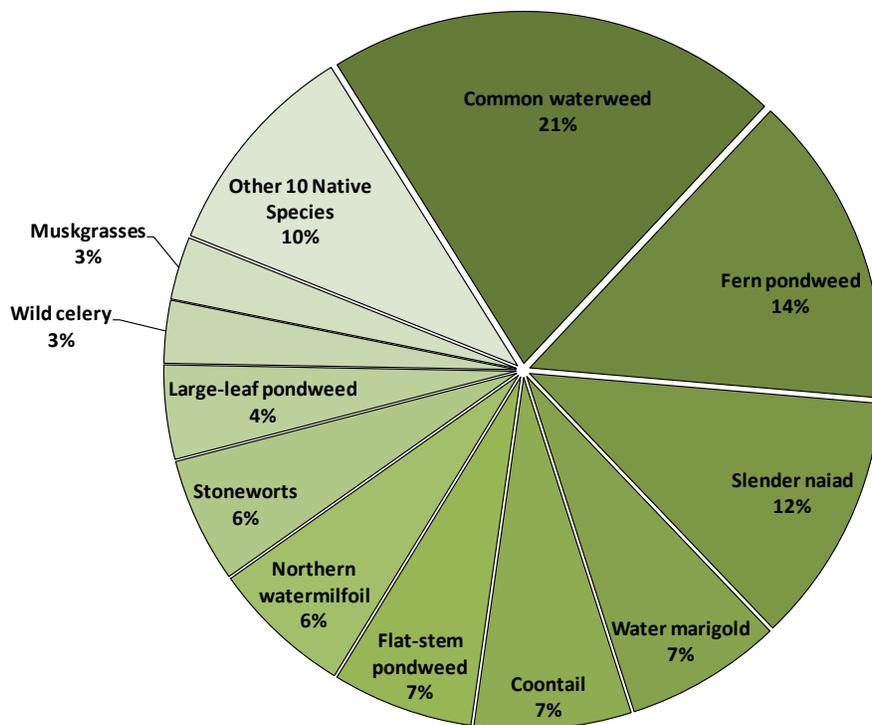
**Figure 8.1.4-6. Rest Lake 2012 aquatic plant relative frequency of occurrence analysis.** Created using data from 2012 point-intercept survey.

As explained earlier in the Manitowish Waters Chain of Lakes-wide document, the littoral frequency of occurrence analysis allows for an understanding of how often each of the plants is located during the point-intercept survey. Because each sampling location may contain numerous plant species, relative frequency of occurrence is one tool to evaluate how often each plant species is found in relation to all other species found (composition of population). For instance, while common waterweed was found at 7% of the littoral sampling locations in Rest Lake in 2012, its relative frequency of occurrence is 21%. Explained another way, if 100 plants were randomly sampled from Rest Lake, 21 of them would be common waterweed. This distribution can be observed in Figures 8.1.4-6 and 8.1.4-7.

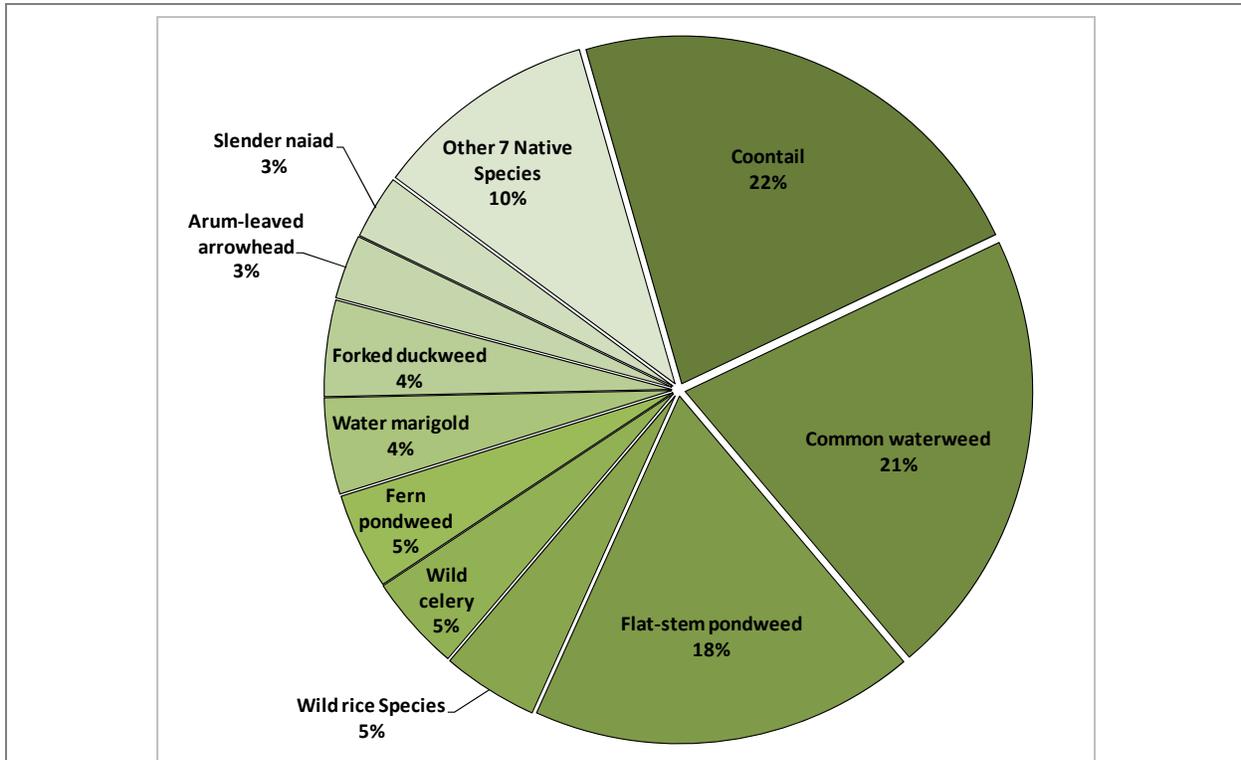
**Figure 8.1.4-7. Papoose Bay 2012 aquatic plant relative frequency of occurrence analysis.** Created using data from 2012 point-intercept survey.

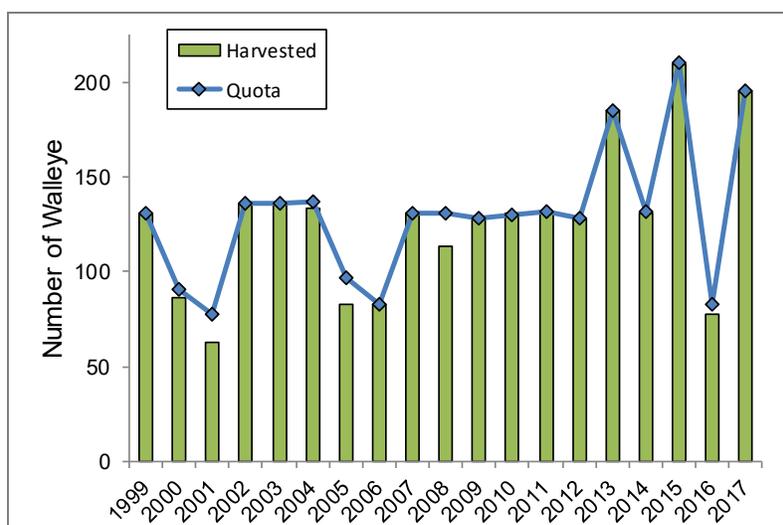
**Figure 8.1.5-1. Rest Lake walleye spear harvest data. (GLIFWC 1999-2017).**

Walleye open water spear harvest records are provided in Figure 8.1.5-1 from 1999 to 2017. As many as 209 walleye have been harvested from the lake in the past (2015), but the average harvest is roughly 127 fish in a given year. Spear harvesters on average have taken 97% of the declared quota. Additionally, on average 8% of walleye harvested have been female.

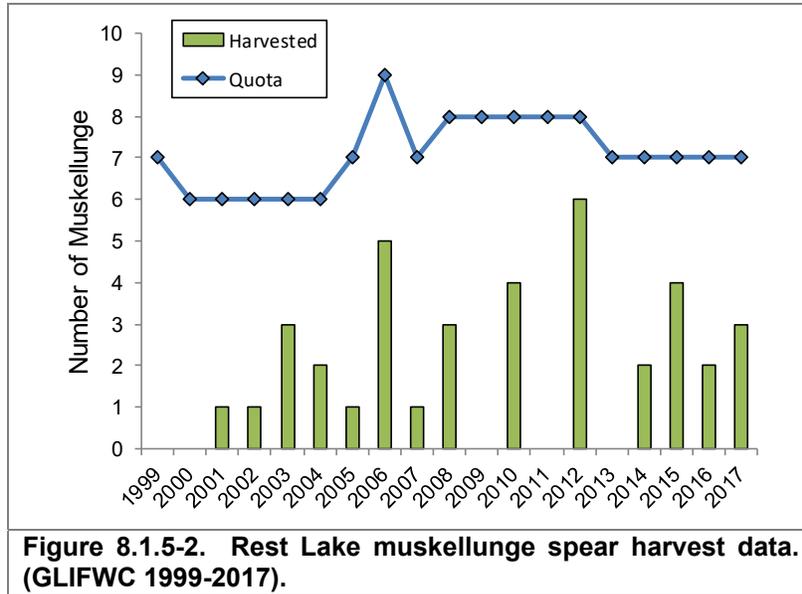
Muskellunge open water spear harvest records are provided in Figure 8.1.5-2 from 1999 to 2017. As many as six muskellunge have been harvested from the lake in the past (2012), however the average harvest is two fish in a given year. Spear harvesters on average have taken 16% of the declared quota. Additionally, on average 27% of muskellunge harvested have been female.

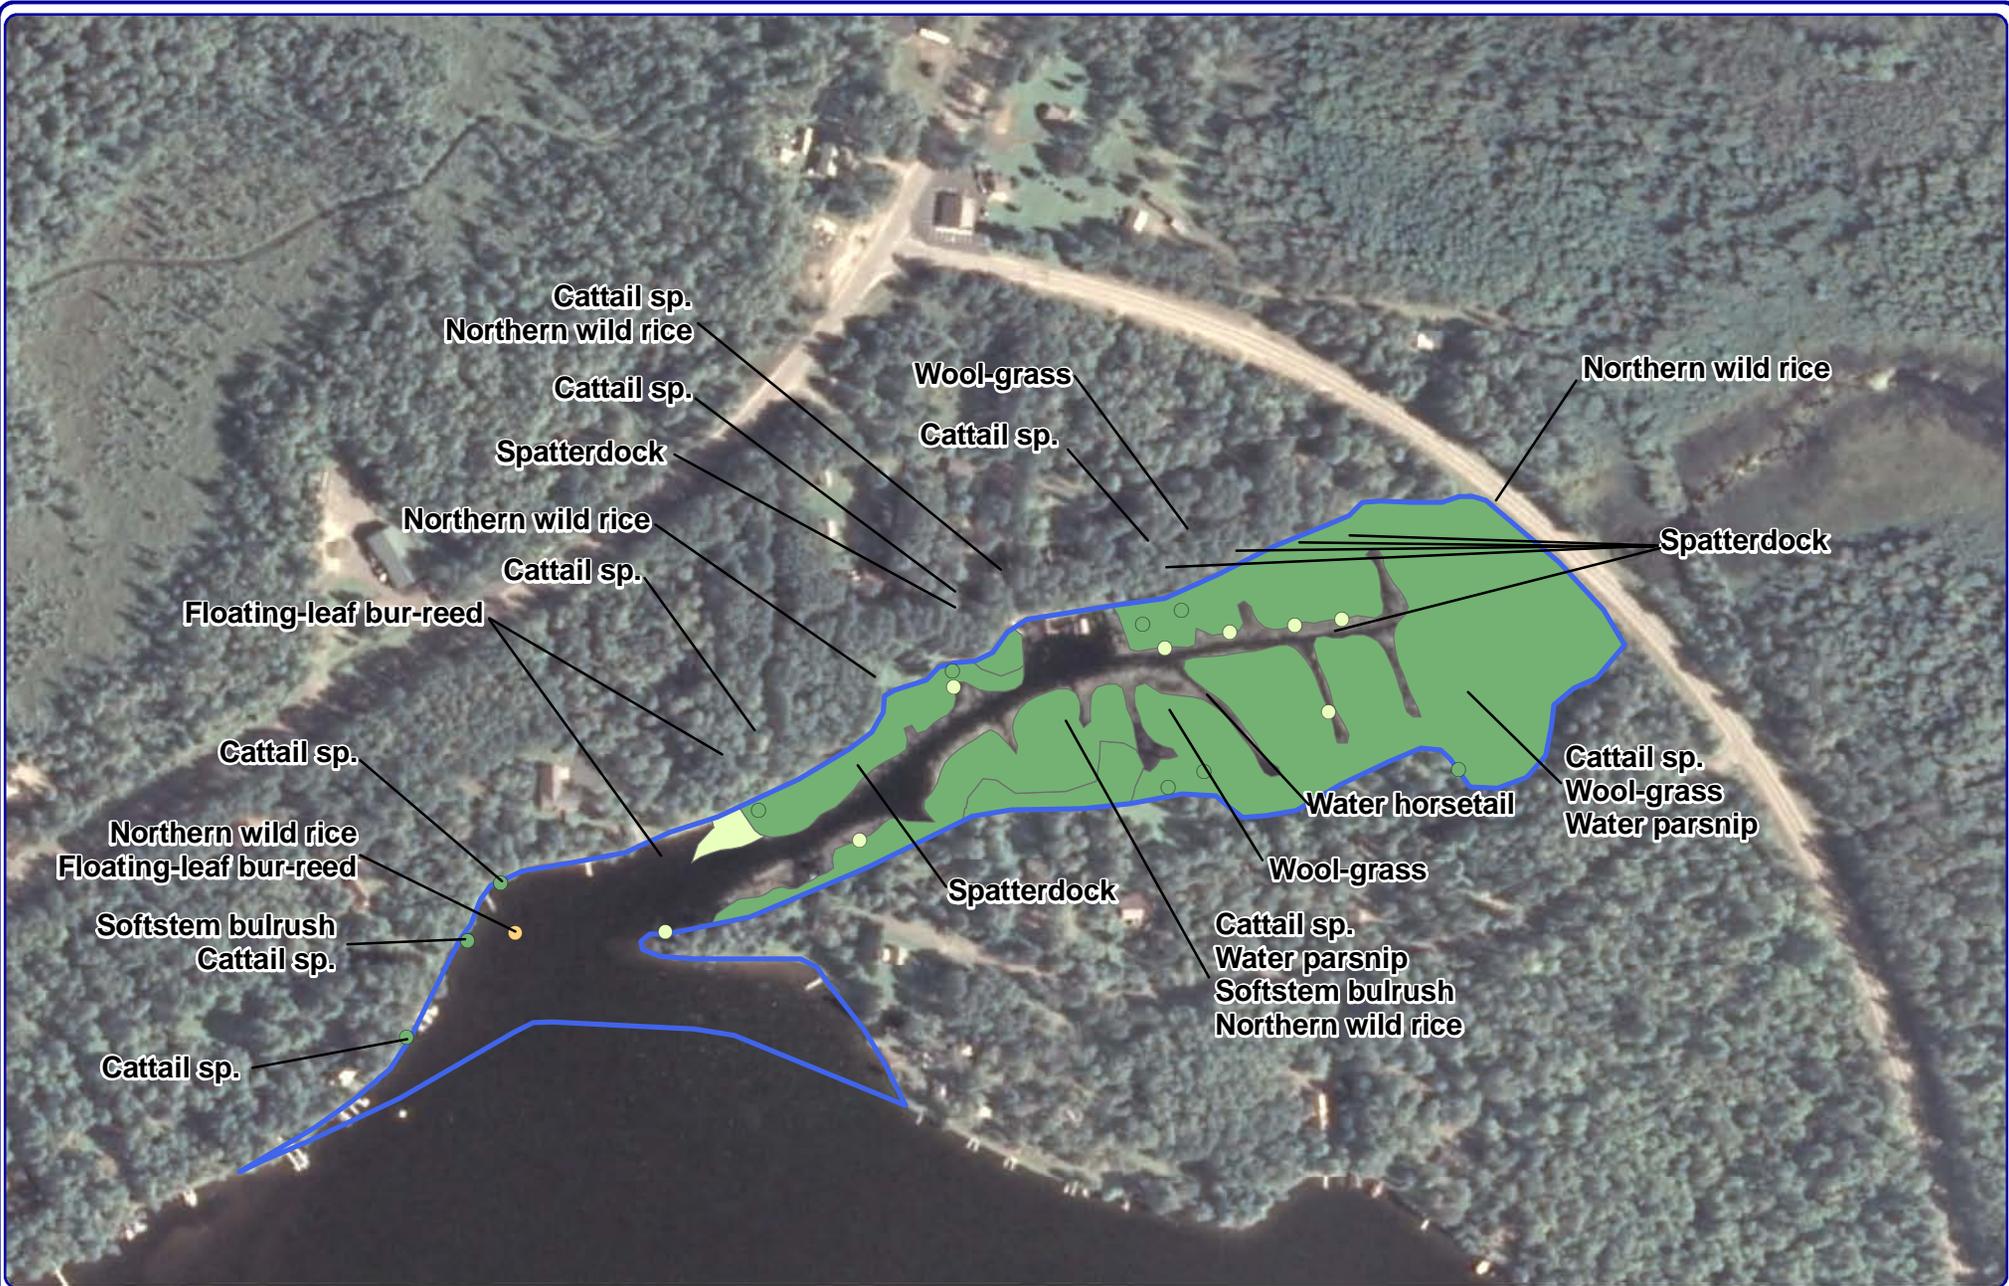
Papoose Bay - Map 1  
 Manitowish Waters  
 Chain of Lakes  
 Vilas County, Wisconsin  
**Aquatic Plant Distribution**

- + No Vegetation
- Total Rake Fullness = 1
- Total Rake Fullness = 2
- Total Rake Fullness = 3
- + Too Deep (Below Max Depth of Plants)
- + Non-navigable

Sources:  
 Aquatic Plants: Onterra, 2012  
 Orthophotography: NAIP, 2010  
 Map date: December 11, 2012  
 Filename: PapooseBay\_Map2\_Comm\_2012.mxd
