Note: Methodology, explanation of analysis and biological background on Stone Lake studies are contained within the Manitowish Waters Chain of Lakes-wide Management Plan document.

8.10 Stone Lake

An Introduction to Stone Lake

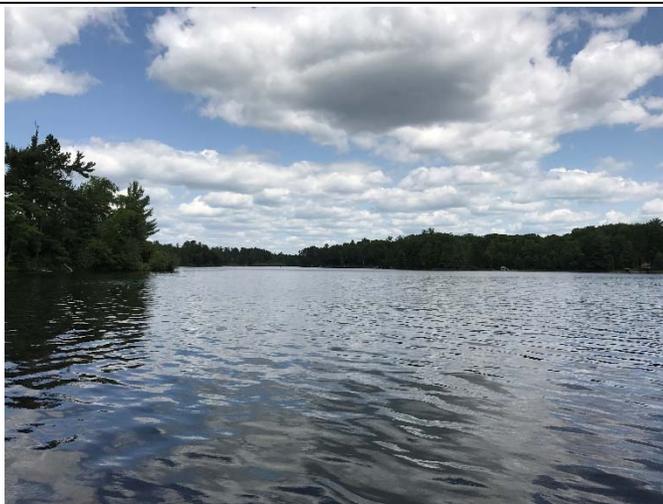
Photo 8.10. Stone Lake, Vilas County

Primarily sandy and rocky substrate observed during the 2017 point-intercept survey. Abundant coarse woody habitat was also observed along the lake's shoreline.
