8.11 Vance Lake

An Introduction to Vance Lake

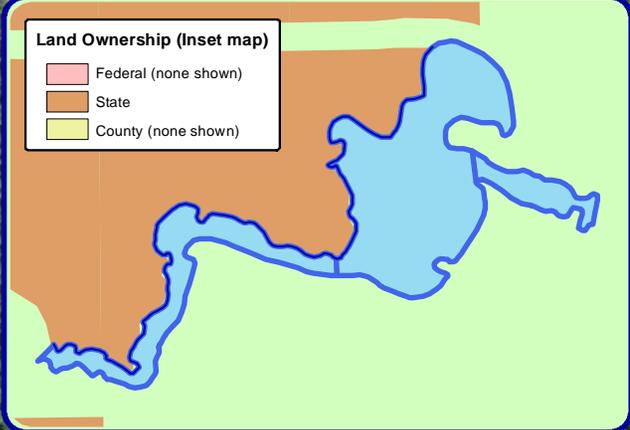
Map 1
 Vance Lake
 Vilas County, Wisconsin
**2017 Shoreland
 Condition**

As mentioned previously in the Chain-wide Shoreland Condition Section, one of the most sensitive areas of the watershed is the immediate shoreland area. This area of land is the last source of protection for a lake against surface water runoff, and is also a critical area for wildlife habitat. In fall of 2017, Vance Lake's immediate shoreline was assessed in terms of its development. Vance Lake has stretches of shoreland that fit all of the five shoreland assessment categories. In all, 2.2 miles of natural/undeveloped and developed-natural shoreline were observed during the survey (Figure 8.11.3-1). This constitutes about 92% of Vance Lake's shoreline. These shoreland types provide the most benefit to the lake and should be left in their natural state if at all possible. During the survey, less than a tenth of a mile of urbanized and developed-unnatural shoreline (3%) was observed. If restoration of the Vance Lake shoreline is to occur, primary focus should be placed on these shoreland areas as they currently provide little benefit to, and actually may harm, the lake ecosystem. Vance Lake Map 1 displays the location of these shoreline lengths around the entire lake.

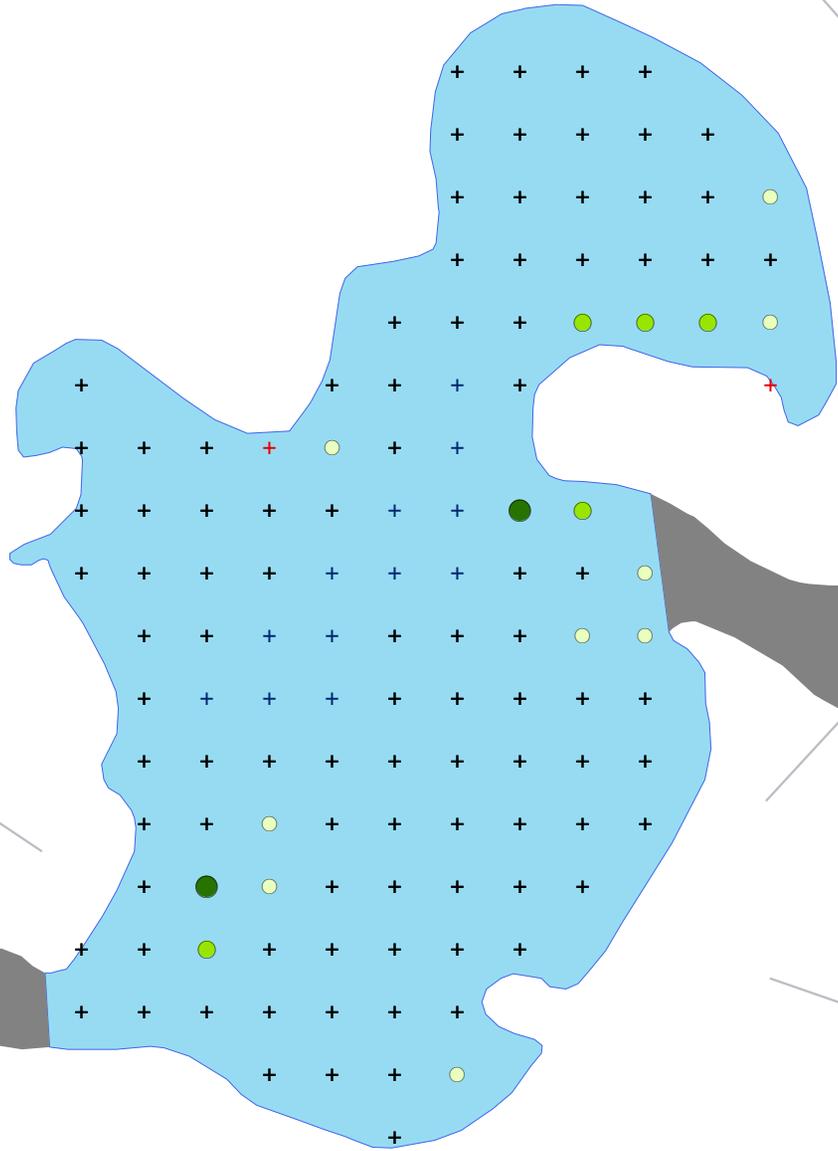
Map 3
Vance Lake
 Vilas County, Wisconsin
2017 PI Survey:
Aquatic Vegetation
Distribution

- Total Rake Fullness = 1
- Total Rake Fullness = 2
- Total Rake Fullness = 3
- + No Vegetation
- + Non-Navigable
