Eurasian water-milfoil (*Myriophyllum spicatum*) and Curly-leaf pondweed (*Potamogeton crispus*) Pre/Posttreatment and Fall EWM Bed Mapping Surveys Lower Vermillion Lake – WBIC: 2098200 Barron County, Wisconsin

Endangered Resource Services, LLC
Matthew S. Berg, Research Biologist
St. Croix Falls, Wisconsin
May 14, June 30, and October 20, 2019

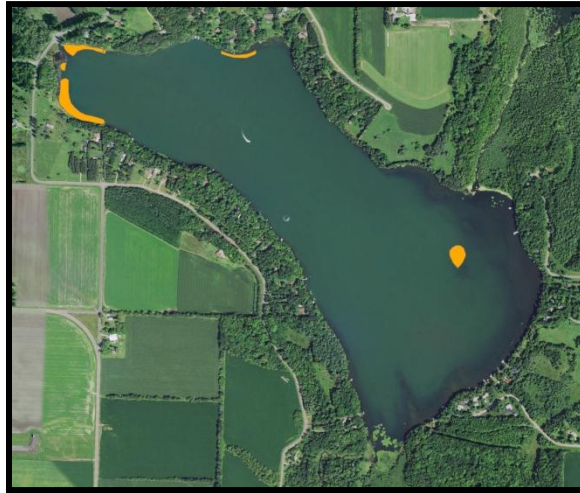
Figure 1: Aerial Photo of 2019 EWM/CLP Treatment Areas

In 2008, the Wisconsin Department of Natural Resources (WDNR) confirmed the presence of Eurasian Water-milfoil (EWM) (*Myriophyllum spicatum*) in Lower Vermillion Lake, and the Vermillion Lakes Association (VLA) has been actively working to control this exotic invasive species ever since. Following the 2018 fall EWM bed mapping survey that found scattered patches of EWM throughout the northwest bays near the boat landing and in the east bay, the VLA, under the direction of D. Blumer - Lake Education and Planning Services, LLC (LEAPS) and in accordance with their WDNR approved Aquatic Plant Management Plan, decided to chemically treat five areas totaling approximately 2.78 acres (1.29% of the lake's total surface area) in 2019. The majority of these areas were simultaneously treated for Curly-leaf pondweed (CLP) (*Potamogeton crispus*) – another exotic invasive species that is locally abundant early in the growing season (Figure 1).

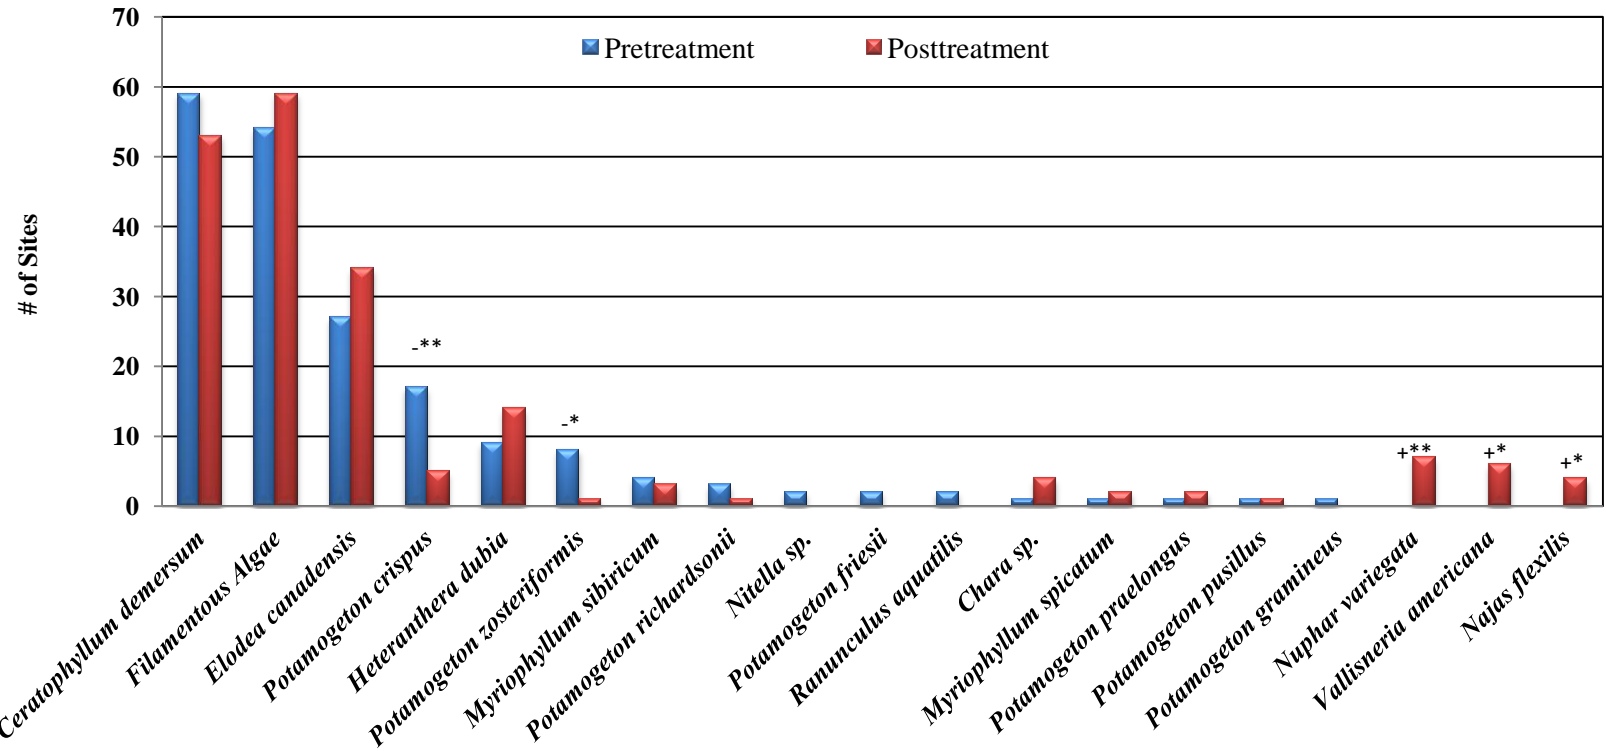
Figure 14: Pre/Posttreatment Macrophyte Changes

Flat-stem pondweed (*Potamogeton zosteriformis*) – a species known to be sensitive to Endothall – was the only native species that suffered a significant decline ($p=0.02$) in distribution posttreatment. Conversely, several late-growing species experienced significant expansions – Spatterdock (*Nuphar variegata*) saw a moderately significant increase in distribution ($p=0.007$), and Wild celery (*Vallisneria americana*) and Slender naiad (*Najas flexilis*) demonstrated significant increases ($p=0.01$)/($p=0.04$) (Figure 14) (Maps for all native species from the pre and posttreatment surveys can be found in Appendixes VI and VII).

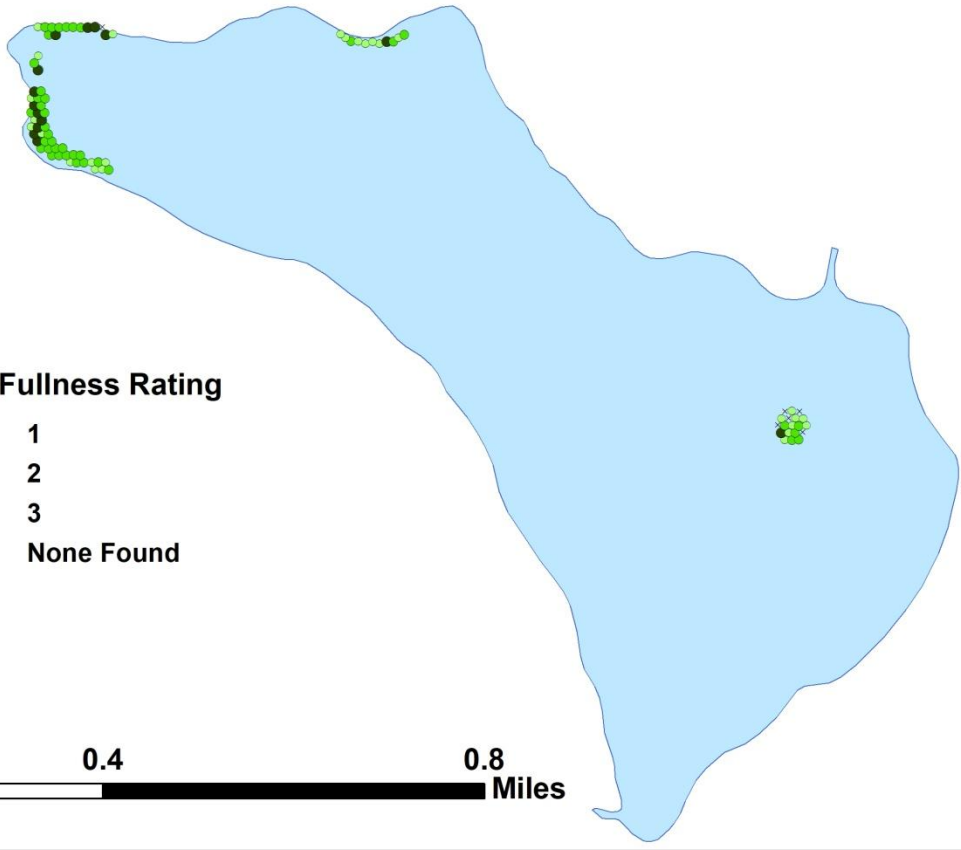
Rake Fullness Rating

- 1
- 2
- 3
- × None Found

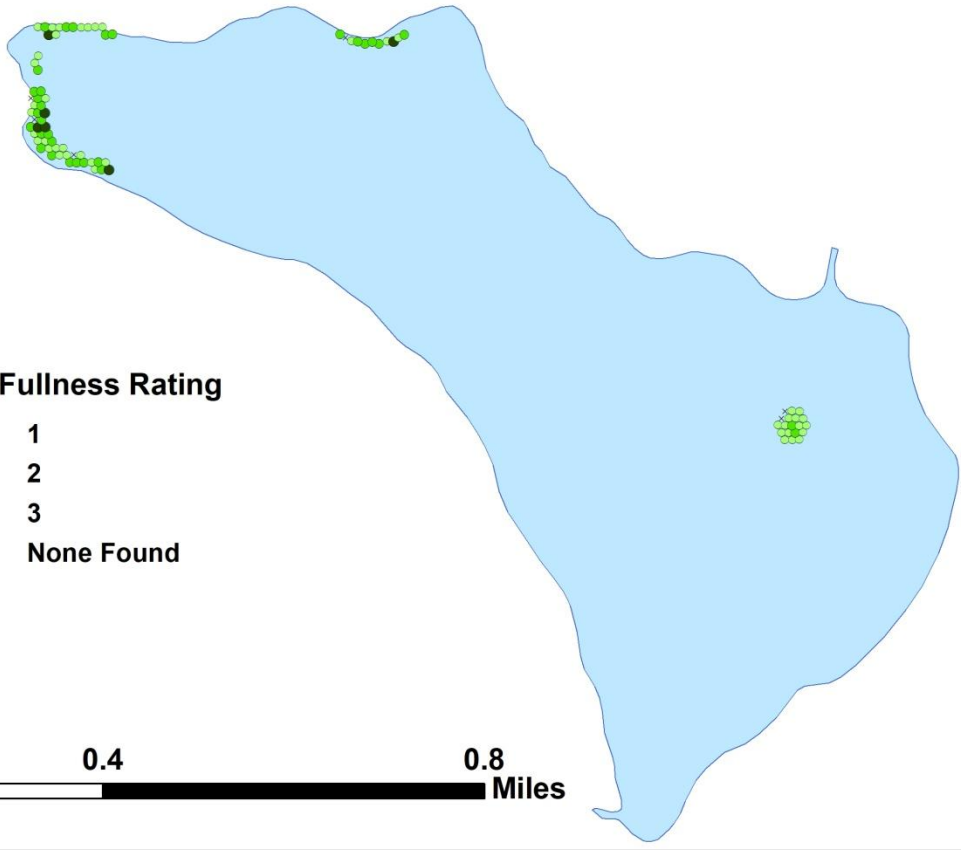
Total Rake Fullness

Posttreatment Survey
Lower Vermillion Lake
Barron County, WI
June 30, 2019

Rake Fullness Rating

- 1
- 2
- 3
- × None Found

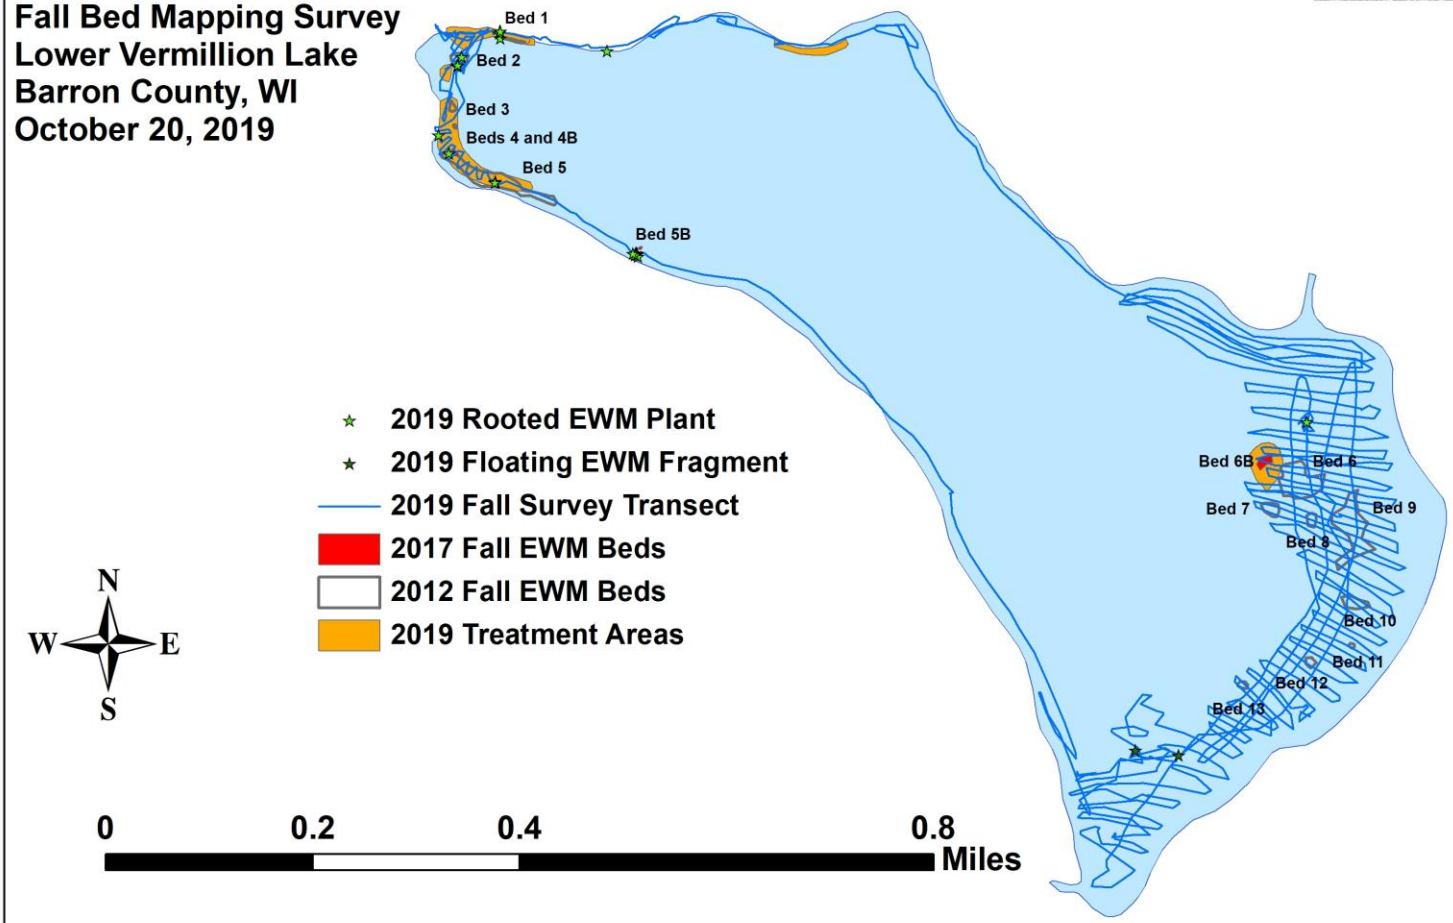
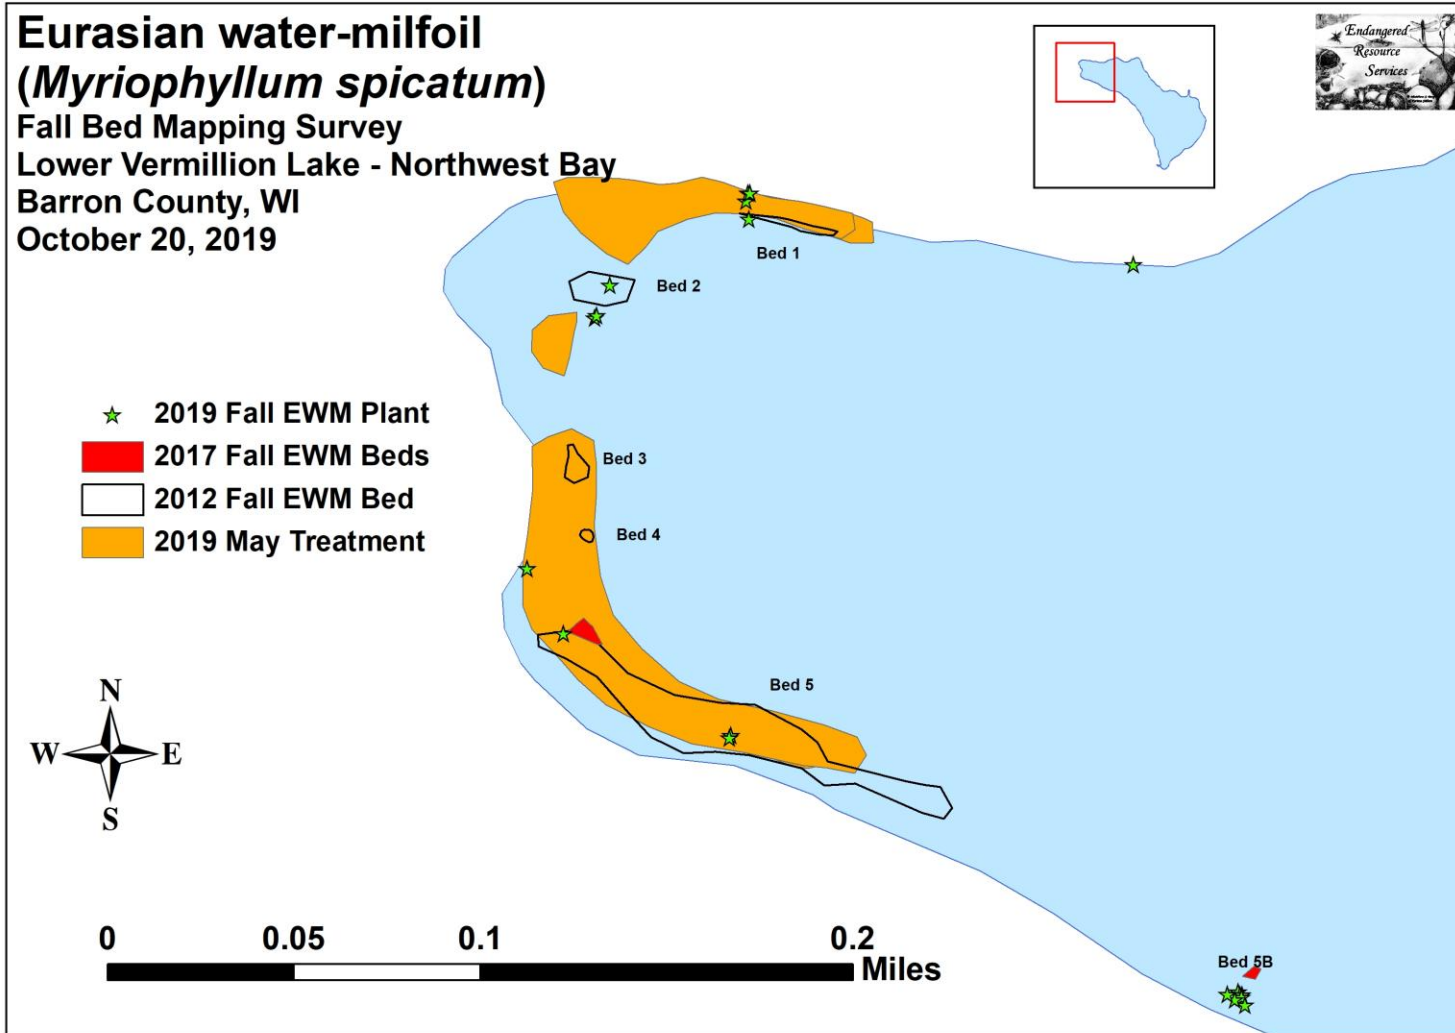
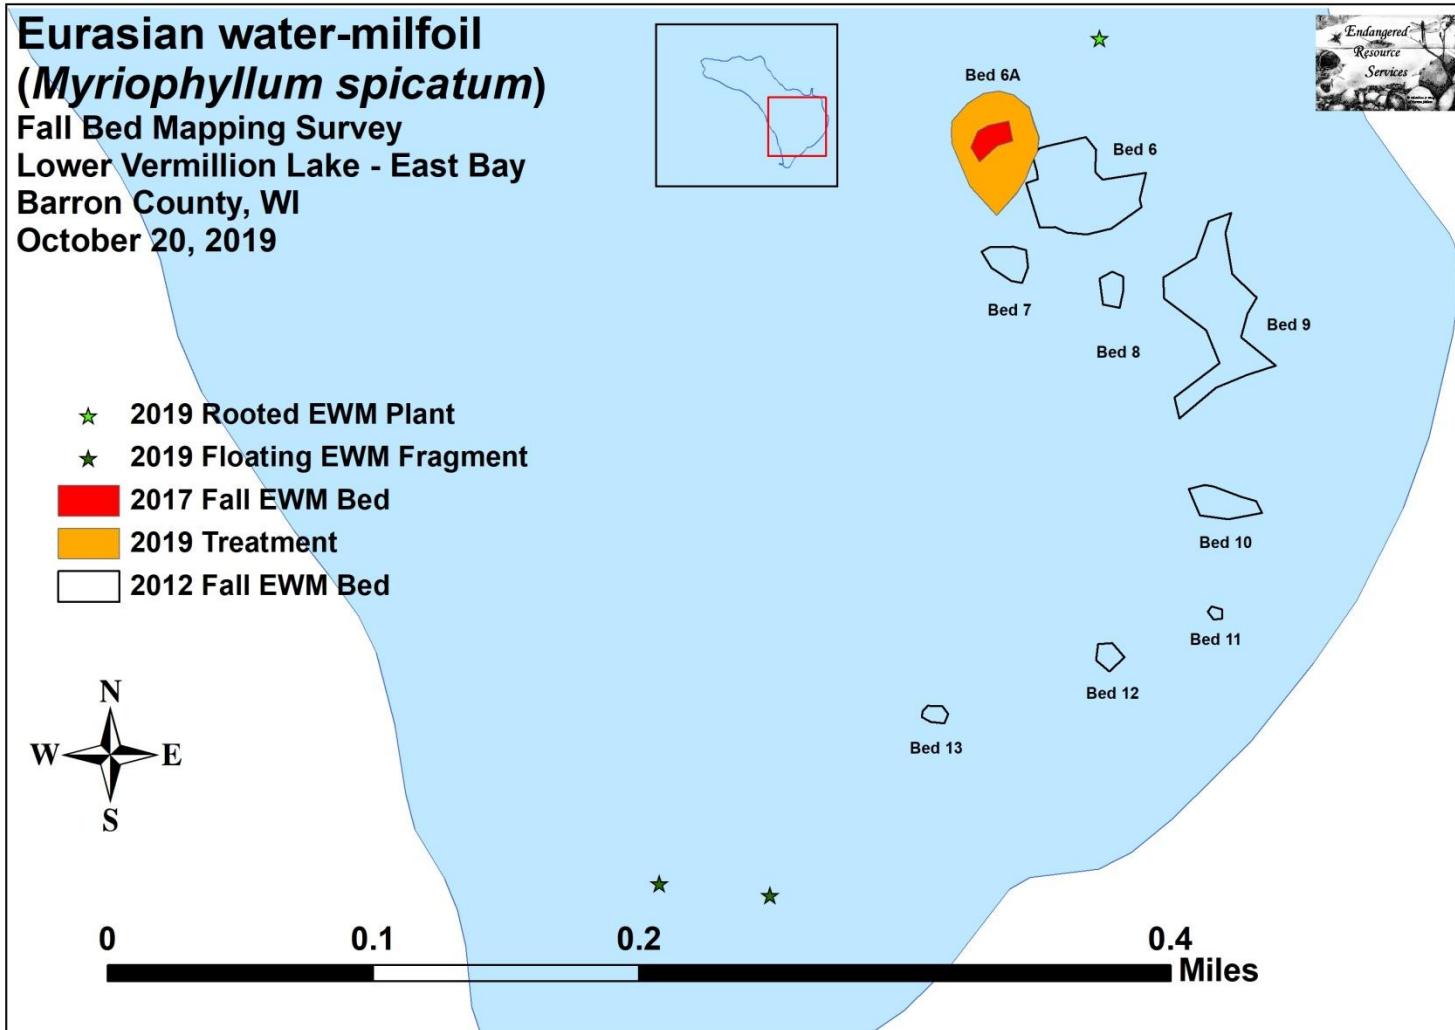
Eurasian water-milfoil (*Myriophyllum spicatum*)

Fall Bed Mapping Survey
Lower Vermillion Lake
Barron County, WI
October 20, 2019

Closer analysis of the 2019 spring treatment areas and fall EWM distribution showed that, for the most part, the treated areas remained relatively free of EWM throughout the growing season (Figure 5). It also showed that, immediately outside of the treated areas, EWM was still present, but generally occurred as scattered individuals. In the east bay, we noted that EWM continues to stubbornly reappear in the same general area on the northwest corner of the flat we have been finding it at since 2012. Whether this is a reintroduction from anglers motoring over from the landing, or if these are simply surviving plants that take several years to expand and canopy following treatment is unknown. Regardless, the area around Bed 6 will continue to be a high priority search area during bed mapping surveys in the future.

Bed 1 and the Northwest Shoreline – Treatment coupled with manual removal efforts eliminated the majority of EWM plants in this area. Five of the six plants we found in this area were located near the boat landing among docks.

Bed 2 – We cleanly raked out the only three plants we found directly out from the public boat landing.
