# LAKE REDSTONE, SAUK COUNTY

## 2016 AQUATIC PLANT MANAGEMENT SUMMARY REPORT WDNR WBIC: 1280400

Prepared by: Dave Blumer, Lake Educator

Revised January 23, 2018

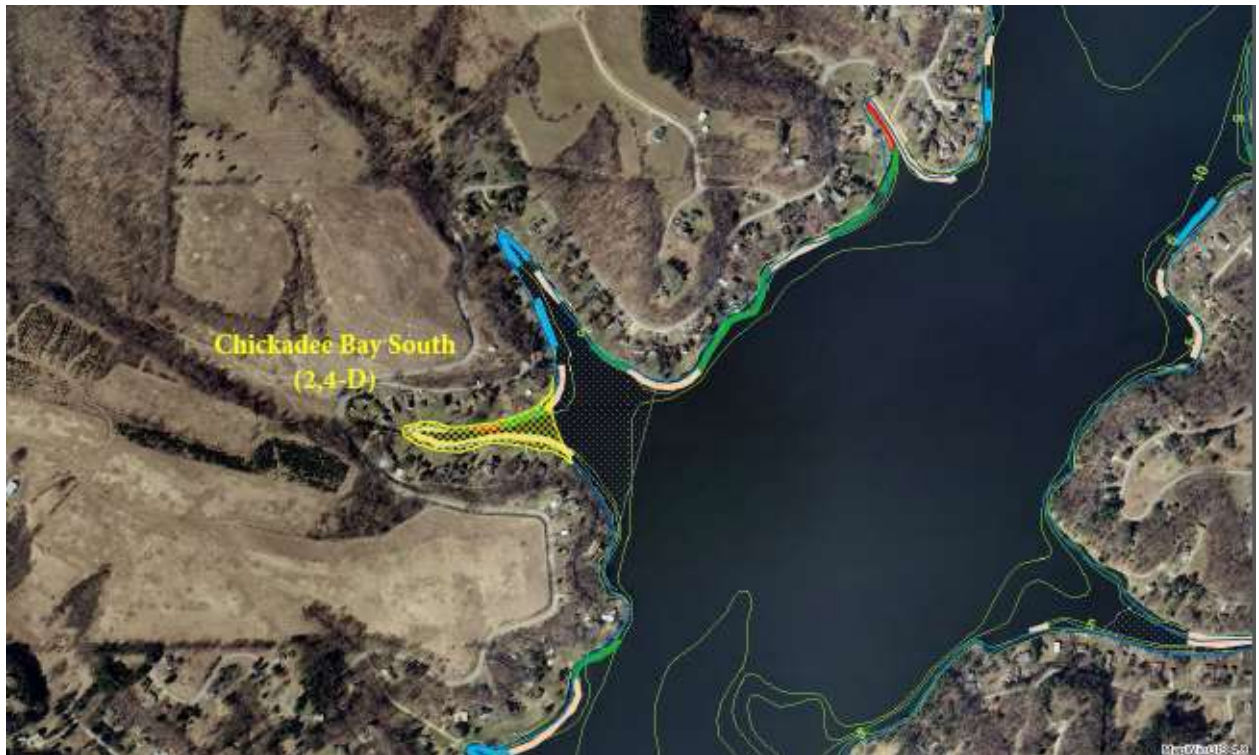
Figure 1 - 2016 Proposed EWM treatment in three bays

Based on a fall EWM survey completed on October 9, 2015 by Cason and Associates, summer point-intercept surveys completed by Aquatic Plant Habitat Services (APHS), and discussions with the Lake Redstone Protection District (LRPD) and Lake Education and Planning Services (LEAPS), a proposal was made by the LRPD and a permit application submitted to the Wisconsin Department of Natural Resources (WDNR) to treat three bays on Lake Redstone totaling 11.8 acres (Table 1, Figure 1). The proposals for these three bays include the application of a liquid formulation of the active ingredient 2, 4-D (DMA 4) at 2.0 ppm on two of them; and diquat (Reward) at the maximum label rate on the third one.

On April 29, 2016 Cason and Associates, the applicator retained by the LRPD completed the application of DMA 4 to 10.3 acres in Oriole and Chickadee Bay South. Diquat was applied to 1.3 acres of Cardinal Bay.

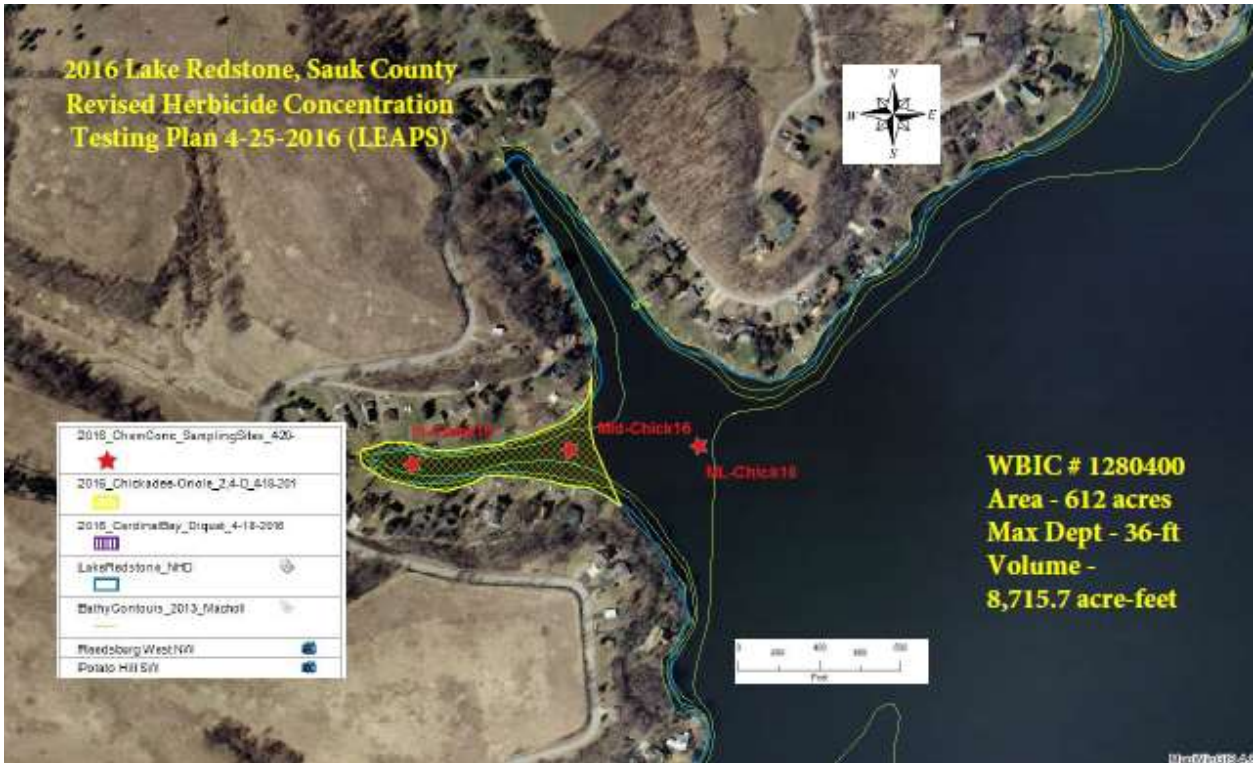
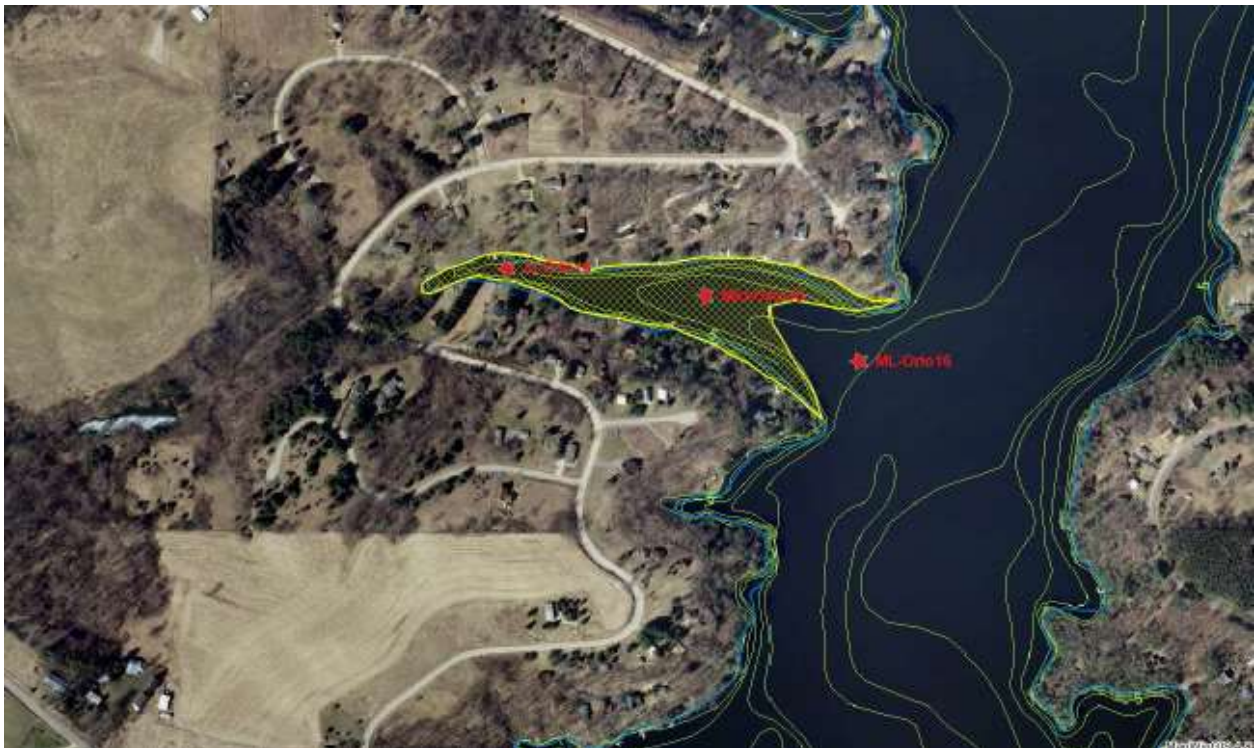
Figure 2 - Chemical Concentration Testing Sites in Chickadee Bay South (top) and Oriole Bay (bottom)

Following the 2016 early season herbicide application in Oriole and Chickadee Bay South, volunteers from the LRPD collected chemical concentration data from six sites in and near the treatment areas and at the outlet of the lake (Figure 2). Each site was sampled at seven different times after treatment: 3 HAT, 6 HAT, 9 HAT, 24 HAT, 36 HAT, 48 HAT and 72 HAT (HAT stands for “Hours After Treatment”). Chemical concentration testing is used to determine the concentration reached in the treated areas and how long the herbicide remains in contact with the target plant. In the 2016 early season treatment, the target concentration in the two treated bays was 2.0 ppm.

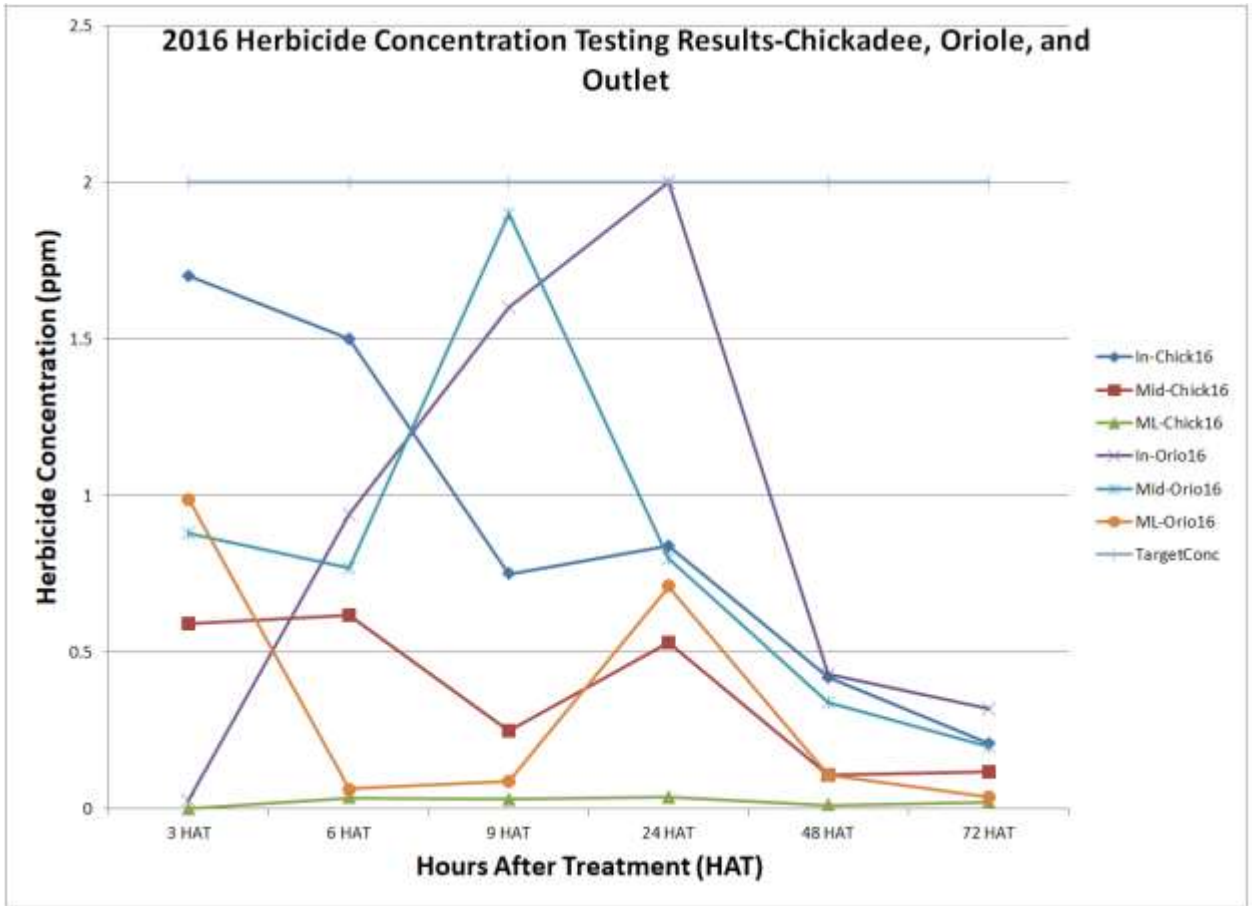
Figure 3 - 2016 Lake Redstone Concentration Testing Results

Only one site in Chickadee Bay, the one furthest into the bay, got close to the target concentration within the first six hours (Figure 3, Table 2). Within the first 24 hours, two sites in Oriole Bay, the middle site and the one furthest in got close to or reached the target concentration. The monitoring sites at the mouths of both treated bays remained low, with the mouth of Chickadee Bay south barely registering the applied herbicide. After 48 hours herbicide concentrations were well below the expected concentrations. Herbicide was not detected (ND) at the outlet until 72 hours later when a concentration of only 0.0042 ppm was documented.

Concentration testing in Oriole Bay showed that the herbicide applied to the middle and inland most portions of the bay reached levels near the target level of 2.0 at 9.0 HAT (1.9 at middle site, and 1.6 at the inside site), and at 24 HAT, the concentration at the inner most site actually reached 2.0 ppm. Given that the herbicide applied actually reached its target level after 24 hours, the amount of herbicide applied appears to have been enough to reduce the density of EWM in the bay, although, not the distribution of it. A slightly higher concentration in the future, might give better, longer lasting results. Concentrations at the open end of the bay may have to be slightly higher than the concentration applied at the middle and inner most portions of the bay.

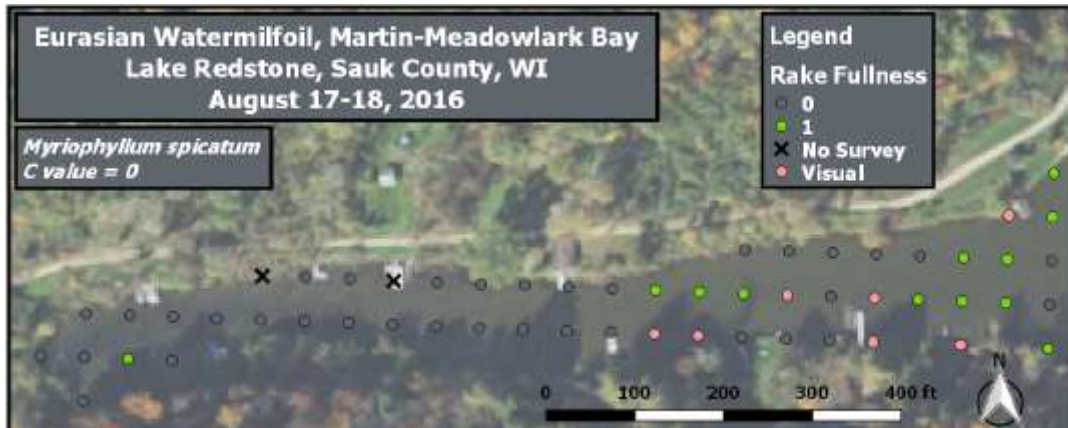
Figure 4 - 2016 EWM in Martin-Meadowlark (APHS, 2016)

The first PI survey in 2014 revealed EWM at 22 sites. Herbicide treatment was conducted in spring of 2015 and a survey that same summer yielded promising results with no EWM found in the bay. No herbicide treatment was done in spring of 2016. The 2016 survey revealed EWM at 12 sites (Figure 4), which is a statistically significant increase from 2015 according to the chi square analysis. There were also 7 sites where EWM was visually observed but not found on the rake sample. The majority of the EWM was found in the eastern half near the mouth of the bay. Even though the increase in EWM was significant, it was not among the most common plant species found in the bay with a low relative frequency of 8.45%. This is not surprising when considering the fact that vegetation was found at 93% of all survey sites. In other words, there was a high abundance of vegetation and relatively high species richness for the small survey area and thus other plant species competing for the same space as EWM.

Both Martin-Meadowlark and Swallow bays were chemically treated in 2015. After treatment, the frequency of occurrence of EWM in both bays was down significantly based on chi-square analysis. In 2016, a year after treatment, the frequency of occurrence of EWM in both bays was up, but only about half of where it was 2014. During this same time frame, the Mean Coefficient of Conservatism (C) and the Floristic Quality Index (FQI), two other measures of the health of the aquatic plant community in the lake, increased steadily for Martin-Meadowlark through all three years. In Swallow, these values increased in the year of treatment, but declined again in the year after treatment, but not to the low levels these values were in 2014, before treatment occurred. This reduction in EWM is considered positive for the lake, but not necessarily for the property owners.

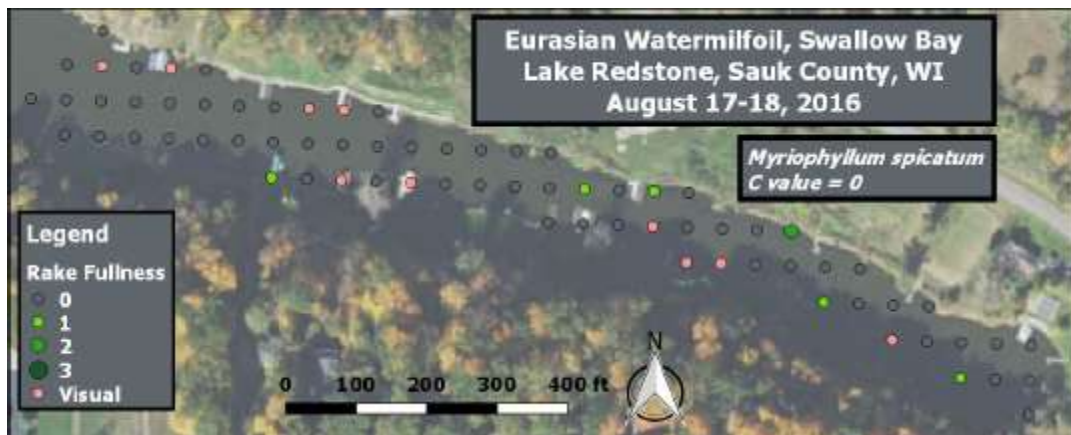
Figure 5 - 2016 EWM in Swallow Bay (APHS, 2016)

The first EWM survey in 2014 revealed EWM at 33 sites. Herbicide treatment was conducted in spring of 2015 and a survey that same summer yielded promising results with EWM at only 1 site with another 4 visual observations. No herbicide treatment was done in spring of 2016. The 2016 survey revealed EWM at 6 sites (Figure 5), which is *not* a statistically significant increase from 2015 according to the chi-squared test. However, if visual observations are included in the analysis, we see an increase from 5 sites in 2015 to 16 sites in 2016, which *is* a statistically significant increase. The EWM was found scattered throughout the bay and not concentrated in any particular area. Even though there was an increase in EWM, it was not among the most common plant species found in the bay with a low relative frequency of 7.5%.

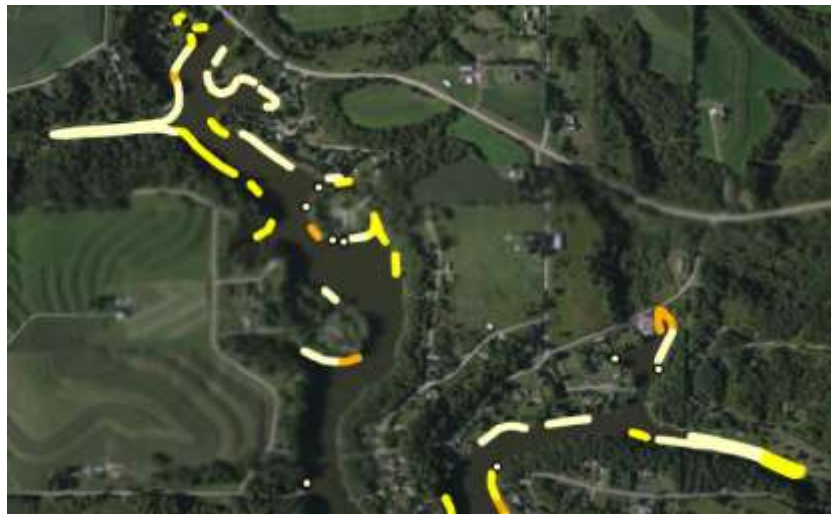
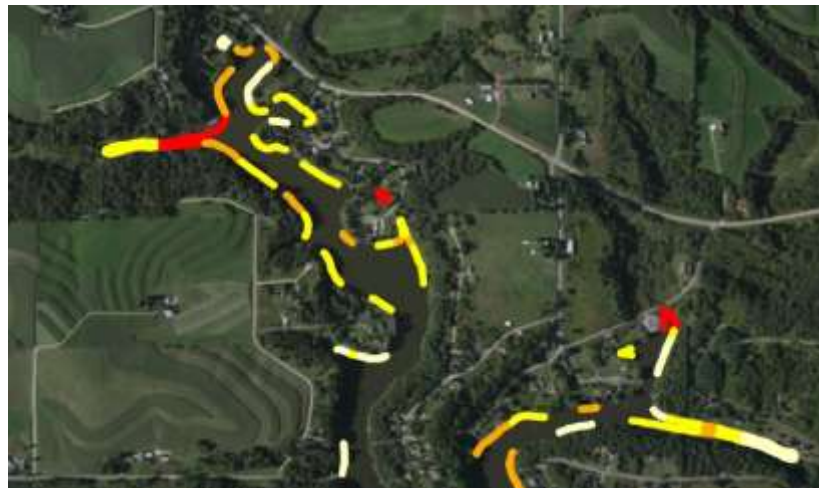
Figure 6 - Fall 2014 (top), Fall 2015 (middle), and Fall 2016 (bottom) EWM Survey Results from Cason and Associates (red represents dense growth, yellow represents scattered growth, orange represents moderate growth, and pale yellow (or white) represents highly scattered growth)

The data suggests that native plants generally increased after treatment of EWM, but probably not enough to be considered at nuisance levels. Fall survey work completed in 2014, 2015, and 2016 by Cason and Associates visually shows a reduction of EWM from 2014 to 2015; and an increase in EWM from 2015 to 2016, but that increase is still less than what was found in the fall of 2014 (Figure 6). Fall survey results are not quantitative and likely reflect other factors that impact the growth of EWM and other vegetation.

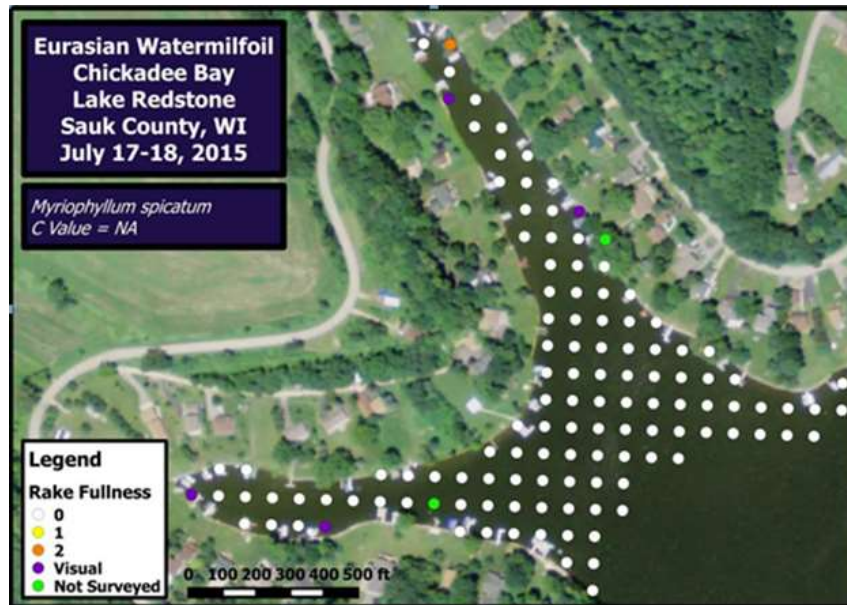
Figure 8 – 2015 APHS EWM Summer Survey Results

During the 2015 Summer PI Survey, six points in the entire bay were identified with EWM (Figure 8). Herbicides were applied to the southern arm of Chickadee Bay in spring of 2016 to combat EWM, based on Cason 2015 fall survey results which showed much more EWM than the 2015 summer did (Figure 9). Only the southern arm of Chickadee Bay was surveyed in 2016 and overall had a low occurrence of all plants with vegetation present at only 25% of sites at or below maximum rooting depth. EWM was found at 3 sites compared to 3 sites in 2015 in the southern arm (Figure 10). A chi-squared test of EWM presence in 2015 compared to 2016 based on the 2015 and 2016 summer PI survey reveals no significant difference between the years, even when visual observations are included in the analysis. The 2016 fall survey completed by Cason indicates that perhaps the density on EWM in the southern arm of Chickadee Bay is less, but the number of points with EWM during the two PI surveys is limited, and the Cason survey results are not quantifiable.

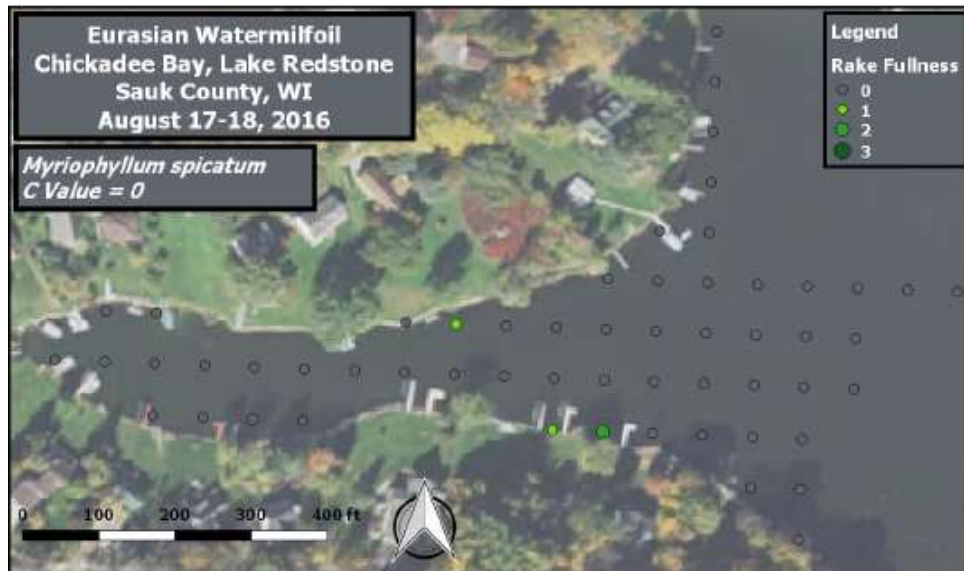
**Figure 10 - 2016 Summer PI EWM Survey Results for Chickadee Bay, Post-Treatment (APHS, 2016)**

The overall littoral frequency of all plants went down from 2015 to 2016. The littoral frequency of EWM was down from 2015 to 2016, however, the rake fullness rating or density was up. The same was true for coontail.

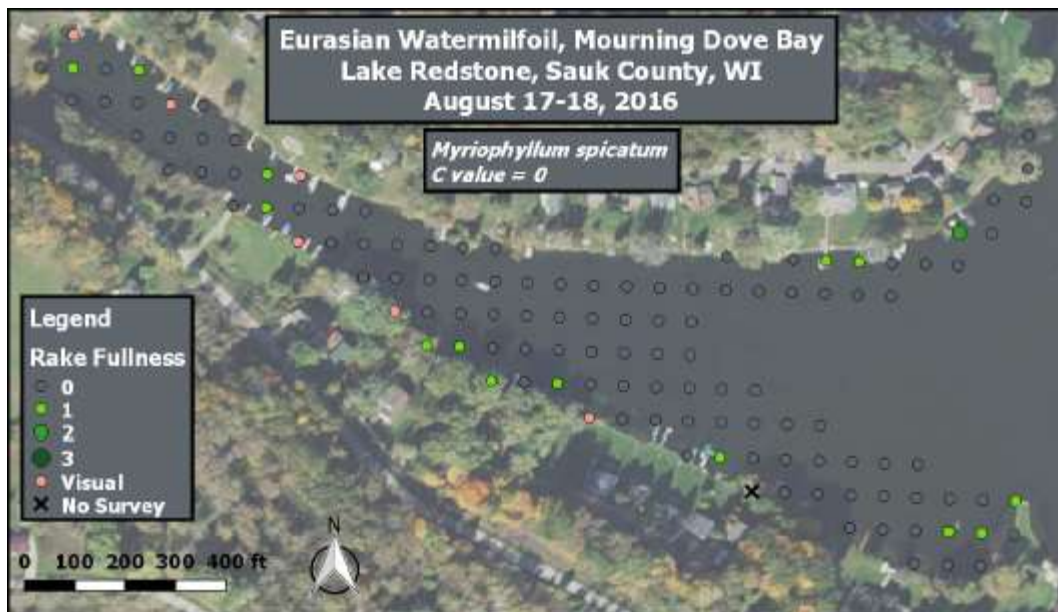
Figure 13 - 2016 EWM in Mourning Dove Bay (APHS, 2016)

A total of 89 points in the bay were surveyed in 2016. EWM was found at 15 survey points with another 6 visual observations (23.6%). It had a littoral frequency of 16.85, making it the second most common plant species in Mourning Dove Bay (Figure 13). Coontail was the most common plant, found at 50 points with a littoral frequency of 55.06. EWM was found scattered along the shore throughout the bay. There were 59 survey points with vegetation (66%) out of 89 points that were equal to or shallower than the maximum rooting depth. Nine different native plants were identified in Mourning Dove Bay in 2016.

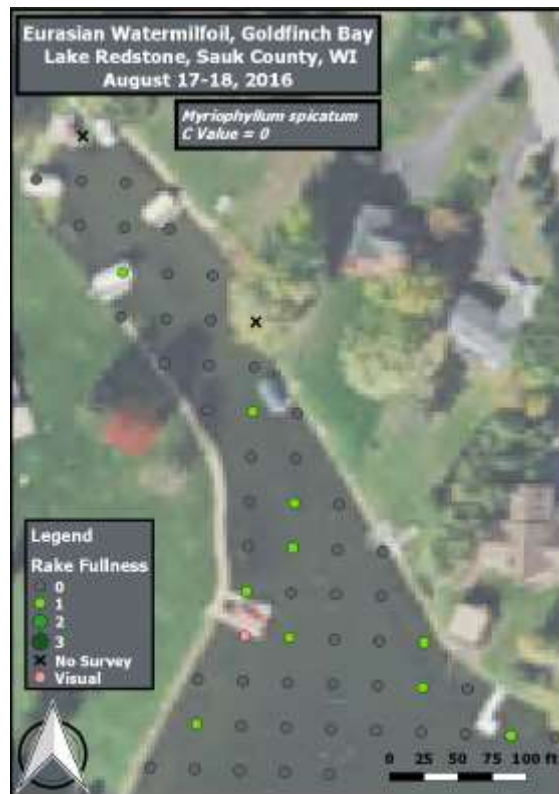
Figure 14 - 2016 Summer PI EWM Survey Results for Goldfinch Bay (APHS, 2016)

EWM was the second most common plant and was found at 10 sites and visually observed at one site (Figure 14). Overall, plants were found at about half the sites (46%) at or shallower than the maximum rooting depth. Herbicide treatment has not been conducted in Goldfinch Bay.

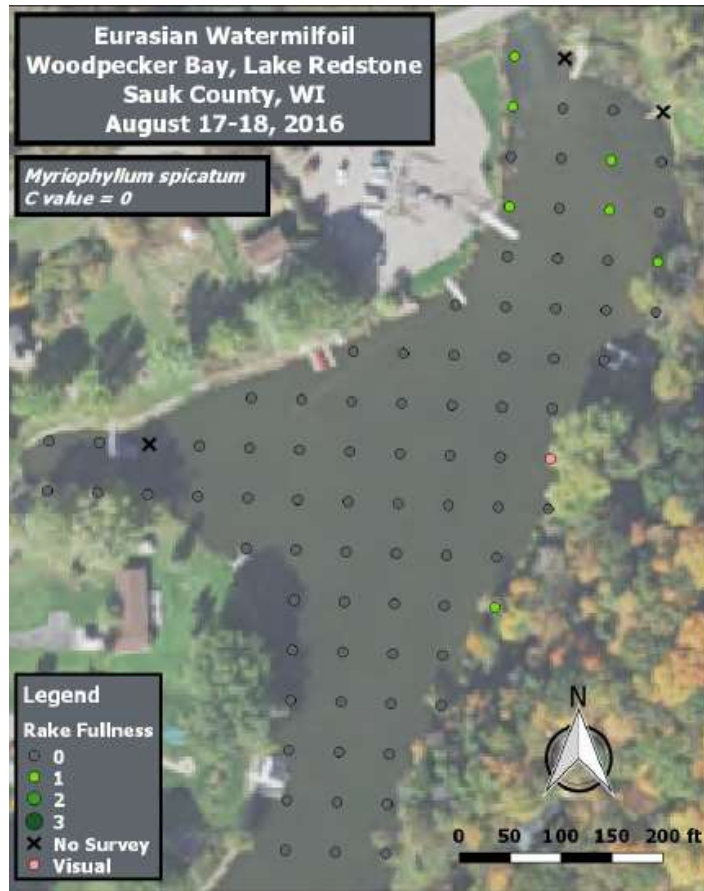
Figure 16 - 2016 Summer PI EWM Survey Results for Woodpecker Bay (APHS, 2016)

EWM was found at 7 survey points and one visual observation with the majority of the EWM in the northern section of the bay (Figure 16). EWM was not among the most common species in the bay with a relative frequency of 12%. There were 22 survey points with vegetation (29%) out of 77 points that were equal to or shallower than the maximum rooting depth. Herbicide treatment has not been conducted in the bay.

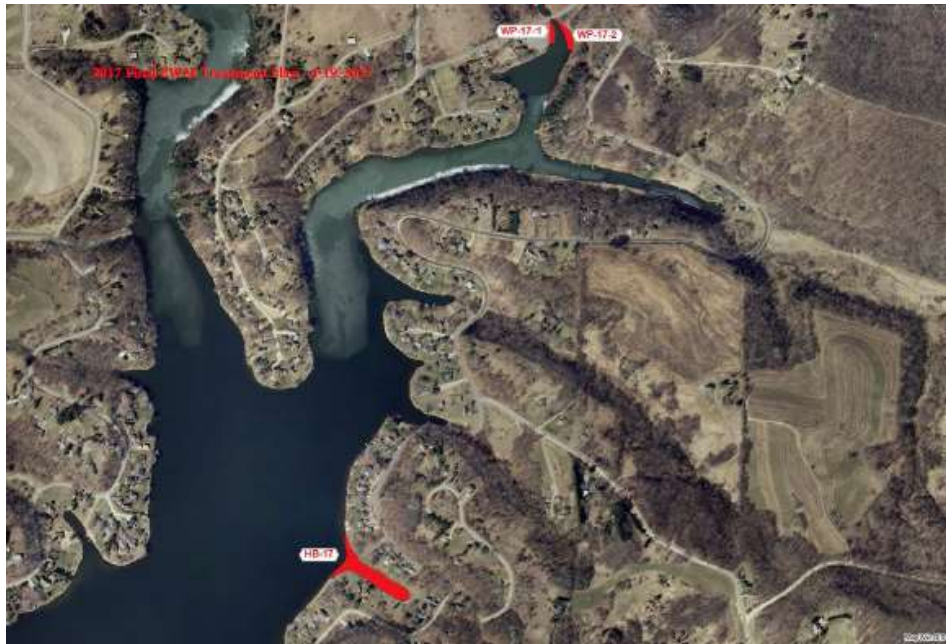
**Figure 18 - 2017 Proposed Chemical Treatment Areas**

Based on the results of the 2016 summer surveys in Hummingbird, Goldfinch, Woodpecker, and Mourning Dove bays and the 2016 Fall EWM survey by Cason and Associates, an early-season, whole bay EWM treatment proposal was made in 2017 that included two of the four bays. Mourning Dove and Goldfinch were left out due to a feeling that treatment could be put off for another year (Table 6, Figure 18). Two of the three treatment areas were in Woodpecker Bay on either side of the channel coming in from the north. These are very small beds and would be treated with diquat. The third was larger and in Hummingbird Bay and would be treated with DMA 4 at 2.0ppm. Concentration testing would be completed post-treatment. Aquatic plant survey work to support 2017 EWM management began with the summer surveys in 2016 and will continue with a repeat of the summer 2016 survey in 2017 and again in 2018. Changes in EWM and other aquatic vegetation will be compared when these surveys are completed. These three areas may not be treated again until 2019 in accordance with the recommendations in the APM Plan.

A WDNR permit request for herbicide application was prepared by the LRPD and Cason and Associates, and approved by the WDNR. Treatment of these three areas occurred on May 9, 2017. Herbicide concentration testing was completed following the treatment according to a plan prepared for the LRPD by LEAPS and the WDNR. The results of the 2017 treatments and concentration testing will be presented in a Summary Report for the 2017 season.
