**Curly-leaf pondweed (*Potamogeton crispus*)
Meandering Littoral Zone and Bed Mapping Surveys
Upper and Middle Eau Claire Lakes
WBIC: 2742700 and 2742100
Bayfield County, Wisconsin**

The Town of Barnes – Aquatic Invasive Species Committee, and the Wisconsin Department of Natural Resources (Grants AIRR-133/134-13)

Endangered Resource Services, LLC
Matthew S. Berg, Research Biologist
St. Croix Falls, Wisconsin
June 19, 2020

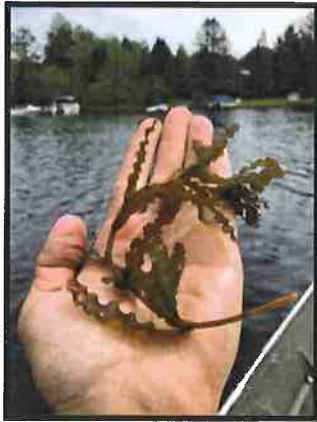
CLP from Upper Eau Claire 6/19/20

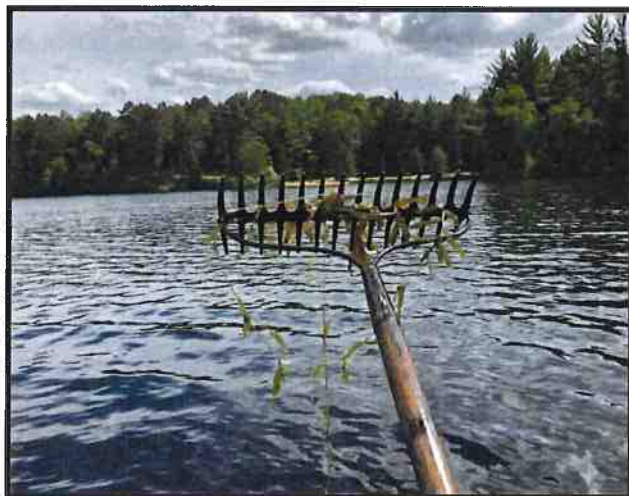
Typical low density CLP rake sample on Middle Eau Claire Lake 6/19/20

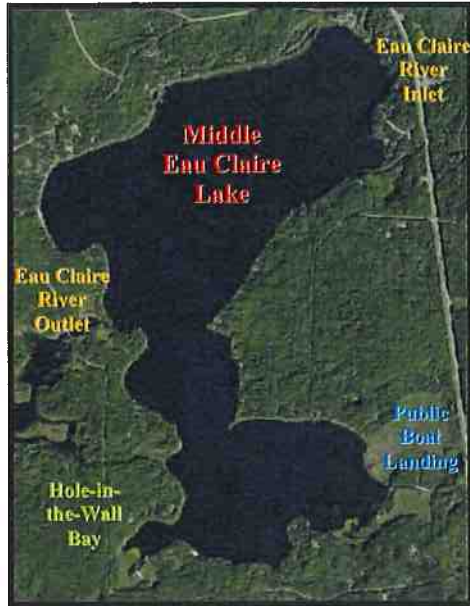
Figure 2: Middle Eau Claire Lake Aerial Photo

Middle Eau Claire Lake (WBIC 2742100) is an 880 acre meso/oligotrophic stratified drainage lake in southwestern Bayfield County, Wisconsin in the Town of Barnes (T44N R9W S19 NW NE). The lake reaches a maximum depth of 66ft in the hole north/northwest of the Eau Claire River Inlet, and has an average depth of approximately 17ft (Figure 2). The bottom is predominately sand and gravel along the shoreline and around the many sunken islands, while muck dominates the deeper basins and bays. Summer Secchi readings from 1987-2019 (the most recent year available) ranged from 11-22ft and averaged 17.8ft (WDNR 2020). This very good clarity produced a littoral zone that reached 20ft in 2020.
