Presque Isle Wilderness Waters Program

Aquatic Plant Management Plan – Stateline Lake

Cite as: Premo, Dean, Angie Stine, and Kent Premo. 2020. Presque Isle Wilderness Waters Program: Stateline Lake Aquatic Plant Management Plan. White Water Associates, Inc.

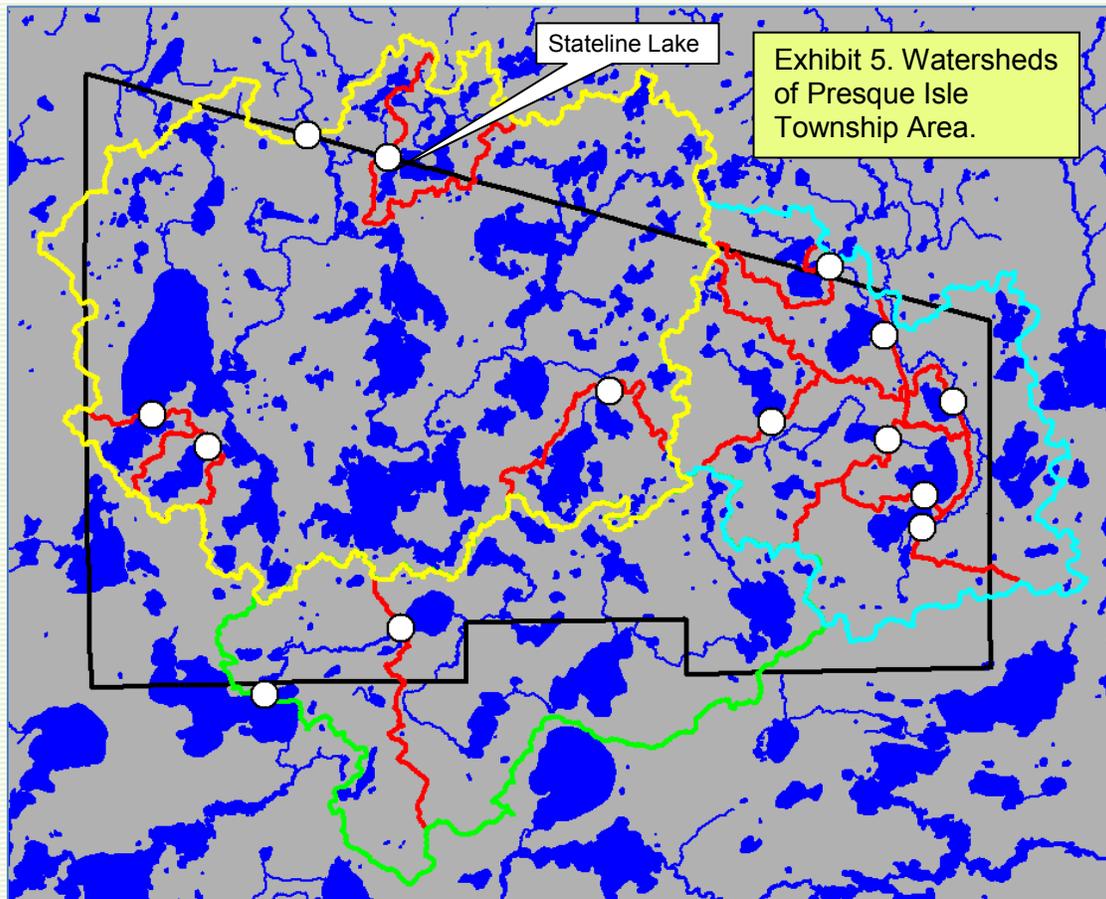
Description: Portions of 3 federal hydrologic sub-watersheds are illustrated: (1) S.Br. Presque Isle River (bounded by yellow), (2) Pomeroy Cr-E.Br. Presque Isle River (bounded by blue and yellow), and (3) Rice Cr. (bounded by green, yellow, and blue). Also shown are the smaller watersheds of individual water bodies subject to the Wilderness Waters studies (bounded by red). White dots show outlet points for the smaller watersheds.

The Presque Isle Township waterscape sits on a large-scale watershed divide. Some of the water drains north through the Presque Isle River system and eventually enters Lake Superior. Some of the water drains into the Wisconsin River system to the Mississippi River and to the Gulf of Mexico. In fact there are two federal hydrologic sub-basins (designated by 8-digit HUC codes) that include Presque Isle Township. The Black-Presque Isle Rivers sub-basin (HUC#04020101) drains north to Lake Superior and the Flambeau River sub-basin (HUC#0705002) drains southwesterly to the Mississippi River. The Black-Presque Isle Rivers sub-basin contains two federal hydrologic sub-watersheds within Presque Isle Township: the South Branch Presque Isle River sub-watershed (HUC#040201010303) and the Pomeroy Creek-East Branch Presque Isle River sub-watershed (HUC#040201010301). The Flambeau River sub-basin contains one sub-watershed within Presque Isle Township: the Rice Creek sub-watershed (HUC#07050020103). Exhibit 5 illustrates these watersheds and the watersheds of the water bodies subject to the Wilderness Waters Program studies. Stateline Lake is contained within the South Branch Presque Isle River sub-watershed (Exhibit 5).

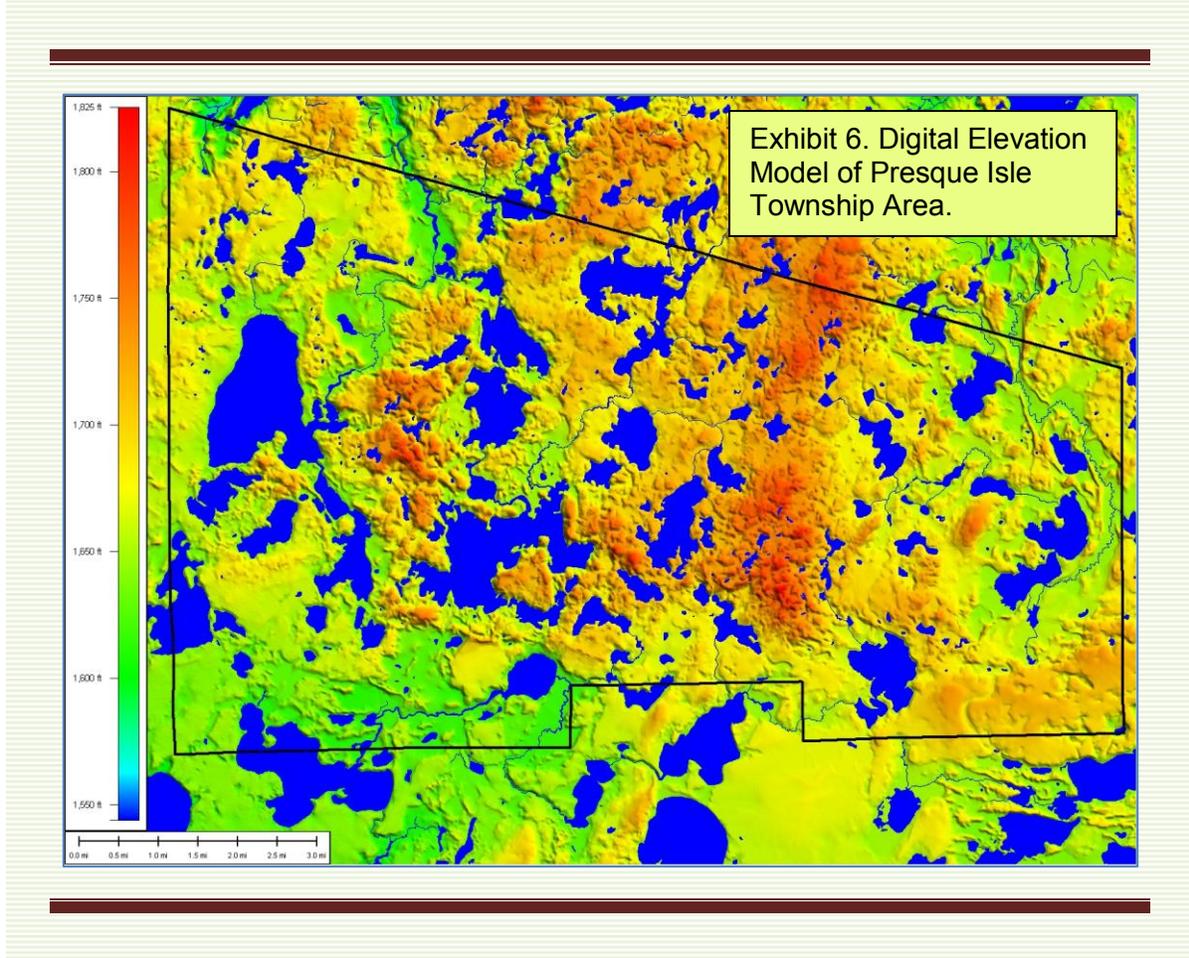
The elevation in Presque Isle Township ranges from around 1,550 feet above sea level to 1,750 feet above sea level. A digital elevation model is provided as Exhibit 6 and shows the relative elevations for the area with orange areas of the landscape being the highest elevations and greens and blues being the lowest elevations.

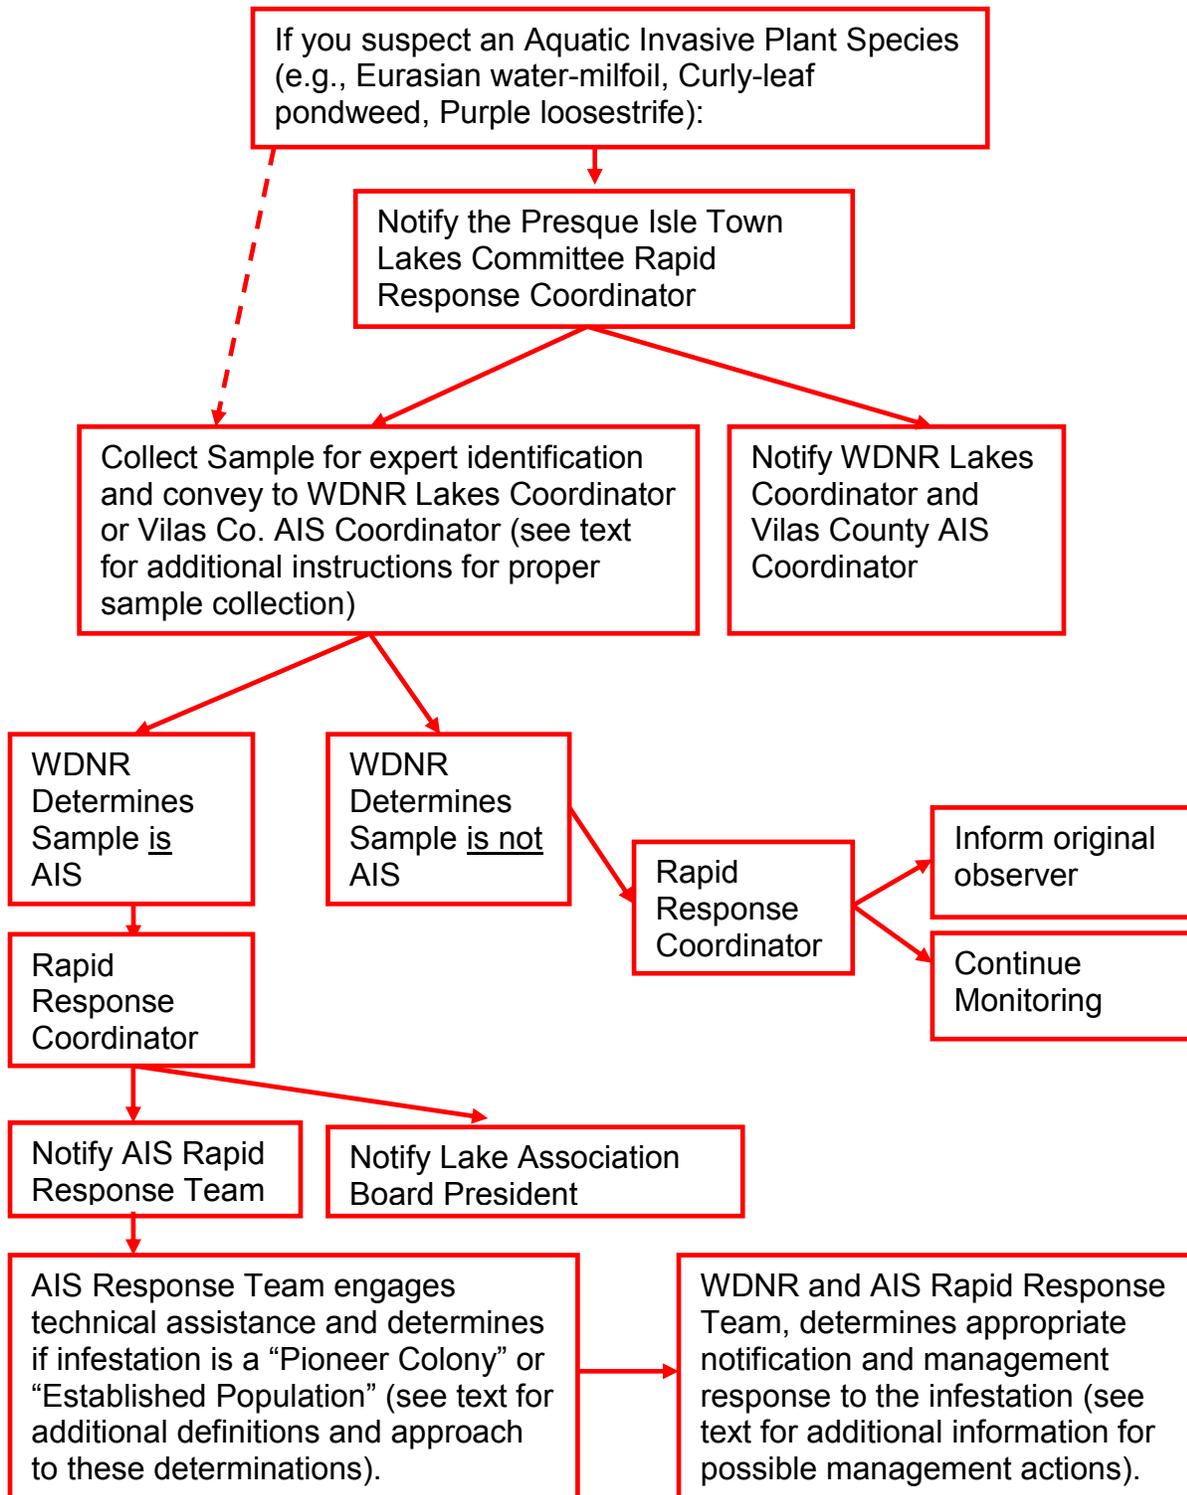
Exhibit 8. Aquatic Invasive Plant Species Rapid Response

When a suspect aquatic invasive plant species is found, either the original observer or a member of the Rapid Response Team (likely the coordinator) should collect an entire plant

specimen including roots, stems, and flowers (if present). The sample should be placed in a sealable bag with a small amount of water to keep it moist. Place a label in the bag written in pencil with date, time, collector's name, lake name, location, town, and county. Attach a lake map to the bag that has the location of the suspect AIS marked and GPS coordinates recorded (if GPS is available). The sample should be placed on ice in a cooler or in a refrigerator. Deliver the sample to the WDNR Water Resource Management Specialist (Kevin Gauthier in Woodruff) or the Vilas County AIS Coordinator (Alan Wirt) as soon as possible (at least within three days). The WDNR or their botanical expert(s) will determine the species and confirm whether it is an aquatic invasive plant species.

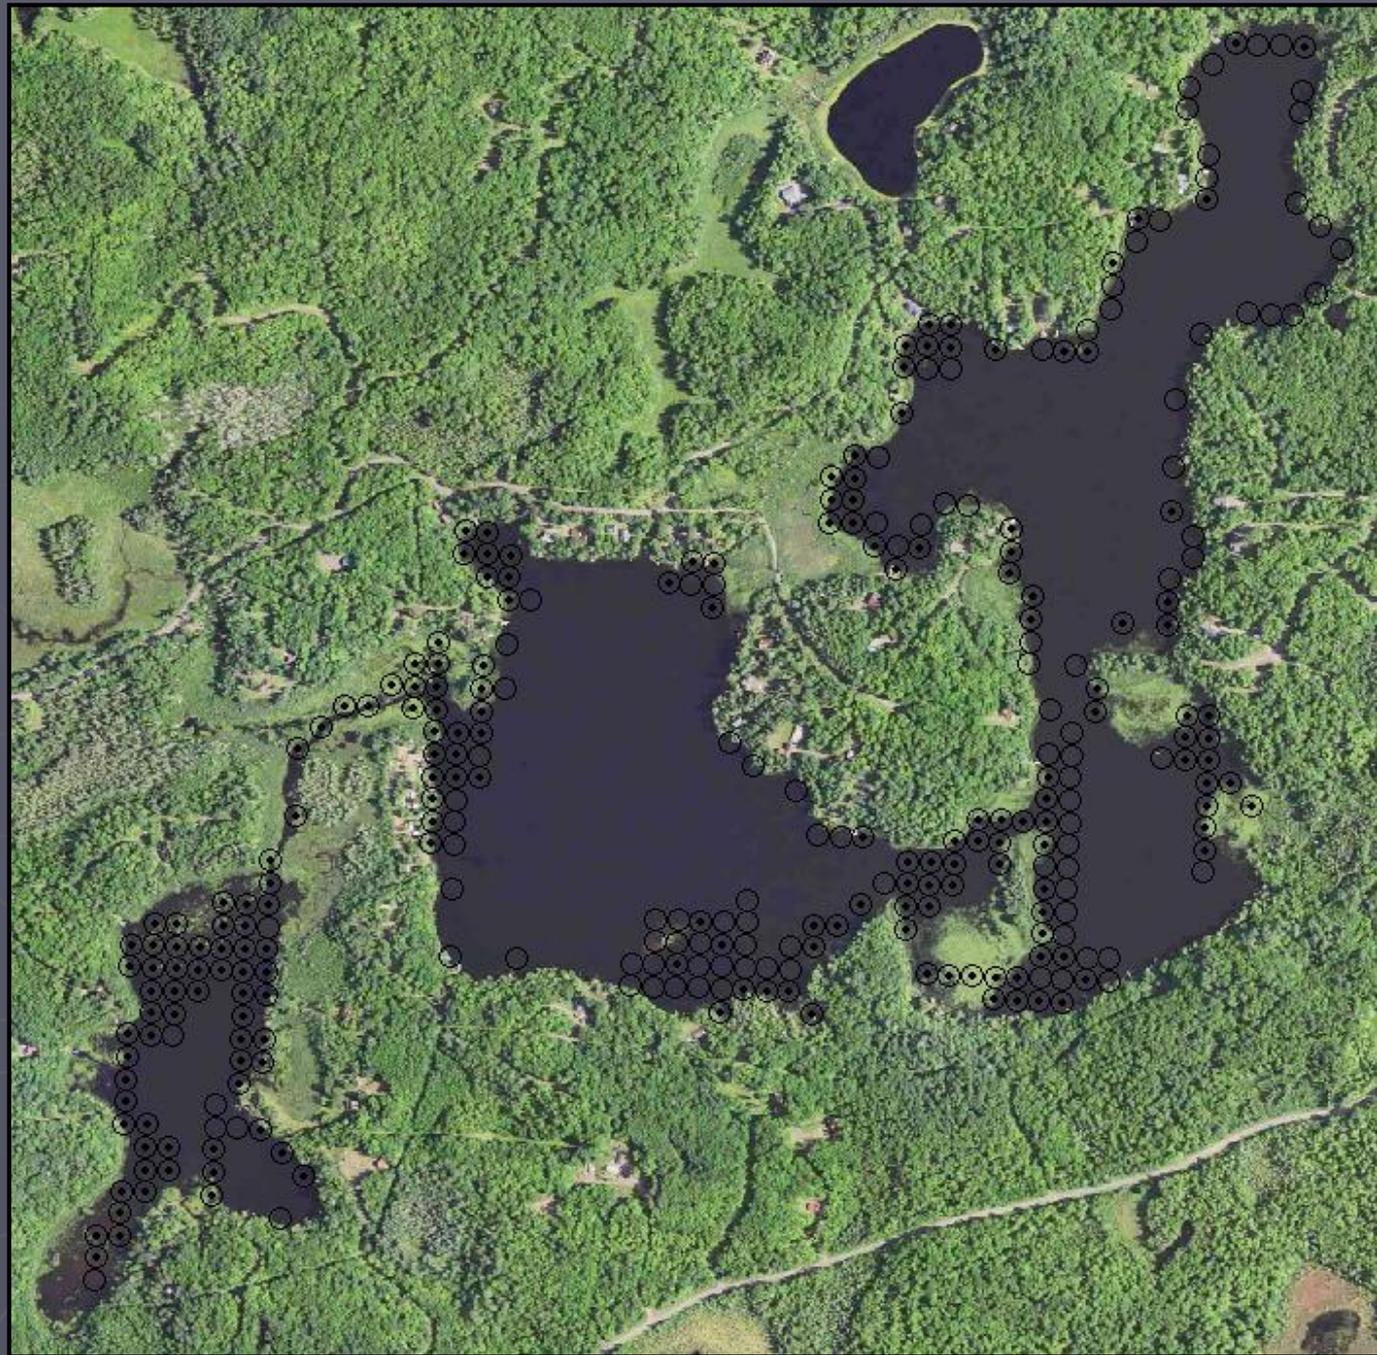
Figure 4. Stateline Lake sampling sites less than or equal to maximum depth of rooted vegetation (2018).

- Site less than or equal to maximum depth of plant colonization (MDC).
- Plant find(s) at site less than or equal to MDC.

The maximum depth of plant colonization was 12.5 feet in 2018 (Table 1 and Figure 3). Rooted vegetation was found at 194 of the 540 sample sites with depth \leq the maximum depth of plant colonization (64.67% of sites). These sites are displayed as a black dot within a circle on Figure 4. This indicates that although availability of appropriate depth may limit the distribution of plants, it is not the only habitat factor involved. Substrate is another feature that influences plant distribution (e.g., soft substrate often harbors more plants than hard substrate). Figures 5 presents the substrates encountered during the aquatic plant survey (mud, sand, or rock).

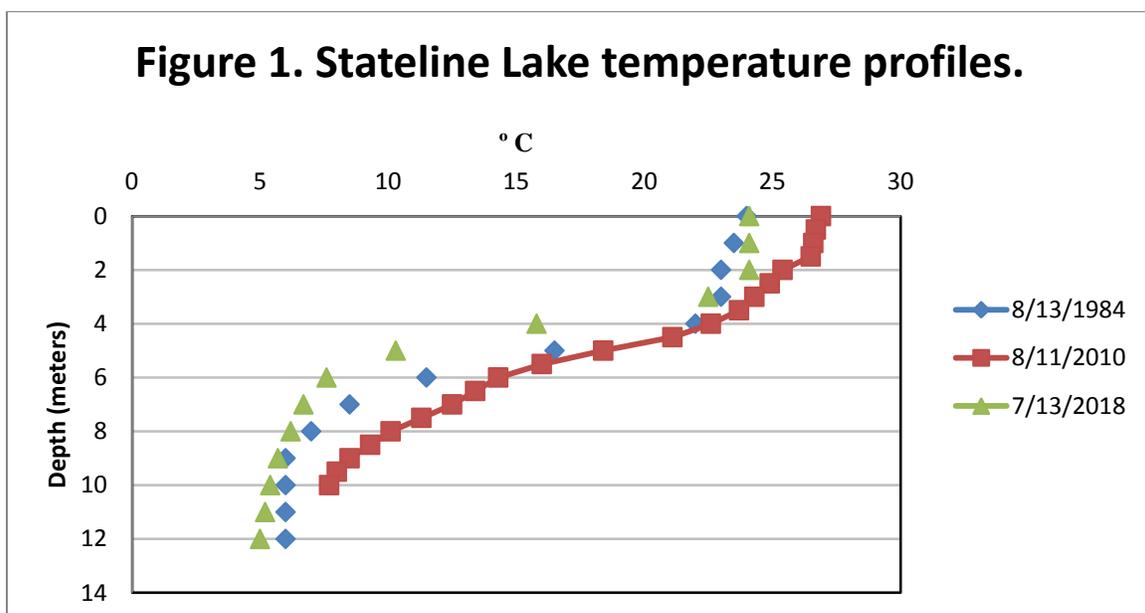
Measuring the temperature of a lake at different depths will determine the influence it has on the physical, biological, and chemical aspects of the lake. Lake water temperature influences the rate of decomposition, nutrient recycling, lake stratification, and dissolved oxygen concentration. Temperature can also affect the distribution of fish species throughout a lake. Figure 1 indicates that the Stateline Lake stratified between 4 and 6 meters in 1984, 2010, and 2018.

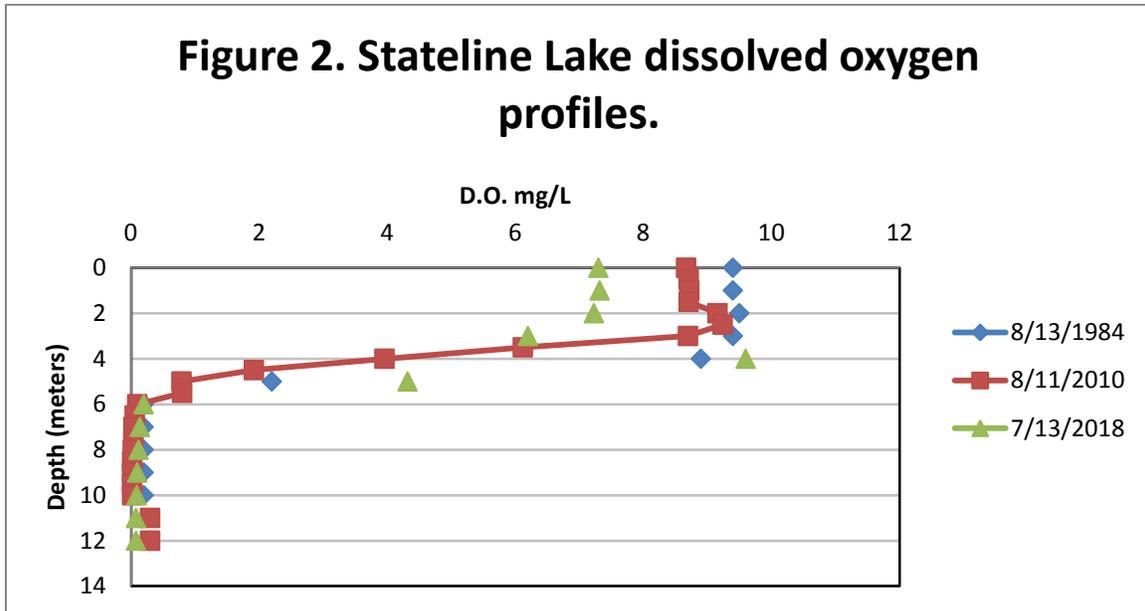
The dissolved oxygen content of lake water is vital in determining presence of fish species and other aquatic organisms. Dissolved oxygen also has a strong influence on the chemical and physical conditions of a lake. The amount of dissolved oxygen is dependent on the water temperature, atmospheric pressure, and biological activity. Oxygen levels are increased by aquatic plant photosynthesis, but reduced by respiration of plants, decomposer organisms, fish, and invertebrates. The amount of dissolved oxygen available in a lake, particularly in the deeper parts of a lake, is critical to overall health. Figure 2 indicates that the Stateline Lake dissolved oxygen level began to decrease at 4 meters.

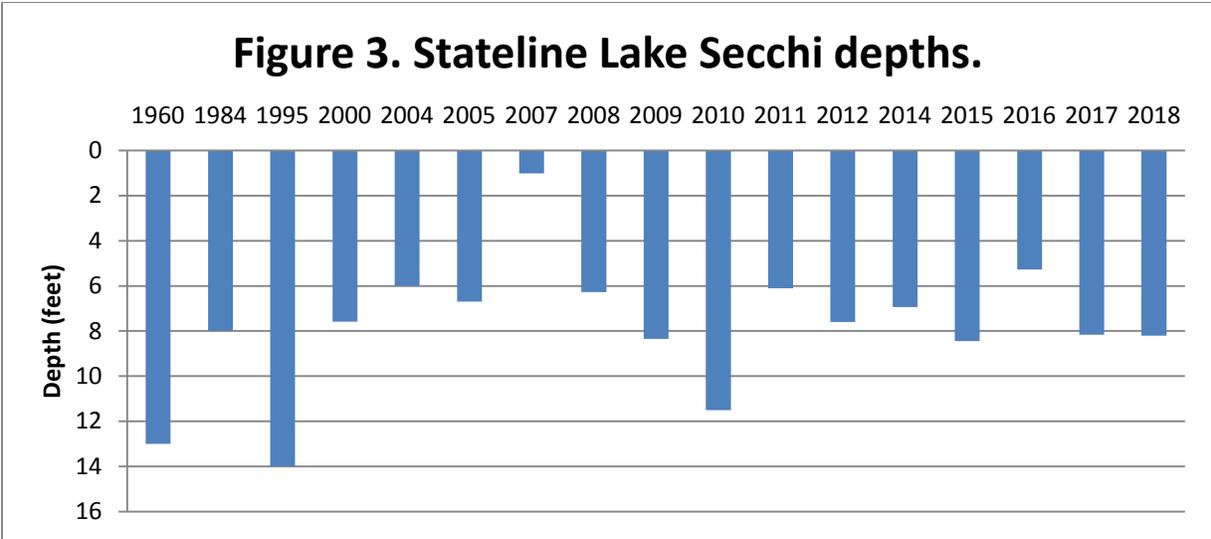
Figure 5 presents the average Secchi depths and demonstrates year to year variability. In 2018 Stateline Lake the Secchi depth mean was “fair” in the water clarity index (Table 1).

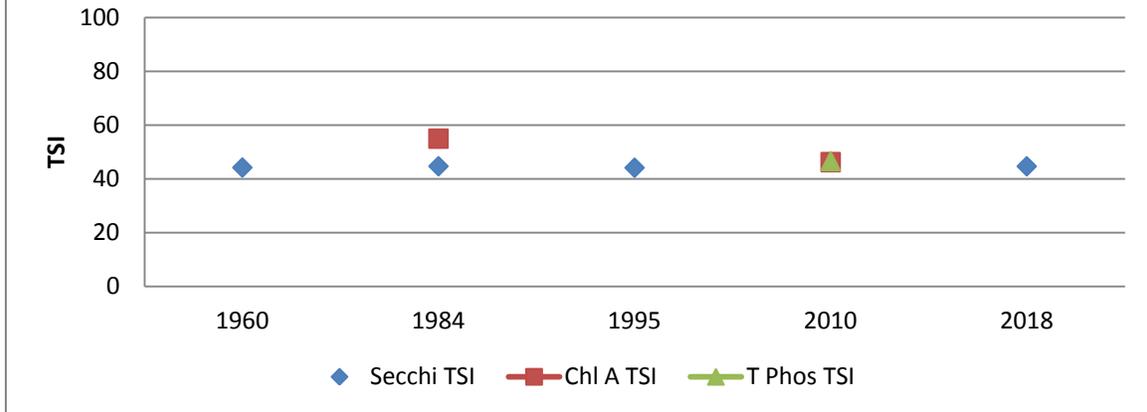
Figure 6. Stateline Lake trophic state index.

Trophic state is another indicator of water quality (Carlson, 1977). Lakes can be divided into three categories based on trophic state – oligotrophic, mesotrophic, and eutrophic. These categories reflect a lake's nutrient and clarity levels (Shaw et al., 2004).

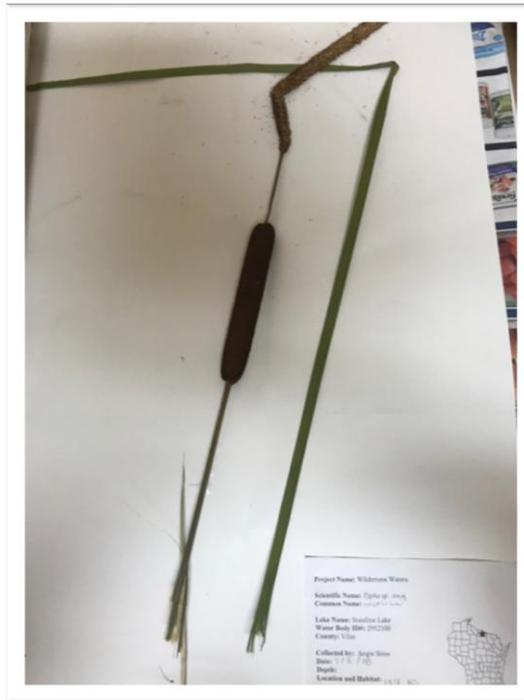
Narrow-leaved cattail (*Typha angustifolia*) is another perennial wetland plant that can grow very tall. It has a flowering spike of male flowers with another section of female flowers just below it (Czarapata, 2005). It grows along shorelines, roadsides, marshes, and wet meadows. Narrow-leaved cattails form monocultures that push out native plant species and can alter the hydrology and wildlife habitat (Czarapata, 2005). Exhibit 4 shows the voucher collected of the narrow-leaved cattail.

Exhibit 4. Photo of the narrow-leaf cattail voucher specimen sent to Dr. Freckmann (U.W. Steven’s Point: Herbarium) for confirmation in January, 2019.

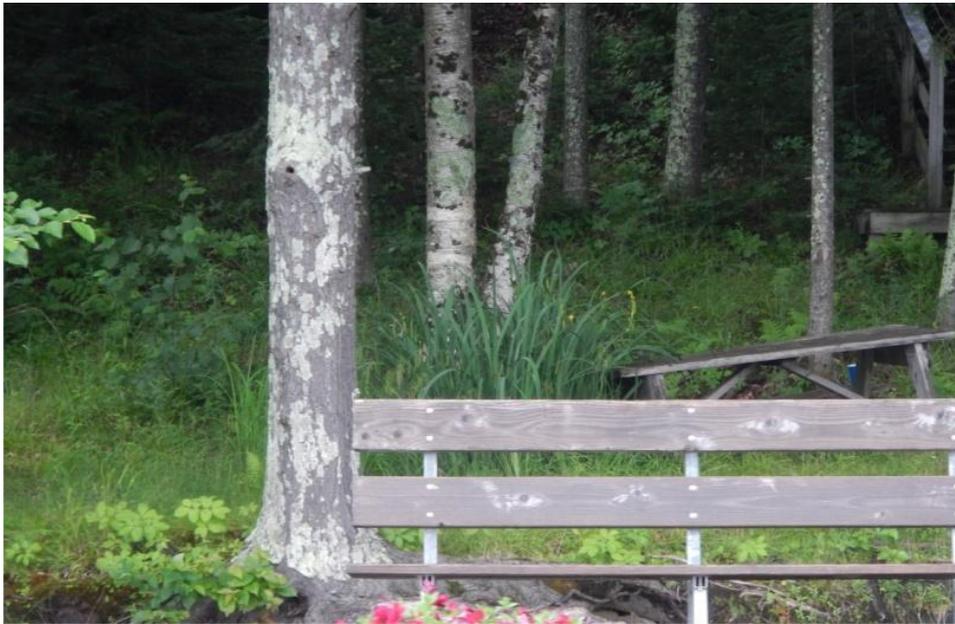
The yellow iris (*Iris pseudacoris*) is a perennial aquatic plant native to Europe, western Asia and North Africa. It was first introduced to North America in the 1800s as an ornamental plant. Over time, the plant has spread to many wetlands and proliferated to the detriment of native plants and animals. Yellow iris is present on numerous Wisconsin lake margins and the Wisconsin Department of Natural Resources has listed this species as “Restricted” which prevents its sale, transfer, transportation and intentional cultivation. Yellow iris can reduce habitat needed by fish and waterfowl (Thomas, 1980). A yellow iris was located along the shoreline at Stateline Lake (Exhibit 5).

Exhibit 5. Photo of a yellow iris located on the shoreline behind the bench at Stateline Lake, July 13, 2018 .
