Presque Isle Wilderness Waters Program

Aquatic Plant Management Plan – Little Presque Isle Lake

White Water Associates, Inc.
Dean Premo, Ph.D.
429 River Lane, P.O. Box 27
Amasa, Michigan 49903

Cite as: Premo, Dean, Angie Stine, and Kent Premo. 2020. Presque Isle Wilderness Waters Program: Little Presque Isle Lake Aquatic Plant Management Plan. White Water Associates, Inc.

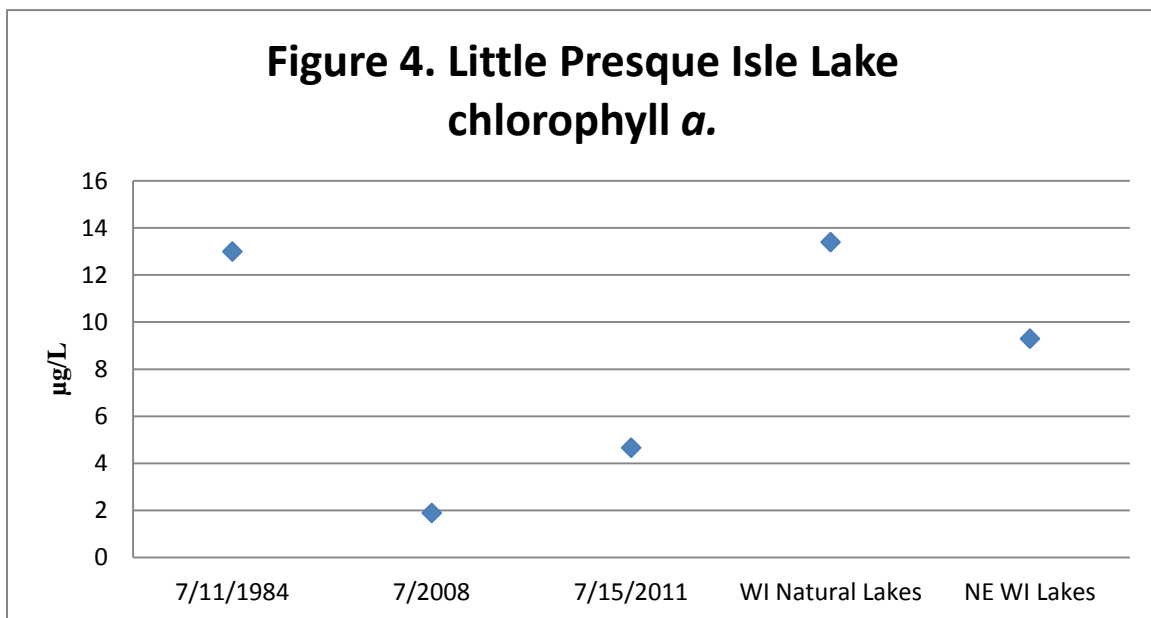
Chlorophyll *a* is the photosynthetic pigment that makes plants and algae green. Chlorophyll *a* in lake water is therefore an indicator of the amount of algae. Chlorophyll *a* concentrations greater than 10 µg/L are perceived as a mild algae bloom, while concentrations greater than 20 µg/L are perceived as a nuisance. Chlorophyll *a* has been monitored in Little Presque Isle Lake twice since 1984 (Figure 4), with the 2008 and 2011 values below nuisance levels.

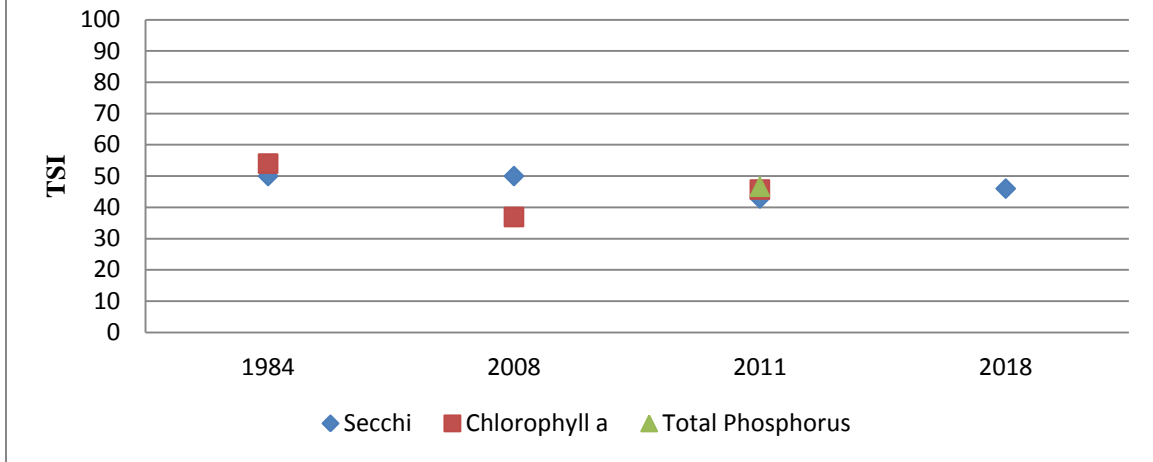
Figure 6. Little Presque Isle Lake trophic state index.

Trophic state is another indicator of water quality (Carlson, 1977). Lakes can be divided into three categories based on trophic state – oligotrophic, mesotrophic, and eutrophic. These categories reflect a lake’s nutrient and clarity levels (Shaw et al., 2004).

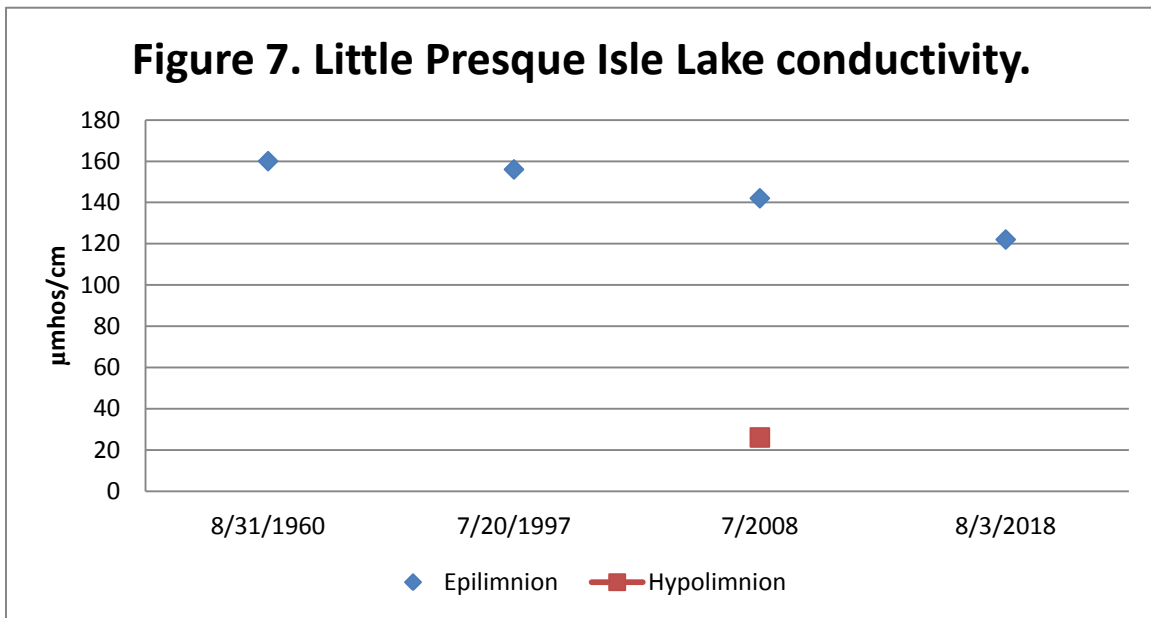
Conductivity is a measure of the ability of water to conduct an electric current. Conductivity is reported in micromhos per centimeter ($\mu\text{mhos/cm}$) and is directly related to the total dissolved inorganic chemicals in the water. Usually, values are approximately two times the water hardness, unless the water is receiving high concentrations of human-induced contaminants (Shaw et al., 2004). The conductivity on Little Presque Isle Lake is illustrated in Figure 7.

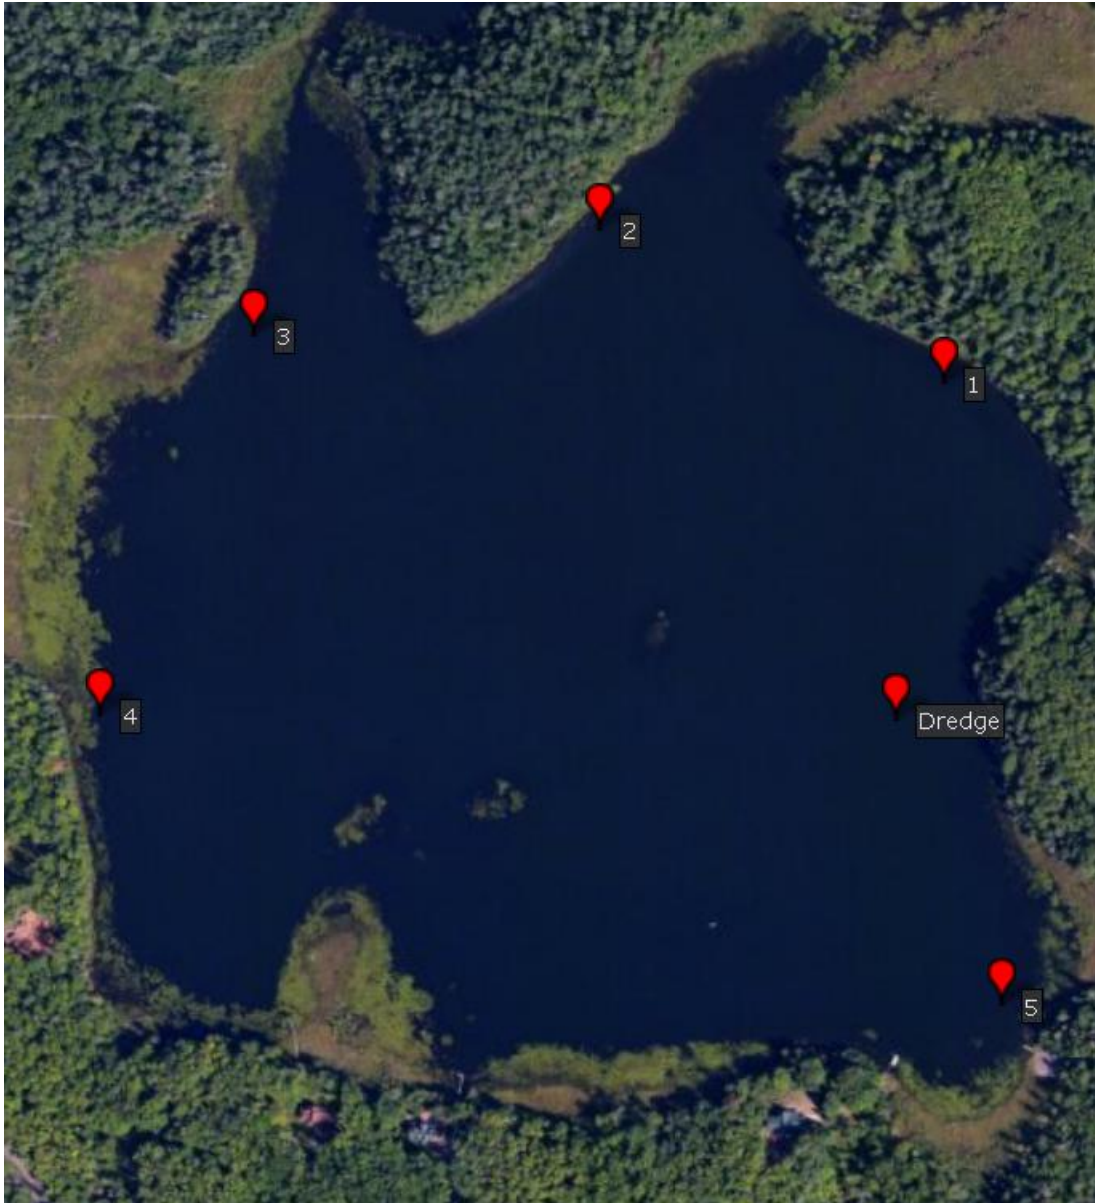
Exhibit 1. Little Presque Isle Lake AIS survey sites 1-5, and the location of the dredge site.

There are no known AIS that are established in Little Presque Isle Lake prior to this survey. During the survey there were no AIS noted.
