# Presque Isle Wilderness Waters Program

## Aquatic Plant Management Plan – Dunn Lake

**Cite as:** Premo, Dean, Angie Stine, and Kent Premo. 2020. Presque Isle Wilderness Waters Program: Dunn Lake Aquatic Plant Management Plan. White Water Associates, Inc.

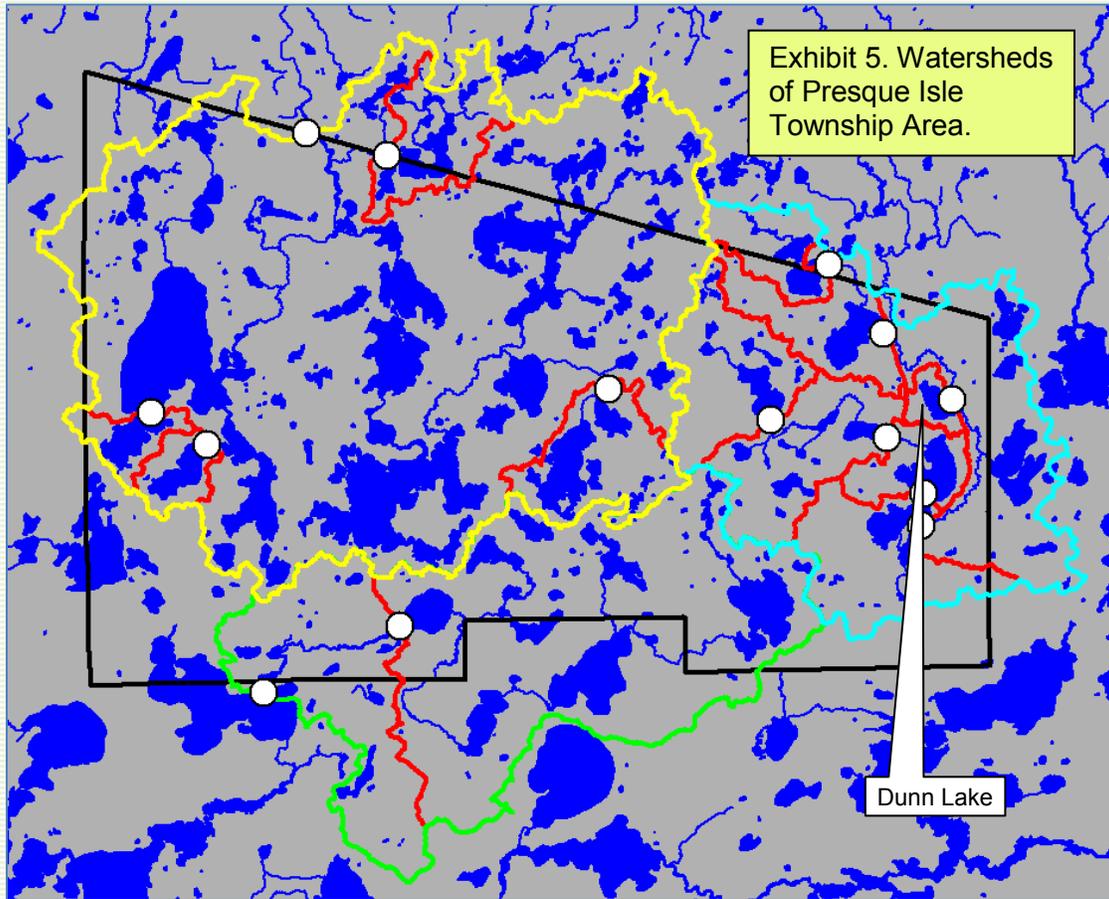
Description: Portions of 3 federal hydrologic sub-watersheds are illustrated: (1) S.Br. Presque Isle River (bounded by yellow), (2) Pomeroy Cr-E.Br. Presque Isle River (bounded by blue and yellow), and (3) Rice Cr. (bounded by green, yellow, and blue). Also shown are the smaller watersheds of individual water bodies subject to the Wilderness Waters studies (bounded by red). White dots show outlet points for the smaller watersheds.

The Presque Isle Township waterscape sits on a large-scale watershed divide. Some of the water drains north through the Presque Isle River system and eventually enters Lake Superior. Some of the water drains into the Wisconsin River system to the Mississippi River and to the Gulf of Mexico. In fact there are two federal hydrologic sub-basins (designated by 8-digit HUC codes) that include Presque Isle Township. The Black-Presque Isle Rivers sub-basin (HUC#04020101) drains north to Lake Superior and the Flambeau River sub-basin (HUC#0705002) drains southwesterly to the Mississippi River. The Black-Presque Isle Rivers sub-basin contains two federal hydrologic sub-watersheds within Presque Isle Township: the South Branch Presque Isle River sub-watershed (HUC#040201010303) and the Pomeroy Creek-East Branch Presque Isle River sub-watershed (HUC#040201010301). The Flambeau River sub-basin contains one sub-watershed within Presque Isle Township: the Rice Creek sub-watershed (HUC#07050020103). Exhibit 5 illustrates these watersheds and the watersheds of the water bodies subject to the Wilderness Waters Program studies. Dunn Lake is contained within the Pomeroy Creek-East Branch Presque Isle River sub-watershed (Exhibit 5).

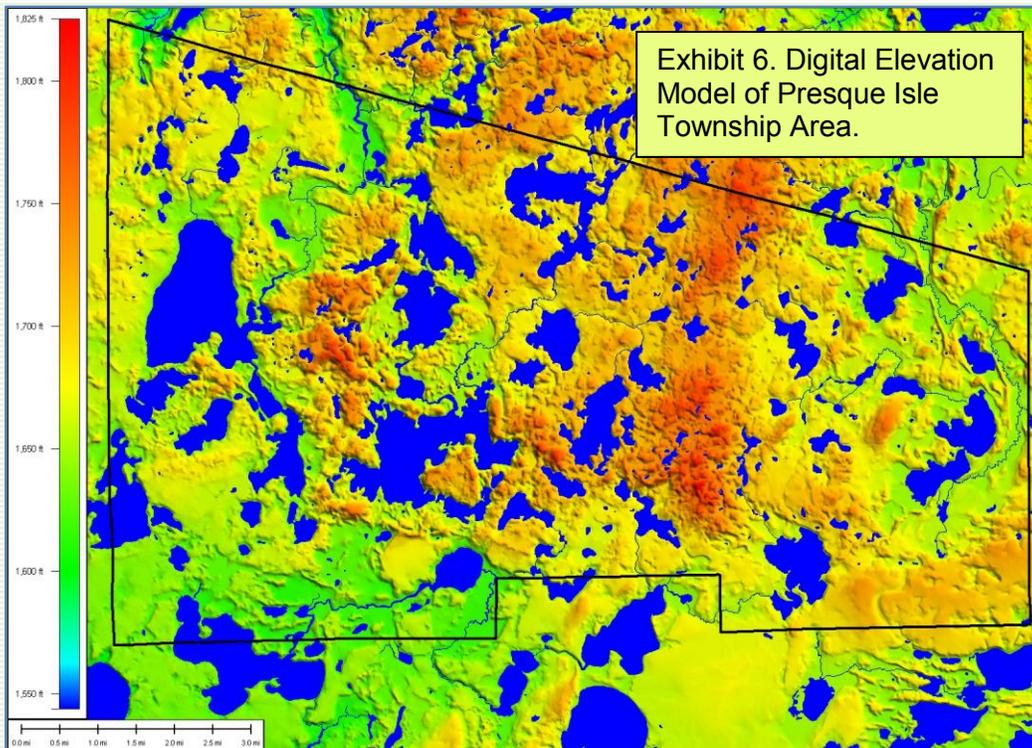
The elevation in Presque Isle Township ranges from around 1,550 feet above sea level to 1,750 feet above sea level. A digital elevation model is provided as Exhibit 6 and shows the relative elevations for the area with orange areas of the landscape being the highest elevations and greens and blues being the lowest elevations.

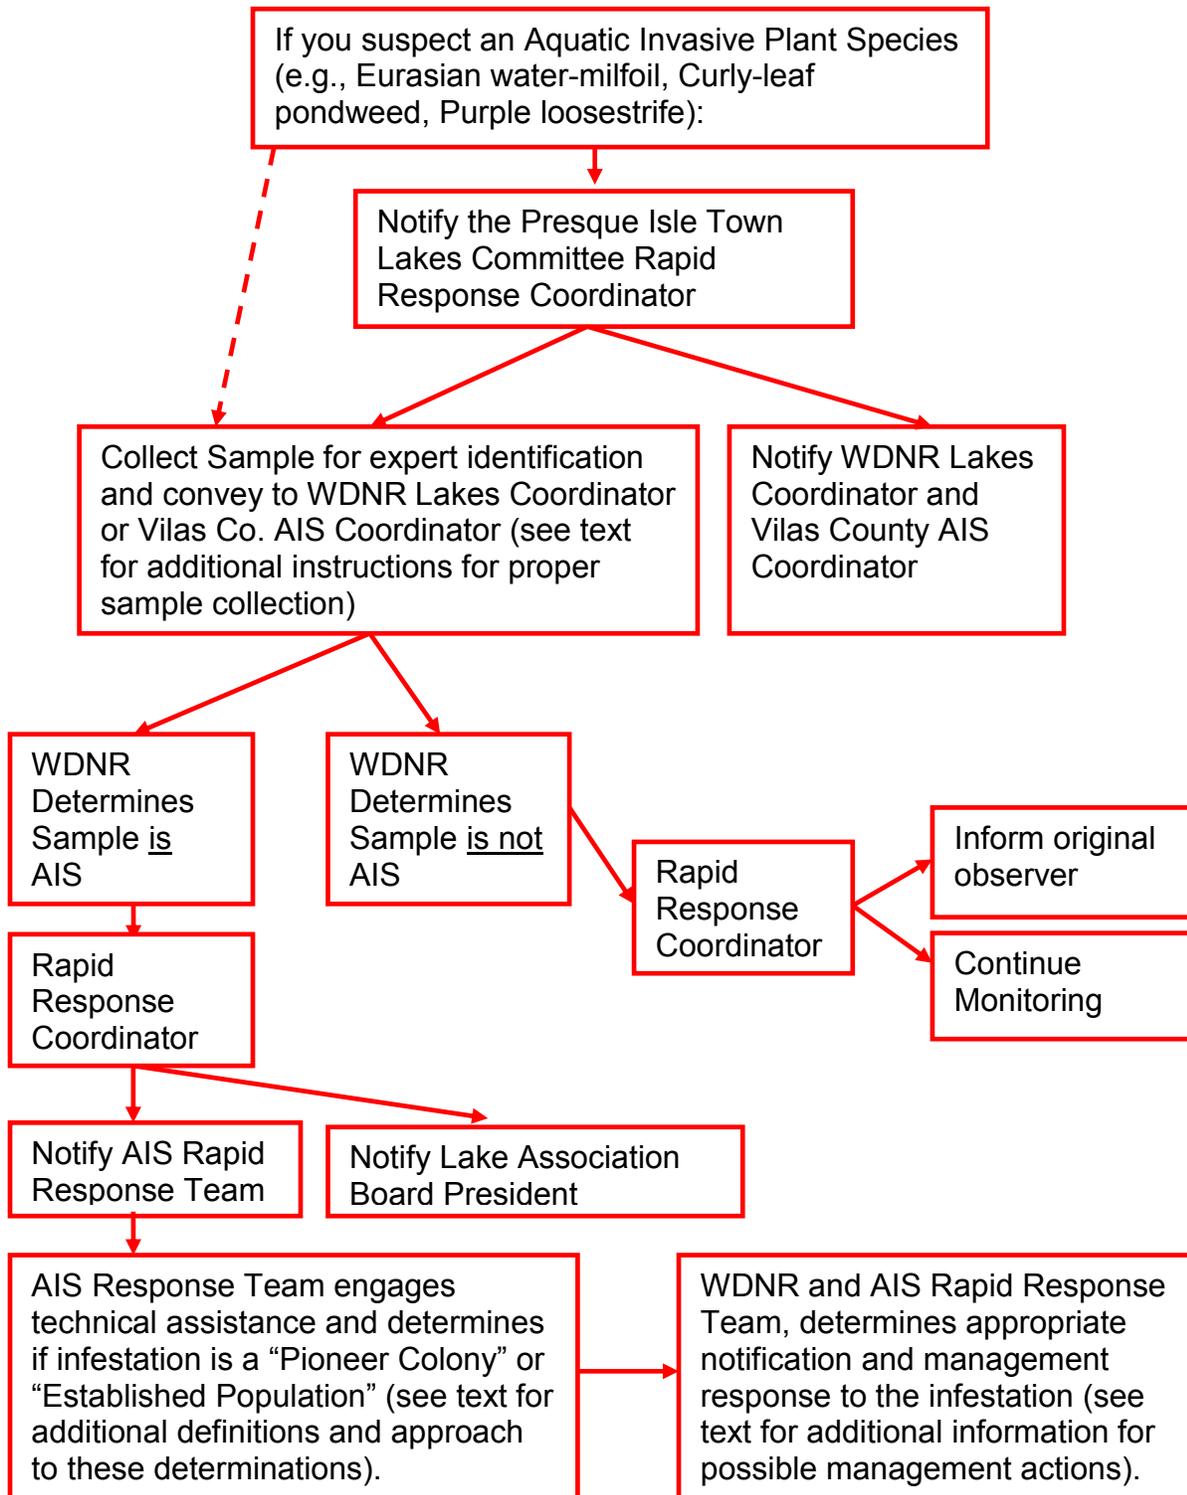
**Exhibit 9. Aquatic Invasive Plant Species Rapid Response**

When a suspect aquatic invasive plant species is found, either the original observer or a member of the Rapid Response Team (likely the coordinator) should collect an entire plant

specimen including roots, stems, and flowers (if present). The sample should be placed in a sealable bag with a small amount of water to keep it moist. Place a label in the bag written in pencil with date, time, collector's name, lake name, location, town, and county. Attach a lake map to the bag that has the location of the suspect AIS marked and GPS coordinates recorded (if GPS is available). The sample should be placed on ice in a cooler or in a refrigerator. Deliver the sample to the WDNR Water Resource Management Specialist (Kevin Gauthier in Woodruff) or the Vilas County AIS Coordinator (Alan Wirt) as soon as possible (at least within three days). The WDNR or their botanical expert(s) will determine the species and confirm whether or not it is an aquatic invasive plant species.

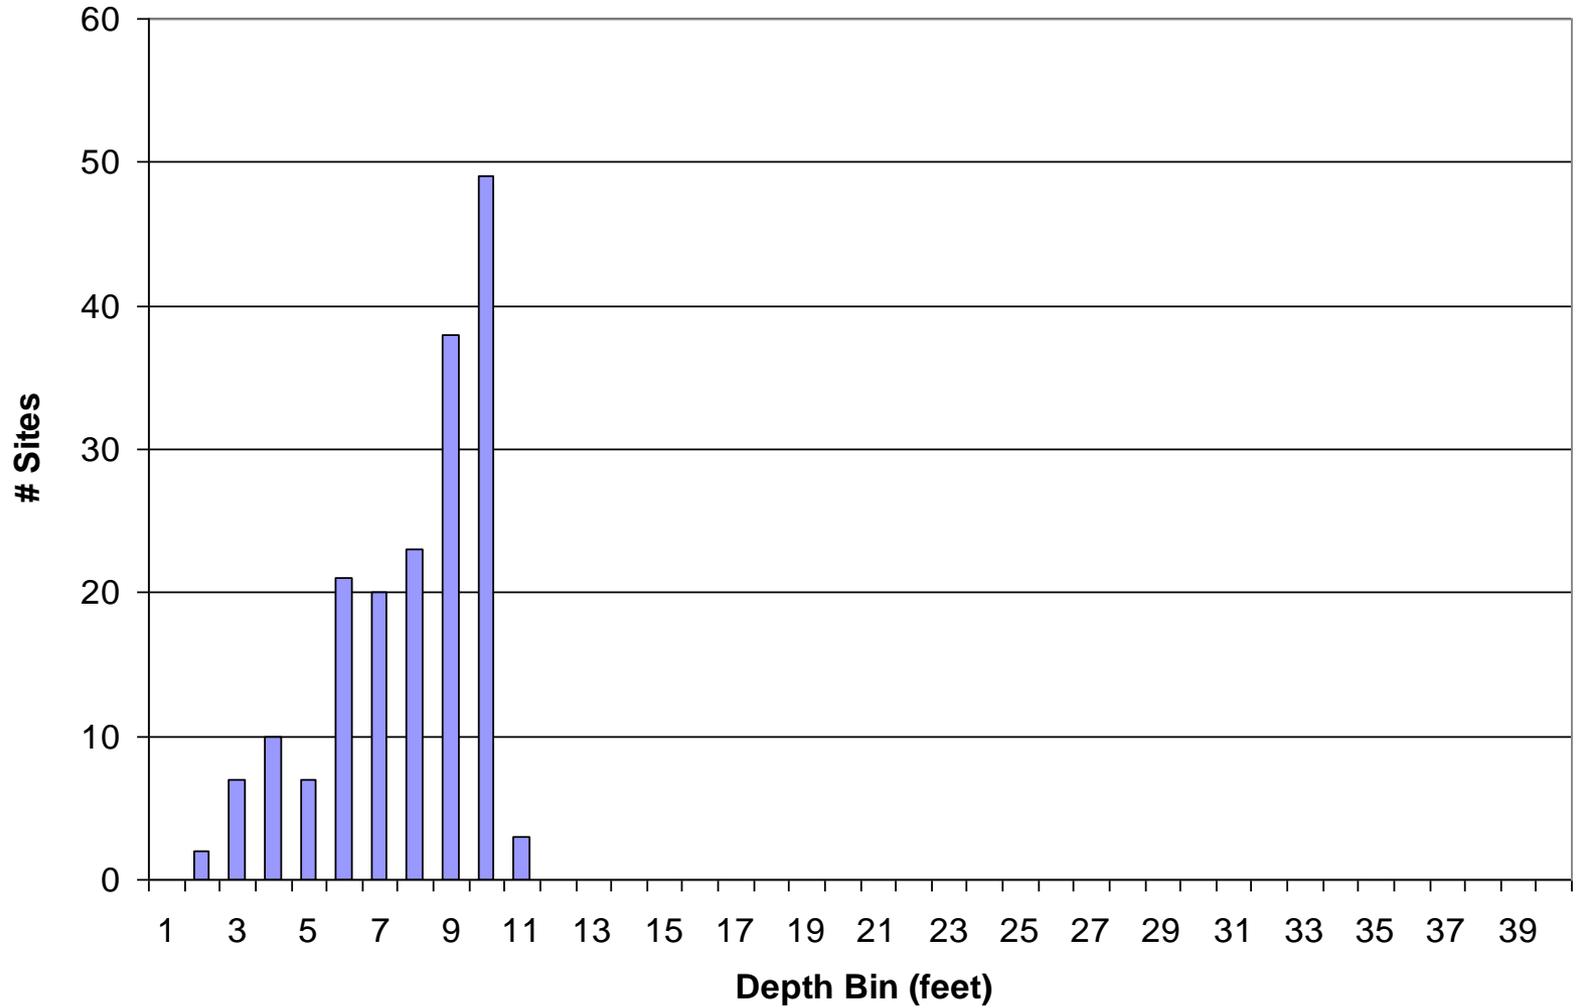
**Figure 3. Maximum Depth of Plant Colonization, Dunn Lake, 2018.**

The maximum depth of plant colonization is 10.5 feet in 2018 (Table 1 and Figure 3) and was very similar to the 2011 value (Table 3). Rooted vegetation was found at 180 of the 200 sample sites with depth  $\leq$  the maximum depth of plant colonization (90.0% of sites). These sites are displayed as a black dot within a circle on Figure 4. This indicates that although availability of appropriate depth may limit the distribution of plants, it is not the only habitat factor involved. Substrate is another feature that influences plant distribution (e.g., soft substrate often harbors more plants than hard substrate). Figures 5 presents the substrates encountered during the aquatic plant survey (mud, sand, or rock).

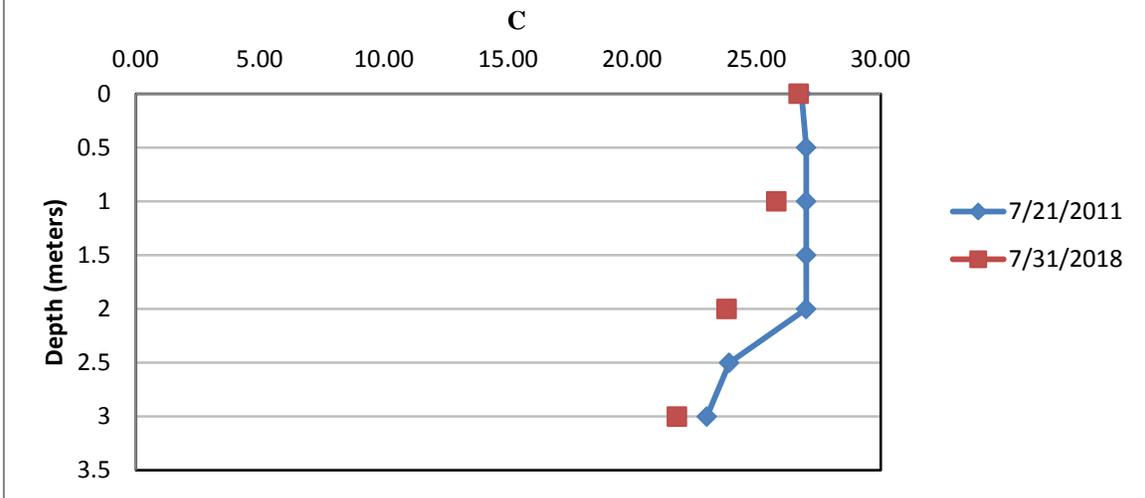
**Figure 2. Dunn Lake temperature profiles.**

Measuring the temperature of a lake at different depths will determine the influence it has on the physical, biological, and chemical aspects of the lake. Lake water temperature influences the rate of decomposition, nutrient recycling, lake stratification, and dissolved oxygen (D.O.) concentration. Temperature can also affect the distribution of fish species throughout a lake. Figure 2 presents water temperature profiles for July of 2011 and 2018. These samples show very some stratification between 5 and 7 feet. Values are typical.

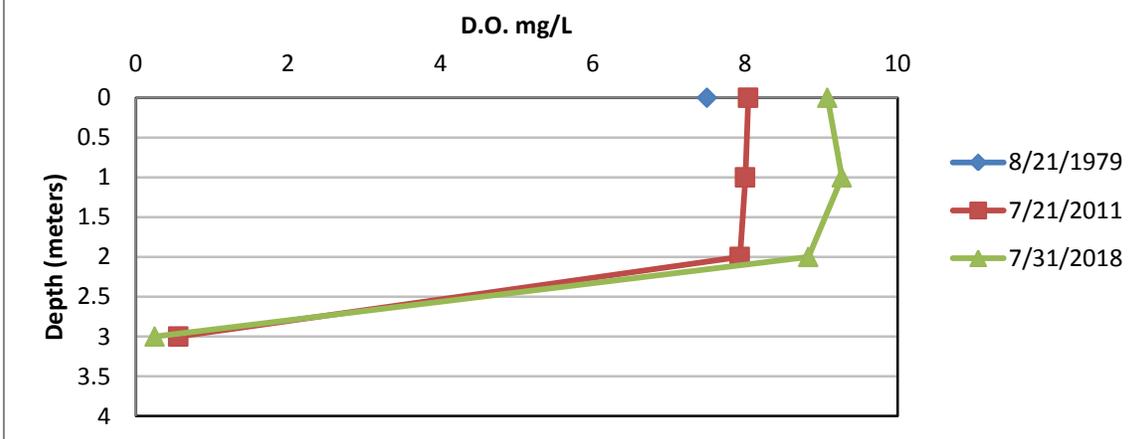
**Figure 3. Dunn Lake dissolved oxygen profiles.**

The dissolved oxygen (D.O.) content of lake water is vital in determining presence of fish species and other aquatic organisms. Dissolved oxygen also has a strong influence on the chemical and physical conditions of a lake. The amount of dissolved oxygen is dependent on the water temperature, atmospheric pressure, and biological activity. Oxygen levels are increased by aquatic plant photosynthesis, but reduced by respiration of plants, decomposer organisms, fish, and invertebrates. The amount of D.O. available in a lake, particularly in the deeper parts of a lake, is critical to overall health. Dunn Lake D.O. profiles are displayed in Figure 3. D.O. levels were between 7.5 and 9.08 mg/L in July and August at the surface. D.O. drops below 4 mg/L at 2.5 meters in Dunn Lake for the year's analyzed. Values are typical.

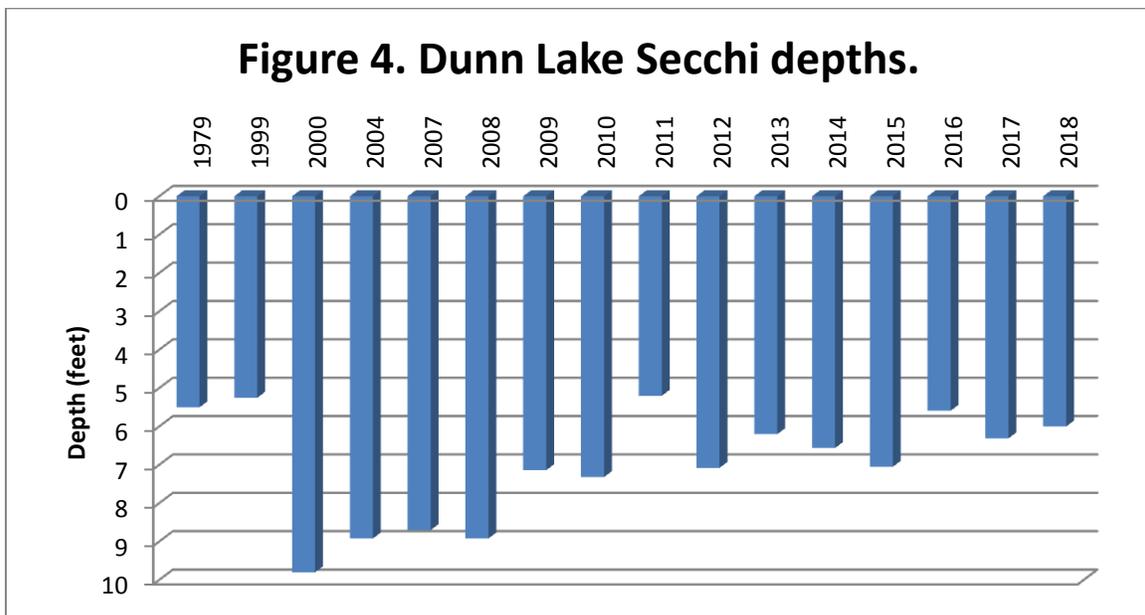
Landsat satellite is used to determine Secchi measurements and the majority of the readings were recorded from the satellite imagery. Figure 4 displays the Secchi depths from 1979, 1999, 2000, 2004, 2007-2018. Dunn Lake’s most recent Secchi depth categorizes it as “fair” with respect to water clarity (Table 1). The shallowest mean Secchi depth was 5.2 feet in 1999, and the deepest mean reading was at 9.8 feet in 2000.

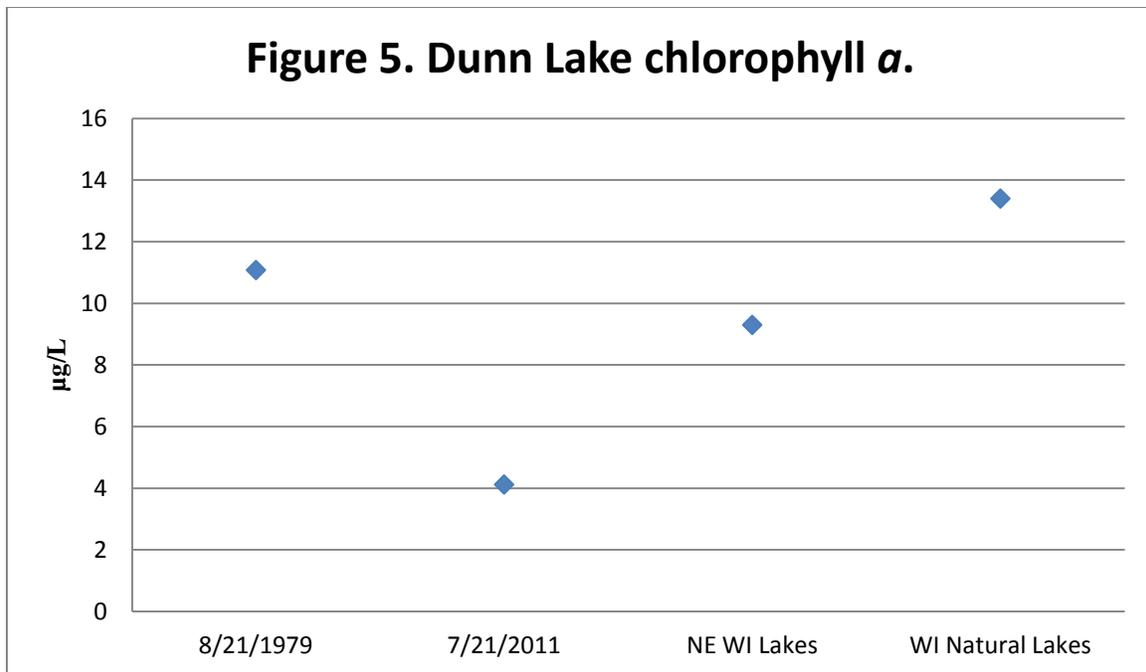
Chlorophyll *a* is the photosynthetic pigment that makes plants and algae green. Chlorophyll *a* in lake water is an indicator of the amount of algae. Chlorophyll *a* concentrations greater than 10 µg/L are perceived as a mild algae bloom, while concentrations greater than 20 µg/L are perceived as a nuisance. Measured chlorophyll *a* values in Dunn Lake have been below nuisance levels and below the average levels for Wisconsin natural lakes (Figure 5). No 2018 value for chlorophyll *a* was obtained.

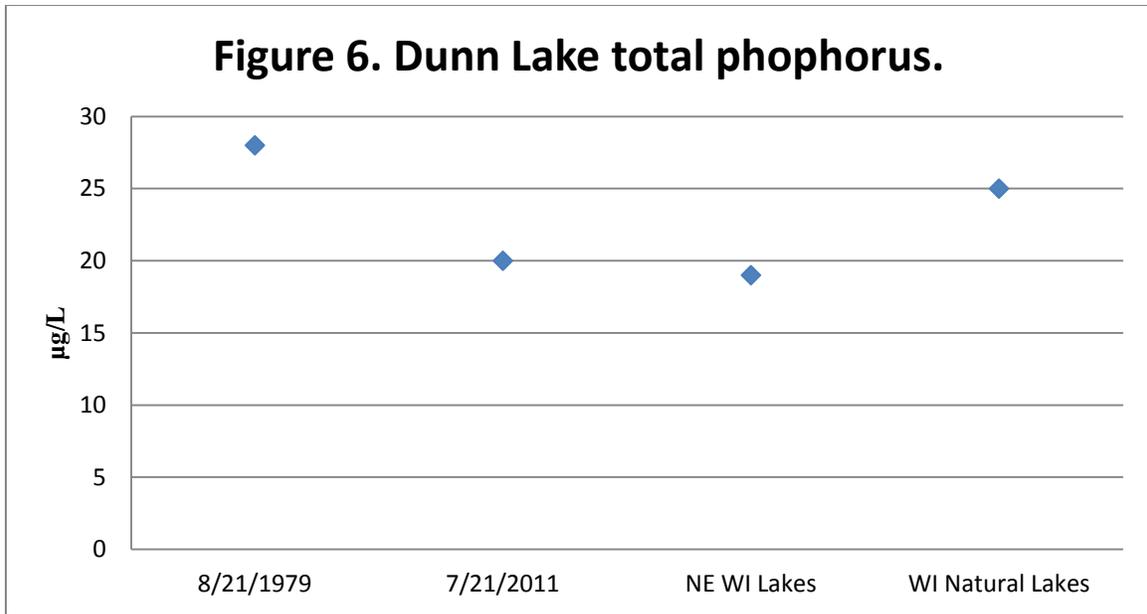
Dunn Lake total phosphorus values are shown in Figure 6 and are considered “good,” (Figure 7) and are comparable to the region and state values. No 2018 value for total phosphorus was obtained.

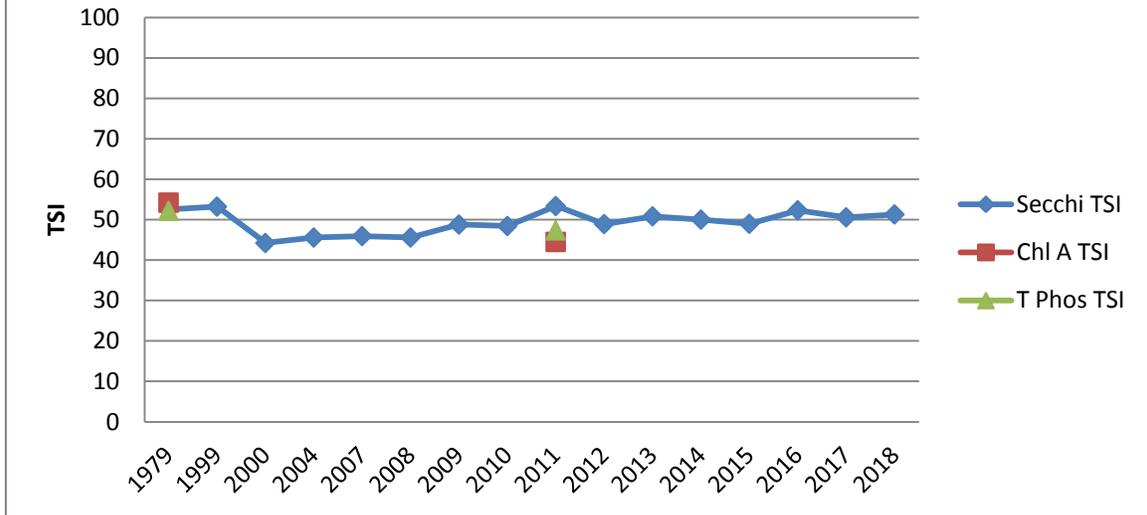
**Figure 8. Dunn Lake trophic state index.**

Trophic State Index (TSI) was calculated by the using only Secchi measurements, chlorophyll *a*, and total phosphorus collected in the field. Figure 8, classifying Dunn Lake as “mesotrophic to medley eutrophic” (Table 2).

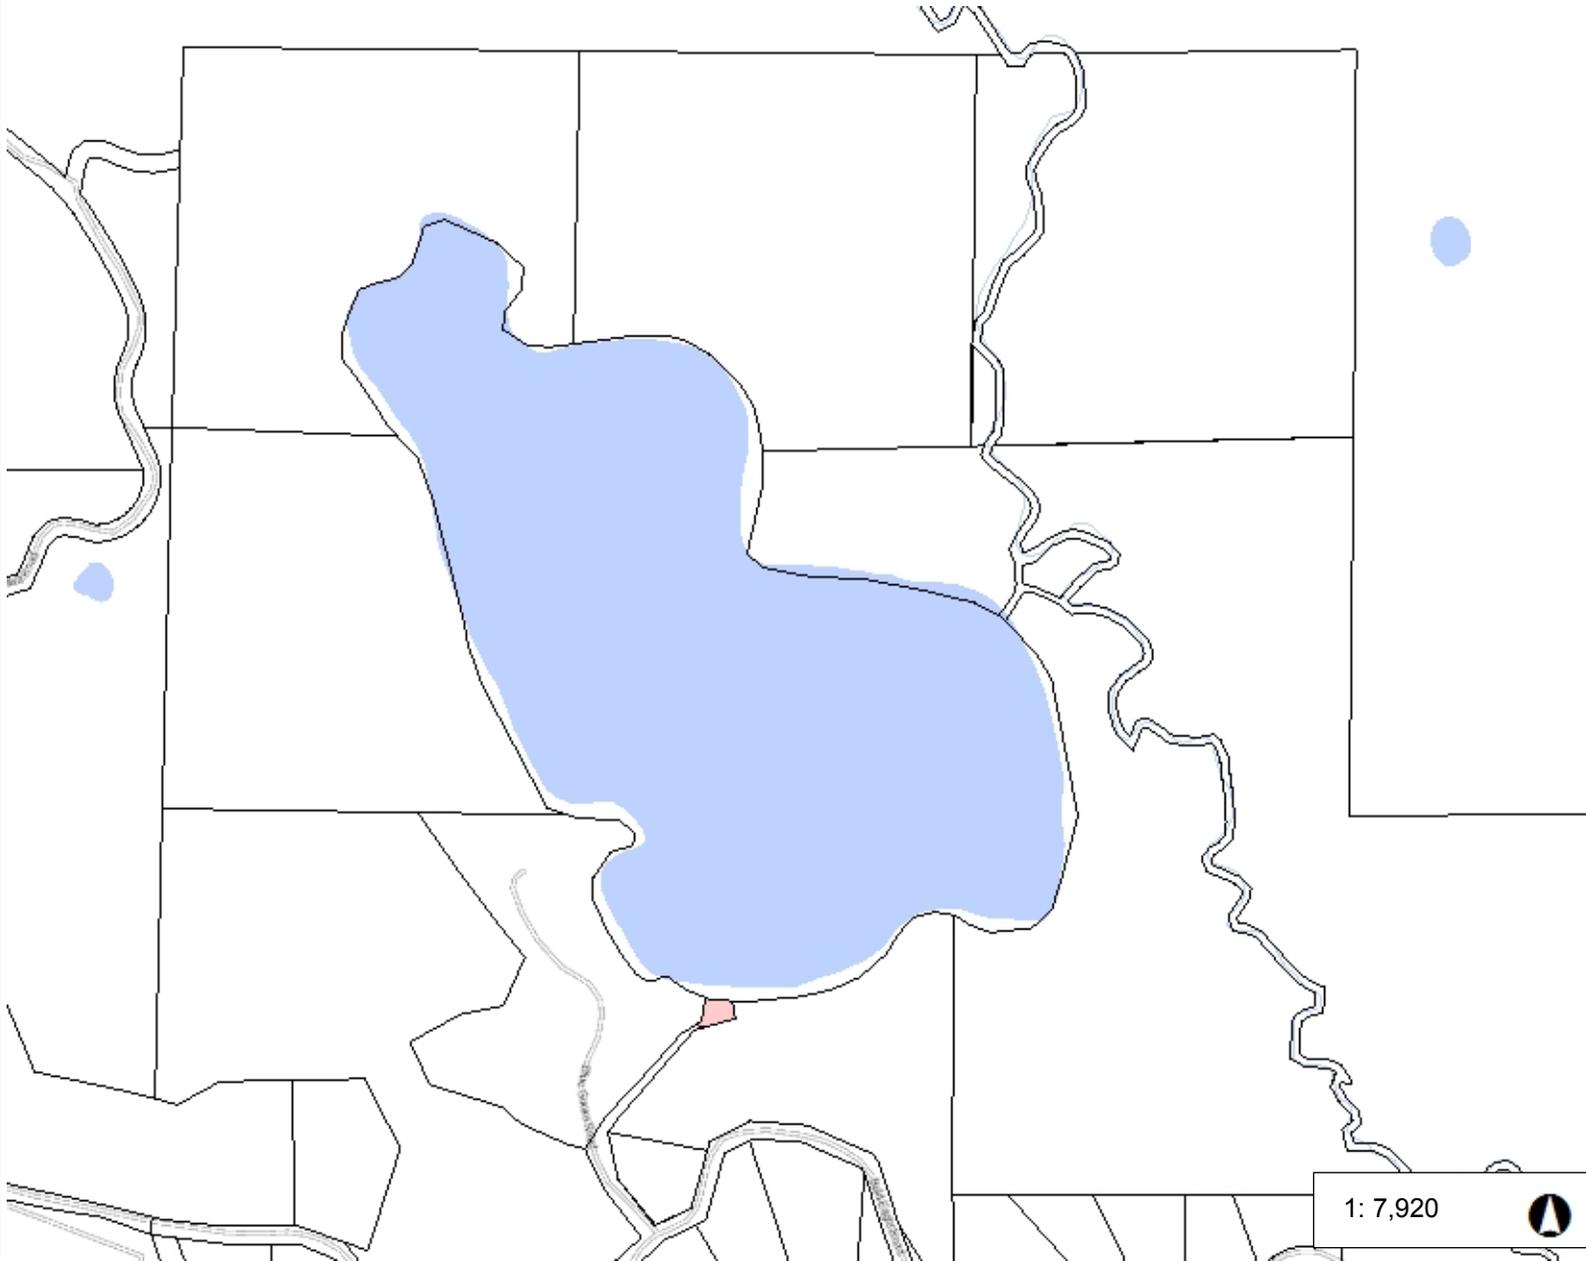
# Exhibit 9. Dunn Lake Bank Erosion and Modifications - 2018

- Bank Erosion >1ft
- Bank Erosion <1ft
- Vertical Sea Wall**
  - 1 - 50 ft
  - 51 - 100 ft
  - 101 - 200 ft
  - 200 + ft
- Rip Rap**
  - 1 - 50 ft
  - 51 - 100 ft
  - 101 - 200 ft
  - 200+ ft
- Other Bank Modifications**
  - 10 - 50 ft
  - 51 - 100 ft
  - 101 - 200 ft
  - 200+ ft
- Artificial Beach**
  - 0 - 50 ft
  - 51 - 100 ft
  - 101 - 200 ft
  - 200+ ft
- Shoreland Parcels
- County Boundary
- Municipality
- State Boundaries
