# Presque Isle Wilderness Waters Program

## Aquatic Plant Management Plan – Beaver Lake

**Cite as:** Premo, Dean, Angie Stine, and Kent Premo. 2020. Presque Isle Wilderness Waters Program: Beaver Lake Aquatic Plant Management Plan. White Water Associates, Inc.

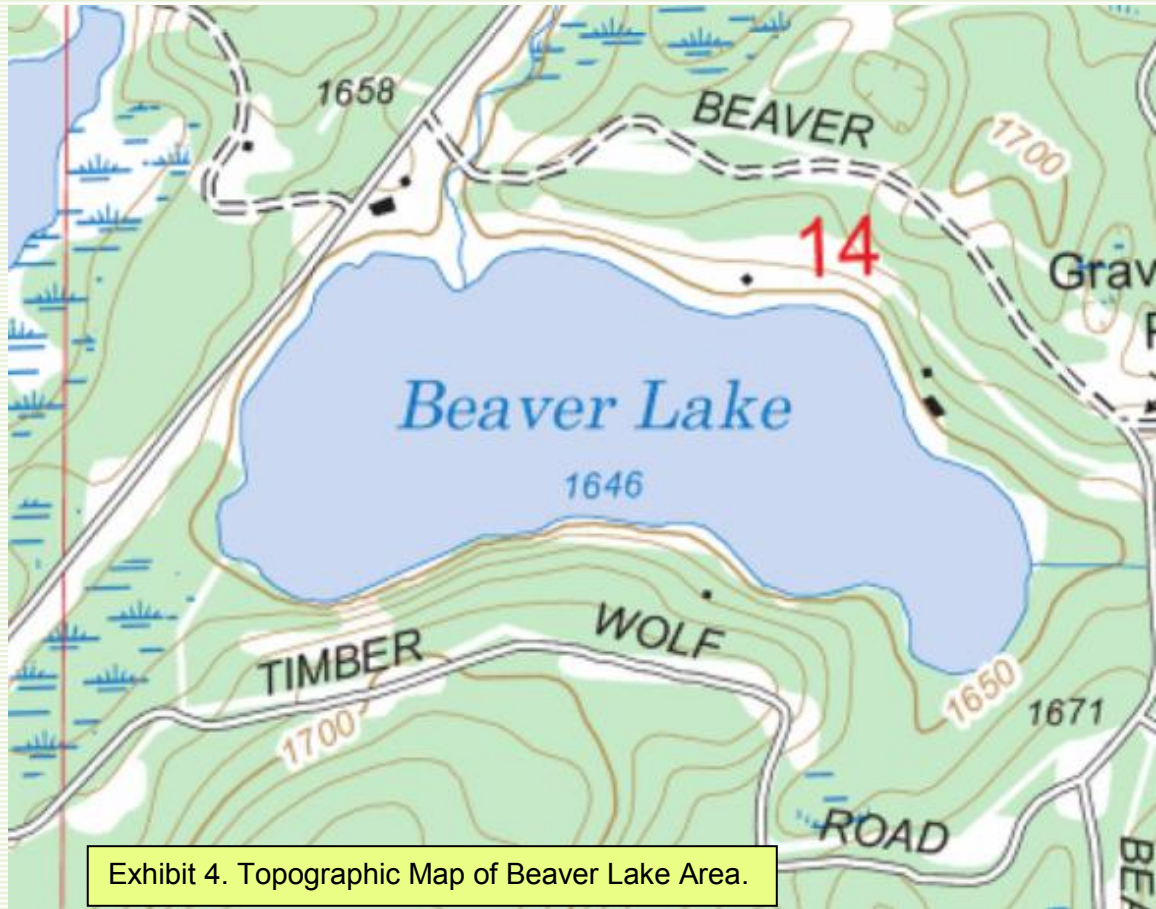
Exhibit 4. Topographic Map of Beaver Lake Area.

Beaver Lake has no public access site. We observe a total of 24 piers on the shoreline of Beaver Lake from 2019 aerial photography or about 14.7 piers per mile of shoreline. The riparian area consists of both upland and wetland areas (Exhibit 4).

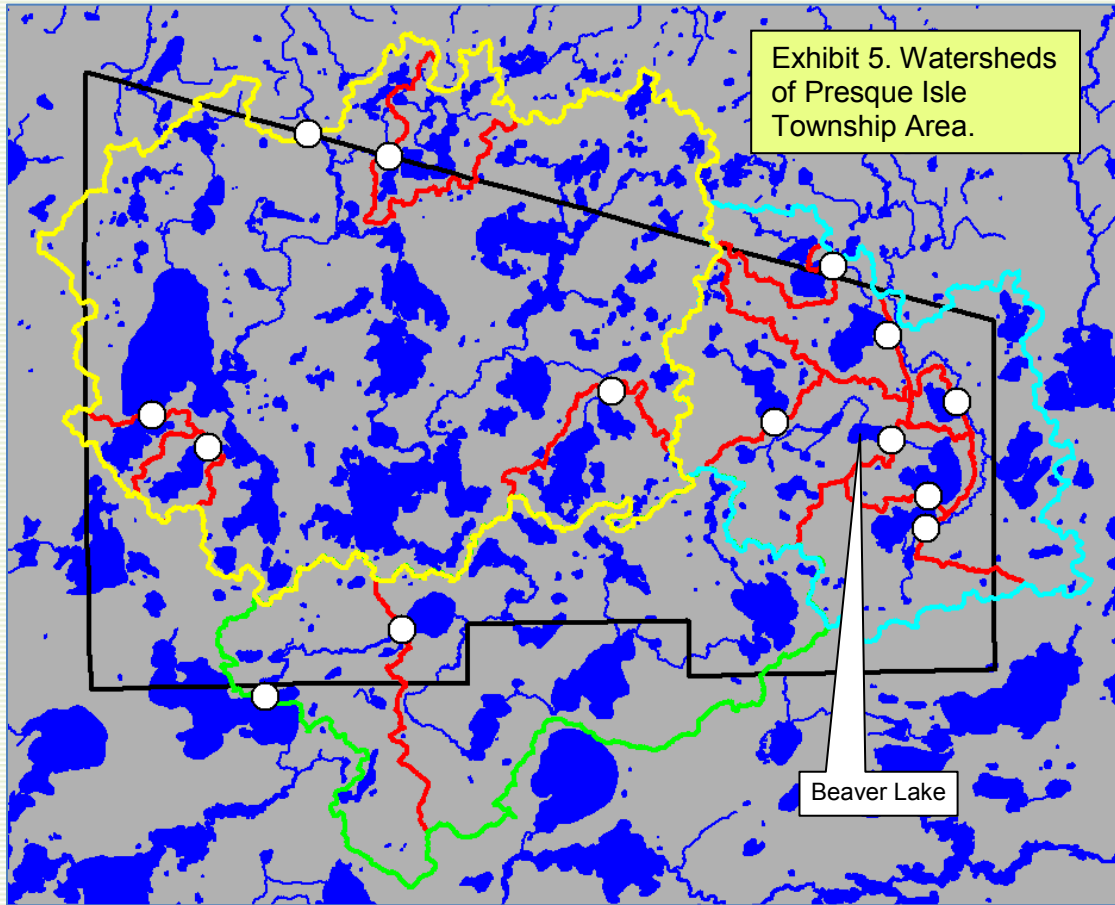
Description: Portions of 3 federal hydrologic sub-watersheds are illustrated: (1) S.Br. Presque Isle River (bounded by yellow), (2) Pomeroy Cr-E.Br. Presque Isle River (bounded by blue and yellow), and (3) Rice Cr. (bounded by green, yellow, and blue). Also shown are the smaller watersheds of individual water bodies subject to the Wilderness Waters studies (bounded by red). White dots show outlet points for the smaller watersheds.

The Presque Isle Township waterscape sits on a large-scale watershed divide. Some of the water drains north through the Presque Isle River system and eventually enters Lake Superior. Some of the water drains into the Wisconsin River system to the Mississippi River and to the Gulf of Mexico. In fact there are two federal hydrologic sub-basins (designated by 8-digit HUC codes) that include Presque Isle Township. The Black-Presque Isle Rivers sub-basin (HUC#04020101) drains north to Lake Superior and the Flambeau River sub-basin (HUC#0705002) drains southwesterly to the Mississippi River. The Black-Presque Isle Rivers sub-basin contains two federal hydrologic sub-watersheds within Presque Isle Township: the South Branch Presque Isle River sub-watershed (HUC#040201010303) and the Pomeroy Creek-East Branch Presque Isle River sub-watershed (HUC#040201010301). The Flambeau River sub-basin contains one sub-watershed within Presque Isle Township: the Rice Creek sub-watershed (HUC#07050020103). Exhibit 5 illustrates these watersheds and the watersheds of the water bodies subject to the Wilderness Waters Program studies. Beaver Lake is contained within the Pomeroy Creek-East Branch Presque Isle River sub-watershed (Exhibit 5).

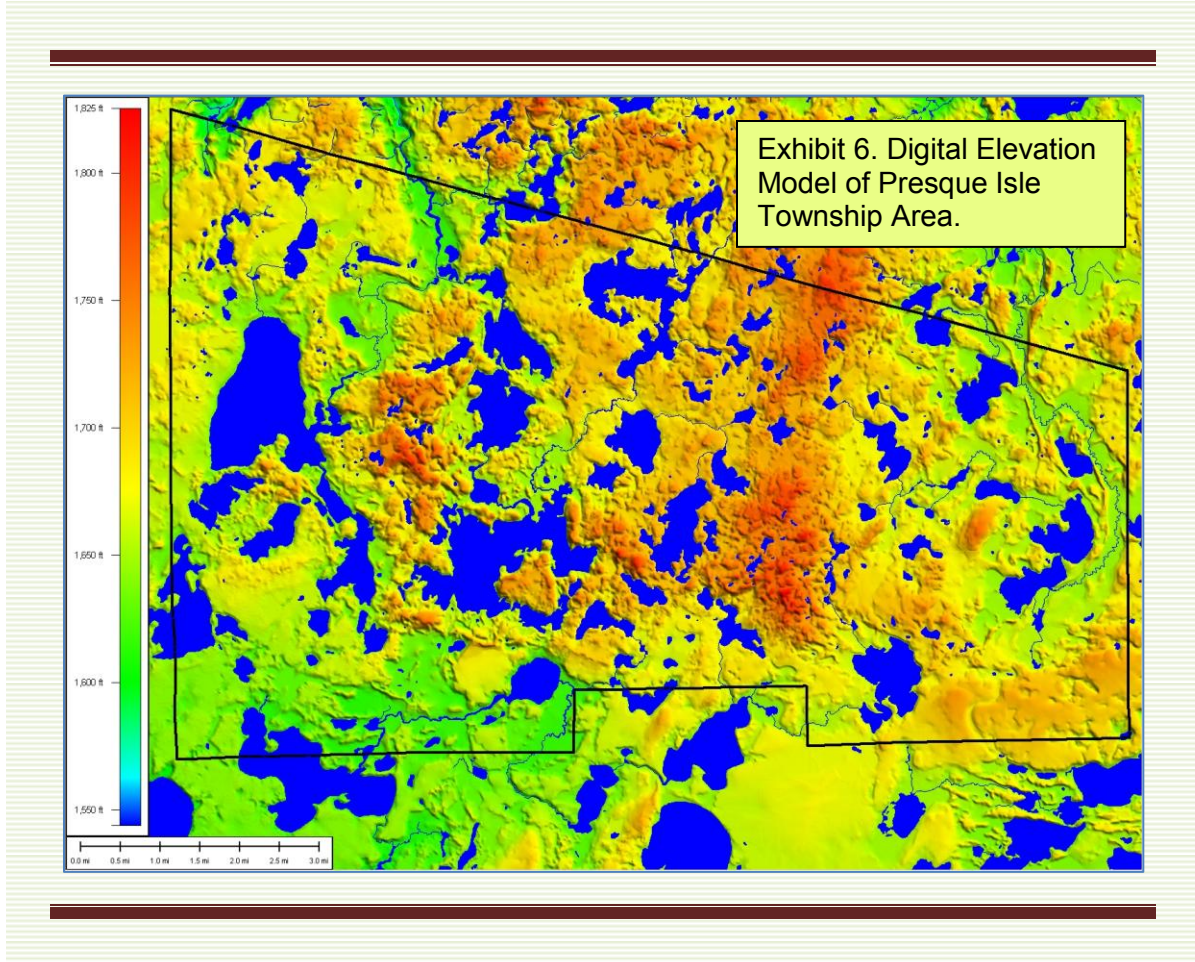
The elevation in Presque Isle Township ranges from around 1,550 feet above sea level to 1,750 feet above sea level. A digital elevation model is provided as Exhibit 6 and shows the relative elevations for the area with orange areas of the landscape being the highest elevations and greens and blues being the lowest elevations.

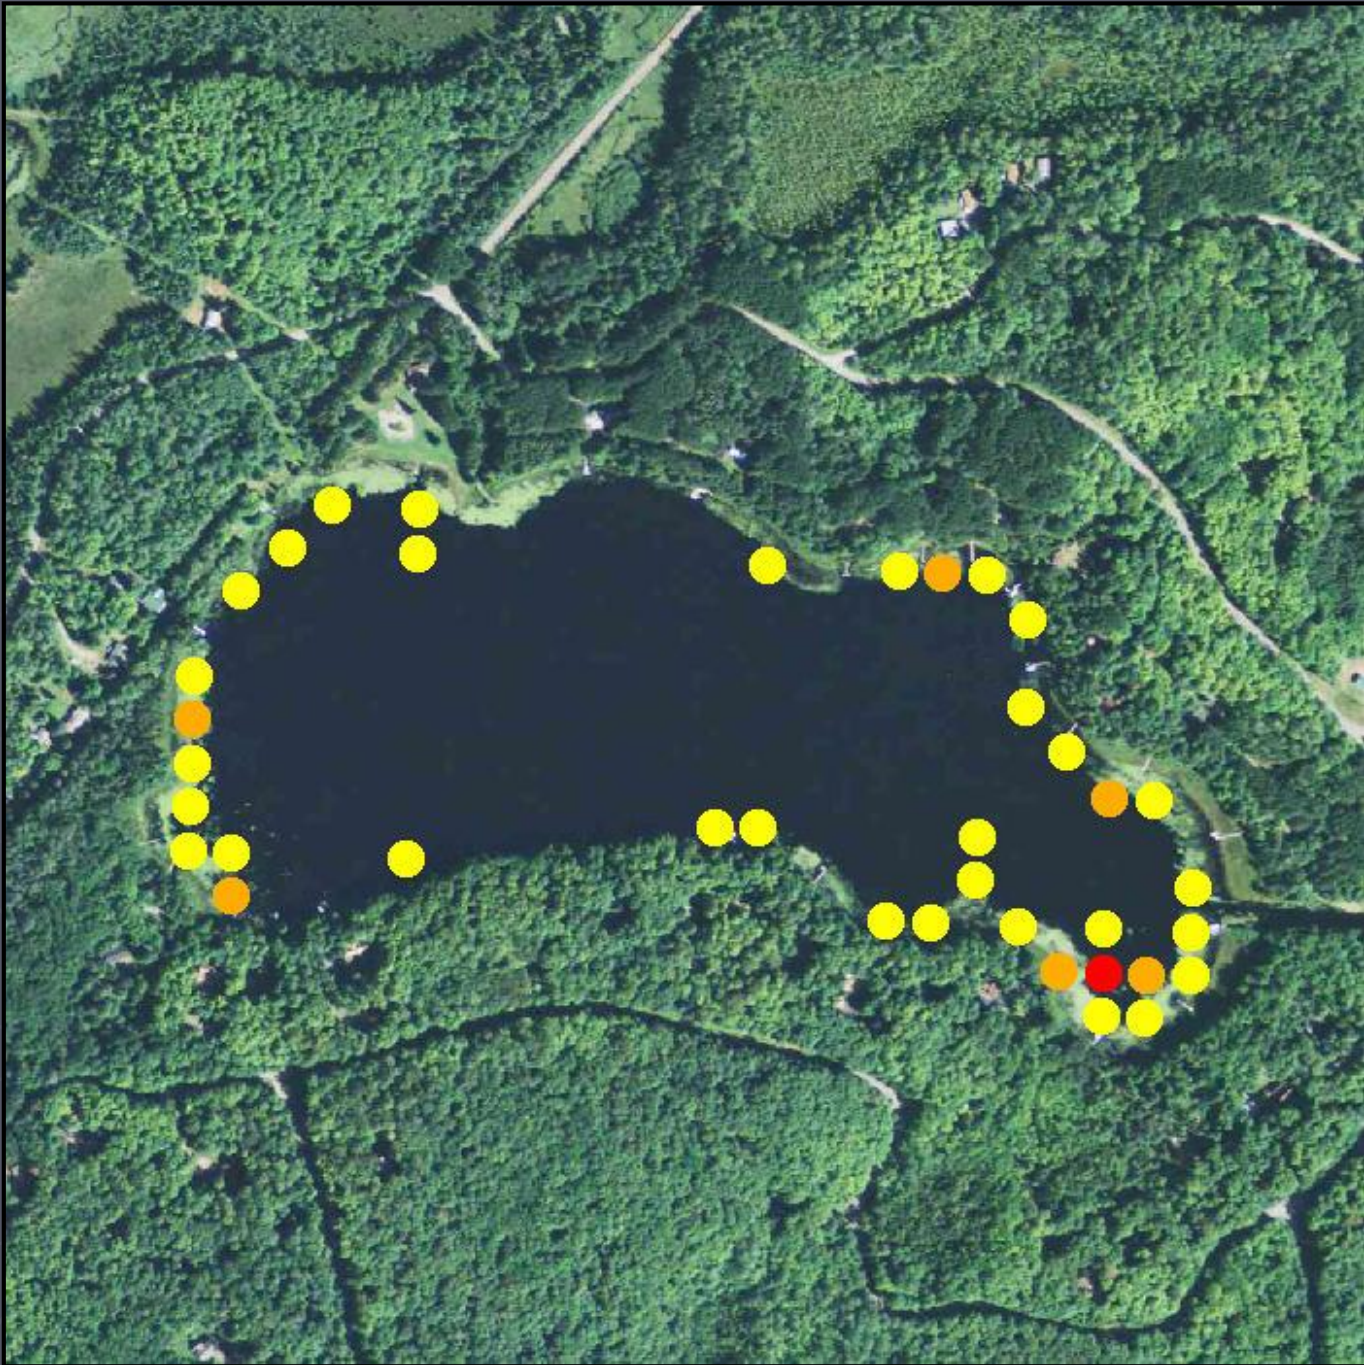
vegetation present. The average number of species encountered at these vegetated sites was 2.58. The actual number of species encountered at each of the vegetated sites is graphically displayed on Figure 1. Plant density is estimated by a “rake fullness” metric (3 being the highest possible density). These densities (considering all species) are displayed for each sampling site on Figure 2.

**Rake fullness  
(all species)**

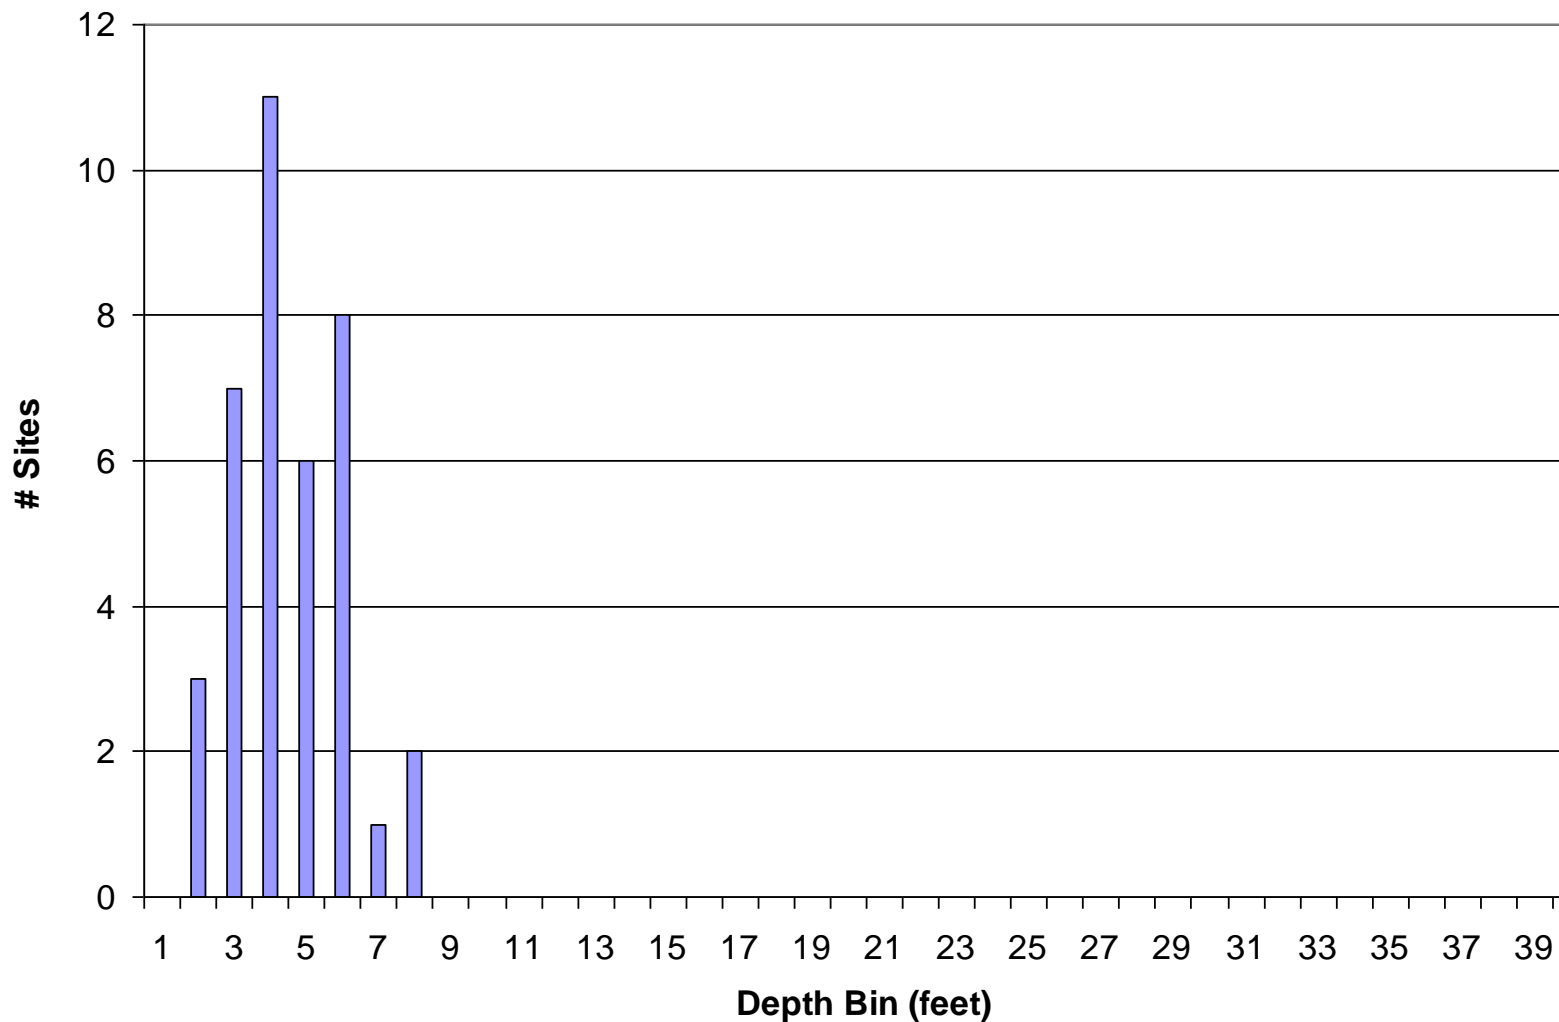
**Figure 3. Maximum Depth of Plant Colonization, Beaver Lake, 2018.**

The maximum depth of plant colonization is 8 feet (Table 1 and Figure 3). Rooted vegetation was found at 38 of the 71 sample sites with depth  $\leq$  the maximum depth of plant colonization (53.5% of sites). These sites are displayed as a black dot within a circle on Figure 4. This indicates that although availability of appropriate depth may limit the distribution of plants, it is not the only habitat factor involved. Substrate is another feature that influences plant distribution (e.g., soft substrate often harbors more plants than hard substrate). Figure 5 presents the substrates encountered during the aquatic plant survey (mud, sand, or rock).

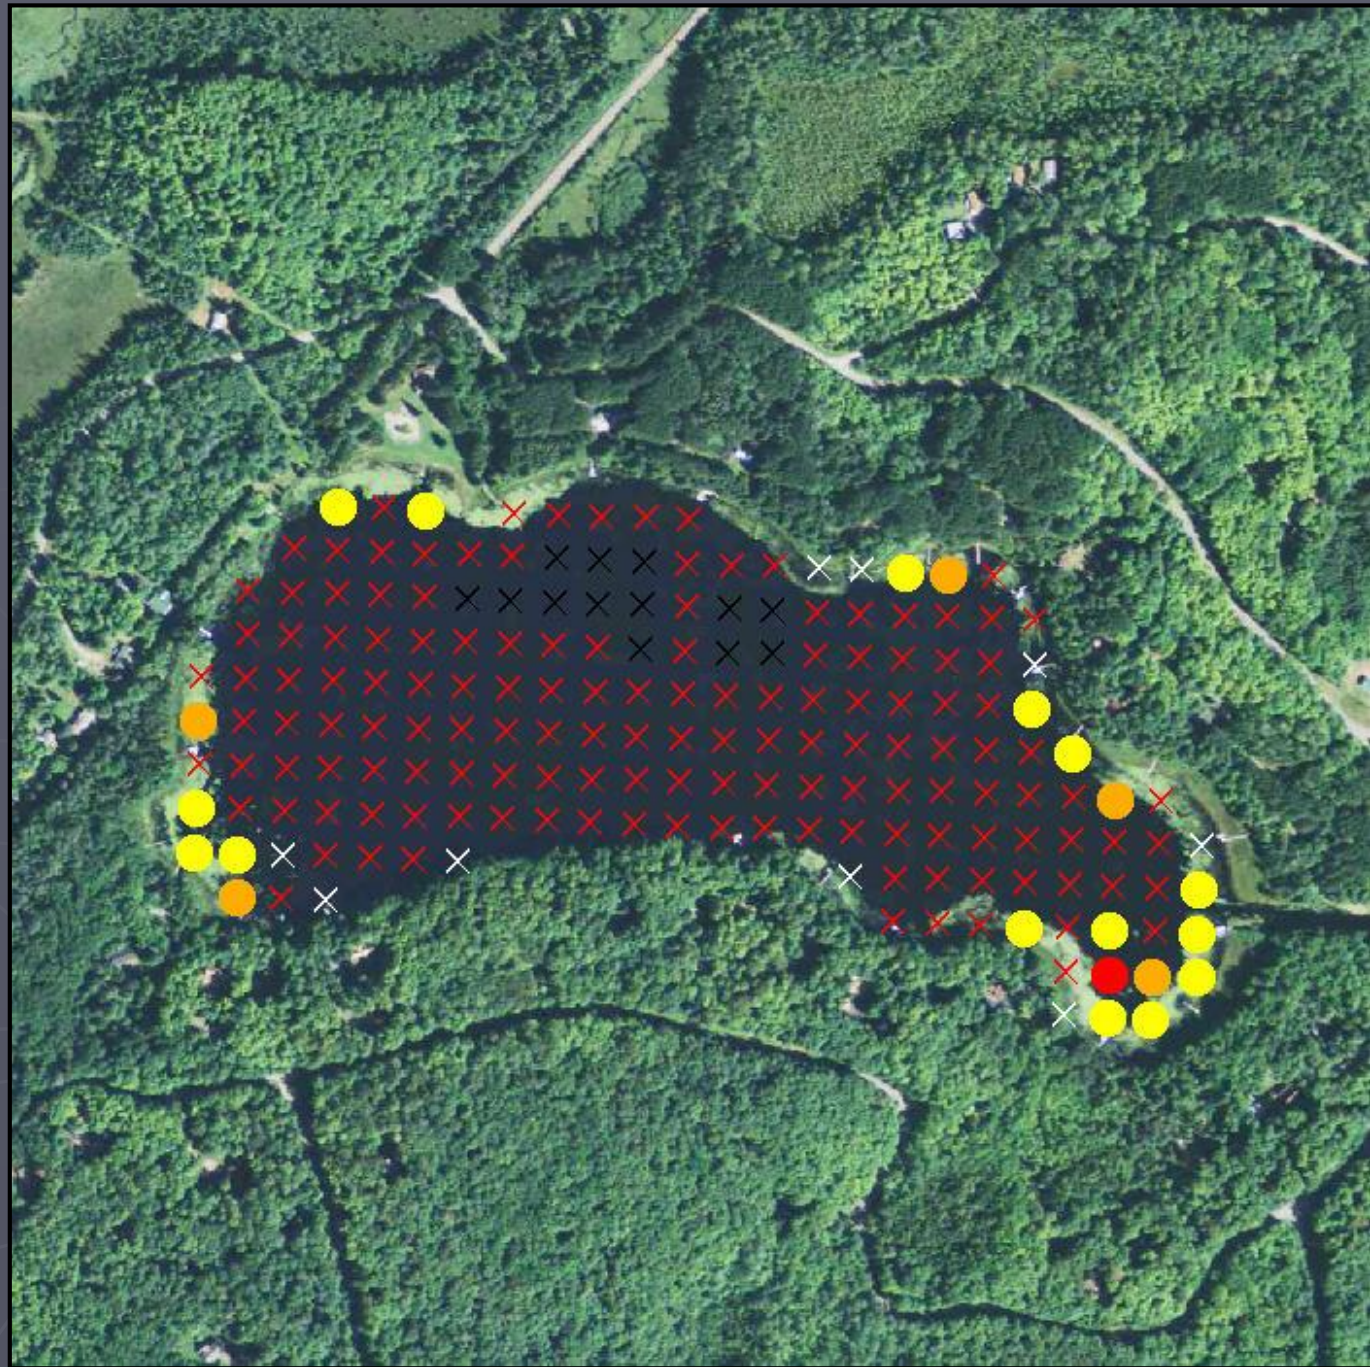
Figure 8. Distribution of plant species, Beaver Lake (2018).

*Potamogeton robbinsii*,  
Fern pondweed

- 1 (Rake fullness)
- 2
- 3
- ▼ Visual
- × Not found
- × Unsampled (depth)
- × Non-navigable

Table 2 provides information about the frequency of occurrence of the plant species recorded in the lake in 2018. Several metrics are provided, including total number of sites in which each species was found and frequency of occurrence at sites  $\leq$  the maximum depth of rooted vegetation. This frequency metric is standardized as a “relative frequency” (also shown in Table 2) by dividing the frequency of occurrence for a given species by the sum of frequency of occurrence for all plants and multiplying by 100 to form a percentage. The resulting relative frequencies for all species total 100%. The relative frequencies for the plant species collected with a rake in 2011 and 2018 are graphically displayed on Figure 6. This display shows that *Potamogeton robbinsii* (Fern pondweed) had the highest relative frequency in both years. *Elodea nuttallii* (Slender waterweed) had the second highest relative frequency in 2018, but was absent in the 2011 survey. *Nitella sp.* had the second highest relative frequency in 2011, but was considerably lower in 2018. These changes are natural fluctuations of the individual populations and no cause for concern. They simply indicate a dynamic plant community. Figure 7 displays sampling sites with emergent and floating aquatic plants. As examples of individual species distributions, we show the occurrences of a few of the most frequently and least frequently encountered plants in Figures 8-14.

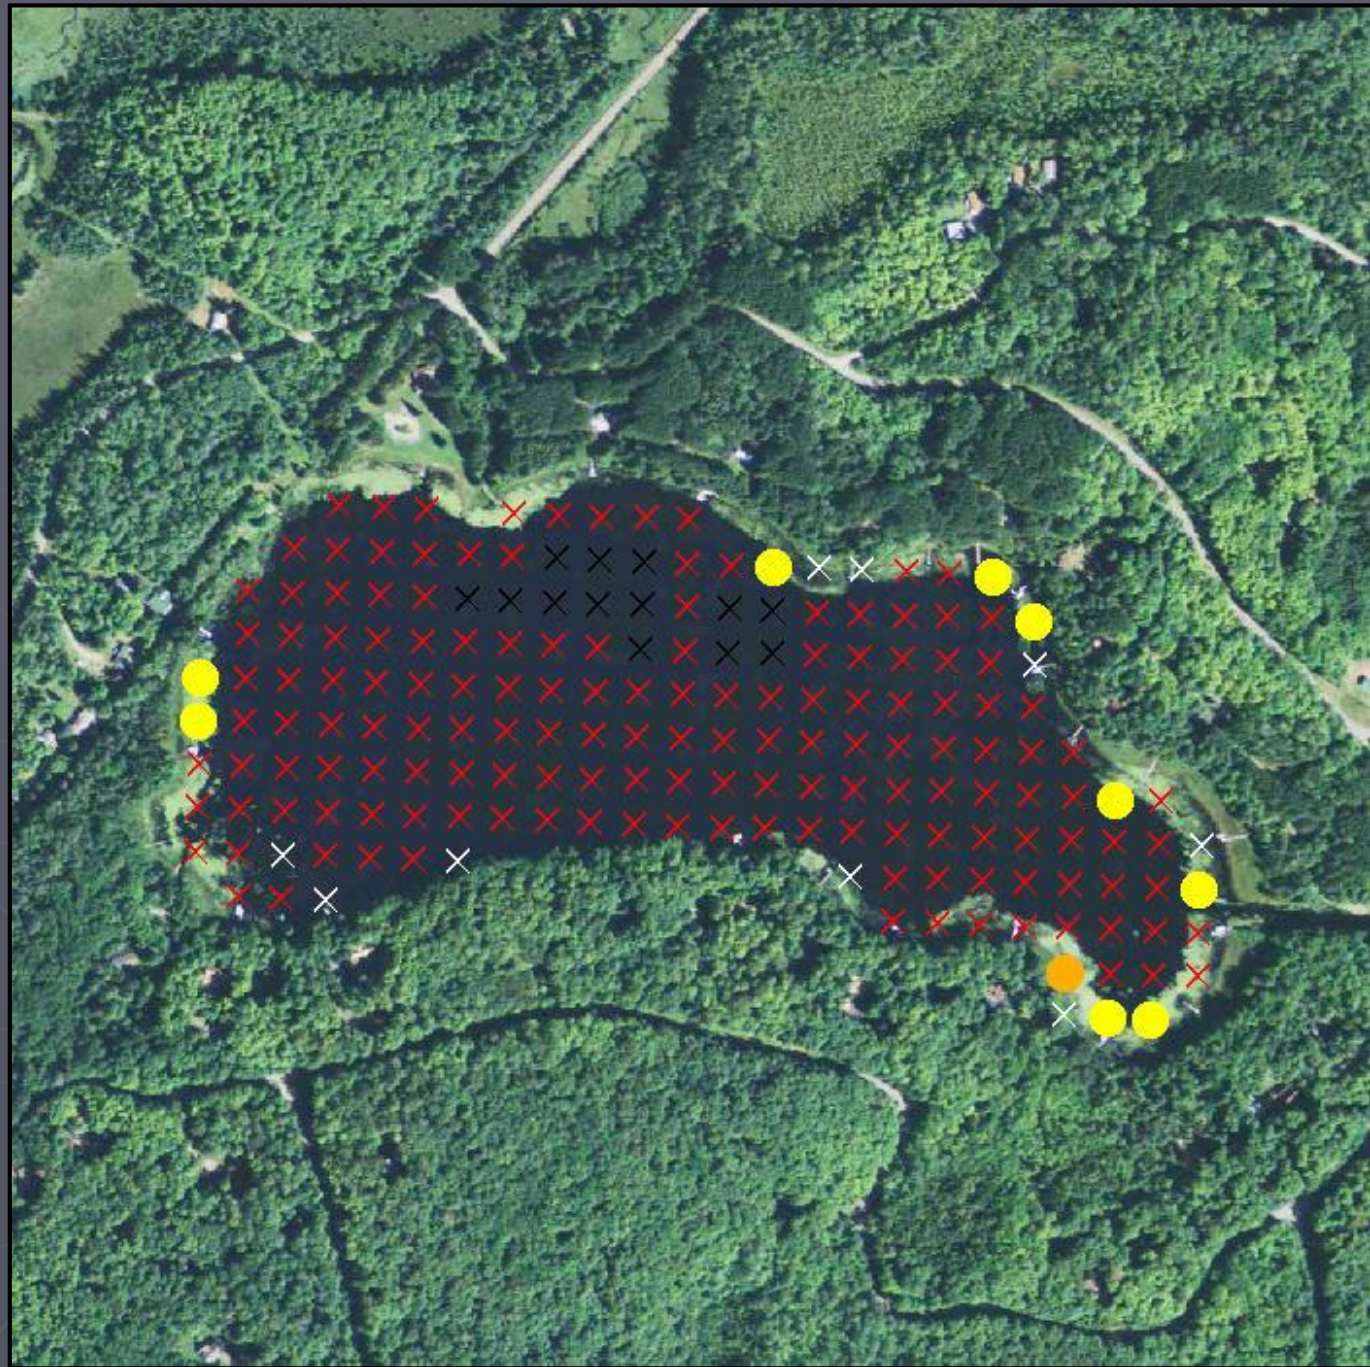
Figure 9. Distribution of plant species, Beaver Lake (2018).

*Elodea nuttallii*,  
Slender waterweed

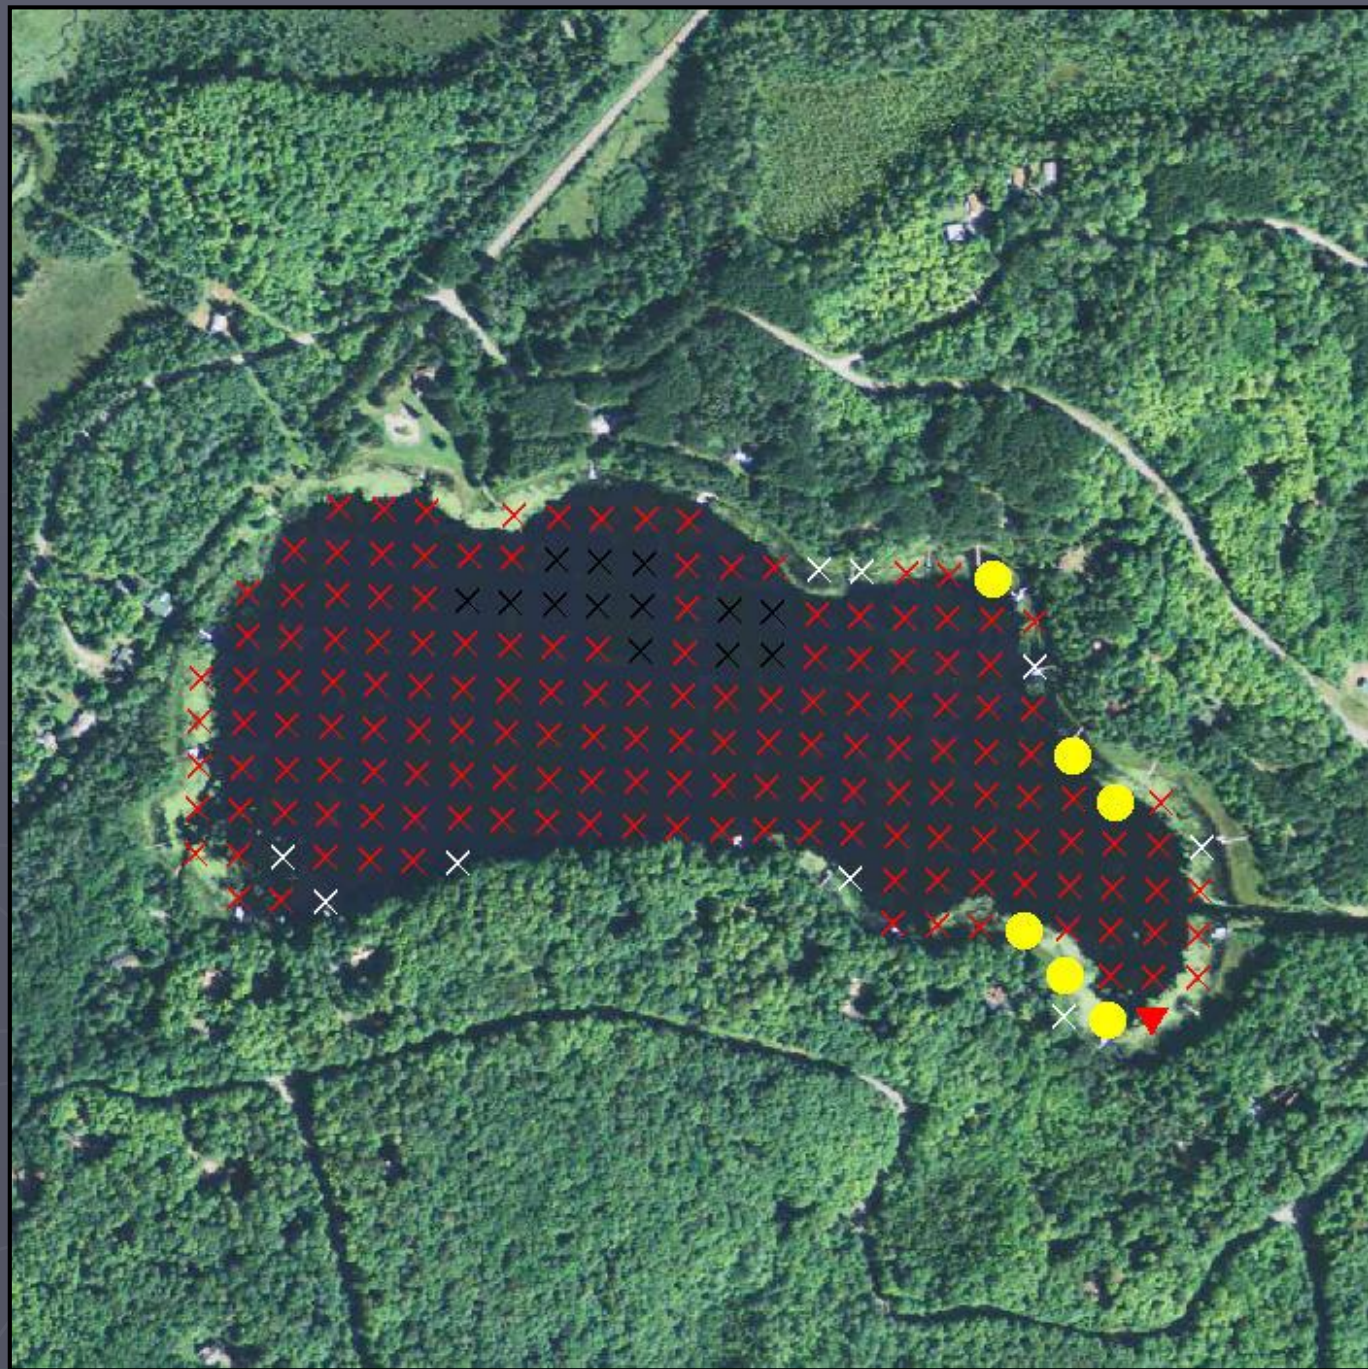
Figure 10. Distribution of plant species, Beaver Lake (2018).

*Bidens beckii*,  
Water marigold

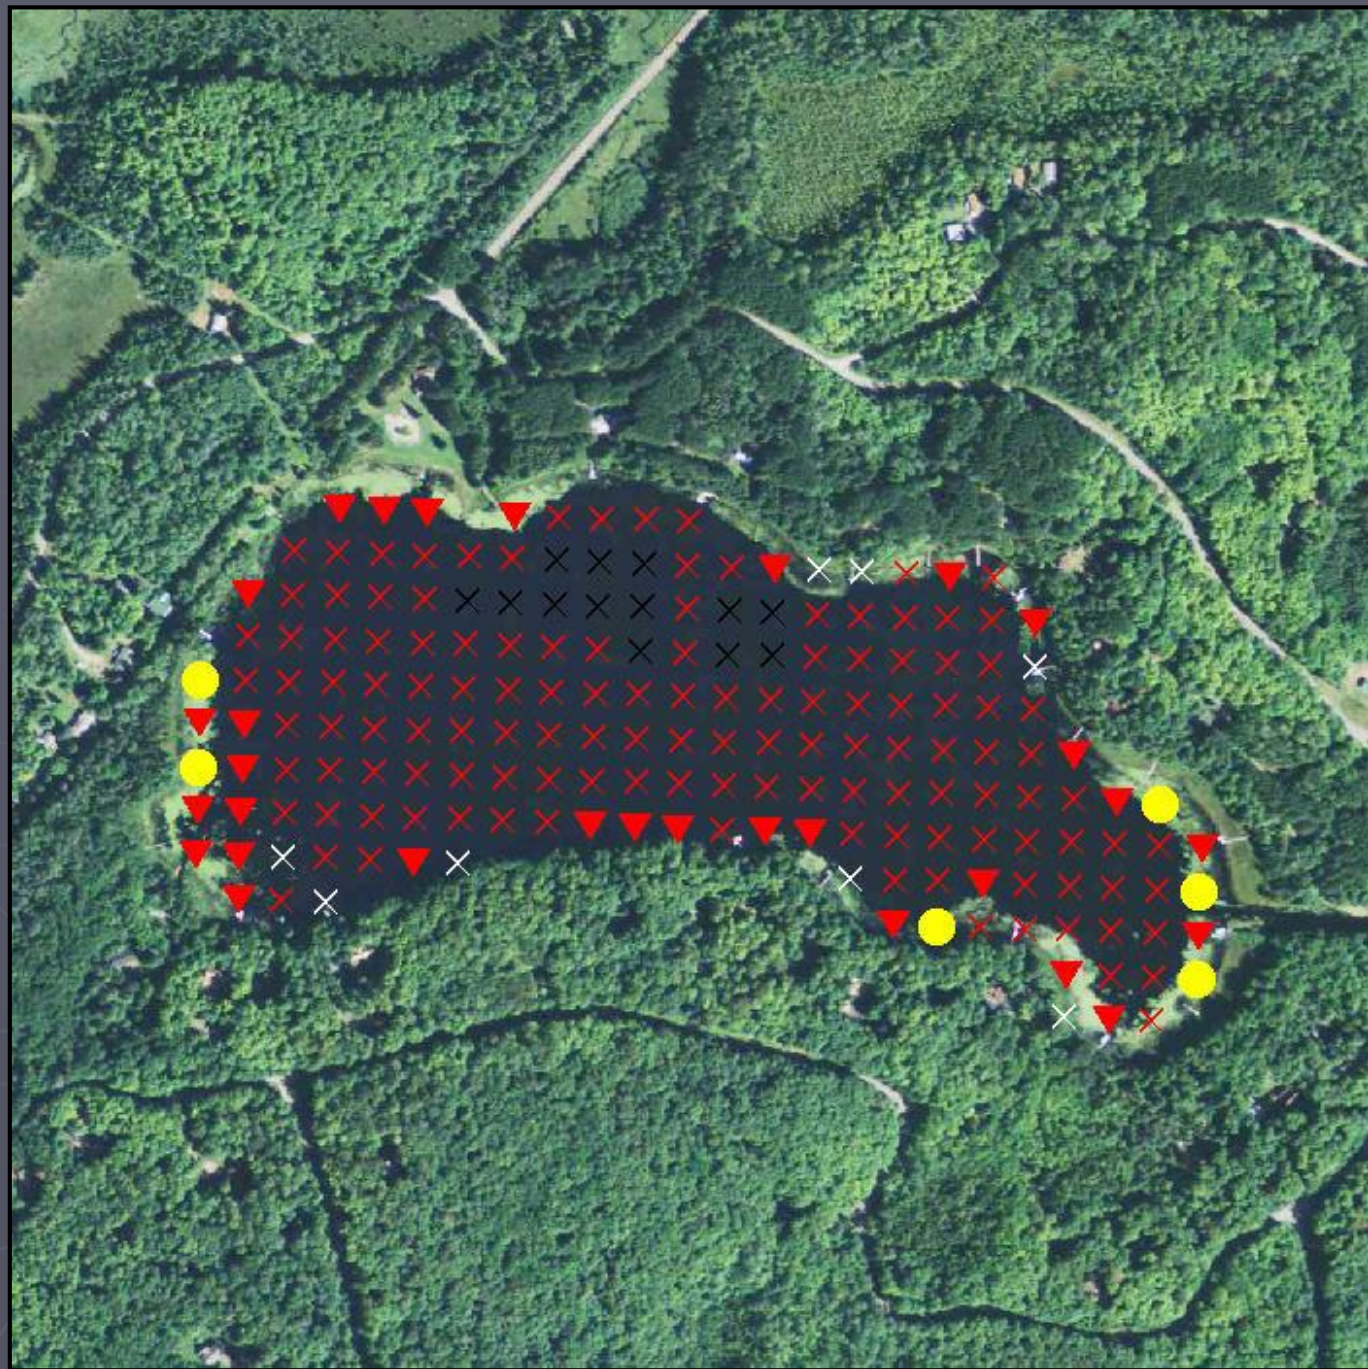
Figure 11. Distribution of plant species, Beaver Lake (2018).

*Nymphaea odorata*,  
White water lily

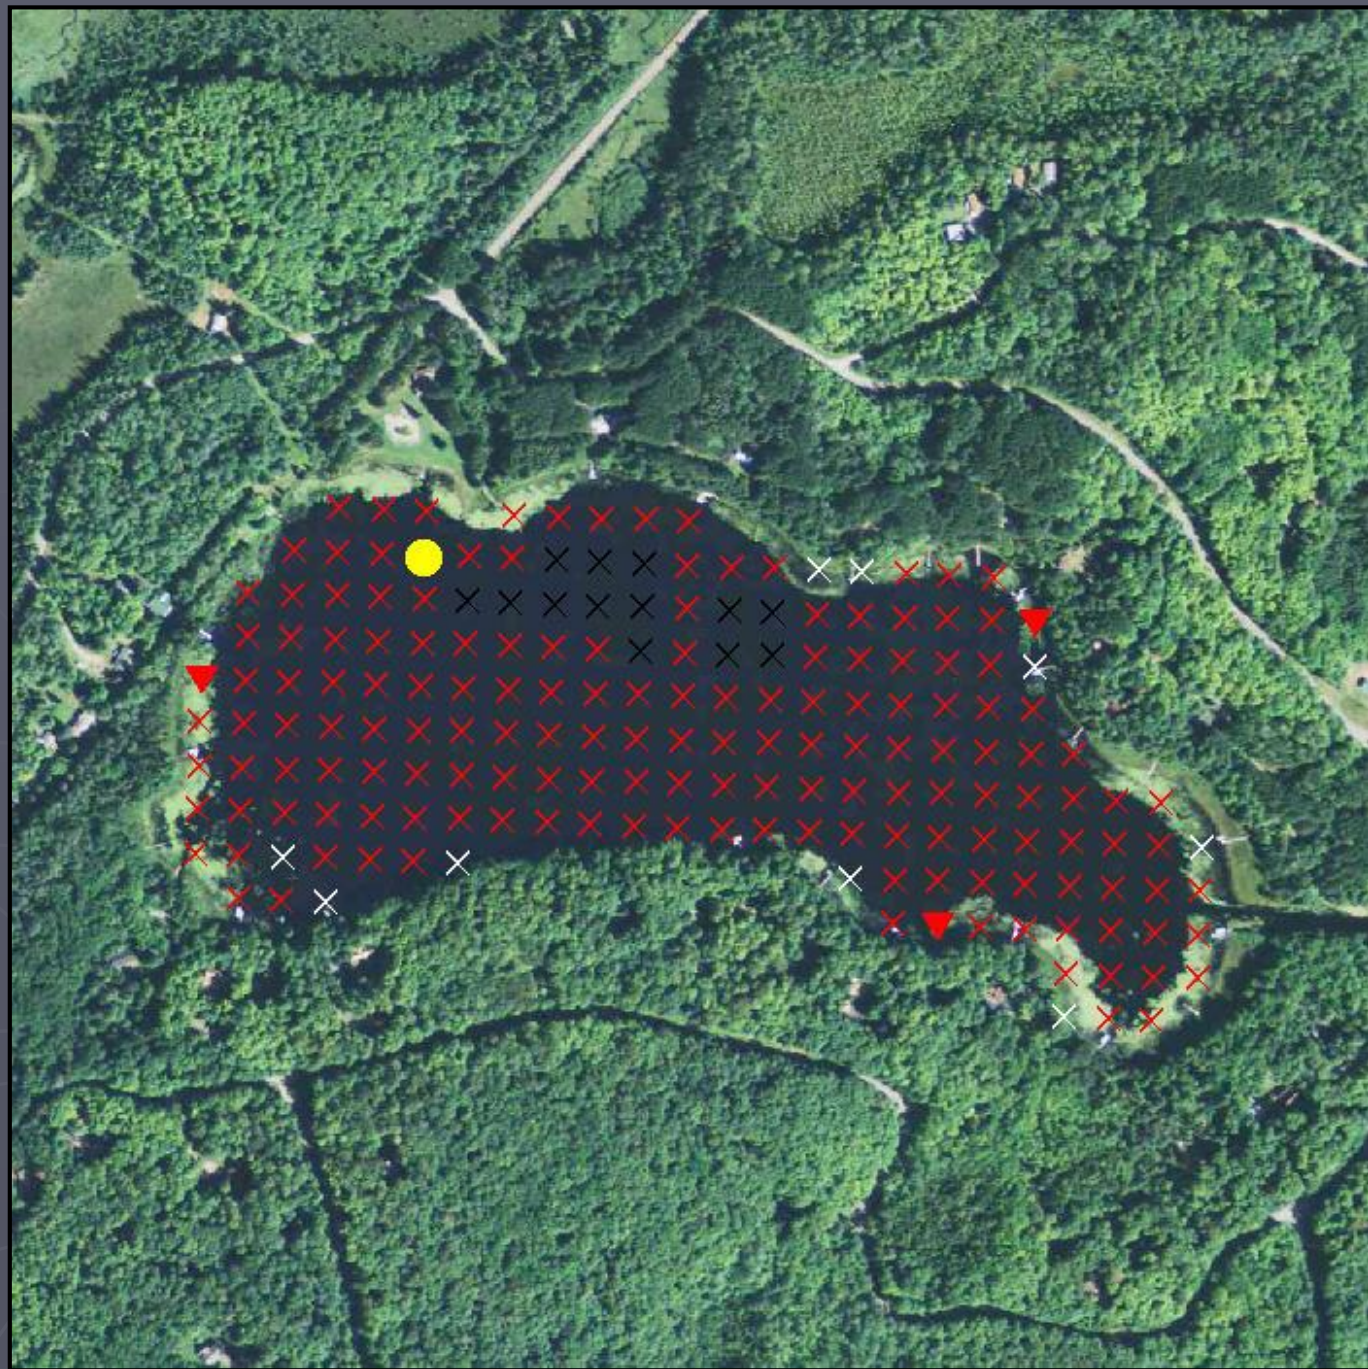
Figure 12. Distribution of plant species, Beaver Lake (2018).

*Heteranthera dubia*,  
Water star-grass

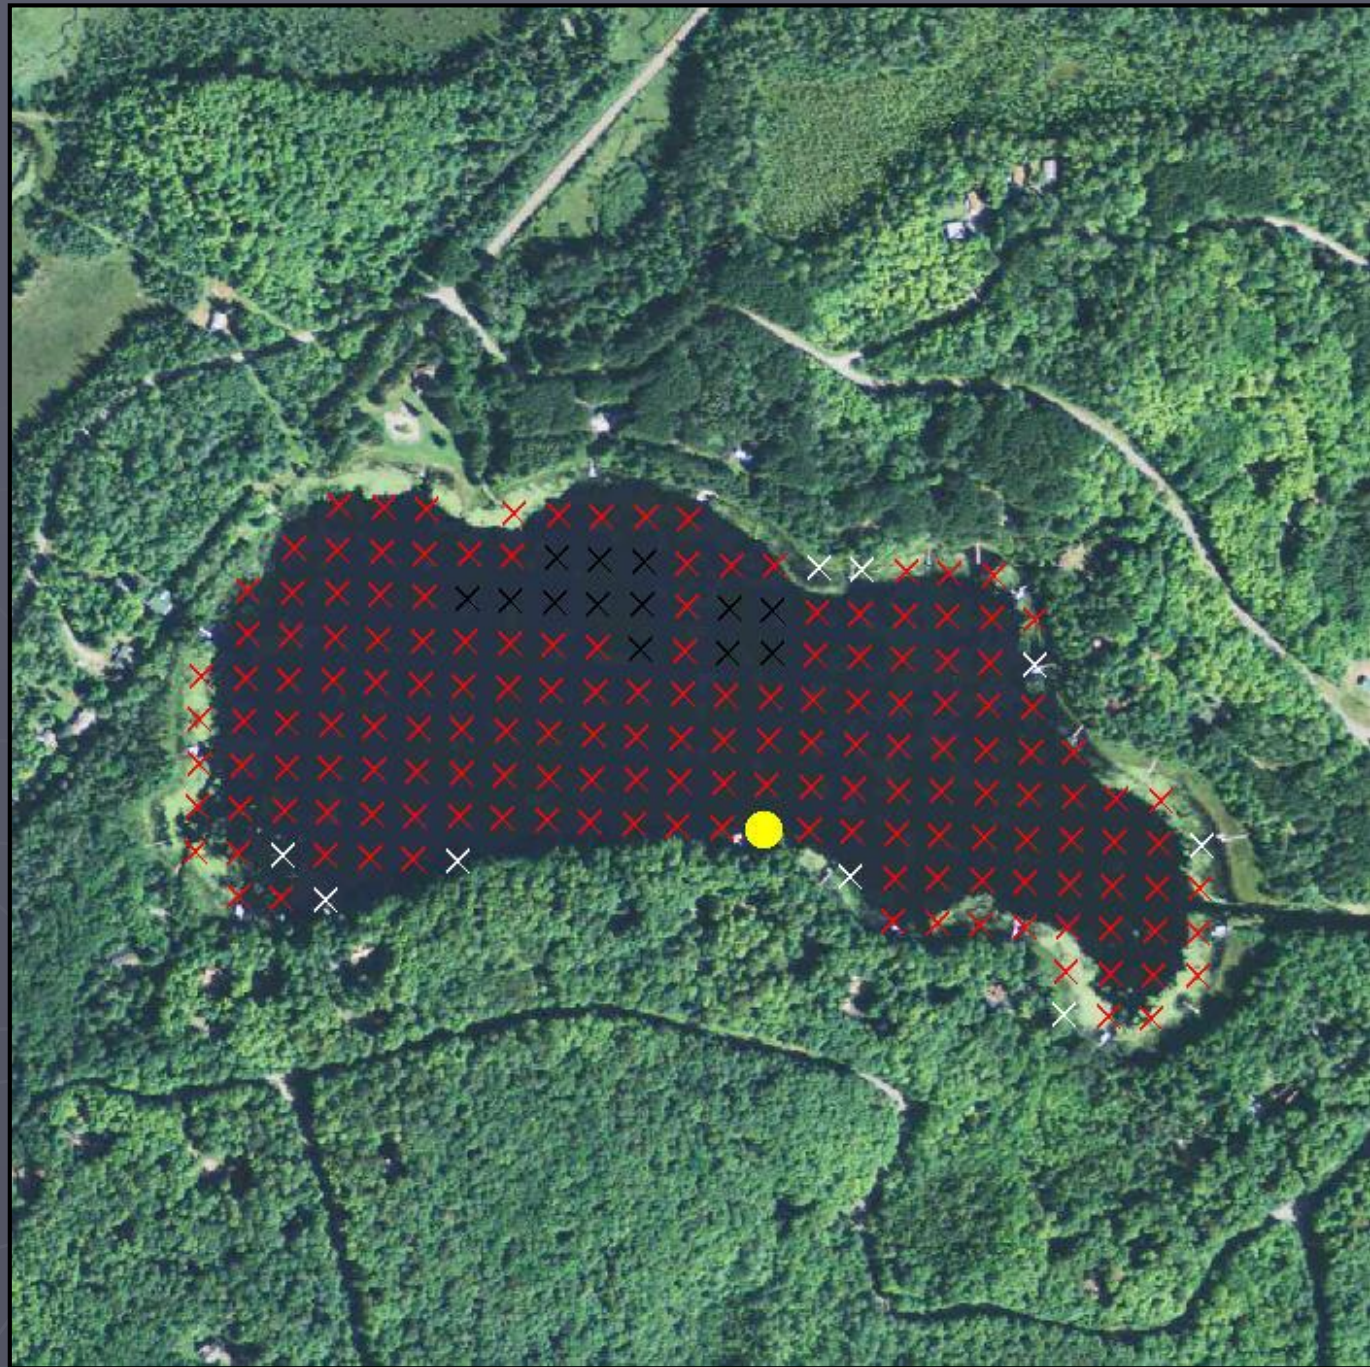
Figure 13. Distribution of plant species, Beaver Lake (2018).

*Myriophyllum sibiricum*,  
Northern water-milfoil

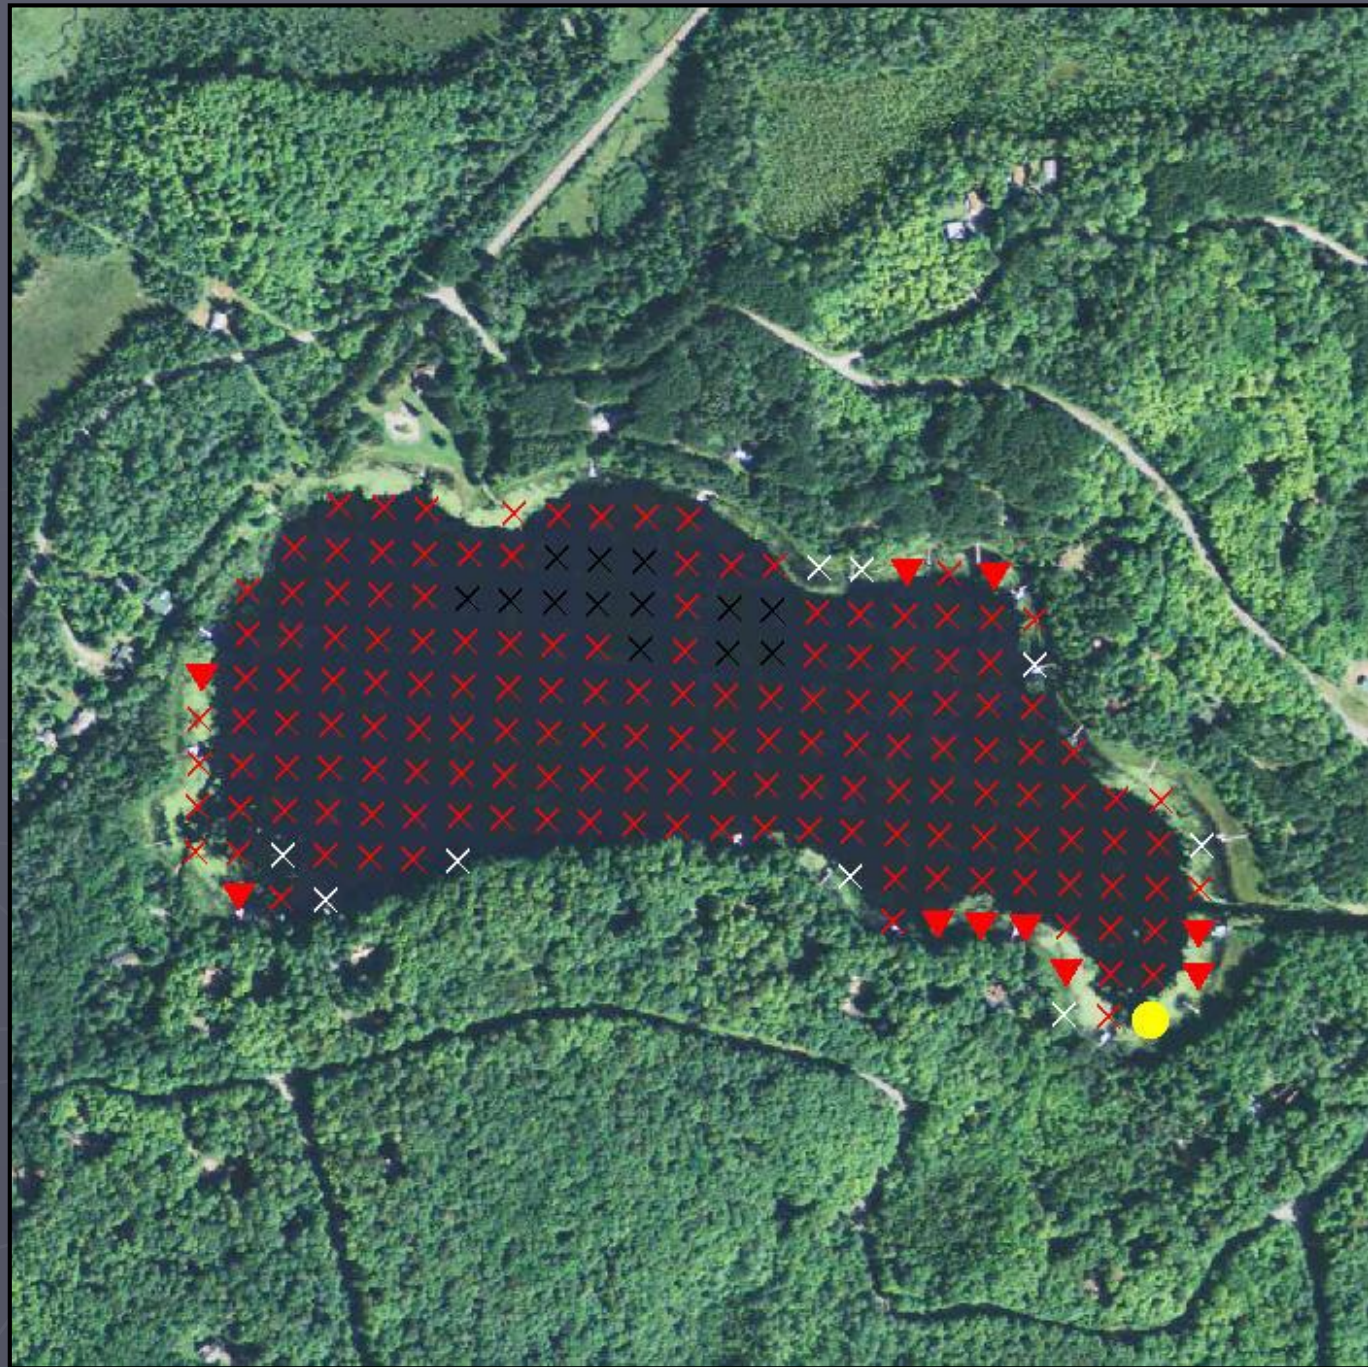
Figure 14. Distribution of plant species, Beaver Lake (2018).

*Pontederia cordata*,  
Pickerelweed

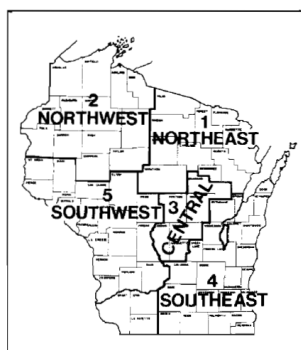
**Figure 1. Wisconsin regions in terms of water quality.**

Lillie and Mason's *Limnological Characteristics of Wisconsin Lakes* (1983) is an excellent resource for evaluating and comparing water quality measures from lakes in northern Wisconsin. For their treatment, Wisconsin is divided into five regions. Vilas County lakes are in the Northeast Region (Figure 1). Water quality measures from a lake can be compared to other lakes within the region using this resource.

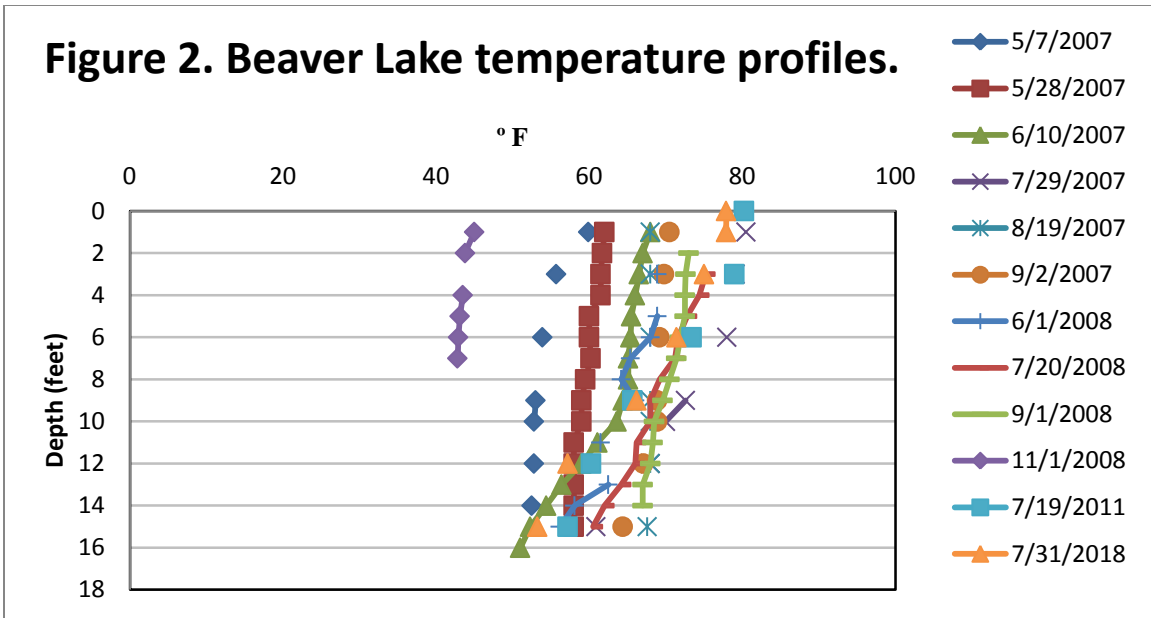
Measuring the temperature of a lake at different depths will determine the influence it has on the physical, biological, and chemical aspects of the lake. Lake water temperature influences the rate of decomposition, nutrient recycling, lake stratification, and dissolved oxygen (D.O.) concentration. Temperature can also affect the distribution of fish species throughout a lake. Figure 2 present water temperature profiles for 2007, 2008, 2011, and 2018. These samples show very little stratification during May. In June the temperature profile show some stratification from surface to bottom depending. In July and August there isn't much variation in temperature from surface to bottom in some years but in others there is definite stratification. Temperature values measured are typical.
