# Presque Isle Wilderness Waters Program

## Aquatic Plant Management Plan – Beaver Lake

**Cite as:** Premo, Dean, Angie Stine, and Kent Premo. 2020. Presque Isle Wilderness Waters Program: Beaver Lake Aquatic Plant Management Plan. White Water Associates, Inc.

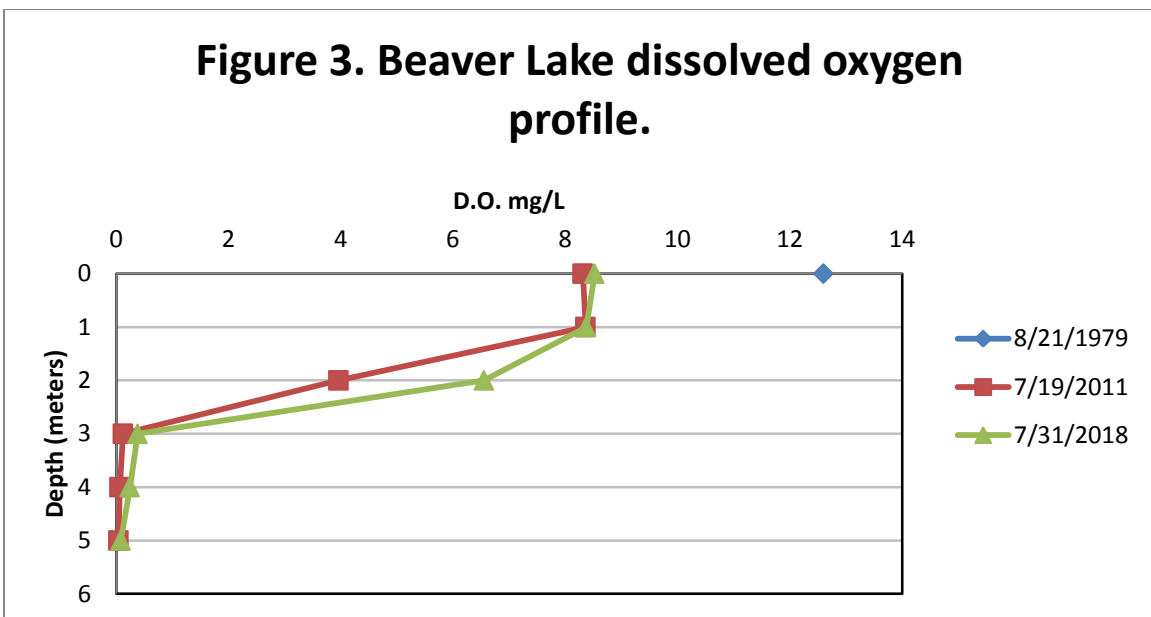
The dissolved oxygen (D.O.) content of lake water is vital in determining presence of fish species and other aquatic organisms. Dissolved oxygen also has a strong influence on the chemical and physical conditions of a lake. The amount of dissolved oxygen is dependent on the water temperature, atmospheric pressure, and biological activity. Oxygen levels are increased by aquatic plant photosynthesis, but reduced by respiration of plants, decomposer organisms, fish, and invertebrates. The amount of D.O. available in a lake, particularly in the deeper parts of a lake, is critical to overall health. Beaver Lake D.O. profiles are displayed in Figure 3. D.O. levels were between 8.31 and 12.6 mg/L at the surface for three years D.O. was analyzed. D.O. levels were near zero at 3 meters in the July profiles. Measured values are typical.

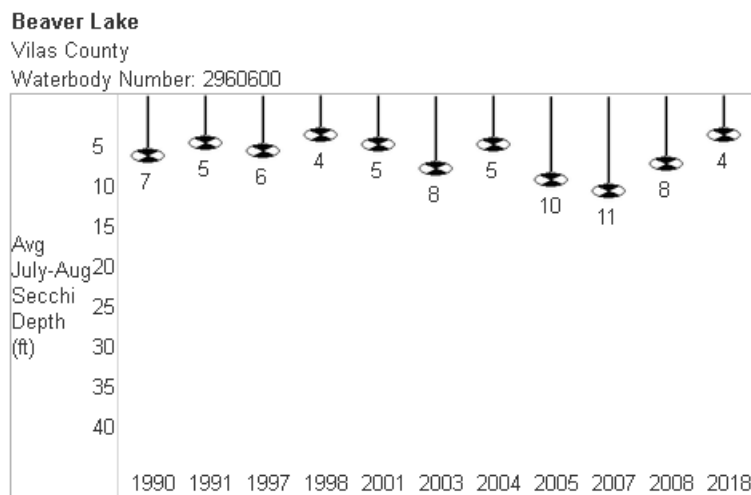
**Figure 4. Beaver Lake Secchi depth averages (July and August only).**

Past secchi averages in feet (July and August only).

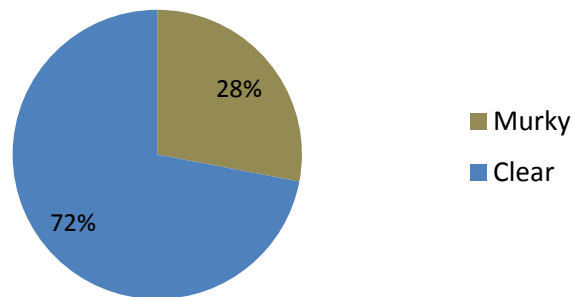
**Figure 6. Beaver Lake water appearance, 1998-2008.**

Turbidity is another measure of water clarity, but is caused by suspended particulate matter rather than dissolved organic compounds (Shaw et al., 2004). Particles suspended in the water dissipate light and reduce the depth to which the light can penetrate. This affects the depth at which plants can grow. Turbidity also affects the aesthetic quality of water. Water that runs off the watershed into a lake can increase turbidity by introducing suspended materials. Turbidity caused by algae is the most common reason for low Secchi readings (Shaw et al., 2004). In terms of biological health of a lake ecosystem, measurements less than 10 Nephelometric Turbidity Units (NTU) represent healthy conditions for fish and other organisms. Beaver Lake turbidity was tested on 8/21/1979 at 2.4 FTU. While checking Secchi depth, CLMN volunteers also rate the water clarity and describe the water as “clear” or “murky.” In the sampled years (1998-2008) Beaver Lake had a water column appearance of “clear” 72% of the time.

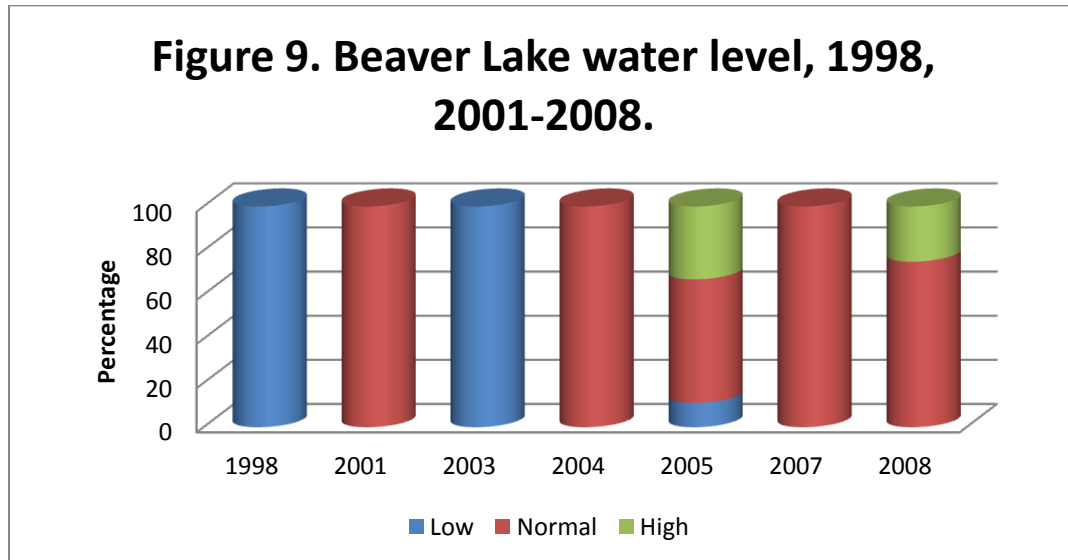
When CLMN volunteers collect Secchi depth readings, they also record the lake level as “high,” “normal,” or “low.” Figure 9 indicates that in 1998 and 2003 the water level in Beaver Lake appeared “low” and in 2001, 2004, and 2007 100% thought the water level was “normal.”

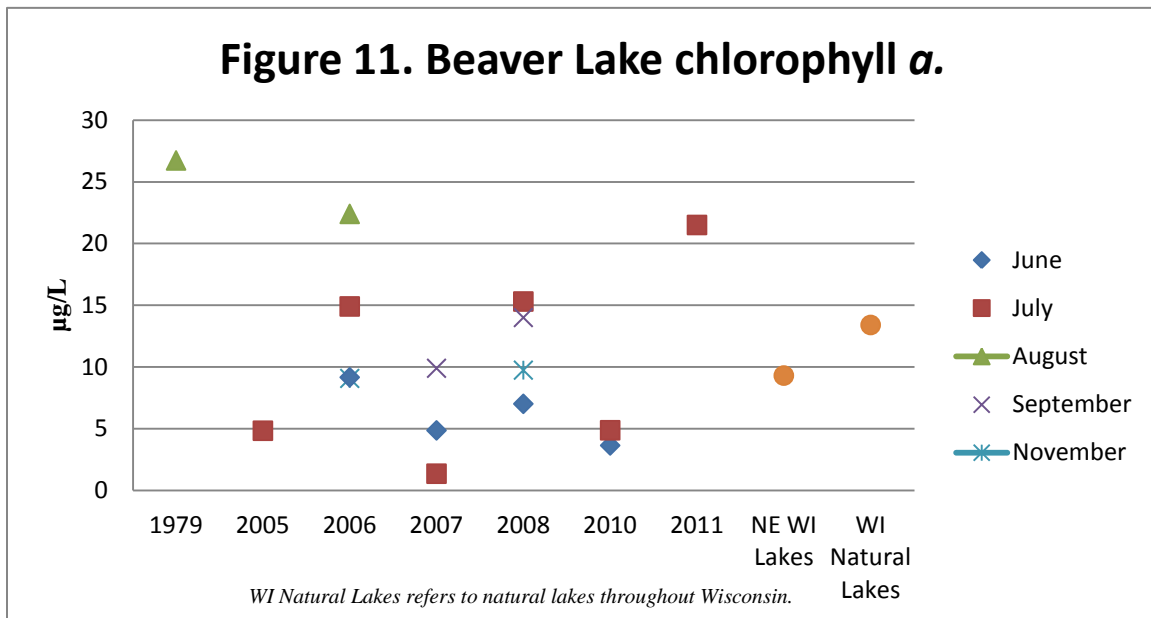
Chlorophyll *a* is the photosynthetic pigment that makes plants and algae green. Chlorophyll *a* in lake water is an indicator of the amount of algae. Chlorophyll *a* concentrations greater than 10 µg/L are perceived as a mild algae bloom, while concentrations greater than 20 µg/L are perceived as a nuisance. Chlorophyll *a* values varied in the years sampled (Figure 11).

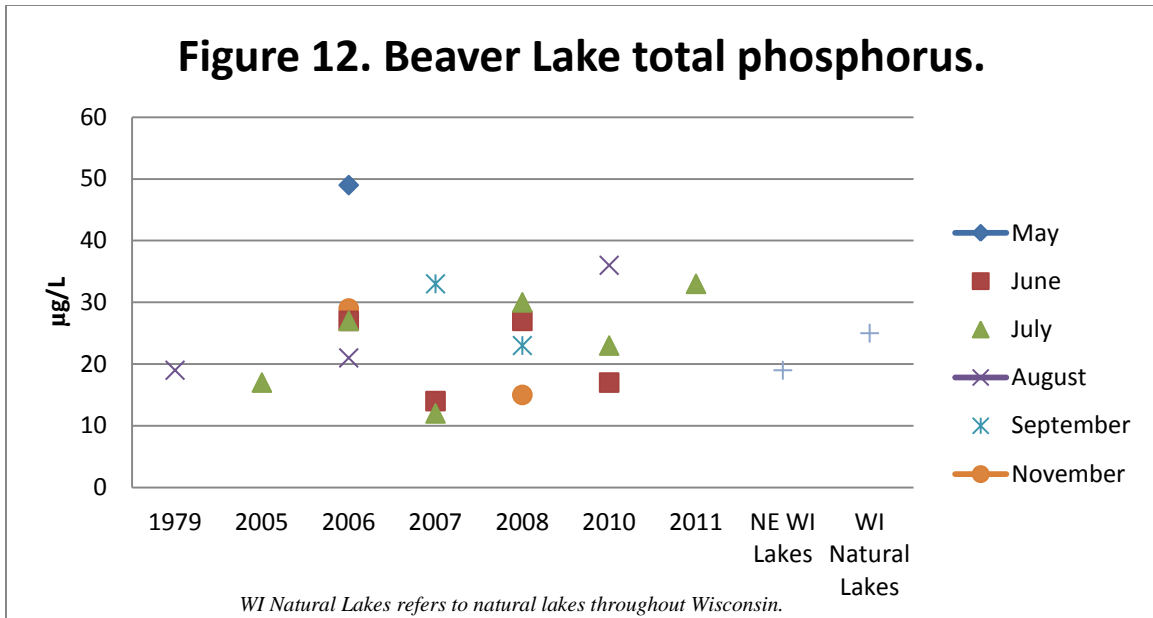
Beaver Lake total phosphorus values were considered "good" to "very good," (Figure 12) and are comparable to the region and state values (Figure 13).

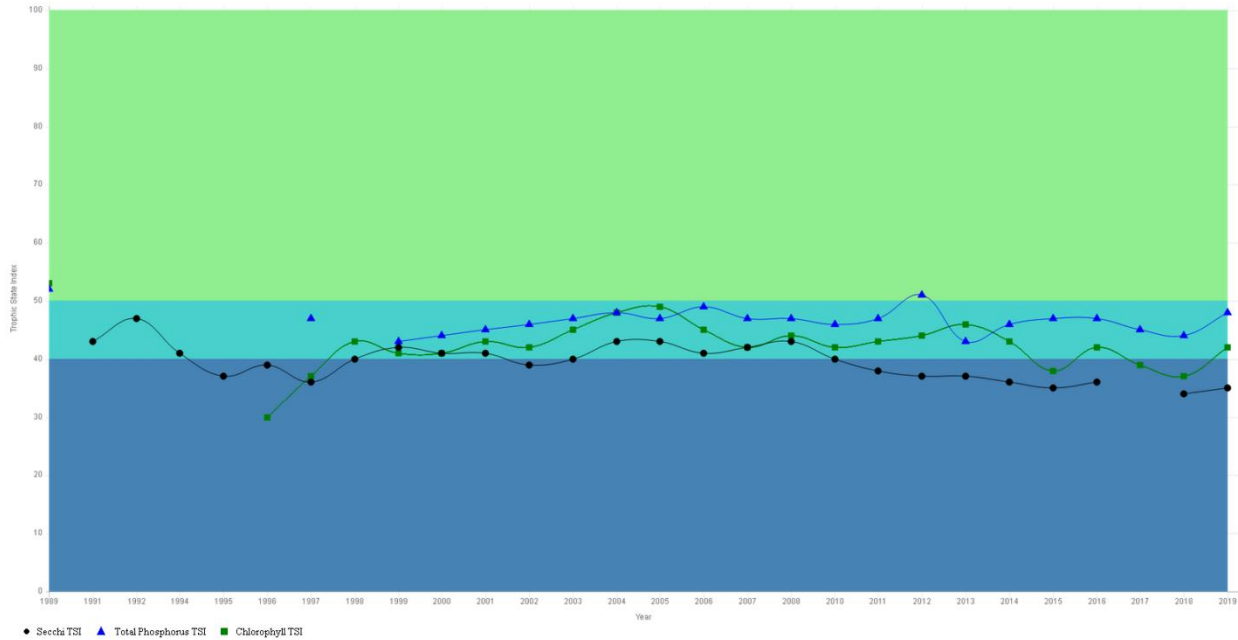
**Figure 14. Beaver Lake Trophic State Index, (1989-2019).** (WDNR, 2019b)

Trophic State Index (TSI) was calculated by the WDNR using only Secchi measurements, chlorophyll *a*, and total phosphorus collected from the CLMN. Figure 14, classifying Beaver Lake as “mesotrophic to eutrophic” (Table 2).

<b>30-40</b>	<b>Oligotrophic:</b> clear, deep water; possible oxygen depletion in lower depths; few aquatic plants or algal blooms; low in nutrients; large game fish usual fishery
<b>40-50</b>	<b>Mesotrophic:</b> moderately clear water; mixed fishery, esp. panfish; moderate aquatic plant growth and occasional algal blooms; may have low oxygen levels near bottom in summer
<b>50-60</b>	<b>Mildly Eutrophic:</b> decreased water clarity; anoxic near bottom; may have heavy algal bloom and plant growth; high in nutrients; shallow eutrophic lakes may have winterkill of fish; rough fish common
<b>60-70</b>	<b>Eutrophic:</b> dominated by blue-green algae; algae scums common; prolific aquatic plant growth; high nutrient levels; rough fish common; susceptible to oxygen depletion and winter fishkill
<b>70-80</b>	<b>Hypereutrophic:</b> heavy algal blooms through most of summer; dense aquatic plant growth; poor water clarity; high nutrient levels

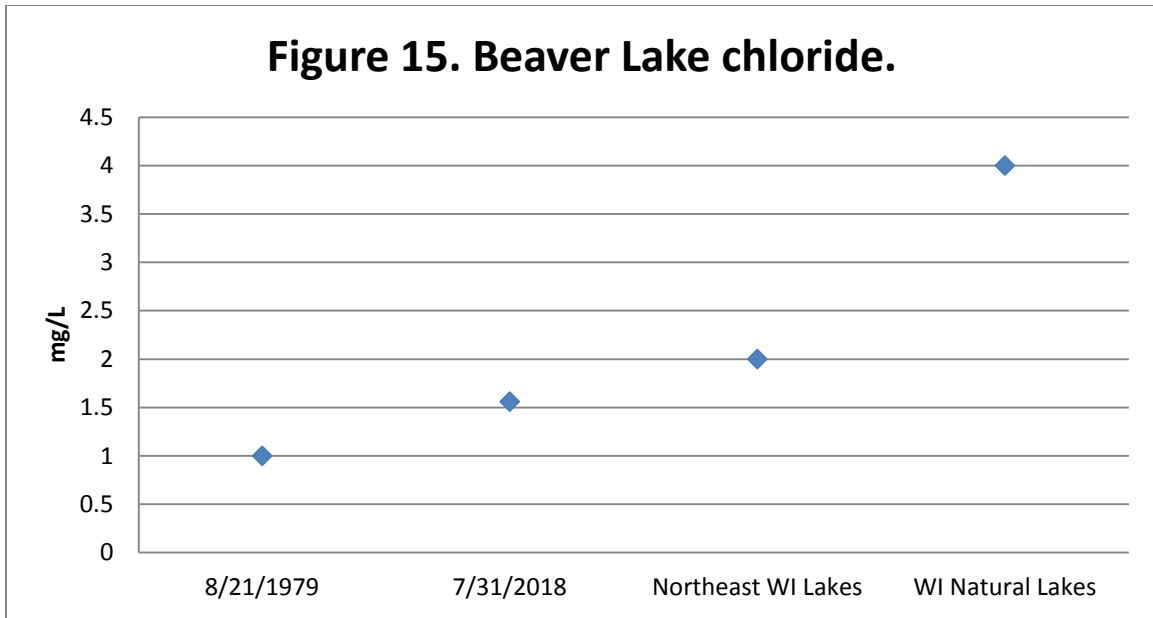
The presence of chloride ( $\text{Cl}^-$ ) where it does not occur naturally indicates possible water pollution (Shaw et al., 2004). Chloride does not affect plant and algae growth and is not toxic to aquatic organisms at most of the levels found in Wisconsin (Shaw et al., 2004). Beaver Lake chloride is shown in Figure 15. For Northeast Wisconsin Lakes the mean for chloride is 2 mg/L and 4 mg/L for Wisconsin Natural Lakes so Beaver Lake has values below the Wisconsin means.

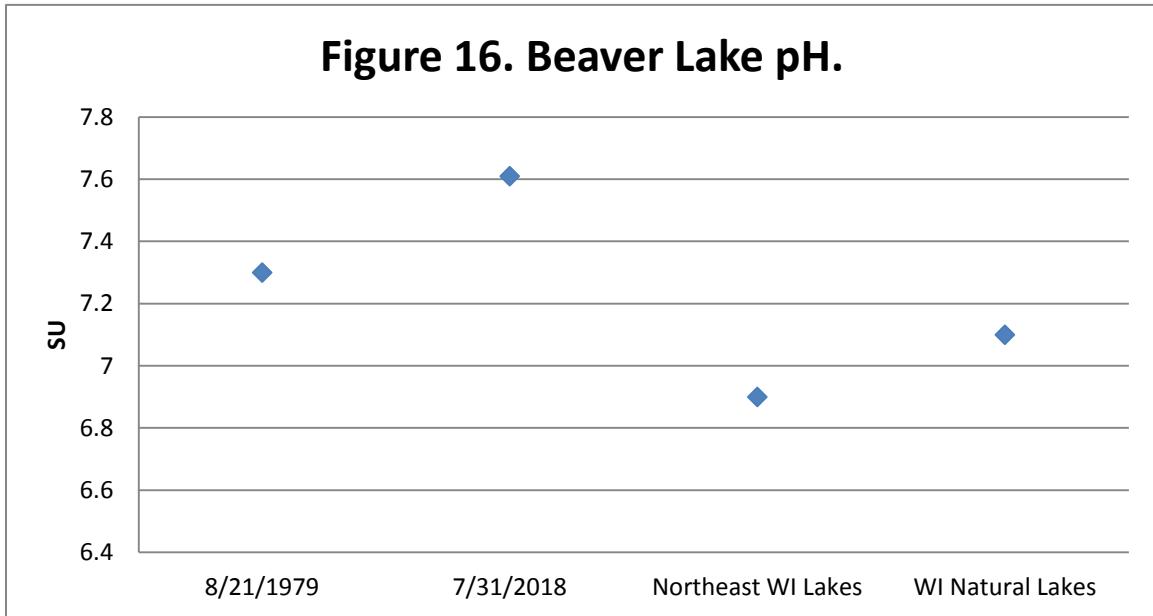
The acidity level of a lake's water regulates the solubility of many minerals. A pH level of 7 is considered neutral. The pH level in Wisconsin lakes ranges from 4.5 in acid, bog lakes to 8.4 in hard water, marl lakes (Shaw et al., 2004). Natural rainfall in Wisconsin averages a pH of 5.6. Some minerals become available under low pH (especially aluminum, zinc, and mercury) and can inhibit fish reproduction and/or survival. Mercury and aluminum are not only toxic to many kinds of wildlife, but also to humans. The pH scale is logarithmic, so every 1.0 unit change in pH increases the acidity tenfold. Water with a pH of 6 is 10 times more acidic than water with pH of 7. A lake's pH level is important for the release of potentially harmful substances and affects plant growth, fish reproduction and survival. A lake with neutral or slightly alkaline pH is a good lake for fish and plant survival. Beaver Lake pH values are shown in Figure 16 and are near neutral.

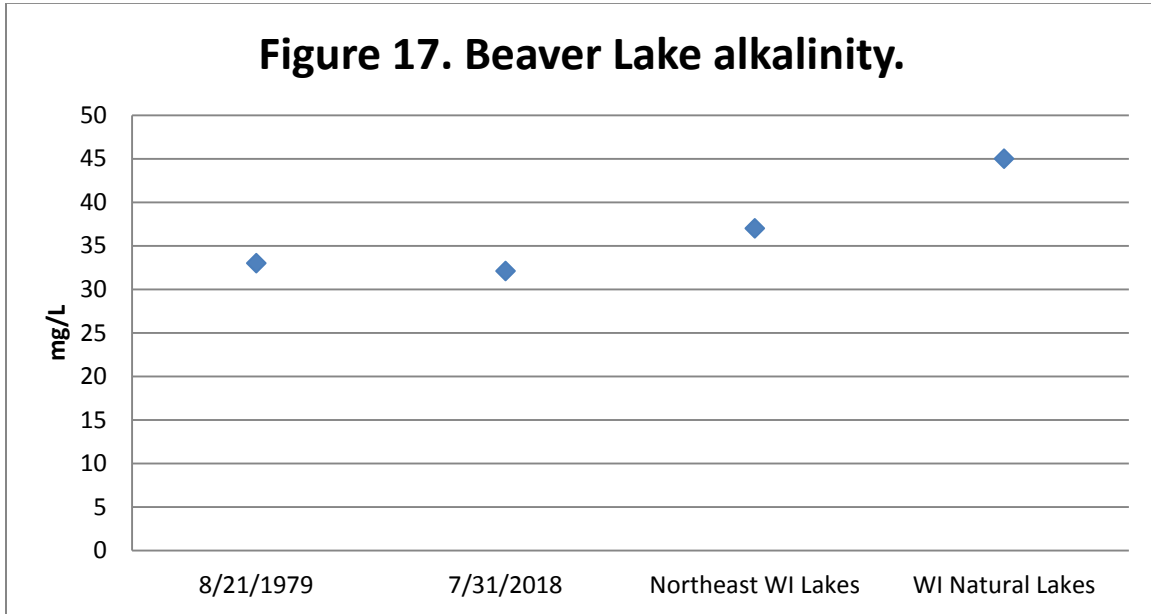
Alkalinity levels in a lake are affected by the soil minerals, bedrock type in the watershed, and frequency of contact between lake water and these materials (Shaw et al., 2004). Alkalinity is important in a lake to buffer the effects of acidification from the atmosphere. Acid rain has long been a problem with lakes that have low alkalinity levels and high potential sources of acid deposition. Beaver Lake alkalinity is shown in Figure 17. This level categorizes Beaver Lake as “none-sensitive” to acid rain (Table 5).

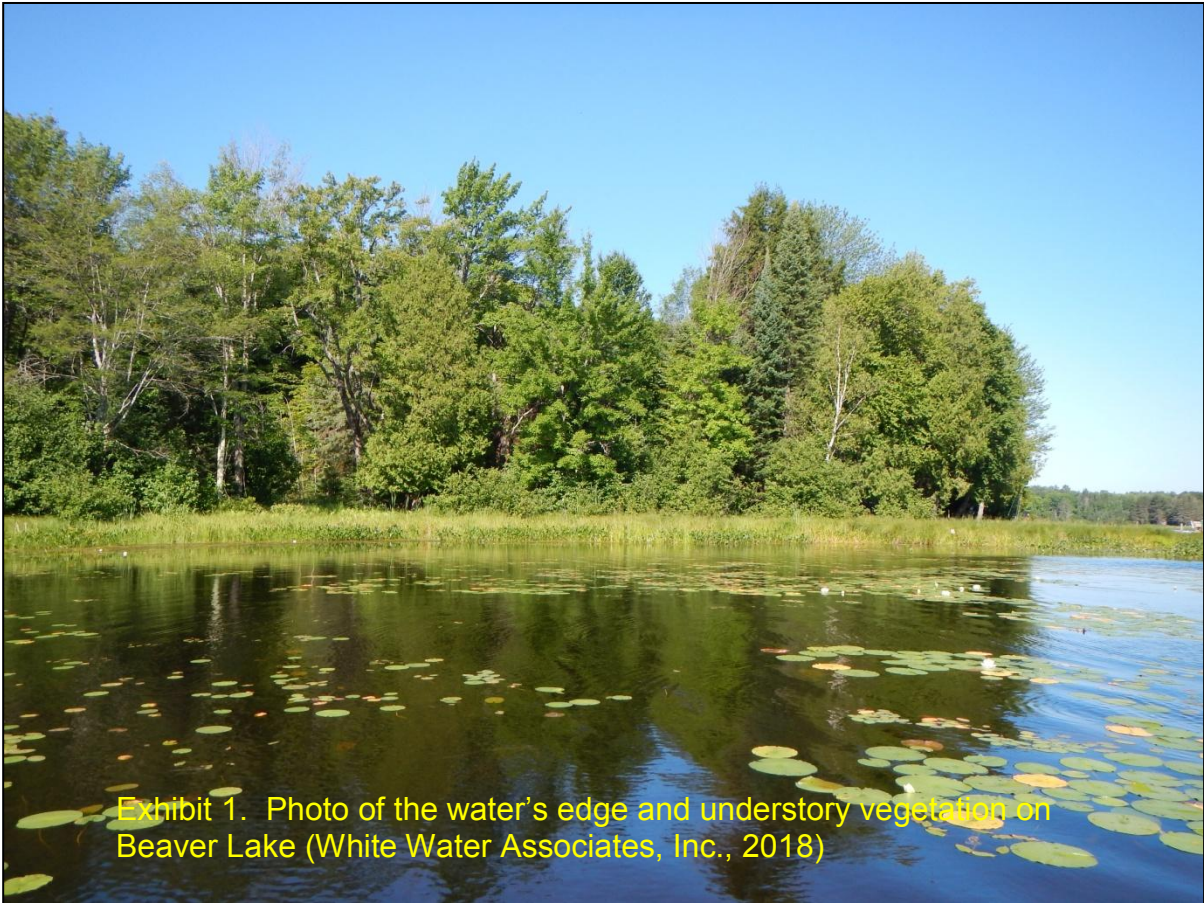
Exhibit 1. Photo of the water's edge and understory vegetation on Beaver Lake (White Water Associates, Inc., 2018)

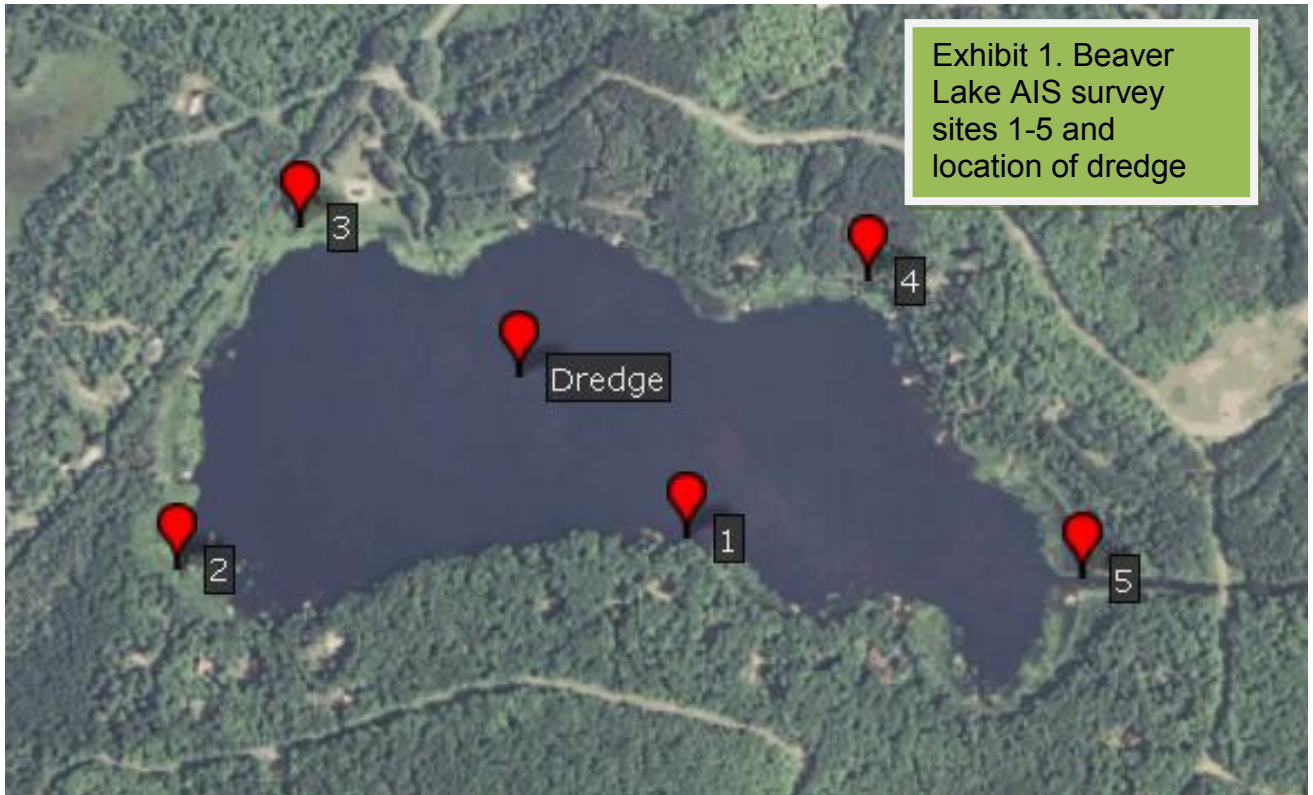
There were no known AIS that were established in Beaver Lake prior to this survey. During the survey there were two new invasive plants that were noted. One was the narrow-leaf cattail (*Typha angustifolia*) and the other was reed canary grass (*Phalaris arundinacea*). Reed canary grass was noted at Site 1 and 3. The narrow-leaf cattail was found at Site 2 (Boat Landing) (Exhibit 4). These specimens were vouchered and sent to Dr. Freckmann and were confirmed January, 2019. Sites 3 and 5 had no AIS present. A sample of *Pharagmites* sp. was collected and it was confirmed native.

<b>Exhibit 2. AIS Survey on Beaver Lake 8/2/2018.</b>			
<b>Density (1-5), and live (L) or dead (D).</b>			
<b>Site</b>	<b>Latitude</b>	<b>Longitude</b>	<b>Species found</b>
1	46.20529	-89.58804	Reed canary grass (L,3)
2	46.20503	-89.59458	Narrow-leaf cattail (L, 3)
3	46.20806	-89.59297	None
4	46.20759	-89.58572	Reed canary grass (L, 3), Phragmites (L, 1) - native
5	46.20493	-89.58300	None

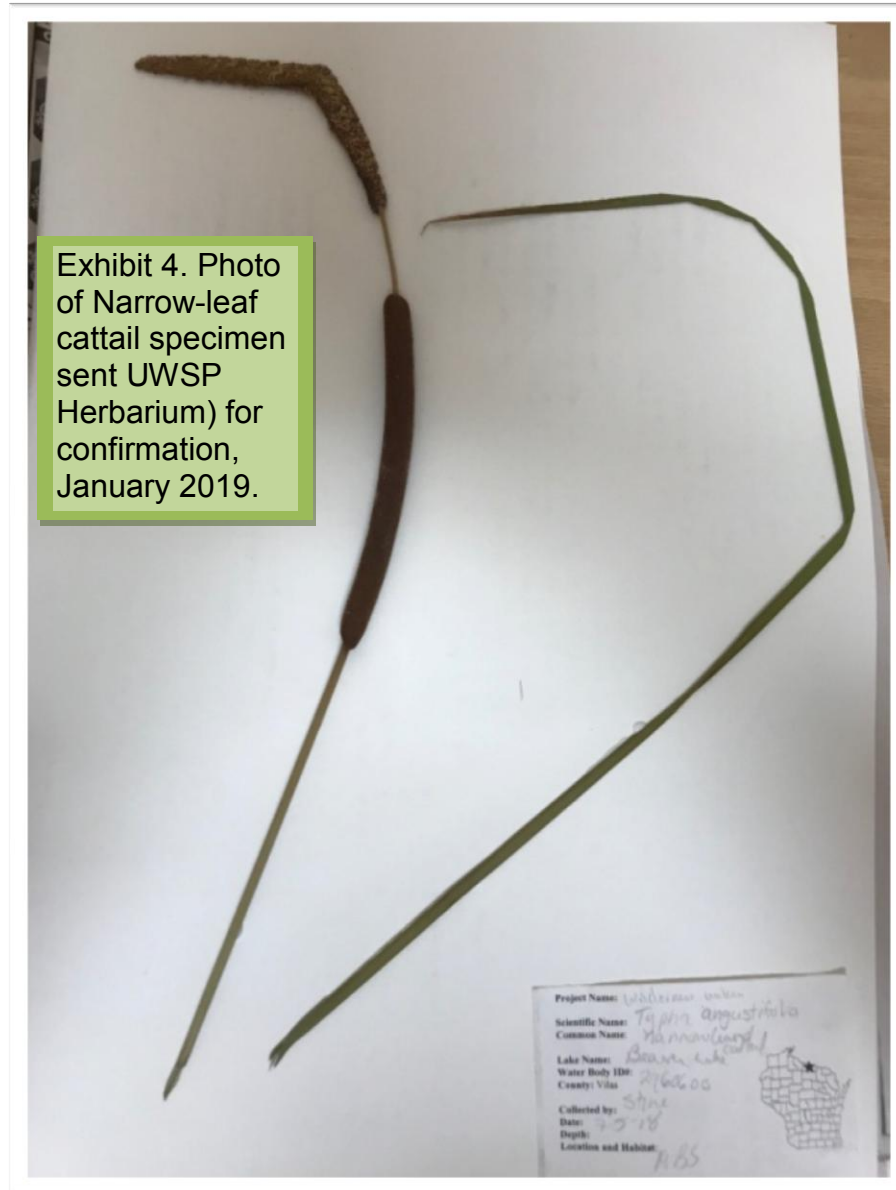
Exhibit 4. Photo of Narrow-leaf cattail specimen sent UWSP Herbarium) for confirmation, January 2019.

Narrow-leaved cattail (*Typha angustifolia*) is another perennial wetland plant that can grow very tall. It has a flowering spike of male flowers with another section of female flowers just below it (Czarapata, 2005). It grows along shorelines, roadsides, marshes, and wet meadows. Narrow-leaved cattails form monocultures that push out native plant species and can alter the hydrology and wildlife habitat (Czarapata, 2005).

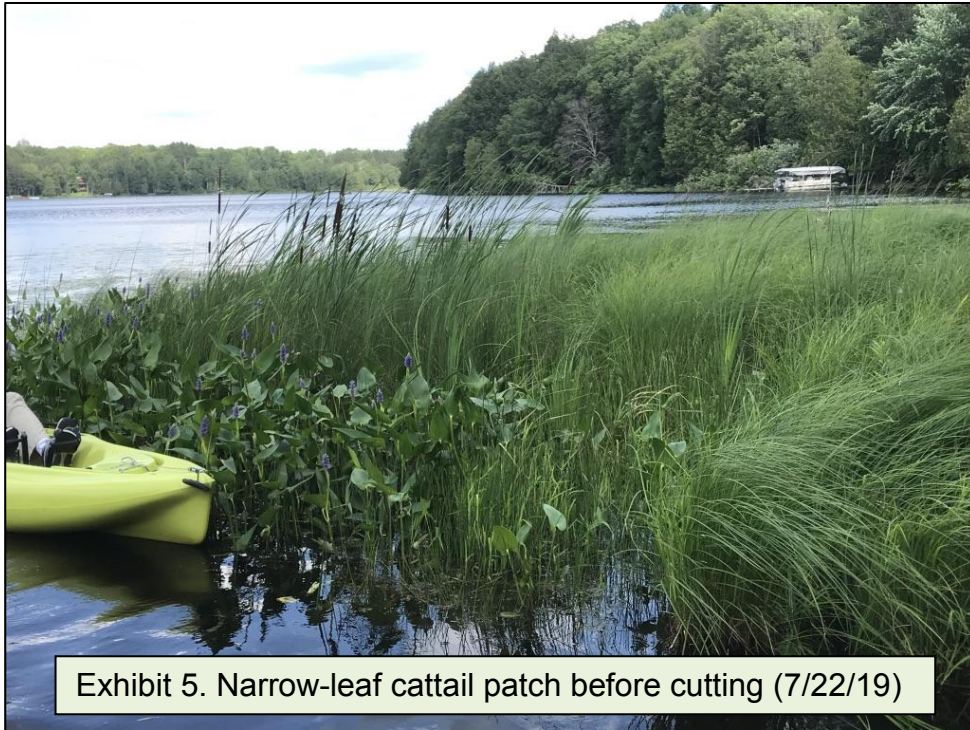
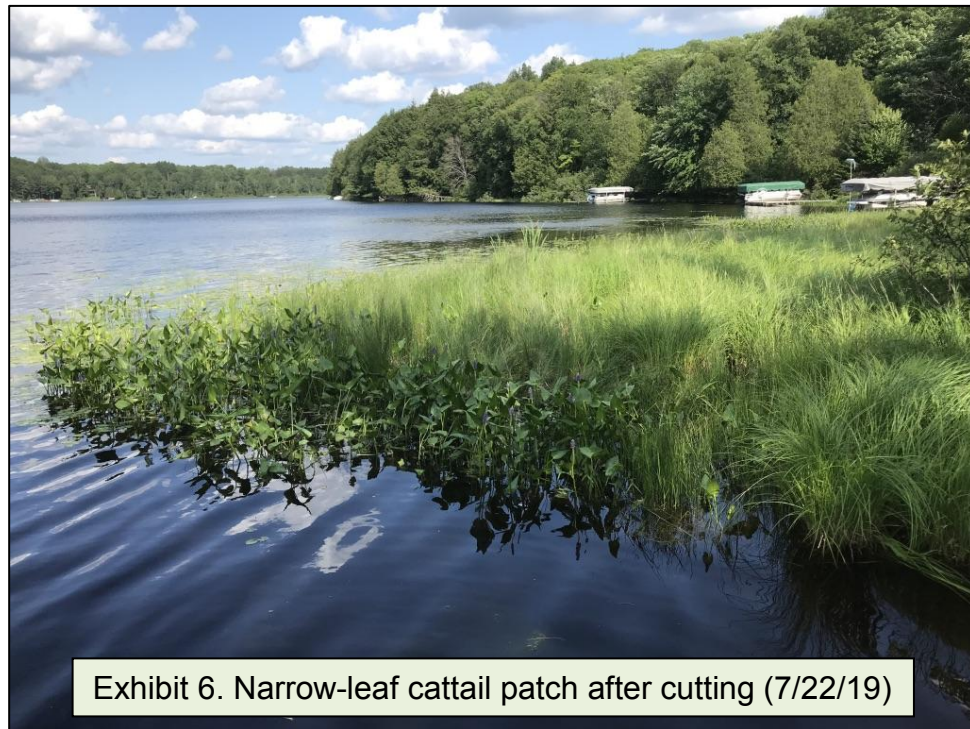
The AIS Rapid Response team for Beaver Lake is the Natural Lakes homeowners association invasives species committee. On 7/22/19 two members of the committee worked on the thin-leaved cattail stand at the landing on Beaver Lake. The volunteers waded into the bed and cut all plants 6” below the water surface. Cut plants were bagged in black plastic bags and disposed of in the landfill. No emerging plants were seen for the rest of the season. Exhibits 5 and 6 depict the before and after conditions of this management activity. The committee will survey the location each year and remove any new cattails.
