Phragmites Management Locations

Benedict & Tombeau Lakes, Kenosha & Walworth County

Mapped: June 27, 2018

AIS Early Detection & Rapid Response Grant: AIR-215-17

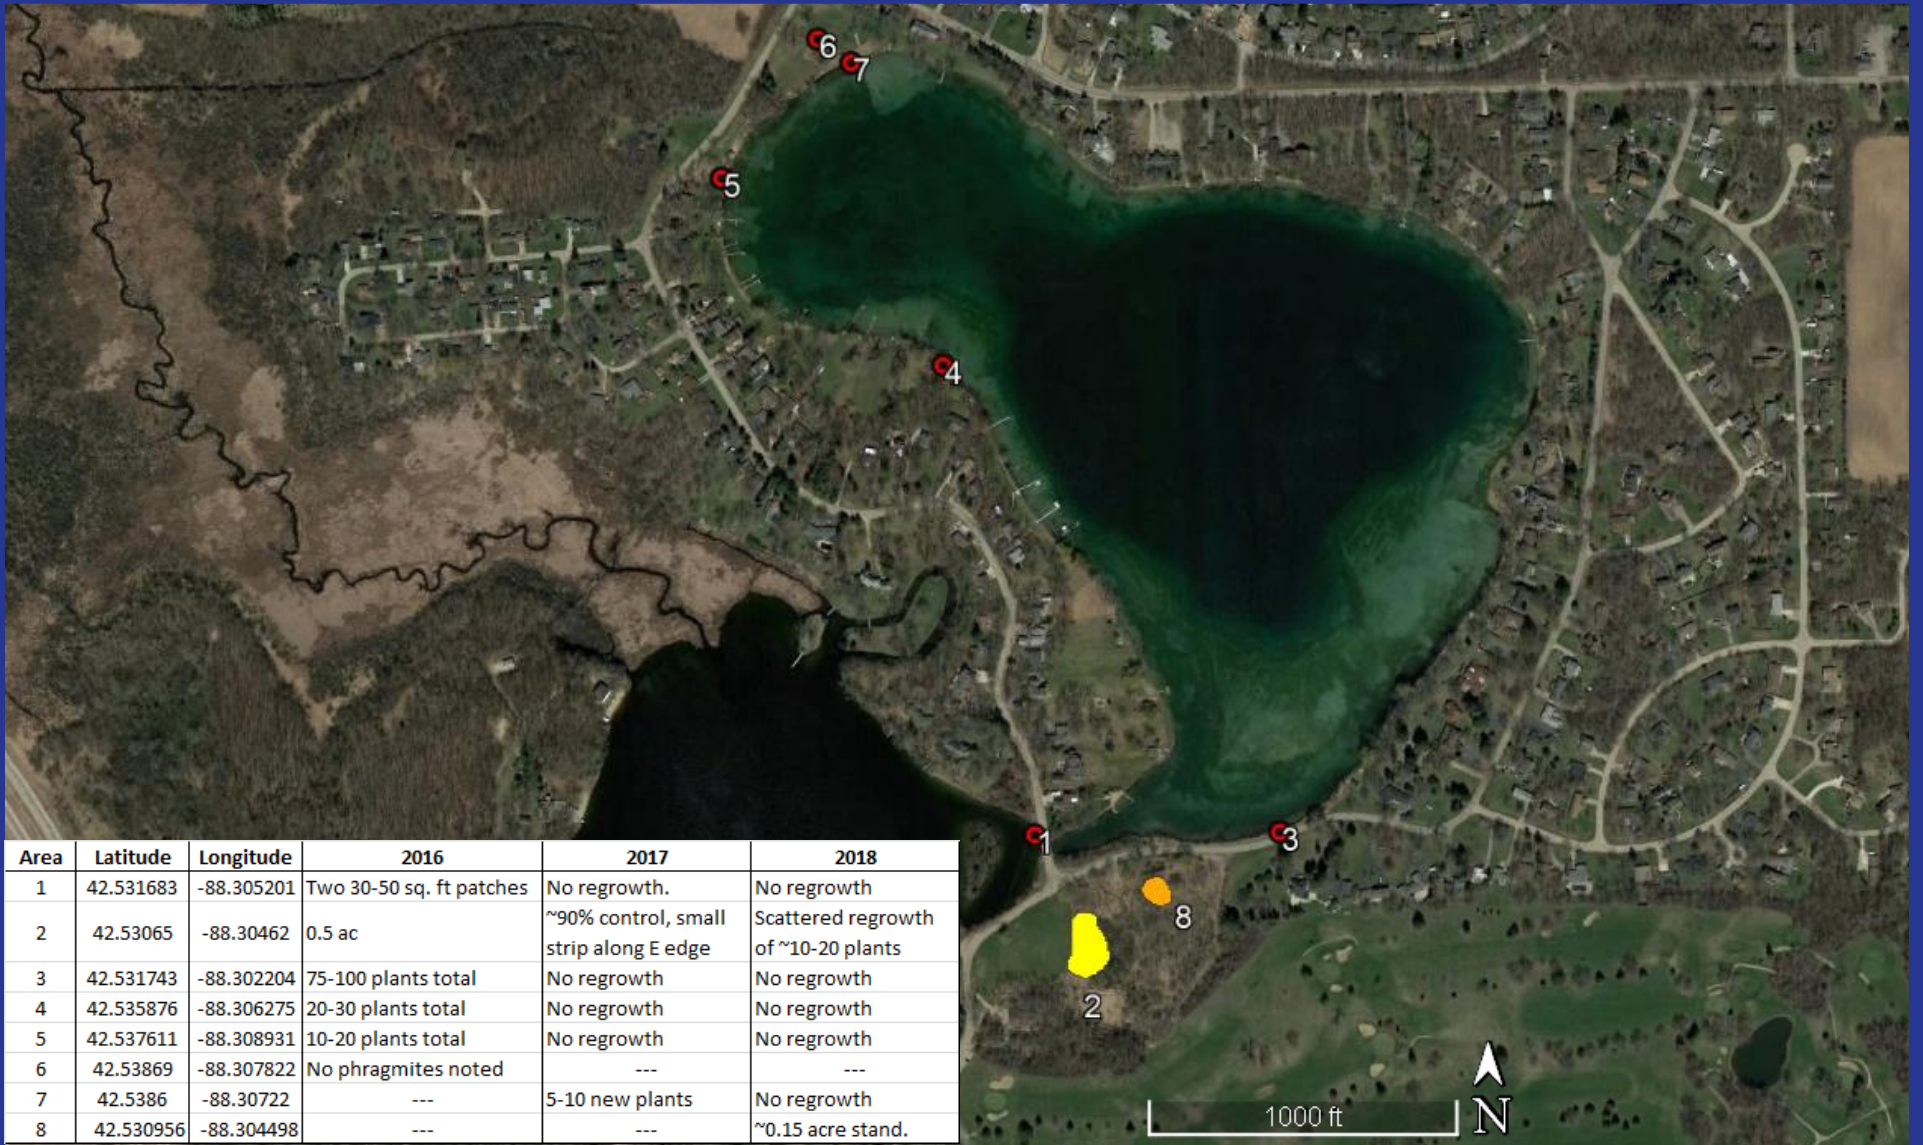
Area	Latitude	Longitude	2016	2017	2018
1	42.531683	-88.305201	Two 30-50 sq. ft patches	No regrowth.	No regrowth
2	42.53065	-88.30462	0.5 ac	~90% control, small strip along E edge	Scattered regrowth of ~10-20 plants
3	42.531743	-88.302204	75-100 plants total	No regrowth	No regrowth
4	42.535876	-88.306275	20-30 plants total	No regrowth	No regrowth
5	42.537611	-88.308931	10-20 plants total	No regrowth	No regrowth
6	42.53869	-88.307822	No phragmites noted	---	---
7	42.5386	-88.30722	---	5-10 new plants	No regrowth
8	42.530956	-88.304498	---	---	~0.15 acre stand.
