## 2019 Big Roche A Cri Aquatic Plant Surveys

Prepared for  
Big Roche A Cri Lake District

September 2019

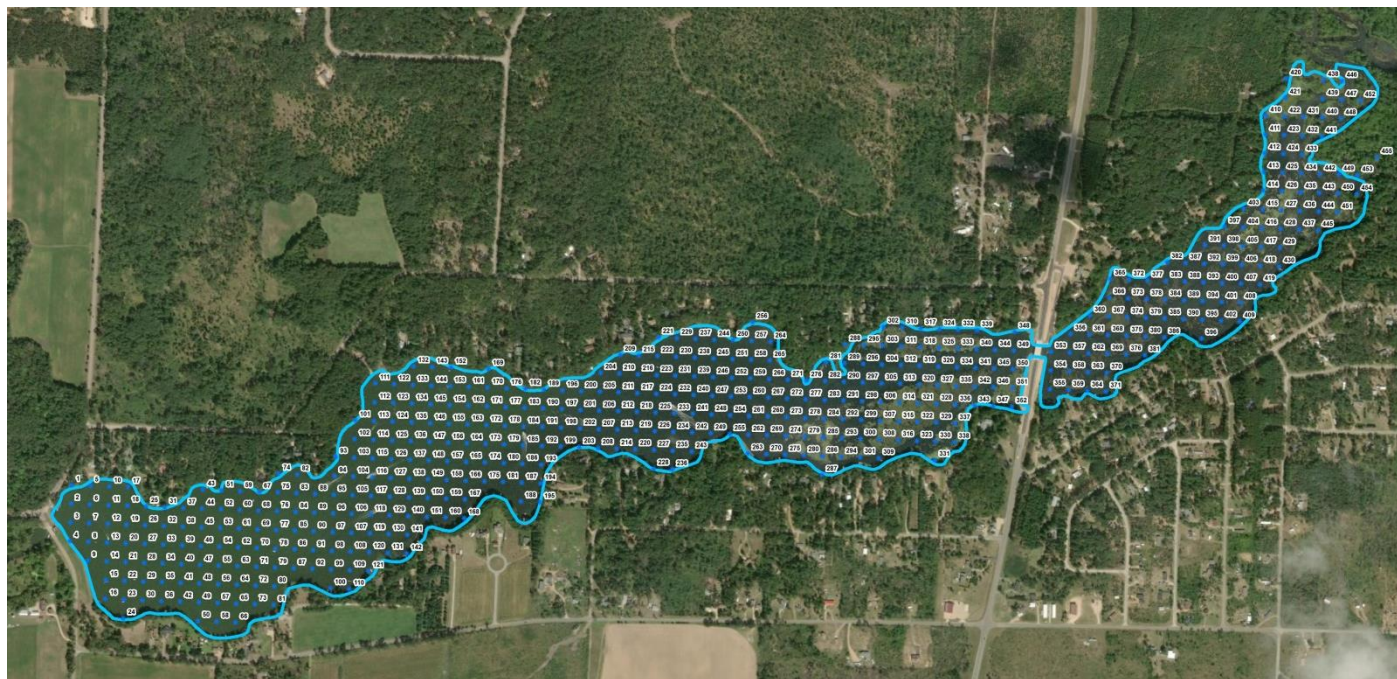
**Figure 1. Big Roche A Cri Plant Survey Sample Points**  
(Map Credit: Endangered Resource Services, LLC)

An aquatic plant survey was performed on May 25, 2019 to assess the distribution and growth density of Eurasian watermilfoil and curly-leaf pondweed. A second aquatic plant survey was performed on July 31, 2019 to assess all plants in Big Roche A Cri. The point intercept plant surveys were completed using a rake to collect plant samples at 455 equally spaced sample points (Figures 1 and 2). In May, the quantity of Eurasian watermilfoil and curly-leaf pondweed on the rake at each sample location were determined to evaluate the density of each species. In July, the overall quantity of plants on the rake at each sample location was determined to evaluate plant density. Next, the individual species collected on the rake were identified. After identification of each species, the quantity of each individual species was determined to evaluate the plant density of each species at each sample location. Rake fullness was used to determine the overall quantity (density) of plants and the quantity (density) of individual species at each sample location. Rake fullness is measured on a scale of 1 to 3 where:

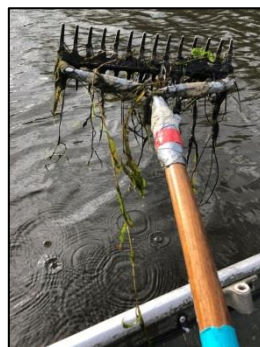
**Figure 2. A rake, pictured to the left, was used to collect the plants in the plant survey**  
(Photo Credit: Endangered Resource Services, LLC)

- 1 = A few plants on the rake head.
- 2 = Rake head is about ½ full of plants and can easily see top of rake head.
- 3 = Rake is overflowing with plants and cannot see top of rake head.

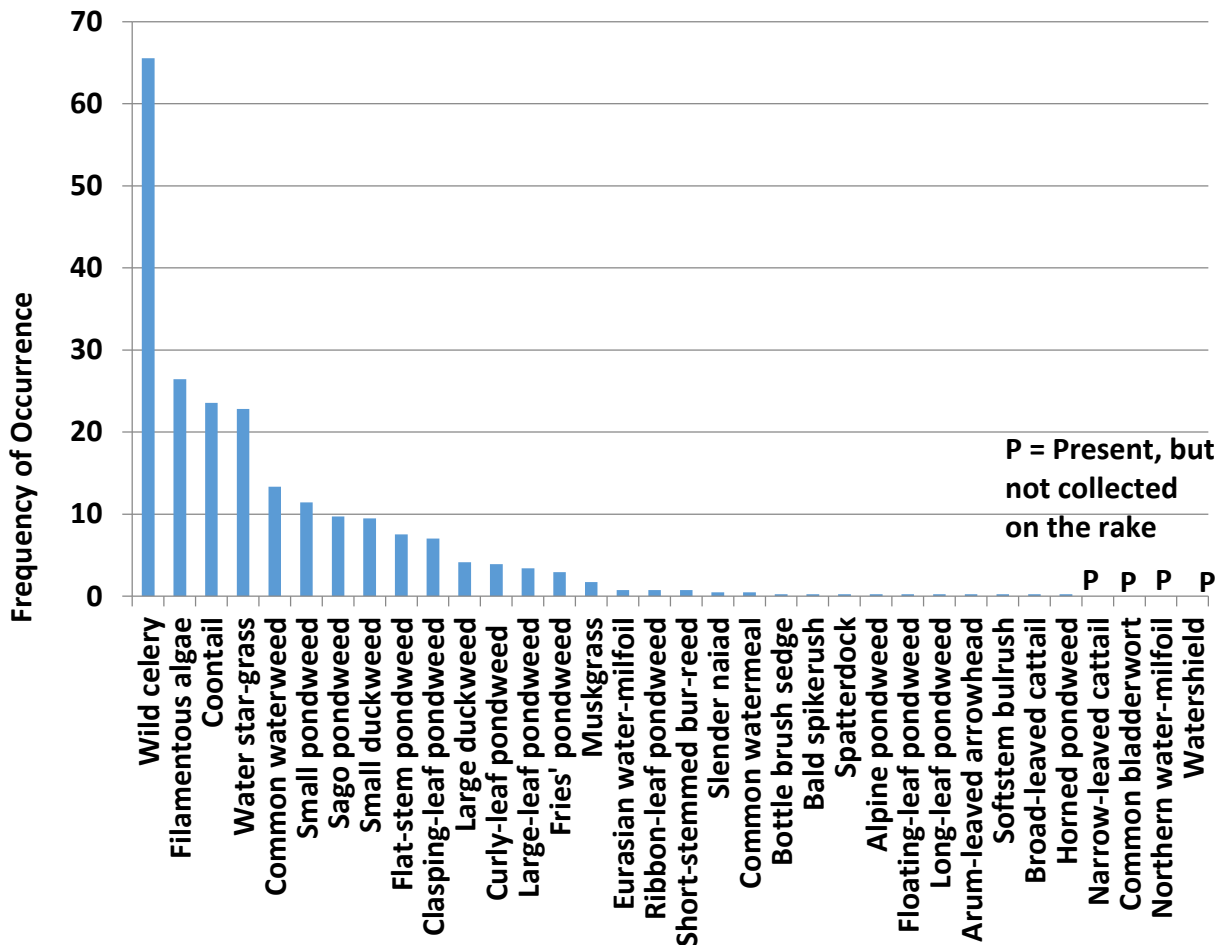
Figure 3. Frequency of Occurrence of Individual Species in the Littoral Area of Big Roche A Cri on July 31, 2019

The 2019 plant survey results indicated the Big Roche A Cri plant community was healthy and diverse. A total of 33 species plus filamentous algae were observed, more than double the median value for lakes in the same ecoregion (median number of species in North Central Hardwood Forests ecoregion is 14) (Nichols 1999)<sup>1</sup>. The maximum depth of Big Roche A Cri during the July plant survey was 18 feet and plants were found growing up to the 13.5 foot depth. The area of the lake where plants grow is called the littoral area. Of the 412 sample points found in the littoral area of Big Roche A Cri, 360 had plants. Hence, plants were found in 87 percent of the sample sites in the littoral area. Wild celery, a native species, dominated the plant community, occurring at two thirds of littoral sample sites and often impaired navigation. Filamentous algae, coontail, water star-grass, common waterweed, and small pondweed occurred at more than 10 percent of littoral sample points while all other plant species occurred at less than 10 percent of littoral sample points (Figure 3). Many species were primarily found in the creek inlet or in the upstream one third of the lake (upstream of the bridge). Nine species occurred primarily in the creek inlet –small pondweed, curly-leaf pondweed, large-leaf pondweed, Fries' pondweed, muskgrass, ribbon-leaf pondweed, short-stemmed bur-reed, bottle brush sedge, and bald spikerush – and four species in the upstream one third of the lake–slender naiad, softstem bulrush, broad-leaved cattail, and horned pondweed. Dense, nearly monotypic stands of narrow-leaved cattail occurred just above and below the bridge.

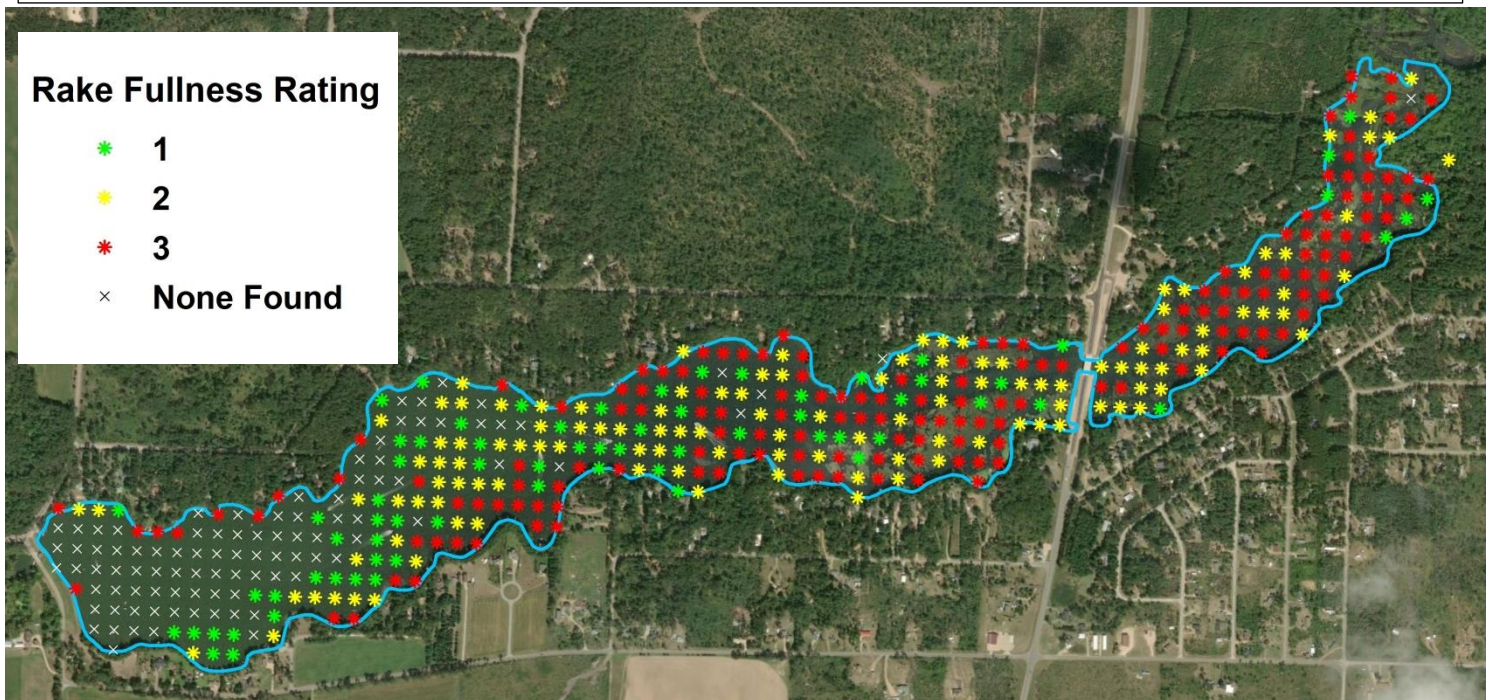
**Figure 4. Average Plant Density (Rake Fullness) Per Sample Point at Big Roche A Cri Sample Locations on July 31, 2019 (Map Credit: Endangered Resource Services, LLC)**

Plant density in Big Roche A Cri was measured by rake fullness on a scale of 1 (low) to 3 (high). In 2019, average plant density ranged from low to high (Figure 4). The average rake fullness in the lake's vegetated sample sites was 2.3. Nearly half of the individual species had an average rake fullness of 1, indicating a low density. Nearly half of the individual species had an average rake fullness of 2, indicating moderate density. Two species (alpine pondweed and floating-leaf pondweed) had an average rake fullness of 3, indicating high density (Figure 5), but were only observed at a single location within the lake.

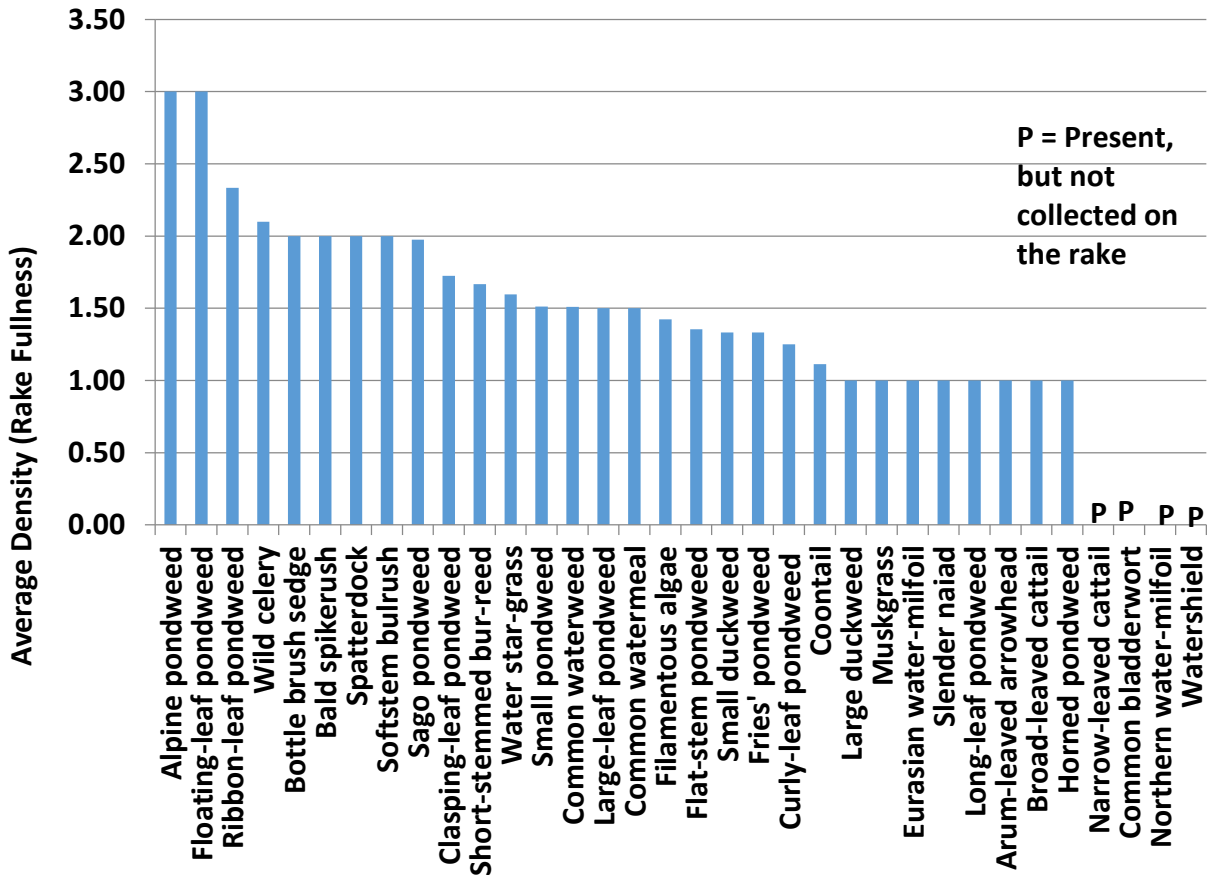
Figure 5. Average Density (Rake Fullness) of Individual Species in Big Roche A Cri on July 31, 2019

Although only 2 species had an average rake fullness of 3 (high density), filamentous algae and 10 additional plant species observed a rake fullness of 3 at one or more locations. Wild celery, the dominant plant in the lake, frequently occurred at high density, noting a rake fullness of 3 at 105 of the 273 locations at which it was observed. Water star-grass was occasionally dense, especially in areas with some flowing water, noting a rake fullness of 3 at 8 of the 110 sites at which it was observed. Small pondweed occurred as canopied mats in the creek inlet, noting a rake fullness of 3 at 11 of the 54 sites at which it was observed. Sago pondweed was occasionally dense, especially in shallow sandy areas near the creek inlet, noting a density of 3 at 14 of the 47 sites in which it was observed. Other species noting a density of 3 at one or more sample points include common waterweed (8 of the 58 sites observed), filamentous algae (7 of 109 sites observed), clasping-leaf pondweed (6 of the 34 sites observed), flat-stem pondweed (3 of the 42 sites observed), large-leaf pondweed (1 of the 15 sites observed), small duckweed (1 of the 39 sites observed), and ribbon-leaf pondweed (1 of 4 sites observed).

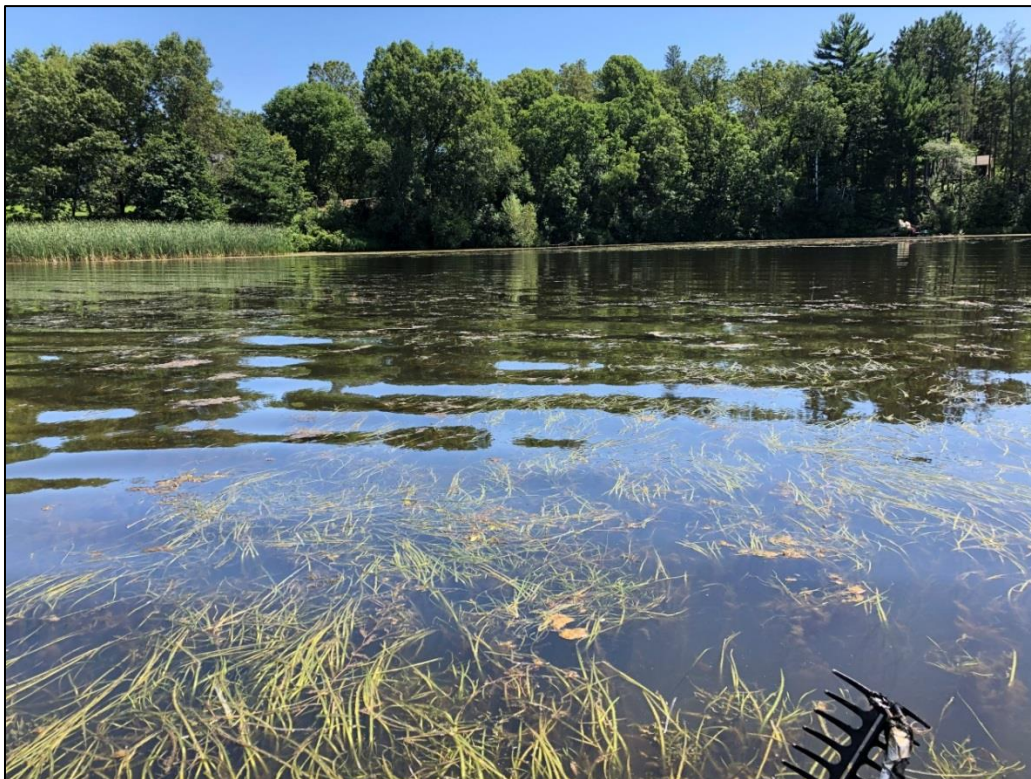
**Wild celery in Big Roche A Cri, pictured above, significantly increased in density in 2019 (Photo Credit: Endangered Resource Services, LLC)**

Between 2008 and 2019, not only did overall plant frequency increase, but increases were also documented for the number of native species collected on the rake (from 19 in 2008 to 27 in 2019), the average C value of the plant community, (from 5.3 in 2008 to 5.6 in 2019), and FQI (from 22.9 in 2008 to 29.1 in 2019) indicating the 2019 plant community was more diverse, less tolerant to degraded conditions, and of higher quality. Additionally, plant density increased in 2019, from a mean plant density (rake fullness) in 2008 of 1.86 to a mean plant density (rake fullness) of 2.26 in 2019.

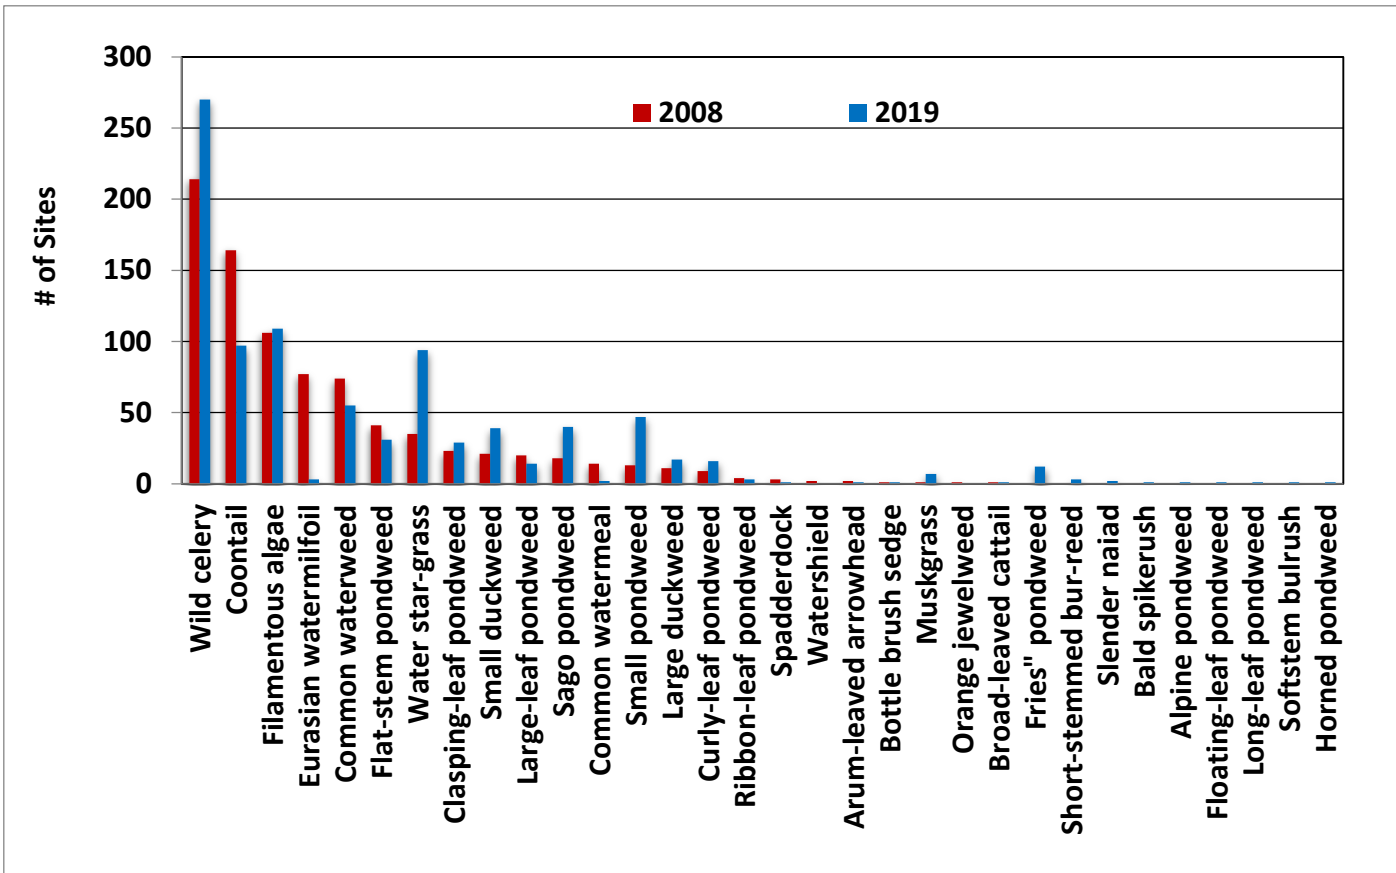
Figure 7. Comparison of 2008 and 2019 Frequency Differences for All Species in Big Roche A Cri (Number of Sites Collected on the Rake during 2008 and 2019) (2008 Data Collected by Wisconsin Department of Natural Resources)

Big Roche A Cri aquatic plant data collected by the rake during mid-August 2008 by the Wisconsin Department of Natural Resources were compared with data collected by the rake during July 31, 2019 by the Big Roche A Cri Lake District to document significant changes in the frequency of plant species. A statistical tool, Chi Squared Analysis, was used to identify significant frequency changes. The analysis documented significant increases in frequency for 7 species and significant decreases in frequency for 4 species (Figures 7 and 8). One of the species that significantly declined in 2019 was Eurasian water milfoil, a positive change for the lake. Eurasian watermilfoil was collected on the rake at 77 sites in 2008 and was collected on the rake at only 3 sites in 2019.

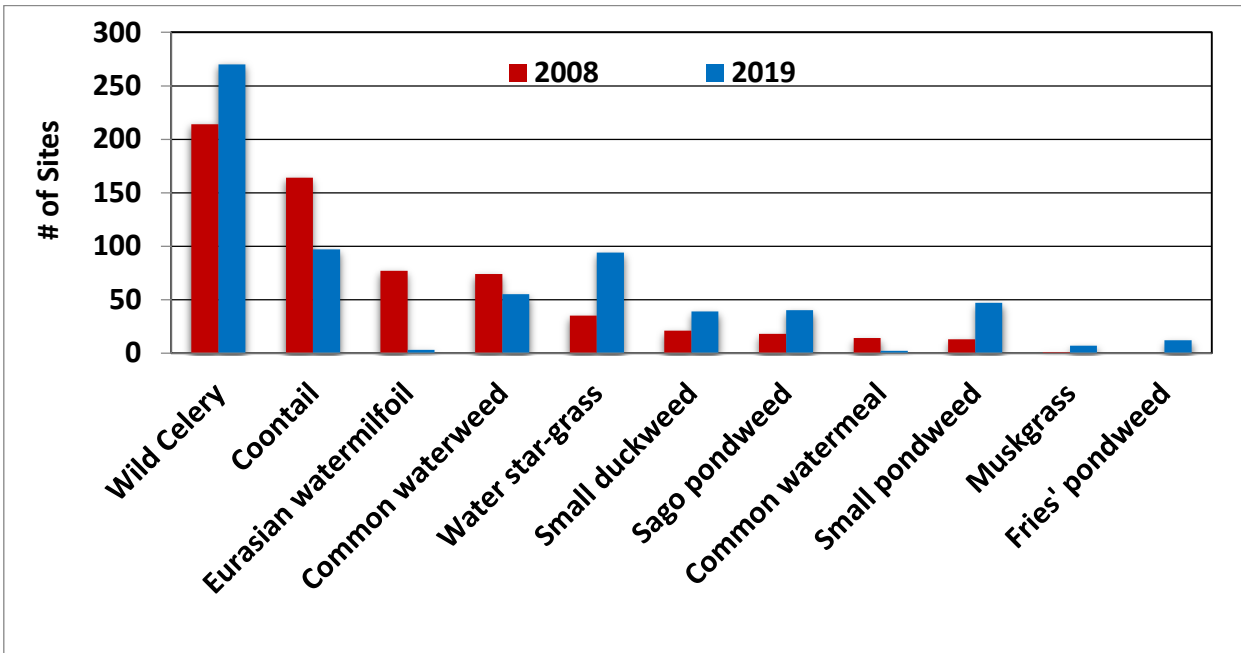
Figure 8. Species with Significant Frequency Differences Between 2008 and 2019 in Big Roche A Cri (Number of Sites Collected on the Rake during 2008 and 2019) (2008 Data Collected by Wisconsin Department of Natural Resources)

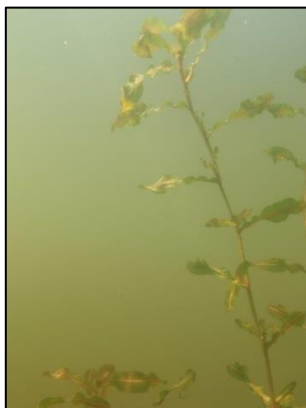
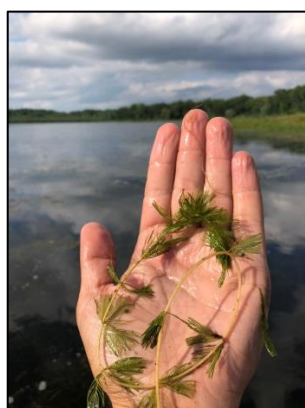
**Pictured below, curly-leaf pondweed (left), Eurasian watermilfoil (middle) and narrow-leaved cattails (right)**

Curly-leaf pondweed (*Potamogeton crispus*) was monitored on May 25 and July 31, 2019. On May 25, curly-leaf pondweed was collected on the rake at 14 locations (Figure 9). On July 25, curly-leaf pondweed was collected on the rake at 16 sample locations and observed near an additional 14 locations (Figure 10).

Eurasian watermilfoil was monitored on May 25 and July 31, 2019. On May 25, Eurasian watermilfoil was collected on the rake at 2 locations and visually observed near one additional sample location (Figure 12). On July 31, 2019, Eurasian watermilfoil was collected on the rake at 3 locations and visually observed near 7 additional sample locations (Figure 13). In July, Eurasian watermilfoil was widely scattered except in the bay just southwest of the bridge - even here it was extremely patchy/low density. Eurasian watermilfoil frequency was lower in 2019 than 2008 and the decline was statistically significant at the 95 percent confidence level. In mid-August of 2008, Eurasian watermilfoil was collected on the rake at 77 sample locations and visually observed near 21 additional locations (Figure 14).

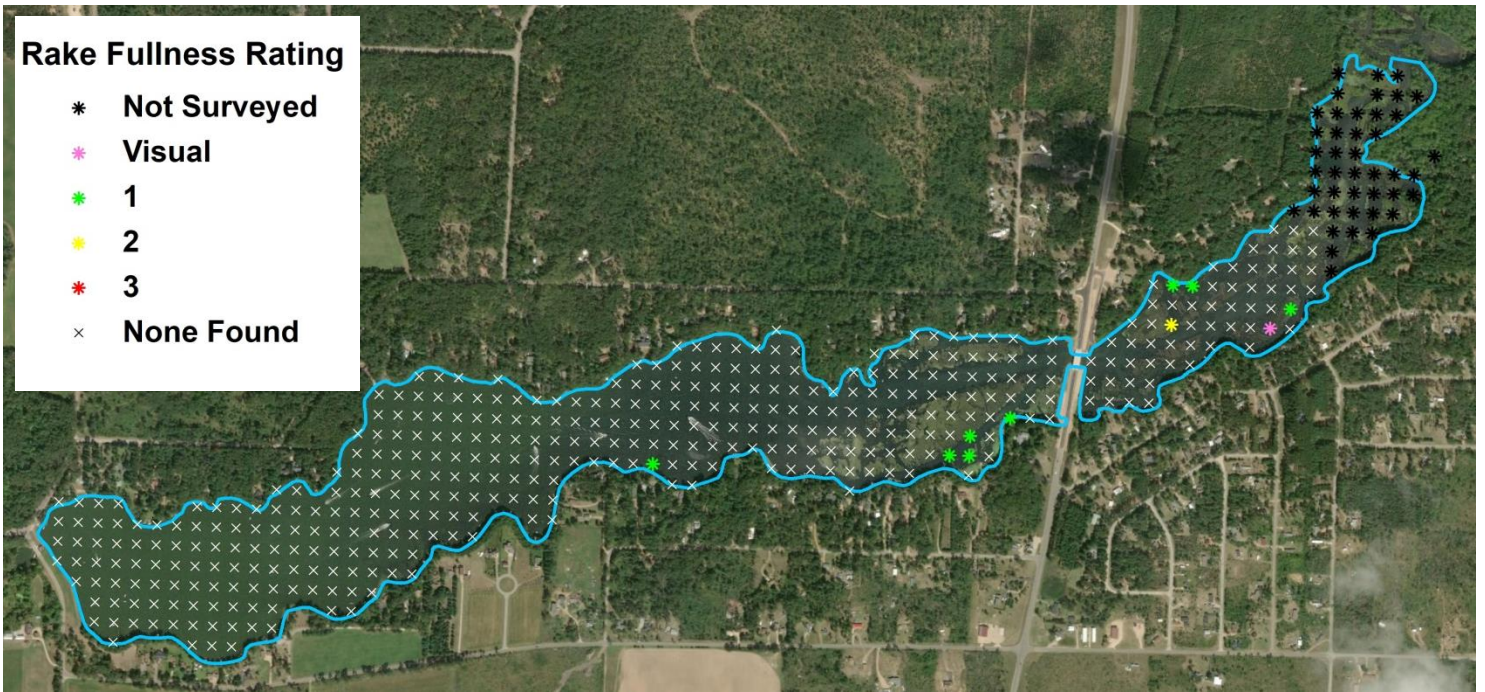
Figure 11. Mid-August 2008 Curly-leaf Pondweed Locations in Big Roche A Cri (2008 Data Collected by Wisconsin Department of Natural Resources) (Map Credit: Endangered Resource Services, LLC)

Curly-leaf pondweed frequency was higher in 2019 than 2008. In mid-August of 2008, curly-leaf pondweed was collected on the rake at 9 sample locations and visually observed near one additional location (Figure 11). The 2019 increase in number of sites where curly-leaf pondweed was collected on the rake is not statistically significant at the 95 percent confidence level. However, the July 31, 2019 increase in the number of sites where curly-leaf pondweed was visually observed near sample locations is a statistically significant increase at the 95 percent confidence level.

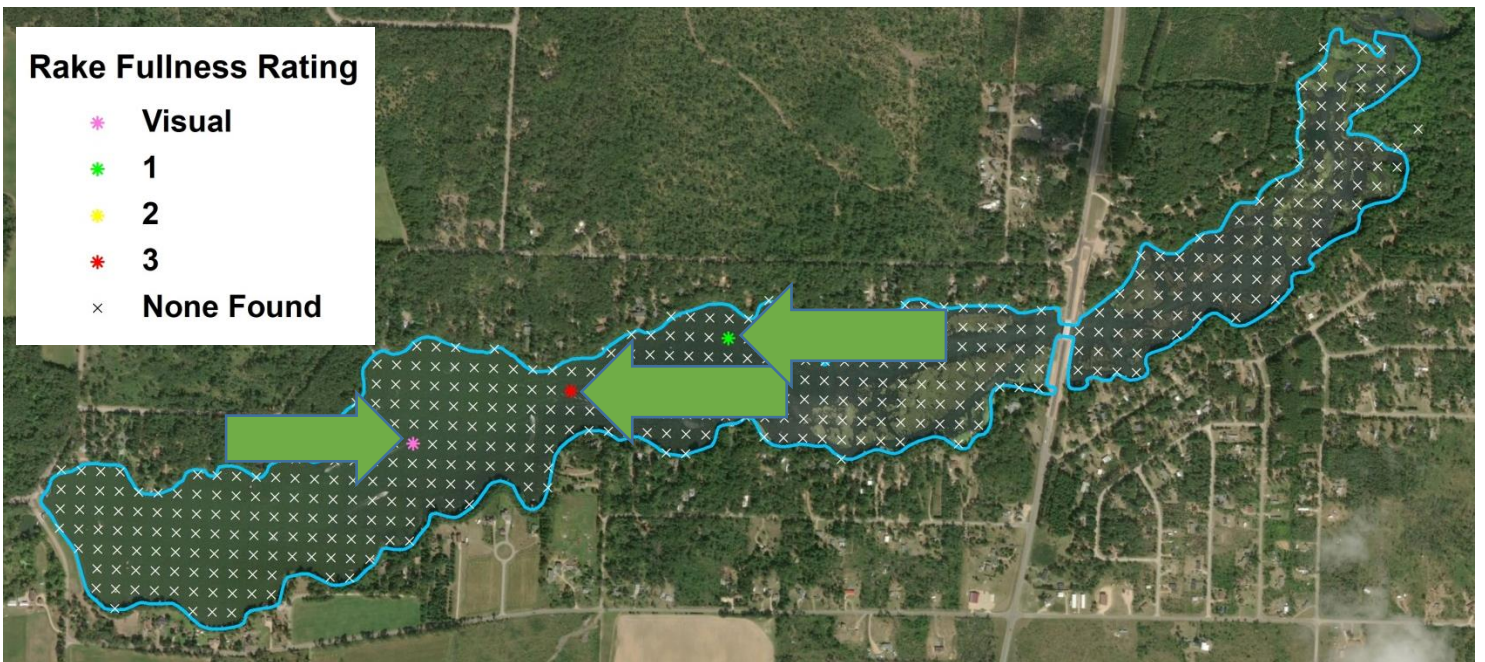
Figure 12. May 25, 2019 Eurasian watermilfoil Locations in Big Roche A Cri (Map Credit: Endangered Resource Services, LLC)

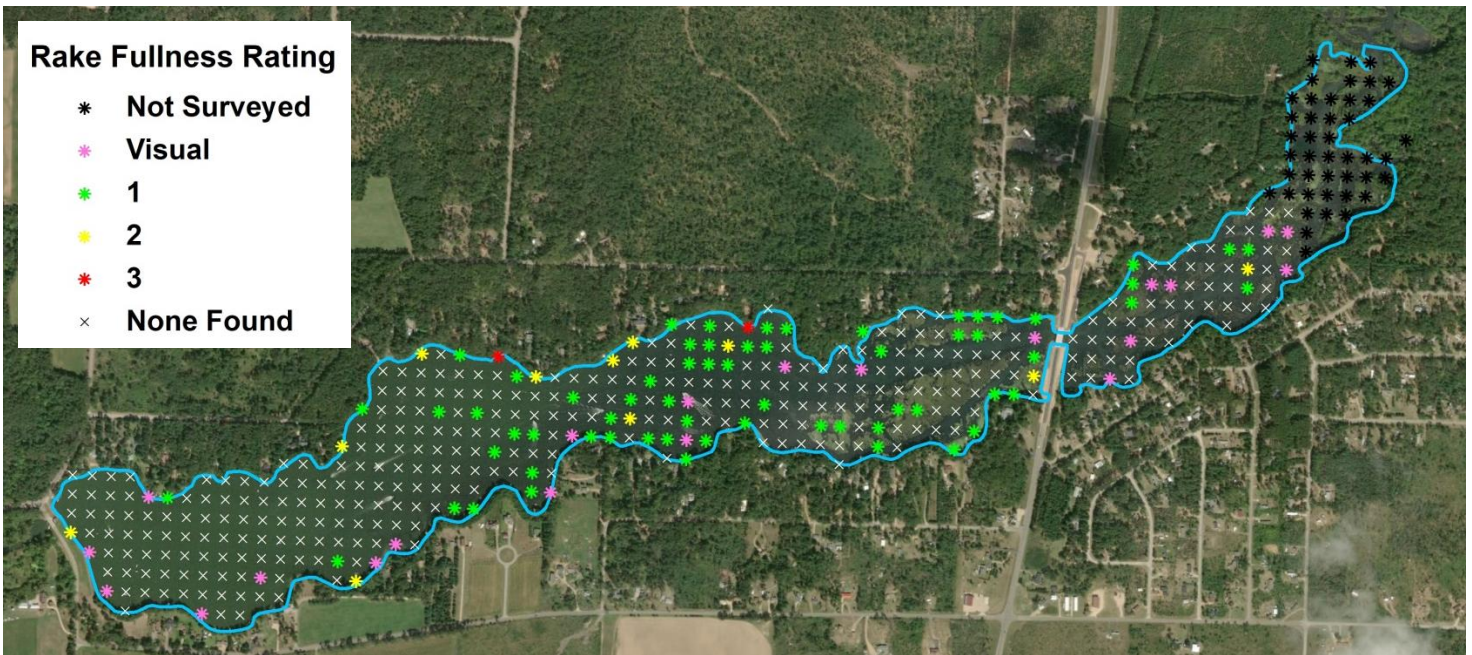
Figure 14. Mid-August 2008 Eurasian watermilfoil Locations in Big Roche A Cri (2008 Data Collected by Wisconsin Department of Natural Resources) (Map Credit: Endangered Resource Services, LLC)
