# BIG CHETAC AND BIRCH LAKES, SAWYER/WASHBURN COUNTY

2020-24 Comprehensive Management Plan  
WDNR WBIC: 2113300 & 2113000

Prepared by: Dave Blumer, Lake Educator  
December, 2019

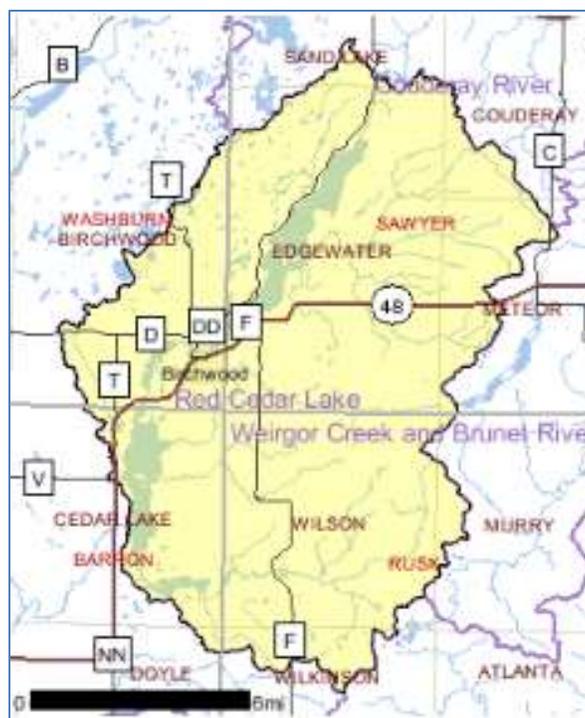
Figure 2: Red Cedar Lake watershed - LC11, (WDNR)

The Big Chetac, Birch, and Little Birch lakes watershed is a sub-watershed of the larger Red Cedar Lake Watershed, an area that includes the headwaters of the Red Cedar River. The Red Cedar Lake Watershed covers the adjoining corners of Barron, Rusk, Sawyer, and Washburn counties (Figure 2). A small portion of the Lac Courte Oreilles Indian Reservation lies within the Red Cedar Lake Watershed north and west of Lake Chetac. Much of this watershed is forested, with county forest land a large component of the watershed. The north central portion of the watershed consists of glacial pitted outwash and contains numerous small to large lakes. Big Chetac and Birch Lake are located in this area. The area is mostly forested, but some agricultural land exists northwest and southeast of Birch Lake. The southeastern part of the watershed is in the rocky, hilly area known as the Blue Hills. The area consists of glacial end moraines and ground moraine. It is underlain by quartzite bedrock and is steep-sloped and forested. There are few lakes present in this area. The western portion of the watershed consists of end moraines and also contains a substantial number of lakes, the largest of which are Red Cedar, Hemlock, and Balsam. Most of the area is forested, though significant agricultural areas exist northeast and east of Red Cedar Lake, and southeast of Hemlock Lake.

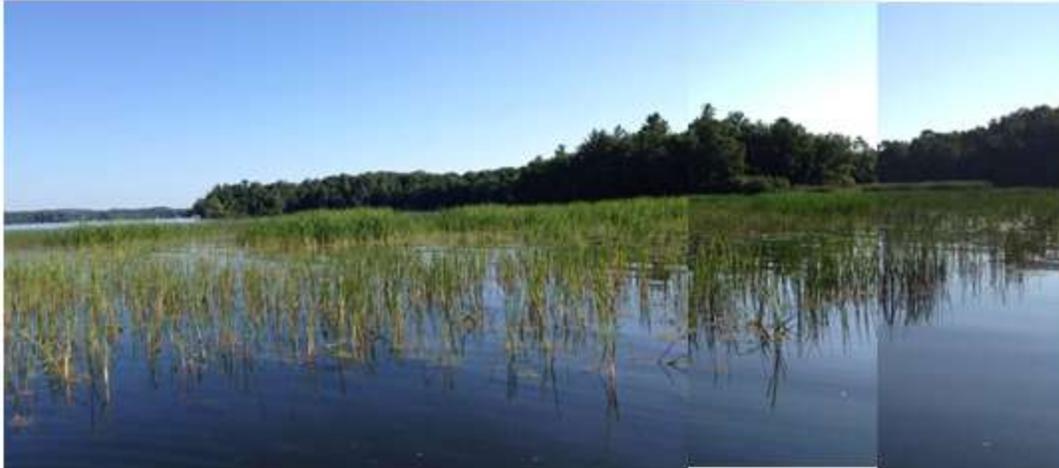
Wild rice, a plant of significant wildlife and cultural value, is present in scattered patches along the creek inlets in the Bullpen (Figure 22). Most areas support only low to moderate density plants, and no areas have ever been mapped that were big enough or dense enough that they would offer profitable human harvest. Outside of this area, wild rice has never been observed growing anywhere else in the system.

Figure 22: Panorama of northern wild rice in Malviney Creek inlet facing northwest into the Bullpen – 7/28/17 (Berg M. S., 2017a)

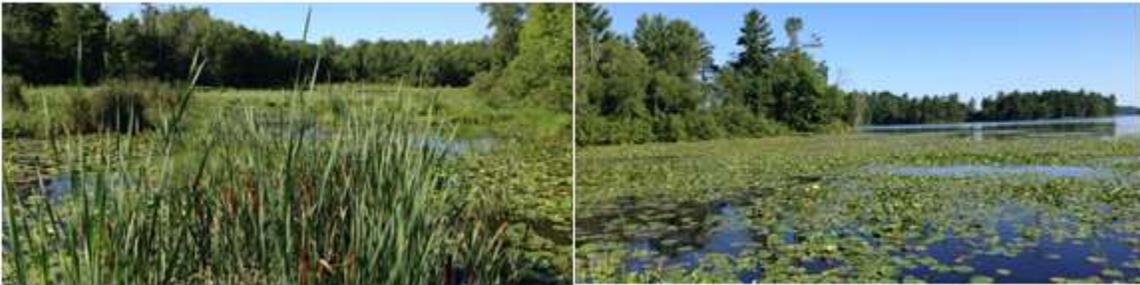
The 2008 survey found a bed of rice in the nearly inaccessible bay south of the Malviney Creek inlet that was moderate to high density. The only two survey points in the lake with rice occurred here, and each had a rake fullness of 3. This shallow bay still had rice in 2014 and 2017, but the area has largely been taken over by water lilies and cattails (Figure 23). In 2014 and 2017, wild rice was found at three points, but each sample consisted of a single plant so the mean rake fullness was 1.00 for each survey (Figure 24).

Figure 23: Rice remnants in bays southwest of Malviney Creek inlet – 7/28/17 (Berg M. S., 2017a)

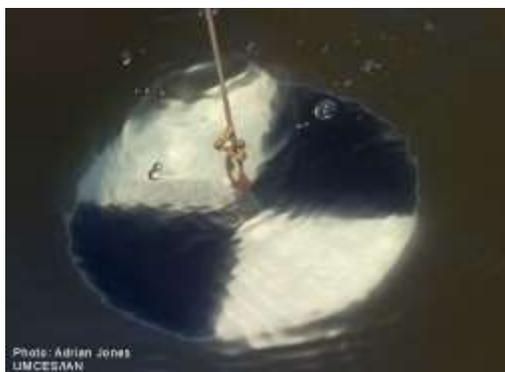
**Figure 31: Secchi Disk**

As previously discussed water clarity is most commonly measured by a Secchi disk (Figure 31). The Secchi disk is lowered into the water column until it can no longer be seen. The depth at which it disappears from view is considered the Secchi depth. Though not a direct measurement of the amount of light passing through the water column at any given depth, it is a reliable substitute if a light meter measuring light irradiance is not available. Caffrey et al found that measuring actual light attenuation with a meter did not predict maximum depth of plant colonization any better than the Secchi disk.

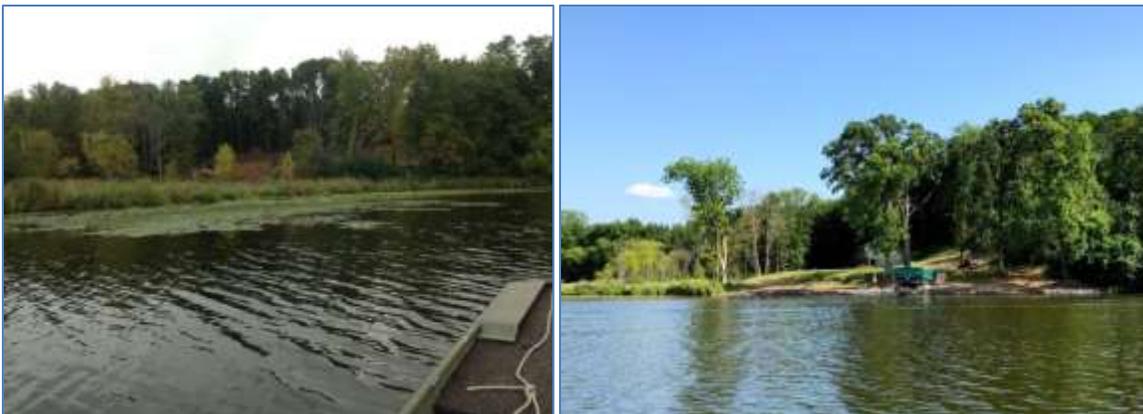
Building too close to the water, removing shoreland plants, and covering too much of a lake shore lot with hard surfaces (such as roofs and driveways) can harm important habitat for fish and wildlife, send more nutrient and sediment runoff into the lake, and cause water quality decline (Figure 32).

**Figure 32: New lakeside development, same site (2016-left); (2018-right)**

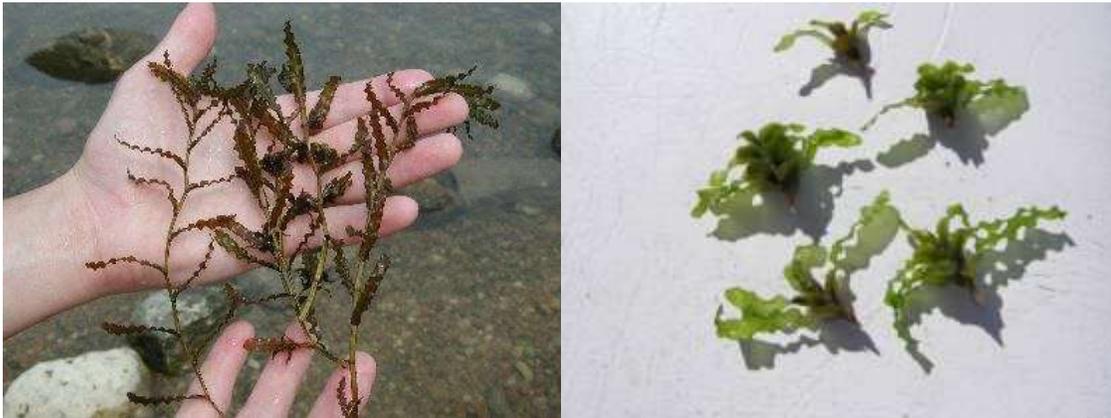
CLP spreads through burr-like winter buds (turions) (Figure 41), which are moved among waterways. These plants can also reproduce by seed, but this plays a relatively small role compared to the vegetative reproduction through turions. New plants form under the ice in winter, making curly-leaf pondweed one of the first nuisance aquatic plants to emerge in the spring. It becomes invasive in some areas because of its tolerance for low light and low water temperatures. These tolerances allow it to get a head start on and out-compete native plants in the spring. In mid-summer, when most aquatic plants are growing, CLP plants are dying off. Plant die-offs may result in a critical loss of dissolved oxygen. Furthermore, the decaying plants can increase nutrients which contribute to algal blooms, as well as create unpleasant stinking messes on beaches. CLP forms surface mats that interfere with aquatic recreation.

**Figure 41: CLP Plants and Turions**

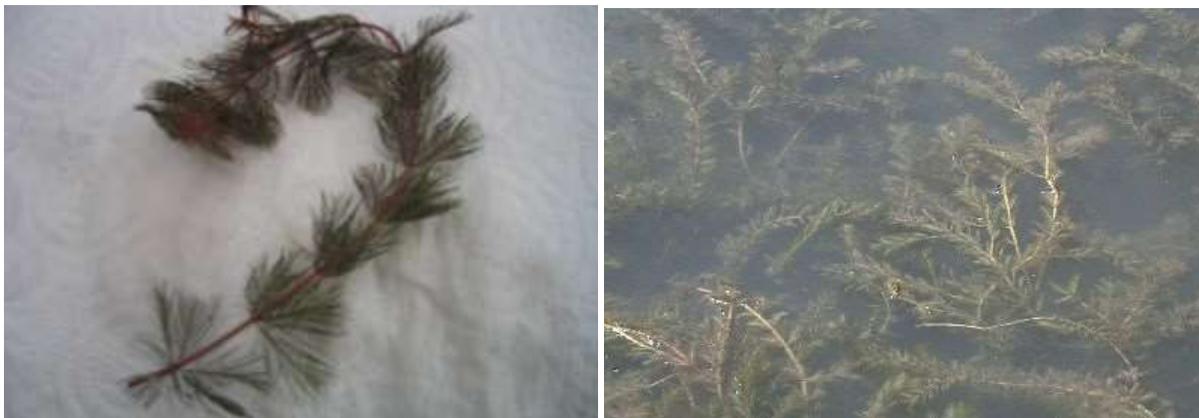
**Figure 42: EWM**

EWM is a submersed aquatic plant native to Europe, Asia, and northern Africa (Figure 42). It is the only non-native milfoil in Wisconsin. Like the native milfoils, EWM has slender stems whorled by submersed feathery leaves and tiny flowers produced above the water surface. The flowers are located in the axils of the floral bracts, and are either four-petaled or without petals. The leaves are threadlike, typically uniform in diameter, and aggregated into a submersed terminal spike. The stem thickens below the inflorescence and doubles its width further down, often curving to lie parallel with the water surface. The fruits are four-jointed nut-like bodies. Without flowers or fruits, EWM is difficult

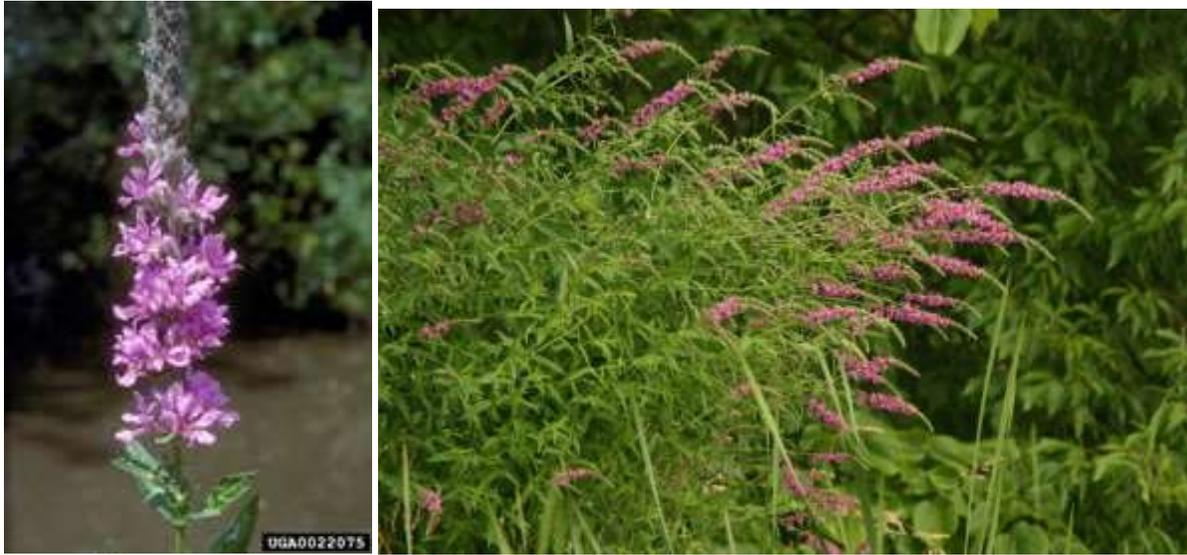
**Figure 43: Purple Loosestrife**

Purple loosestrife (Figure 43) is a perennial herb 3-7 feet tall with a dense bushy growth of 1-50 stems. The stems, which range from green to purple, die back each year. Showy flowers that vary from purple to magenta possess 5-6 petals aggregated into numerous long spikes, and bloom from August to September. Leaves are opposite, nearly linear, and attached to four-sided stems without stalks. It has a large, woody taproot with fibrous rhizomes that form a

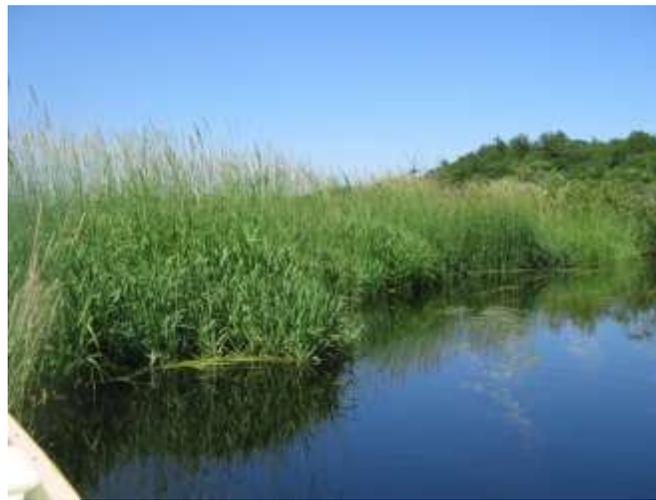
**Figure 44: Reed Canary Grass**

Reed canary grass (Figure 44) is a large, coarse grass that reaches 2 to 9 feet in height. It has an erect, hairless stem with gradually tapering leaf blades 3 1/2 to 10 inches long and 1/4 to 3/4 inch in width. Blades are flat and have a rough texture on both surfaces. The lead ligule is membranous and long. The compact panicles are erect or slightly spreading (depending on the plant's reproductive stage), and range from 3 to 16 inches long with branches 2 to 12 inches in length. Single flowers occur in dense clusters in May to mid-June. They are green to purple at first and change to beige over time. This grass is one of the first to sprout in spring, and forms a thick rhizome system that dominates the subsurface soil. Seeds are shiny brown in color.

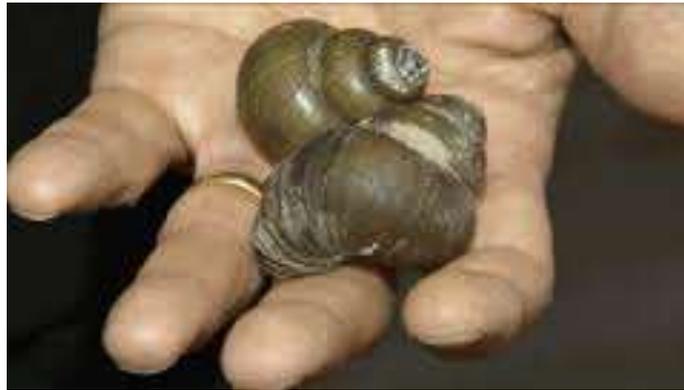
**Figure 45: Chinese Mystery Snails**

The Chinese mystery snails and the banded mystery snails (Figure 45) are non-native snails that have been found in a number of Wisconsin lakes. There is not a lot yet known about these species, however, it appears that they have a negative effect on native snail populations. The mystery snail's large size and hard operculum (a trap door cover which protects the soft flesh inside), and their thick hard shell make them less edible by predators.

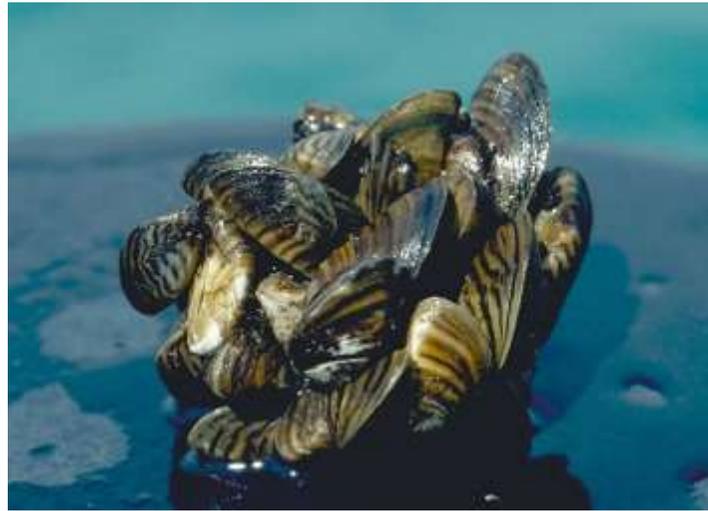
**Figure 47: Zebra Mussels**

Zebra mussels (Figure 47) are an invasive species that have inhabited Wisconsin waters and are displacing native species, disrupting ecosystems, and affecting citizens' livelihoods and quality of life. They hamper boating, swimming, fishing, hunting, hiking, and other recreation, and take an economic toll on commercial, agricultural, forestry, and aquacultural resources. The zebra mussel is a tiny (1/8-inch to 2-inch) bottom-dwelling clam native to Europe and Asia. Zebra mussels were introduced into the Great Lakes in 1985 or 1986, and have been spreading throughout them since that time. They were most likely brought to North America as larvae in ballast water of ships that traveled from fresh-water Eurasian ports to the Great Lakes. Zebra mussels look like small clams with a yellowish or brownish D-shaped shell, usually with alternating dark- and light-colored stripes. They can be up to two inches long, but most are under an inch. Zebra mussels usually grow in clusters containing numerous individuals.

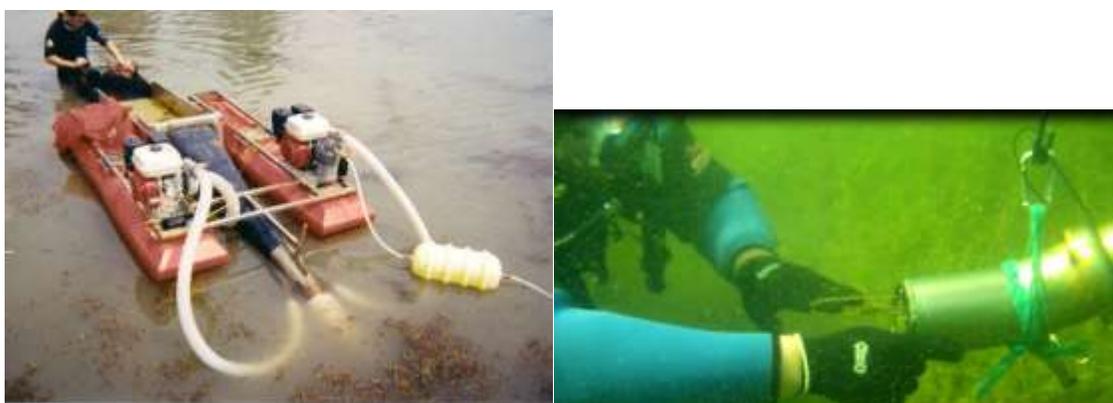
**Figure 49: DASH Diver Assisted Suction Harvest (Aquacleaner Environmental, <http://www.aquacleaner.com/index.html>); Many Waters, LLC)**

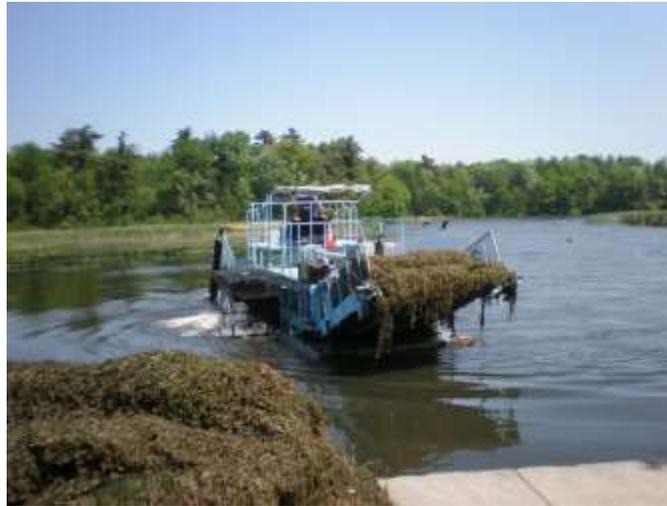
**Figure 50: Aquatic Plant Harvester on Rice Lake, WI**

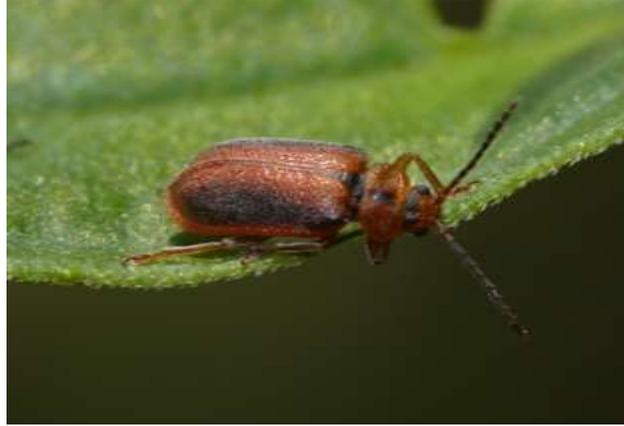
**Figure 51: Galerucella Beetle**

Two species of Galerucella beetles are currently approved for the control of purple loosestrife in Wisconsin (Figure 51). The entire lifecycle of Galerucella beetles is dependent on purple loosestrife. In the spring, adults emerge from the leaf litter below old loosestrife plants. The adults then begin to feed on the plant for several days until they begin to reproduce. Females lay their eggs on loosestrife leaves and stems. When the larvae emerge from these eggs they begin feeding on the leaves and developing shoots. When water levels are high these larvae will burrow into the loosestrife stems to pupate into adult beetles. These new adults emerge and begin feeding on the loosestrife again (Sebolt, 1998). Galerucella beetles do not forage on any plants other than purple loosestrife. Because of this the populations, once established, are self-regulating. When the purple loosestrife population drops off, the beetle population also declines. When the loosestrife returns, the beetle numbers will usually increase.

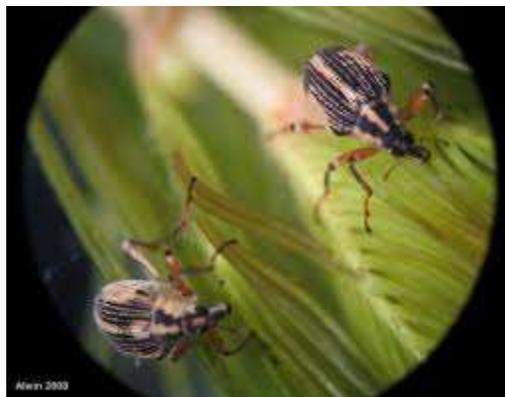
**Figure 52: EWM Weevil**

While many biological controls have been studied, only one has proven to be effective at controlling EWM under the right circumstances. *Euhrychiopsis lecontei* is an aquatic weevil native to Wisconsin that feeds on aquatic milfoils (Figure 52). Their host plant is typically northern watermilfoil; however they seem to prefer EWM when it is available. Milfoil weevils are typically present in low numbers wherever northern or Eurasian water milfoil is found. They often produce several generations in a given year and over winter in undisturbed shorelines around the lake. All aspects of the weevil's life cycle can affect the plant. Adults feed on the plant and lay their eggs. The eggs hatch and the larva feed on the plant. As the larva mature they eventually burrow into the stem of the plant. When they emerge as adults later, the hole left in the stem reduces buoyancy often causing the stem to collapse. The resulting interruption in the flow of carbohydrates to the root crowns reduces the plant's ability to store carbohydrates for over wintering reducing the health and vigor (Newman, Holmberg, Biesboer, & Penner, 1996).

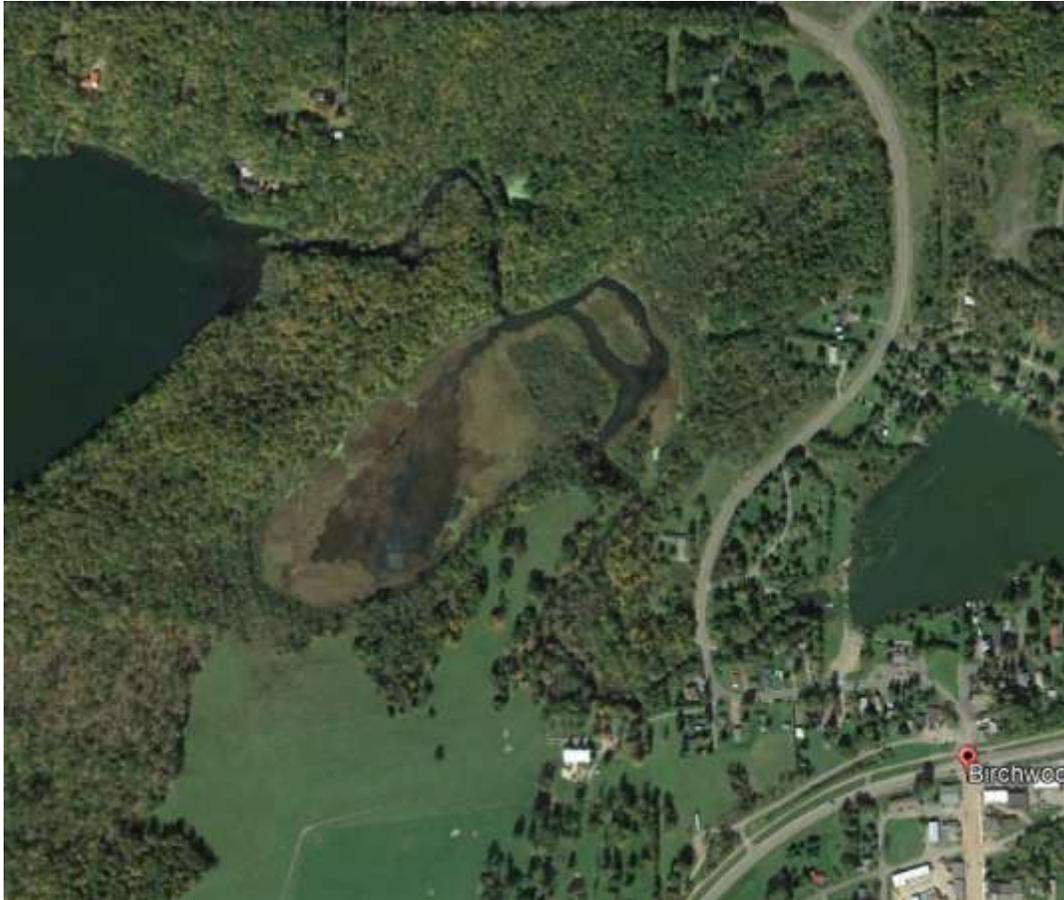
Another aspect of the water and nutrient budget in all of the lakes is the large wetland complex that exists between Birch Lake and Balsam Lake. It may be that this is the one single feature in the watershed that has protected Balsam and Red Cedar lakes from more rapid deterioration due to upstream phosphorus inputs (Figure 60).

Figure 57: Wetland Complex between Birch and Balsam Lakes (Google Earth)
