**Curly-leaf pondweed (*Potamogeton crispus*)
Point-intercept and Bed Mapping Surveys, and
Warm-water Macrophyte Point-intercept Survey
Granite Lake - WBIC: 2100800
Barron County, Wisconsin**

Endangered Resource Services, LLC
Matthew S. Berg, Research Biologist
St. Croix Falls, Wisconsin
June 4 and 12, and July 31, 2018

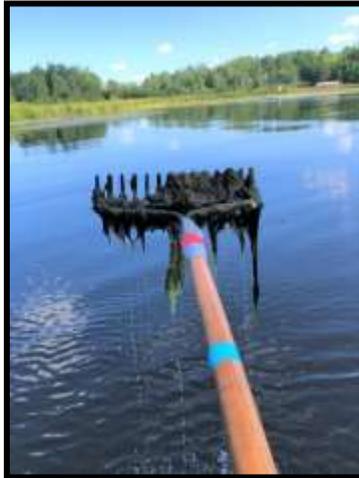
Filamentous algae covering bottom at inlet

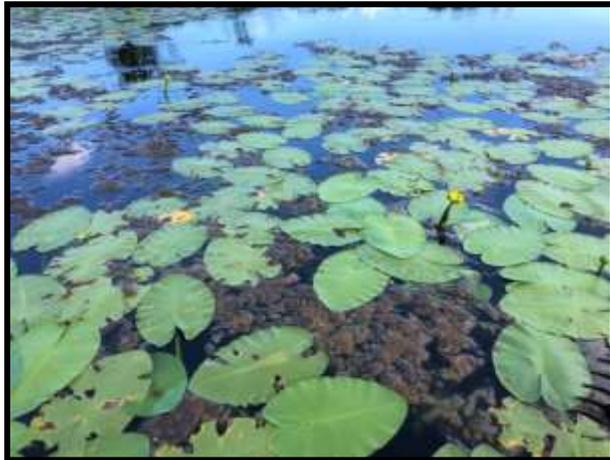
Spatterdock with mats of filamentous algae at the inlet 7/31/18

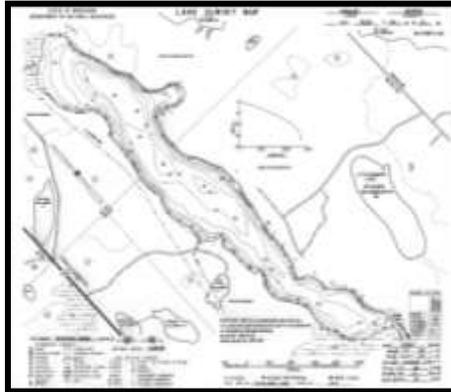
Figure 1: Granite Lake Bathymetric Map

Granite Lake (WBIC 2100800) is a 155 acre, stratified, drainage lake located in the Town of Lakeland in northwest Barron County (T36N R13W S29 SE SW). It reaches a maximum depth of 34ft in the north-central basin due west of the east bay and has an average depth of 18ft (WDNR 2018). The lake is eutrophic in nature with Secchi readings from 1994-2018 averaging 5.3ft (WDNR 2018). This poor water clarity produced a littoral zone that reached approximately 10.0ft in 2018. The lake's bottom substrate is predominantly rock and sand along the central basin with organic muck in the north and south bays as well as the creek inlet/outlet (Figure 1) (Bush et al. 1967).

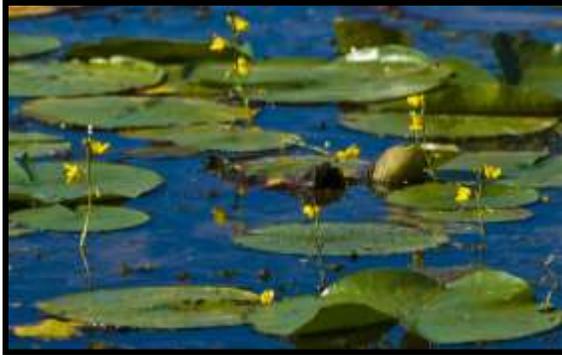
Near the outlet, we also found a few Common bladderworts (*Utricularia vulgaris*). Rather than drawing nutrients up through roots like other plants, bladderworts trap zooplankton and minute insects in their bladders, digest their prey, and use the nutrients to further their growth.

Common bladderwort flowers among lily pads (Hunt 2010)

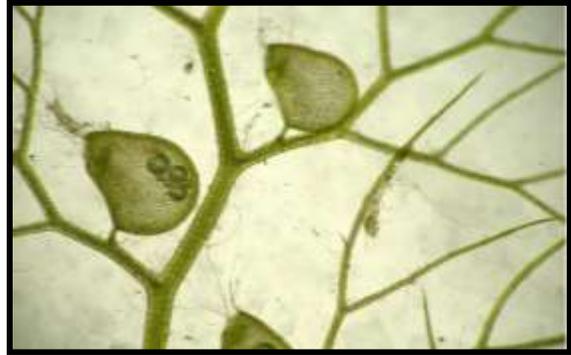
Bladders for catching plankton and insect larvae (Wontolla 2007)
