Project Name | Library Lake Southeast Stormwater Park

From / Contact info | Jimmy Marty and Britta Hansen, Emmons and Olivier Resources, Inc.

Regarding | Library Lake Habitat and Wildlife Assessment

Library Lake Habitat and Wildlife Assessment

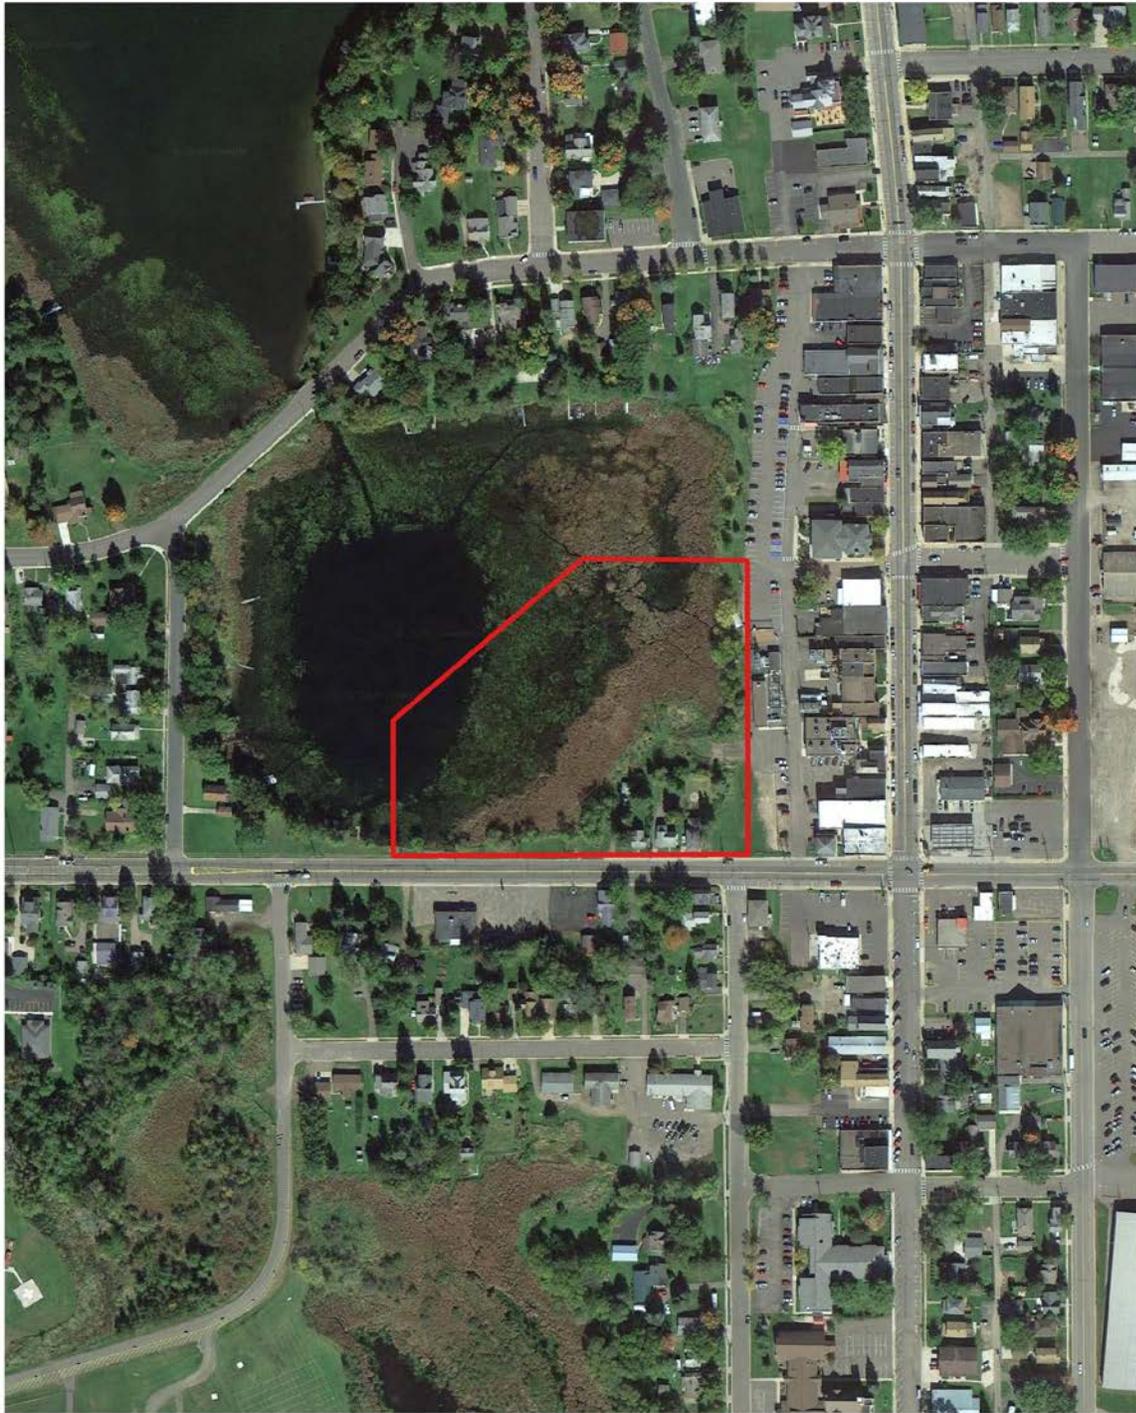
Figure 1. Study Area boundary

The assessment focused on an approximately 6.7-acre Study Area that encompasses the proposed grading limits of the project along with a buffer to account for contingencies and characterize the project vicinity (Figure 1). Methods consisted of a meander survey through upland and wetland areas on foot and open water areas via kayak. An Endangered Resources Review was also completed through Wisconsin Department of Natural Resources (WI DNR) to account for rare species/features and evaluate permitting needs.

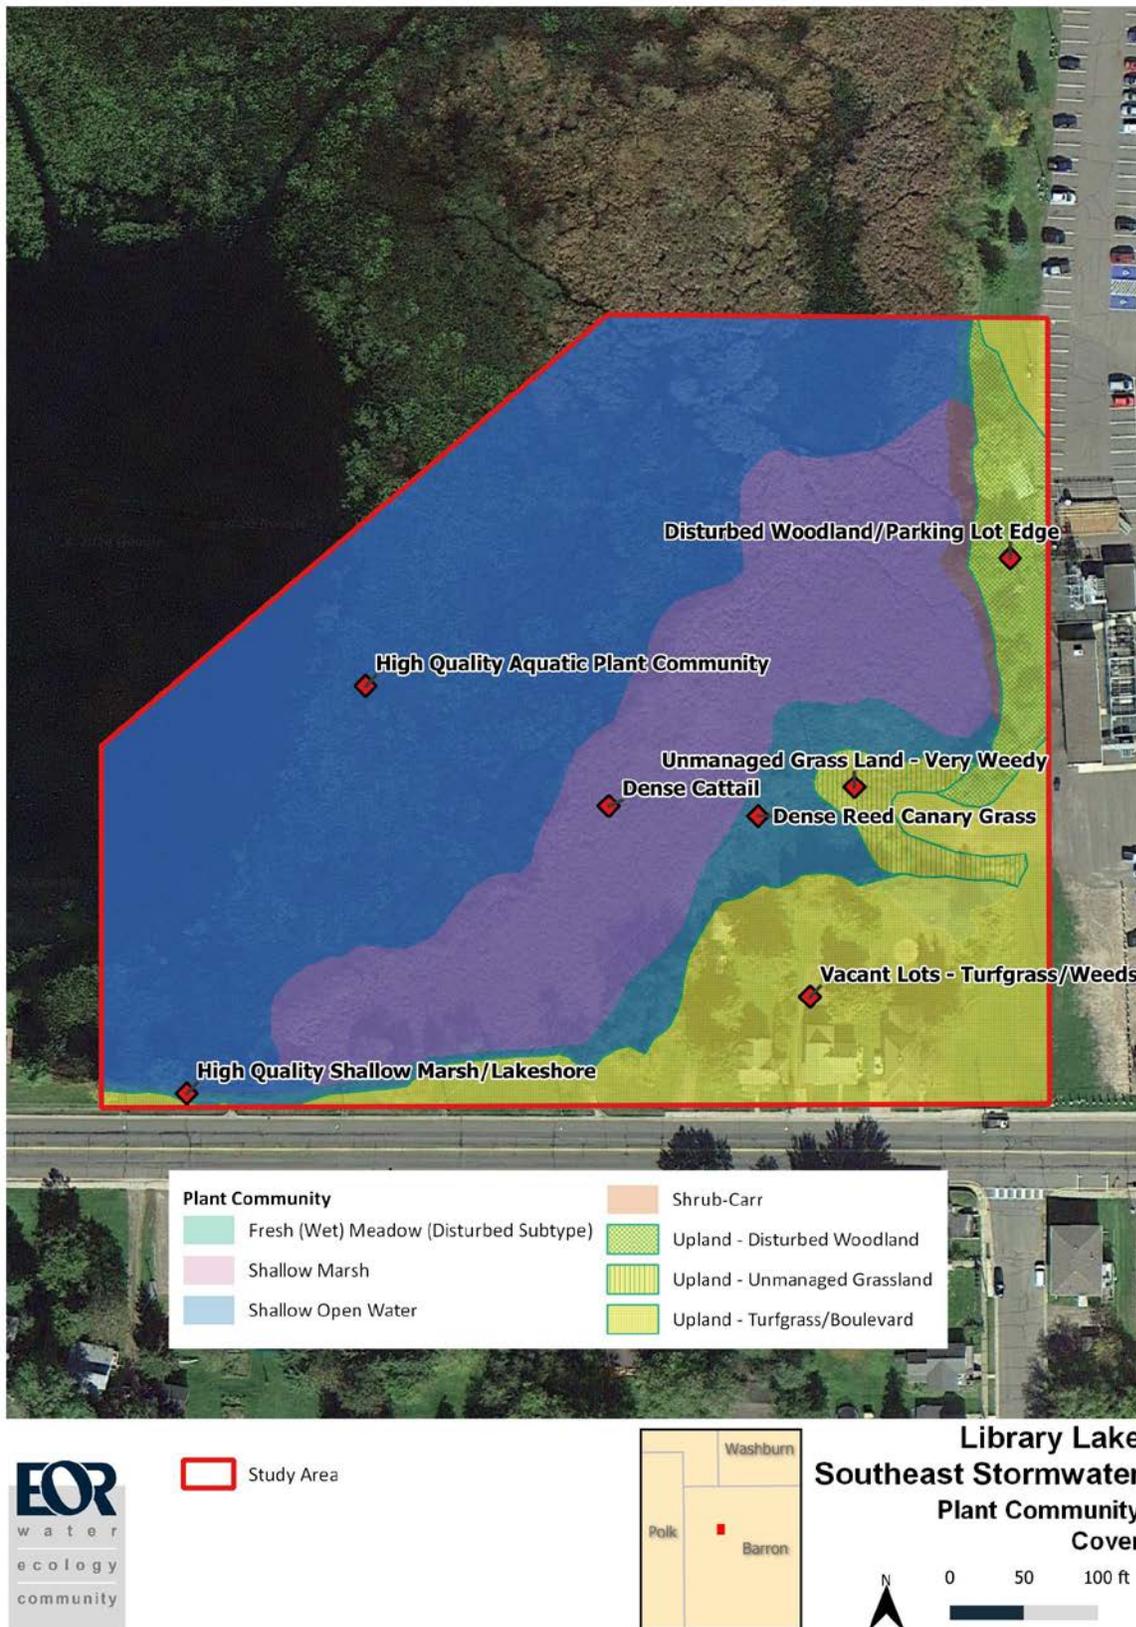
Figure 2. Plant community cover and notes.

The site borders urban areas adjacent to Wisconsin Highway 48 and 2nd Avenue within the City of Cumberland, Barron County. Most of the Study Area consists of wetland around and within Library Lake and includes wet meadow, shallow marsh, shrub-carr, and open water wetland types (Figure 2). Adjacent upland areas include vacant residential lots, unmanaged grassland, disturbed woodland, and manicured lawn/boulevard.

One area of good quality shoreline vegetation was located in the southwestern portion of the Study Area along a transition from wet meadow to shallow open water (Figure 2). This area was dominated by an even mix of native species including broad-leaf cattail, three-way sedge, broad-leaved arrowhead, pickerelweed, white water lily, common spikerush, hardstem bulrush, northern blue flag, dark green bulrush, marsh milkweed, marsh cinquefoil, water smartweed, and bristly sedge. Woody plants along the lakeshore consisted of speckled alder and silver maple.

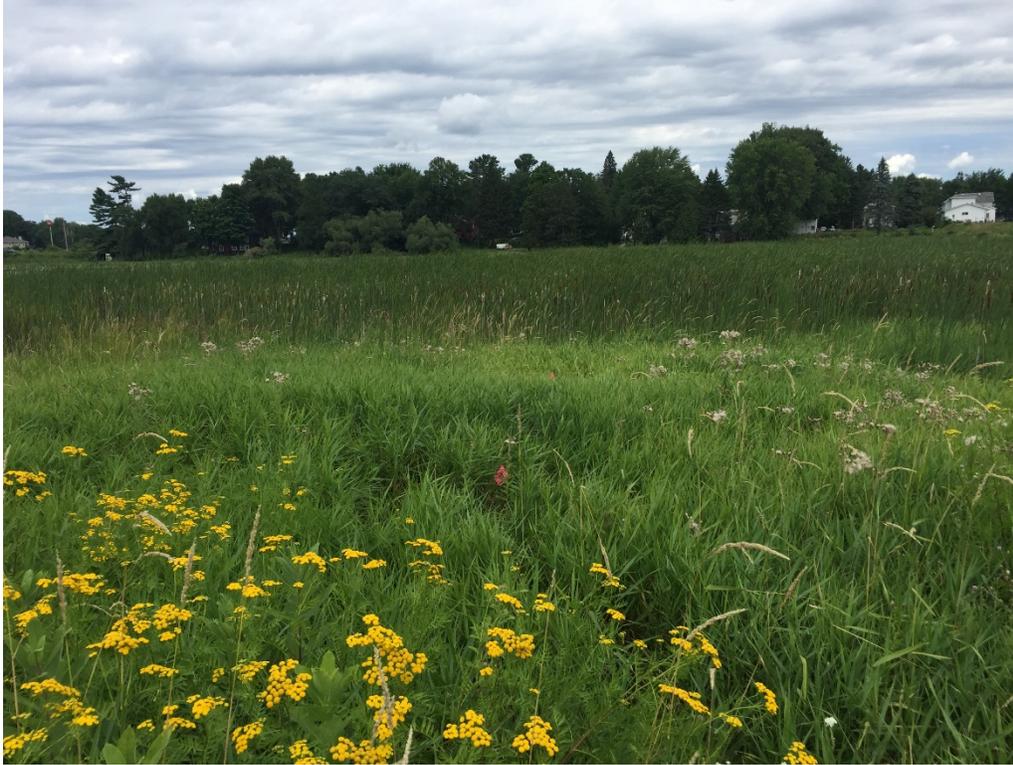
The wet meadow was dominated by invasive reed canary grass. Although native species cover was sparse to patchy, diversity was fair and included dark green bulrush, lake sedge, bluejoint, rice cut grass, American manna grass, marsh bellflower, tall goldenrod, marsh milkweed, water smartweed, tearthumb, and field mint. Other non-native species included reedtop.

The shallow marsh was dominated by invasive hybrid cattail extending onto Library Lake via floating mat. Native species cover was sparse and included jewelweed, marsh bellflower, bluejoint, broad-leaved arrowhead, lake sedge, fen wiregrass sedge, northern blue flag, bulbet-bearing water hemlock, great water dock, stiff marsh bedstraw, and northern bugleweed. Other invasive species included purple loosestrife.

Photograph 1. Looking toward reed canary grass-dominated wet meadow and cattail-dominated shallow marsh from the edge of unmanaged, weed-dominated grassland.

Restoration should first focus on control of invasive and non-native species. In wet meadow, shrub-carr, and upland areas, combinations of chemical and mechanical treatment should be effective to remove or reduce cover of invasive herbaceous and woody vegetation. Planting plans following invasive species control should include species described in Eggers and Reed and WI DNR

The shallow marsh community is dominated by invasive cattail and occupies nearly the entire lakeshore within the Study Area. Control of dense cattail stands is challenging and requires a careful assessment of risks and benefits. Management would require long-term commitment to chemical and mechanical treatments before the site is suitable for revegetation. Dredging/scraping of the cattail may also be an option for quicker results but would require permits from WI DNR and may significantly disturb the site. If dredging is considered a viable option, management should occur from the shore toward the open water as to minimize disturbance to the adjacent high quality shallow open water community. Finally, although the cattail stand is generally poor habitat, it may be providing some water quality benefit as a buffer to stormwater runoff from the City of Cumberland. Restoration to a native plant community would also provide a buffer to stormwater, but perhaps not as effectively as the dense stand of cattail. That said, the proposed stormwater BMPs will improve pre-treatment of runoff and lessen the impact of removing the cattail.

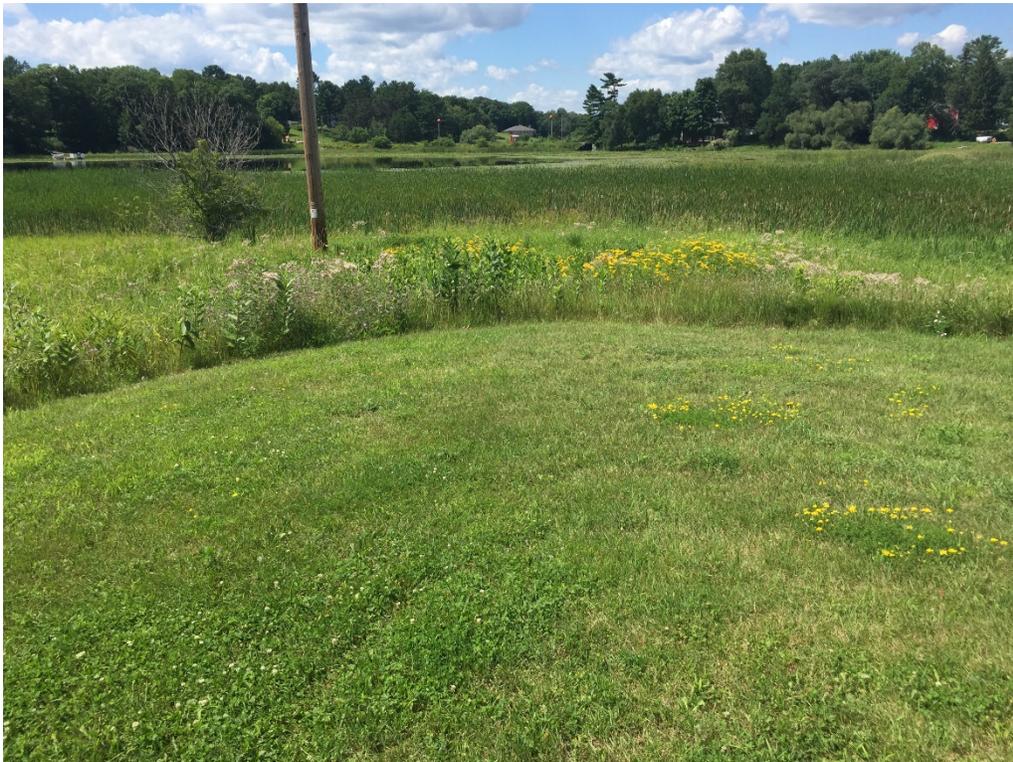
Open upland areas were dominated by non-native or invasive species such as smooth brome, reed canary grass, tansy, Canada thistle, Kentucky bluegrass, hoary alyssum, quackgrass, spotted knapweed, crown vetch, and bird's foot trefoil. Native species were a minor component but included Canada goldenrod, common milkweed, field horsetail, common evening primrose, red raspberry, and yarrow.

Photograph 2. Transition from mowed turfgrass to unmanaged, weed-dominated grassland with wet meadow and cattail marsh in background.

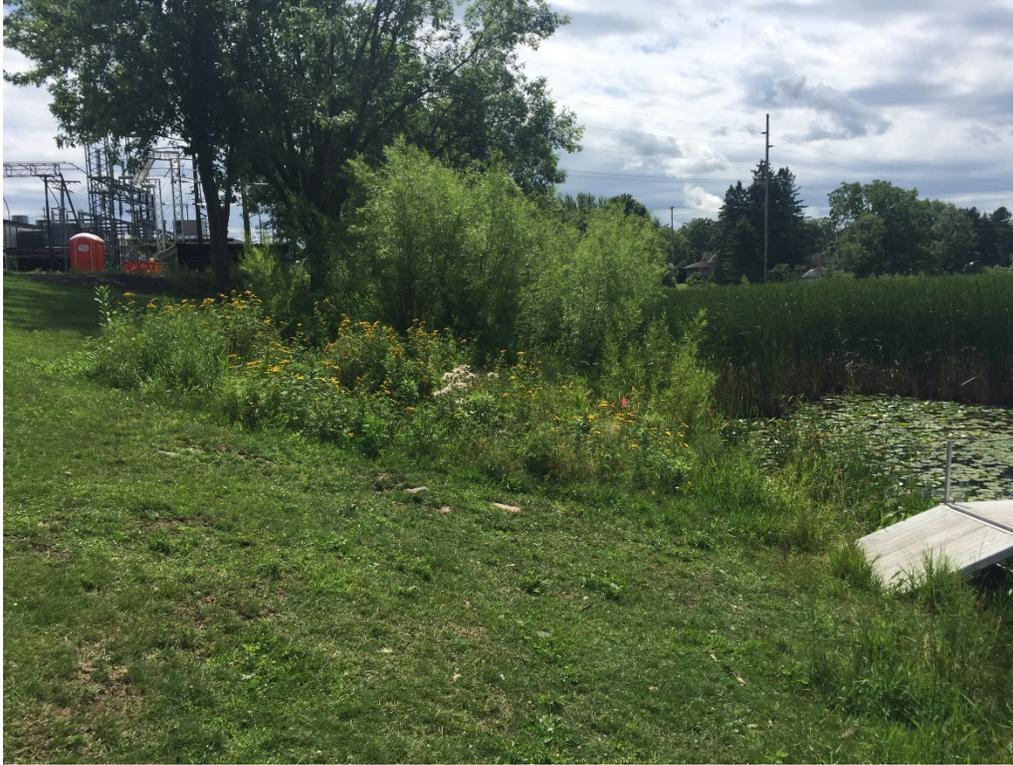
Disturbed woodland areas were dominated by a dense shrub layer of invasive species common buckthorn and exotic honeysuckle, with a patchy canopy of native trees including box elder and green ash.

The shrub-carr was dominated by invasive common buckthorn and native shrub sandbar willow. A sparse canopy of native trees green ash and box elder was present. Ground cover consisted of similar species to the wet meadow, primarily dominated by reed canary grass.

Photograph 3. From northern extent of the Study Area looking at transition between disturbed woodland, shrub-carr dominated by sandbar willow, and shallow marsh dominated by cattail.

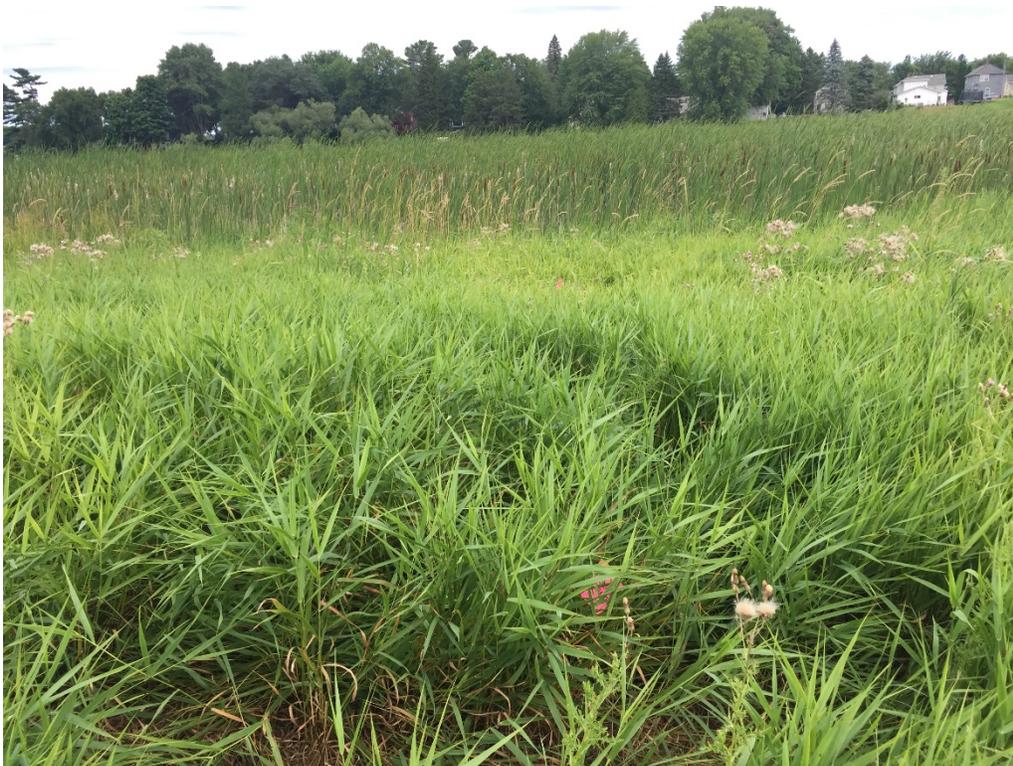
Photograph 4. Wet meadow dominated by reed canary grass looking toward shallow marsh dominated by cattail.

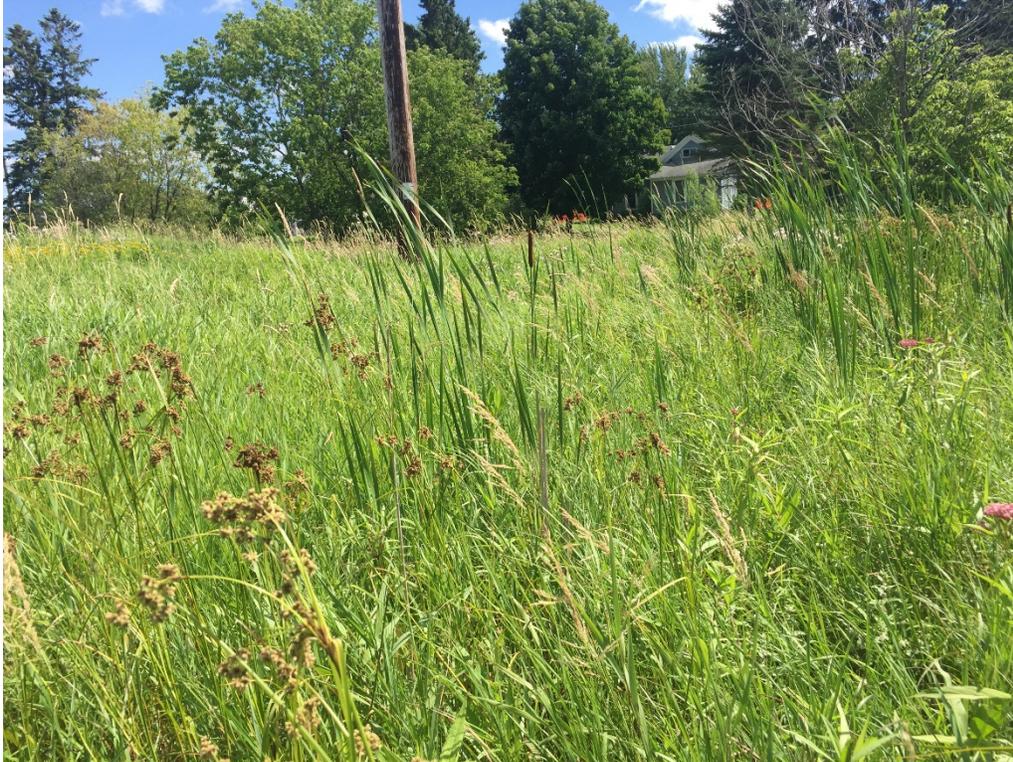
Photograph 5. Area of wet meadow with some diversity of native species including bluejoint, dark green bulrush, and marsh milkweed. Reed canary grass is still dominant.

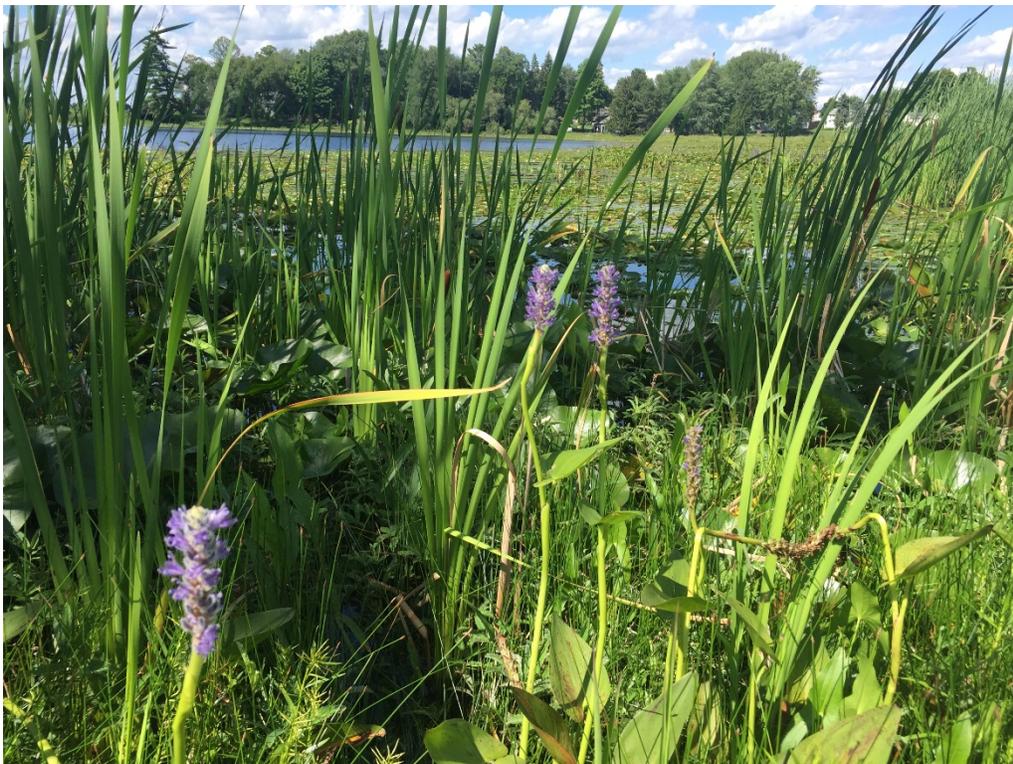
Photograph 6. Good-quality shallow marsh in southwestern portion of Study Area dominated by broad-leaf cattail, pickerelweed, three way sedge, and common spikerush.

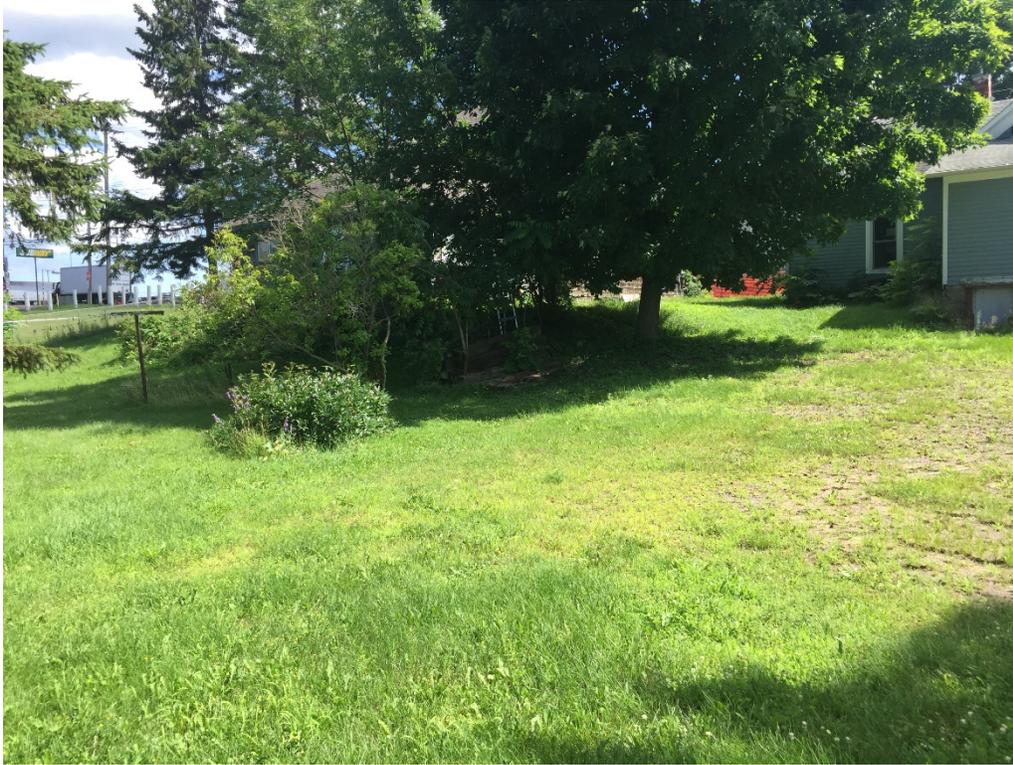
Vacant lots and lawn/boulevard areas were dominated by turfgrass and common lawn weeds with some cultural trees such as white spruce, Norway spruce, sugar maple, and black walnut in the canopy.

Photograph 7. Turfgrass and lawn weeds in vacant residential lots, with ornamental plantings, sugar maple, and spruce.

descriptions of [Northern Sedge Meadow](#) and [Shrub-Carr](#) for respective wetland community types. Upland areas are suitable for restoration to a variety of communities, but [Mesic](#) and [Wet-Mesic Prairie](#) may afford both good wildlife habitat and allow for scenic views from the City of Cumberland.

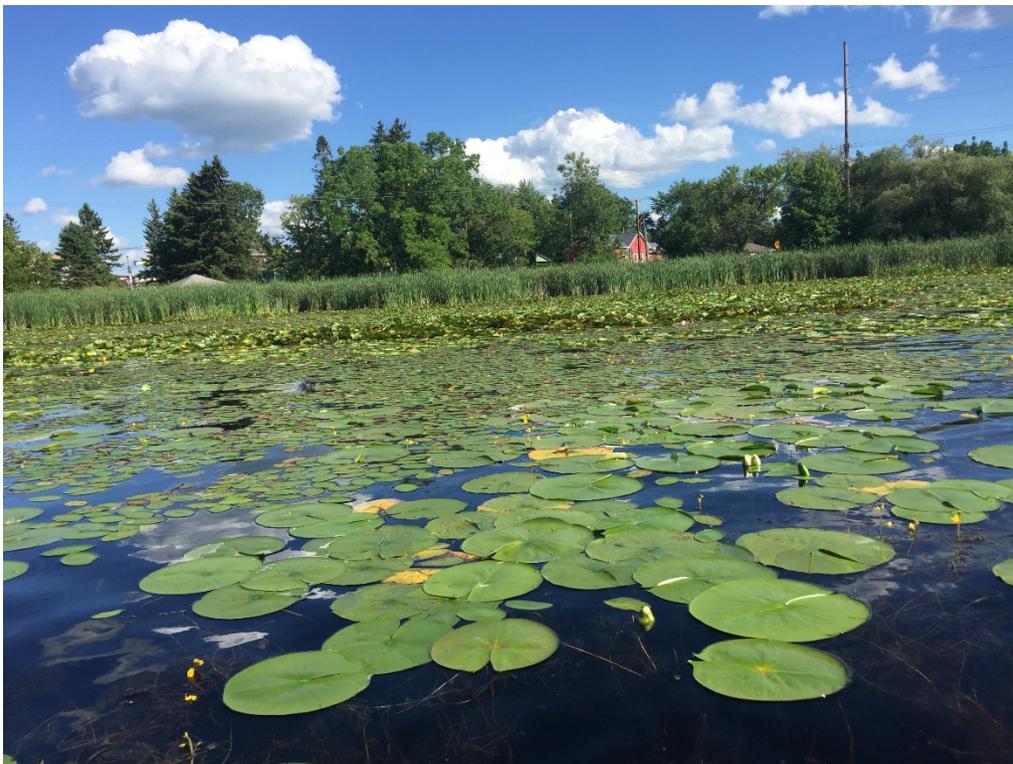
The open water community was dominated by dense cover of native submerged and floating-leaved species, with excellent diversity. Floating-leaved species white water lily, spatterdock, and watershield formed a dense mat on the surface. Submerged species were abundant below and included coontail, Illinois pondweed, variable pondweed, flat-stem pondweed, sago pondweed, fern-leaf pondweed, ribbon-leaf pondweed, floating pondweed, large-leaf pondweed, small pondweed, water stargrass, Canada waterweed, slender naiad, muskgrass, common bladderwort, and small bladderwort. Emergent species included pickerelweed and swaying bulrush. One invasive species, Eurasian watermilfoil, was observed.

Photograph 8. High-quality aquatic plant community; floating-leaved plants white water lily and watershield are visible in foreground along with yellow flowers of common bladderwort.

The shallow open water community within the Study Area is high quality and preservation should be high priority. Additionally, this community may harbor an aquatic plant species of special concern as designated by the WI DNR. Recommendations to avoid impact to the rare species were provided in the WI DNR Endangered Resources Review Letter and should be adhered to during proposed work. These species-specific guidelines are also suitable for avoiding impact to the entire community. Appropriate erosion control methods should be employed and disturbance to the shallow open water community should be avoided.
