# 2019 Sand Lake NE Wash Data Collection and Loading Calculations – LEAPS 4/18/2020

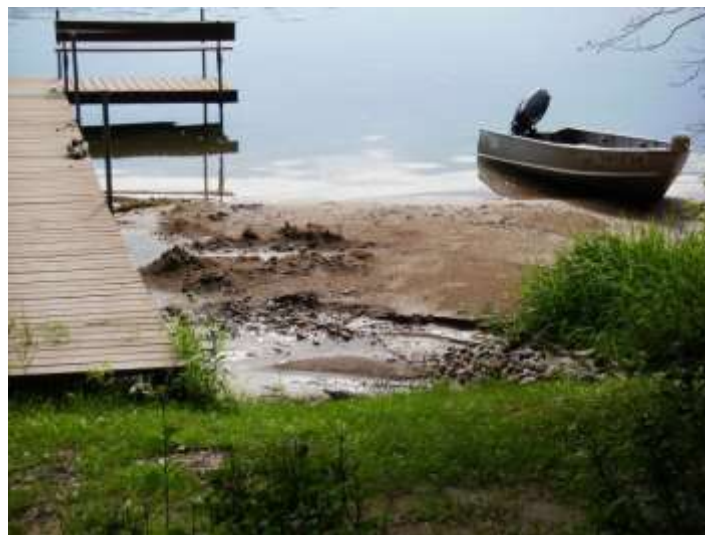
Figure 1: Sand Lake - Bottom of the NW Wash after a 2010 significant rain event (LEAPS)

Sand Lake is a 318 acre drainage lake in northwestern Barron County. There are several perennial and intermittent streams/drainage gullies that contribute water, sediment, and nutrients to the lake. In 2016, one of the largest gullies, known locally as the NW Wash was repaired with funds provided by a WDNR lake protection grant. The NW Wash was a relatively short, but very steep and ragged gully that became a huge negative impact after a 2010 rain event that dumped more than 8" of rain over a very short period of time. The resulting runoff and gully erosion filled in a 0.12-acre area of the lake that was previously more than two feet deep in a single day (Figure 1).

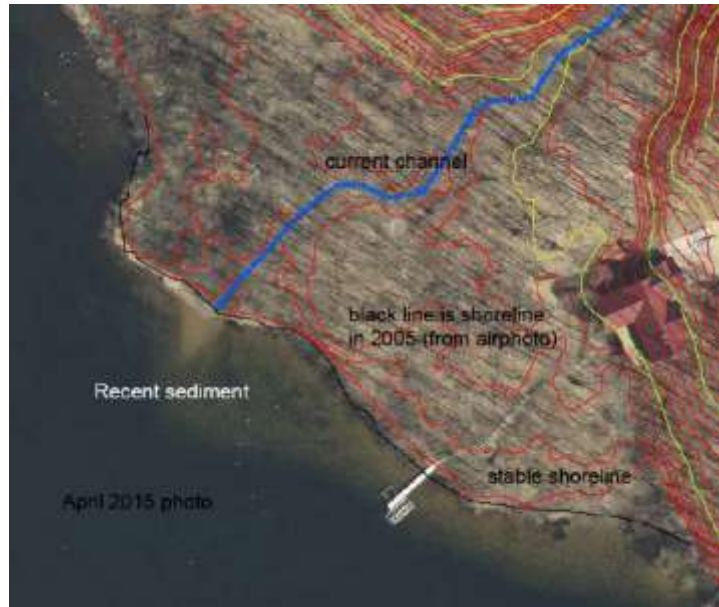
Figure 2: 2015 evidence of new sediment in the lake from the NE Wash

On the other side of the lake, is another wash, locally known as the NE Wash. While not in as bad a shape as the NW Wash was in before it was repaired, the NE Wash has been contributing significant amounts of sediment for decades. Recent observations seem to support that it might be getting worse (Figure 2). The NE Wash is a 1.7 mile long intermittent stream that drops at least 100-ft from the top (28<sup>th</sup> Ave) to the bottom where it exits into the lake (Figure 3). The 1.7 miles of the NE Wash is fed by a watershed that covers more than 2,423 acres (Figure 4). Every drop of water that falls on this area moves toward Sand Lake. Along the way, some water is soaked into the ground; some is captured in small ponds and other depressions in the landscape, and more evaporates or is used up by the flora and fauna in the region. However, when enough rain water or snowmelt occurs that it fills all the ponds and

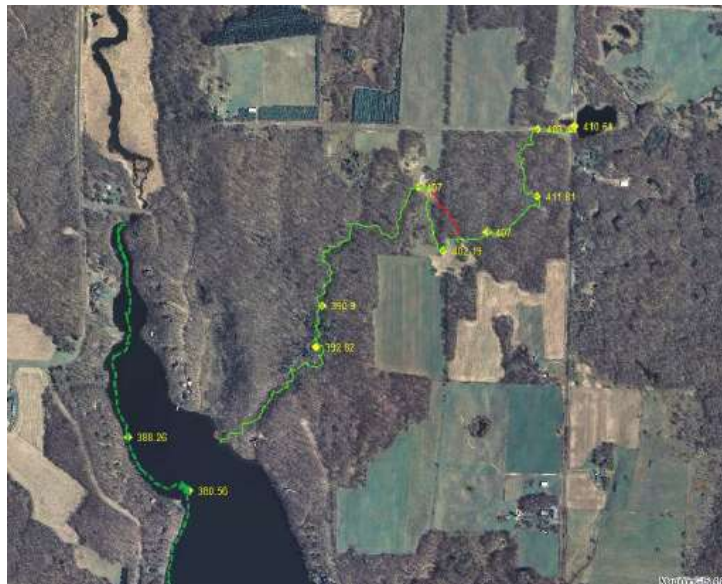
Figure 3: Sand Lake, Barron County NE Wash (lime green line)

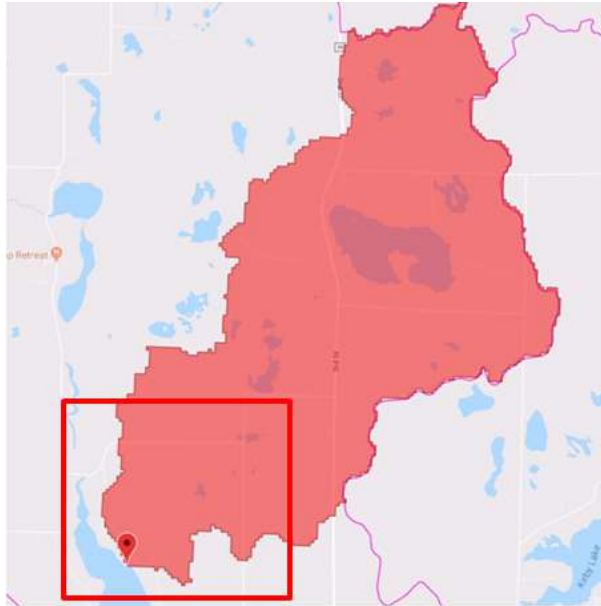
Figure 4: Sand Lake, Barron County NE Wash watershed. Red square represents the area in Figure 3 (LEAPS)

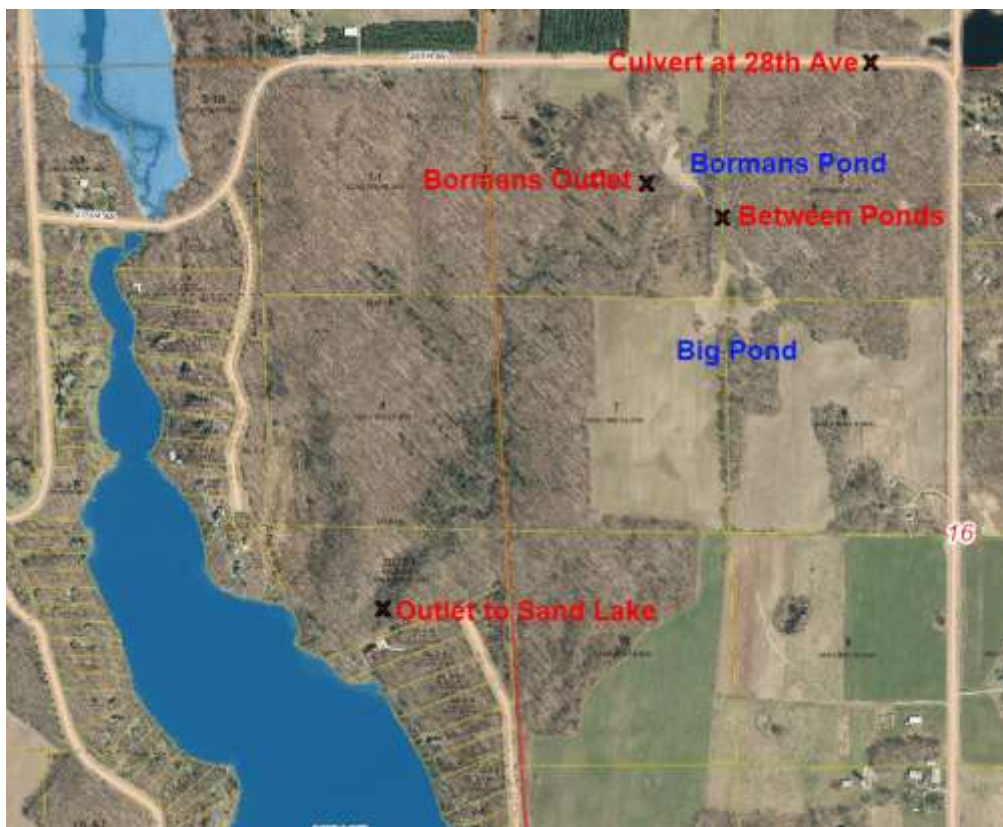
Figure 5: NE Wash transducer locations and the Two Ponds

Ecological Integrity Services (EIS) owned and operated by Steve Schieffer was contracted with to provide transducer installation, data readout, and data analysis. His data coupled with flow data and water samples collected by volunteers was used to establish water discharge and loading values for TSS and TP. Four transducers were placed in the NE Wash, both in 2018 and 2019. A fifth transducer was installed to record air pressure in the area. Pressure transducers were installed at the Culvert under 28<sup>th</sup> Ave, Between Big Pond and Bormans Pond, just below Bormans Outlet, and at the Bottom of the wash approximately 300 yards upstream of the lake (Figure 5).

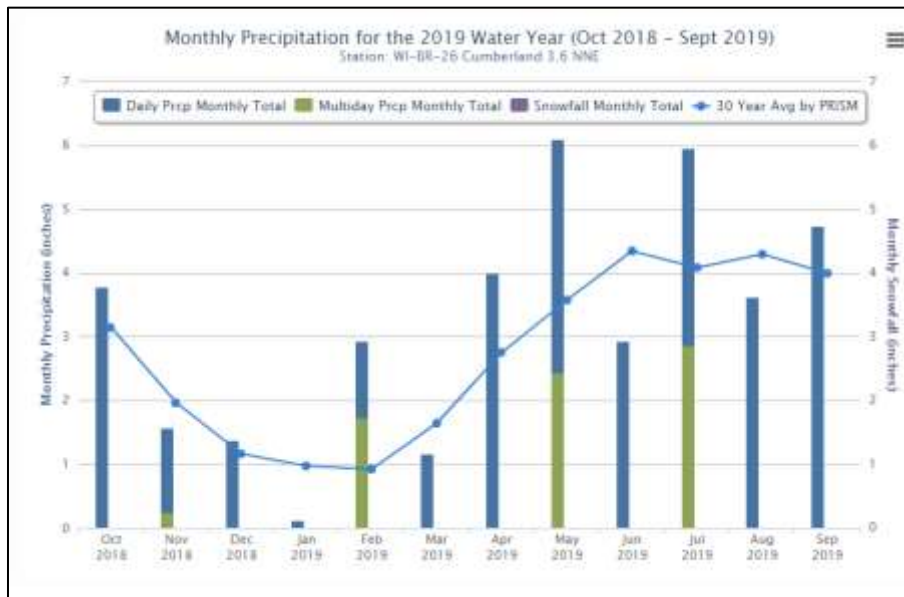
Figure 6: Rainfall data near the north end of Granite Lake, Barron County (CoCoRaHS - last accessed 4/19/20)

But what a difference a year makes. The year 2019 was a wet year that provided a great deal of data. Water moved through the system making its way into Sand Lake for a period of 72-84 days between late March and mid-June. Although not quantified, water again made it to the lake during some timeframe in the fall of 2019 as well. Precipitation was monitored at one site near Granite Lake just to the east of Sand Lake. A volunteer recorded rainfall data with the Community Collaborative Rain Hail and Snow (CoCoRaHS) program. Nearly 8” of rain was documented at this site from March 15, 2019 to June 10, 2019. Figure 6 reflects how rainfall recorded at this site measures up to normal rainfall in WI. Rainfall in April and May was well above what is a 30-yr average. Couple this with snowmelt that began and ended in the last two weeks of March and there was a lot of water movement.

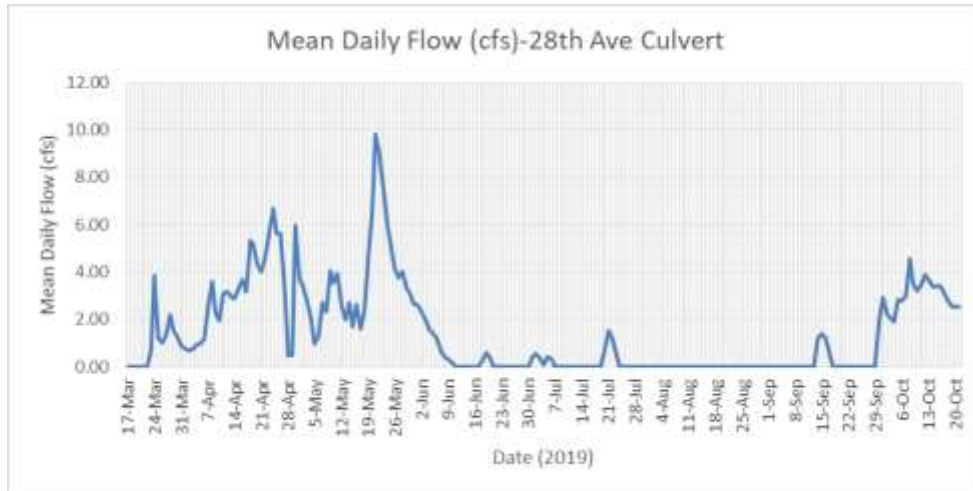
Figure 7: 2019 Seasonal mean daily flow - Culvert at 28th Ave (EIS, 2019)

Based on pressure transducer data, flow from the Culvert under the road at the top of the NE Wash started on or about March 18, 2019 and ended about June 10, 2019 for a total of 84 days (Figure 7). Flow did not drop to “zero” until June 10. Actual flow was recorded in the field only once on May 30, 2019. The average flow over the entire 84 day time frame is estimated at 2.1-cuft/sec. No water samples were collected and no other flow readings were recorded.

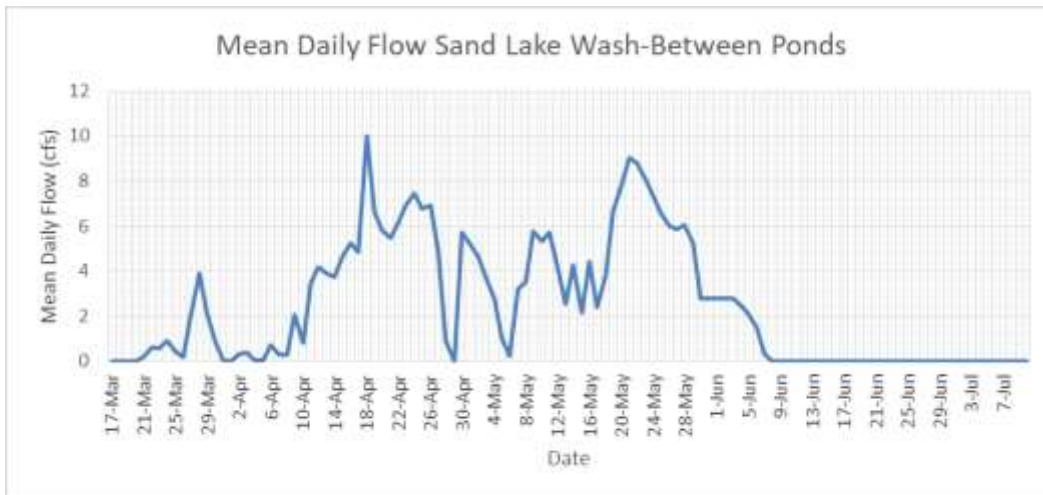
Figure 8: 2019 Seasonal mean daily flow - Between Ponds (EIS, 2019)

Based on pressure transducer data, flow between the Big Pond and Bormans Pond was first recorded on or about March 22, 2019 and ended about June 8, 2019 for a total of 78 days of flow (Figure 8). Flow dropped to “zero” at least five times during that time frame, but then started up again. Actual flow was recorded in the field on April 18 and on May 30. The average flow over the entire 78 day time frame is estimated at 2.14-cuft/sec. No water samples were collected and no other flow readings were recorded.

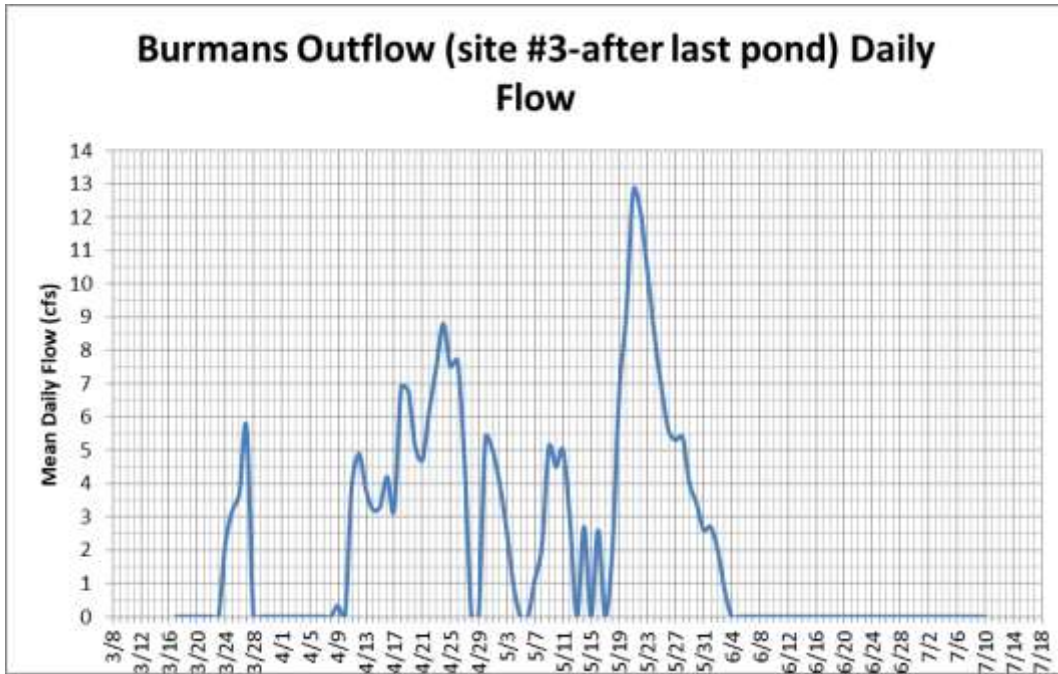
Figure 9: 2019 Seasonal mean daily flow - Bormans Outlet (EIS, 2019)

Based on pressure transducer data, flow from Bormans Pond began on or about March 23, 2019 and ended about June 3, 2019 for a total of 72 days (Figure 9). Flow dropped to “zero” at least seven times during that time frame. Actual flow was recorded in the field on four separate dates (4/18, 5/15, 5/19, and 5/30). The average flow over the entire 72 day time frame is estimated at 2.63-cuft/sec. TSS and TP water samples were collected four times (4/15, 5/15, 5/19, and 5/30). No other flow readings or water samples were recorded.

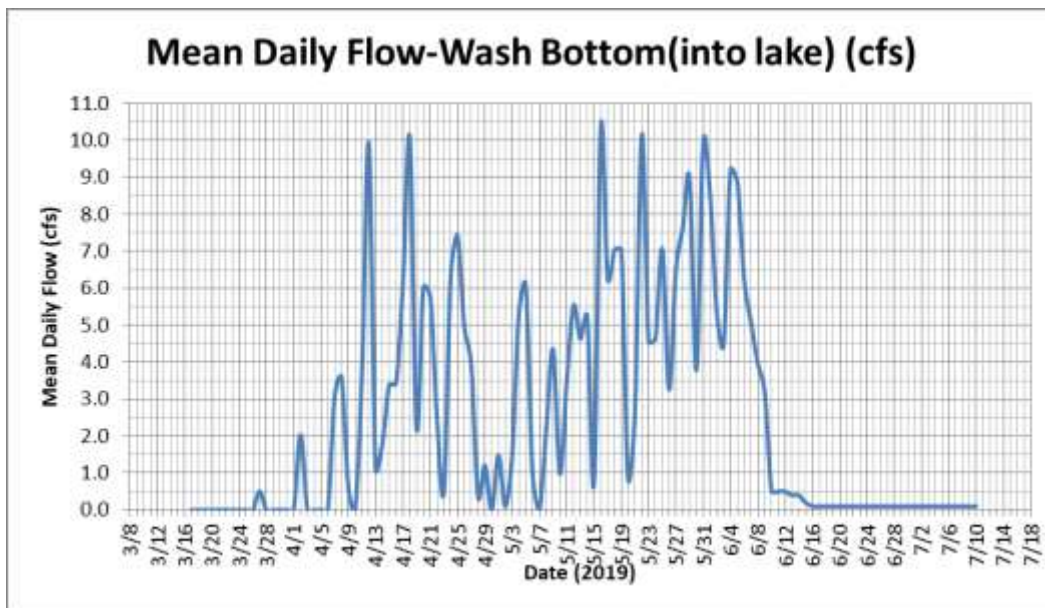
Figure 10: 2019 Seasonal mean daily flow, Outlet to Sand Lake (EIS, 2019)

Based on pressure transducer data, flow from the outlet of the NE Wash to the lake started on or about March 27, 2019 and ended on or about June 10, 2019 for a total of 75 days of flow (Figure 10). Flow dropped to “zero” at least five times during that time frame, but then started up again. Actual flow was recorded in the field on five separate dates (4/15, 4/18, 5/15, 5/19, and 5/30). The average flow over the entire 75 day time frame is estimated at 2.5-cuft/sec. TSS and TP water samples were collected four times (4/15, 5/15, 5/19, and 5/30). No other flow readings or water samples were recorded.

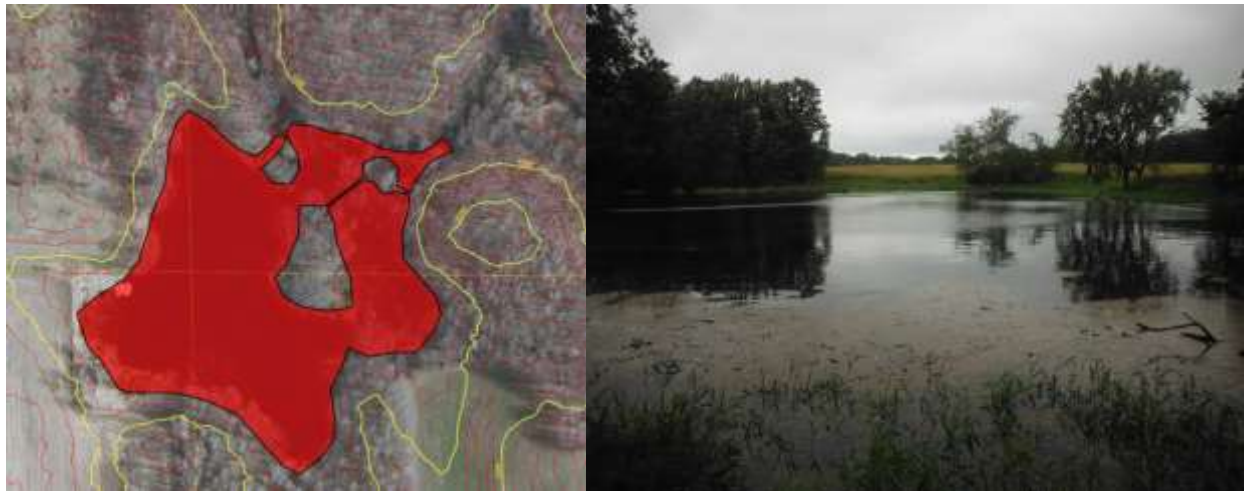
**Figure 11: Big Pond - First retention basin, approx. 3.2 acres (LEAPS, 2020)**

Based on transducer data from 2019, on the fifth day after flow was recorded in the Culvert on top, flow was recorded between the Big Pond and Bormans Pond, suggesting it took four days to fill the Big Pond in 2019. The Big Pond covers approximately 3.2 acres when full enough to flow out into the channel that leads to Bormans Pond (Figure 11). The average flow from the culvert to the Big Pond was estimated at 2.1-cuft/sec. Based on transducer results from the culvert site, once flow started around March 18<sup>th</sup>, it maintained consistent flow with no “zero” readings. If the assumption is made that the water flowing from the culvert to the Big Pond started at “zero” on day one, and was at the mean level by day four, then the average flow over that four day period would have been 1.05-cuft/sec. This equates to 8.33-acft of water in four days to fill the Big Pond. If the big pond is 3.2 acres, its average depth would then be 2.6-ft when full.

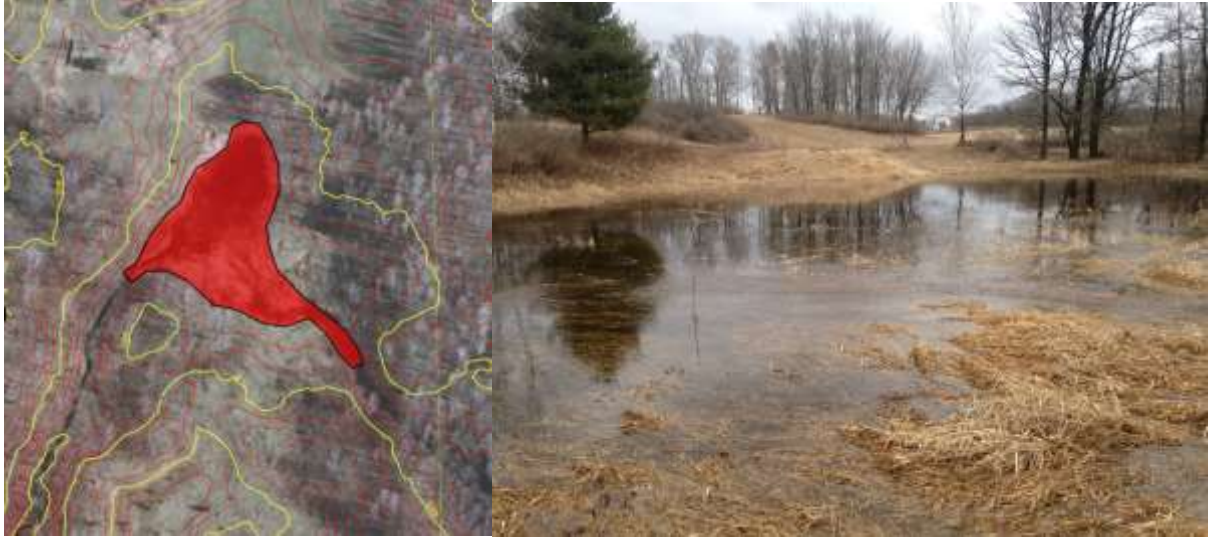
Figure 12: Bormans Pond - Second retention area, approx. 0.70 acres (LEAPS, 2020)

Based on transducer data from 2019, on the third day after flow was recorded in the channel between the Big Pond and Bormans Pond, flow was recorded coming out of Bormans Pond, suggesting it took two days to fill Bormans Pond in 2019. Bormans Pond covers approximately 0.70 acres when full enough to flow out into the NE Wash that leads down the hill to Sand Lake (Figure 12). The average flow between the Big Pond and Bormans Pond was estimated at 2.14-cuft/sec. Based on transducer results every site except the Culvert, it took about 18 days for consistent flow to be reached and maintained at each site. If the assumption is made that the water flowing from the Big Pond to Bormans Pond started at “zero” on day one, and was at the mean level by day eighteen, then at day two it would have been at 0.24-cuft/sec. This equates to 0.95-acft of water in two days to fill Bormans Pond. If Bormans Pond is 0.70 acres, its average depth would then be 1.36-ft when full.

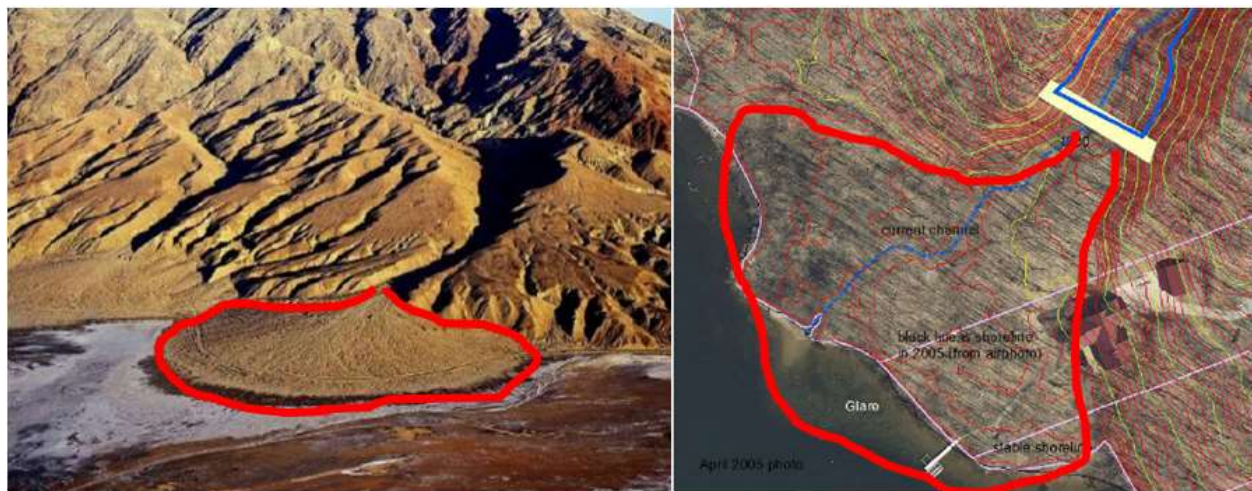
Figure 13: Mountainous alluvial plain (left); Sand Lake NE Wash alluvial plain (right) (Barron County, 2018)

Water flow from the Culvert lasted a week longer in June than did flow from the Big Pond or Bormans Pond. Flow out of Bormans Pond into the steep part of the NE Wash ravine stopped 12 days before water exiting the bottom of the NE Wash stopped. Related to this is the fact that the pressure transducer placed at the bottom of the NE Wash recorded data for an extended period when even though there was water at the site, none of it was reaching the lake. The bottom of the NE Wash is reminiscent of an alluvial fan of sediment that is frequently seen in mountainous regions (Figure 13). This alluvial plain consists of mostly sand and quickly infiltrates water coming down the ravine, at least until it gets saturated or runoff exceeds the capacity of the area to infiltrate the water. Sand and sediment in this area has likely been building up for centuries, at least since the last glacier went through and carved out the Sand Lake basin. Larger and more frequent rain storms may be exacerbating the issue.

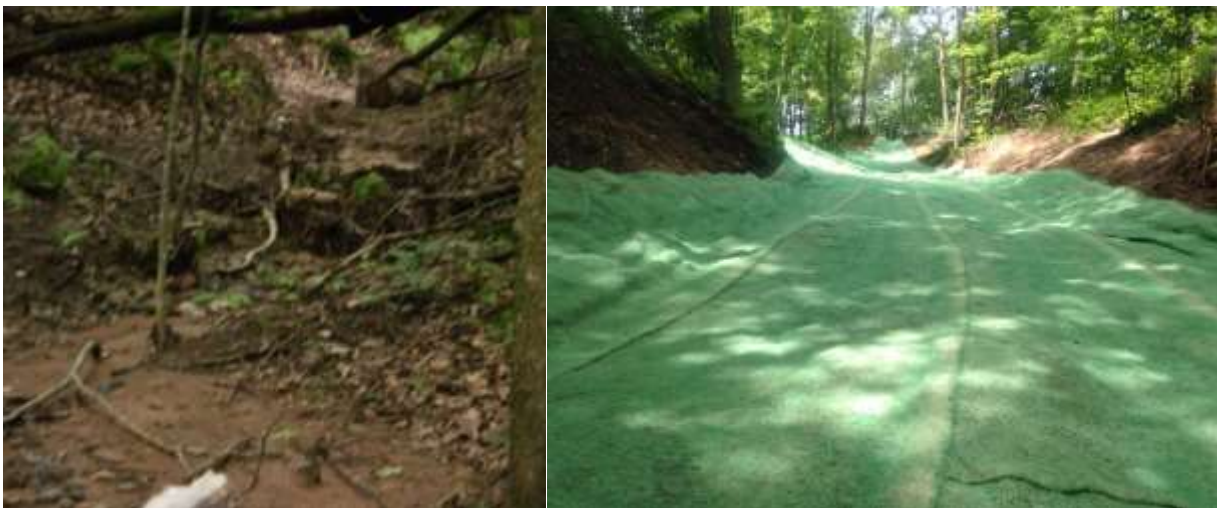
Figure 16: NW Wash repair project (LEAPS, 2016)

The second task is to figure out how to shore up areas of the NE Wash between Bormans Outlet and the Bottom of the wash to reduce the amount of sediment and other suspended solids being eroded away and carried into the lake. This was the main issue with the NW Wash, however it was only 600-ft long, drained only a 16.3 acre watershed, and only changed in elevation 50-ft from top to bottom. To repair the NW Wash, a culvert was buried to carry the water from the top of the wash to the lake, thereby eliminating the erosion. Then the wash itself was stabilized by flattening and planting of vegetation (Figure 16). This will likely not be possible in the NE Wash, at least not for the entire length.
