EQUIPMENT RECORDING SONAR MAPPED SEPT. 1978

Source: Wisconsin Department of Natural Resources 608-266-2621  
Crooked Lake – Adams County, Wisconsin DNR Lake Map  
Date – Sep 1978 - Historical Lake Map - Not for Navigation  
A Public Document - Please Identify the Source when using it.

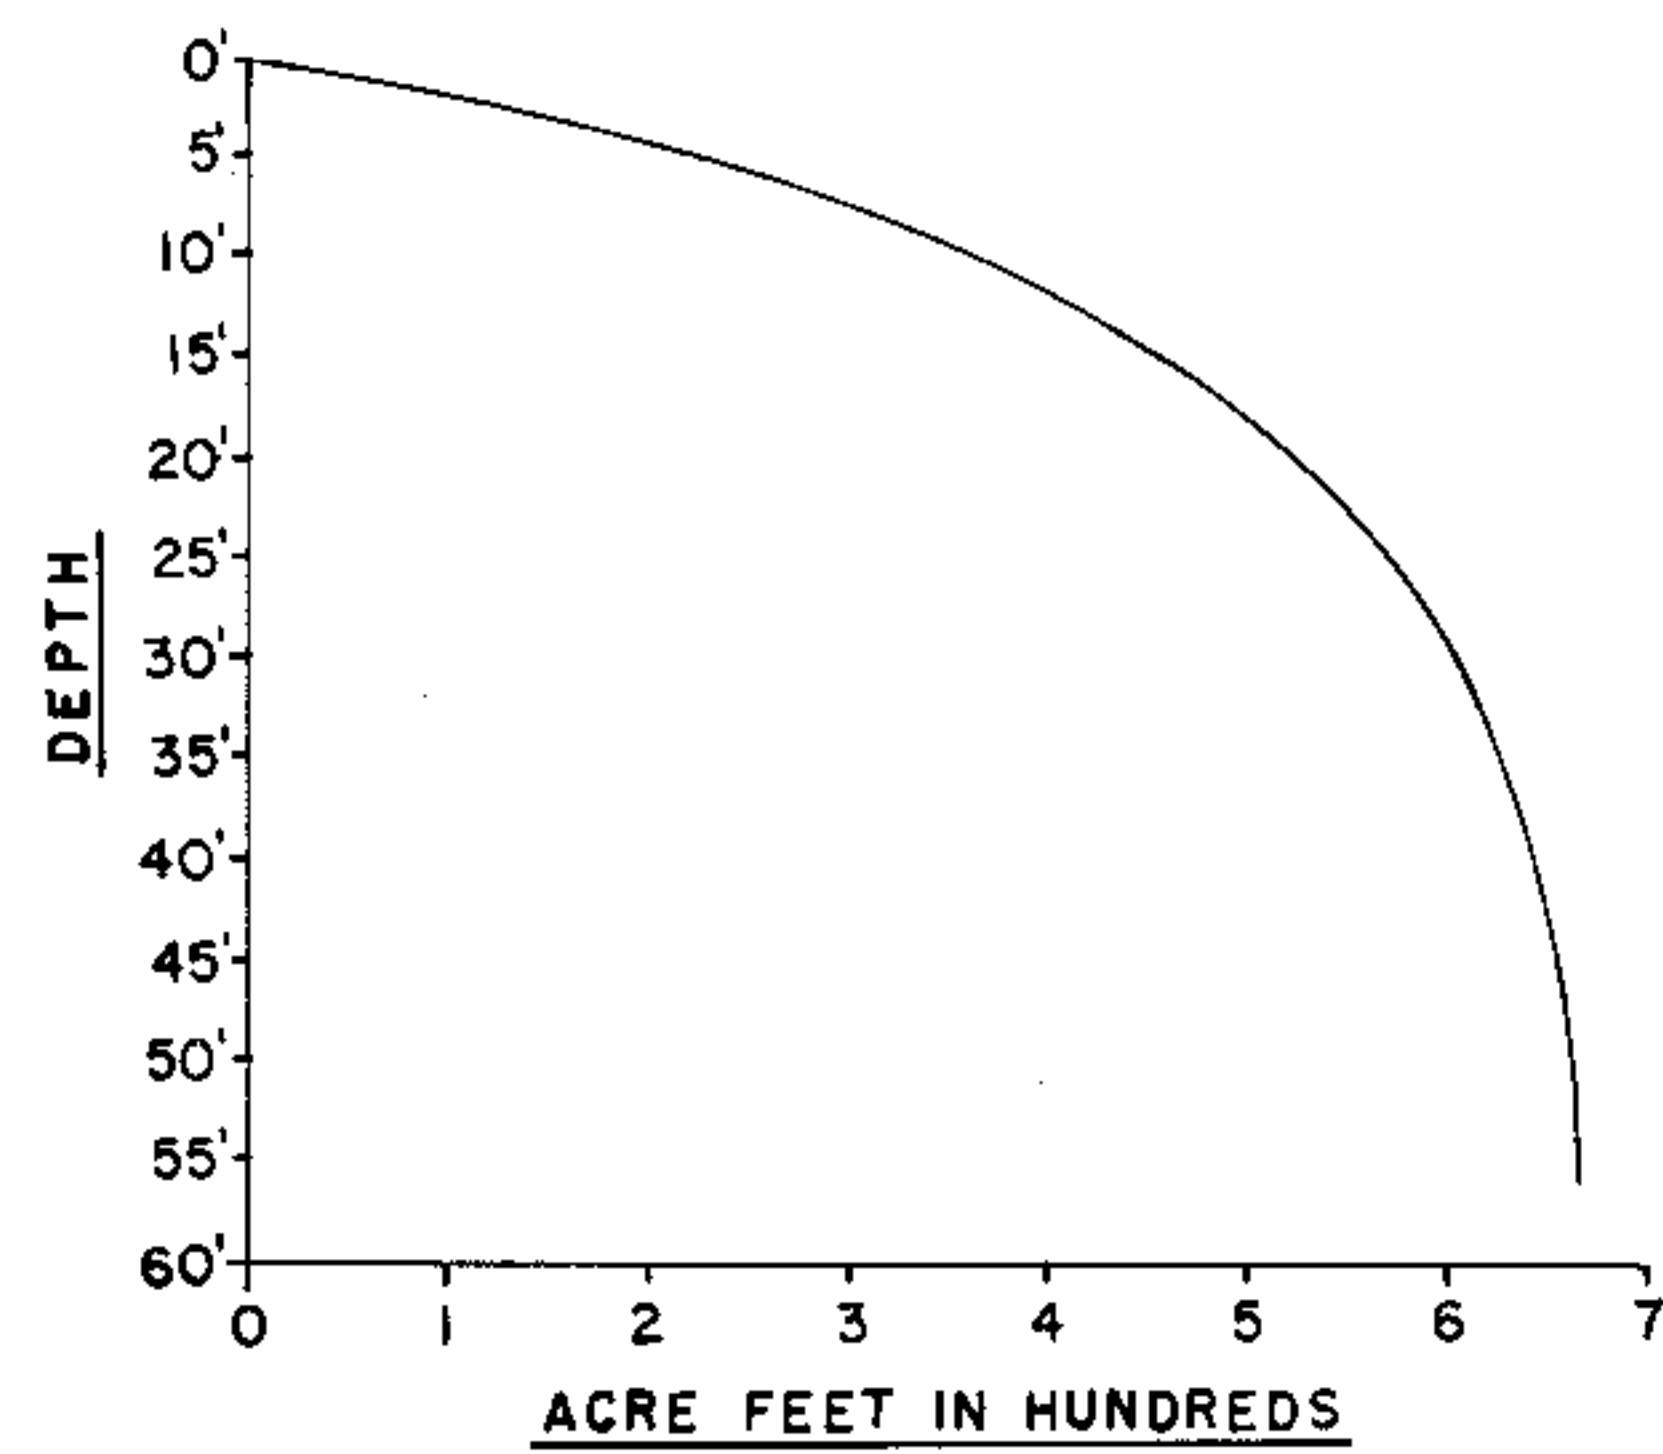
T.B.M. "X" is a square nail driven into the base of a 3" diameter willow tree growing at the waters edge 18' East of the public boat landing on the North shore of the lake.  
Assumed Elevation = 100.00'  
Water Level = 99.00'

WATER AREA 58.80 ACRES  
UNDER 3 FT. 30.66 %  
OVER 20 FT. 19.33 %  
MAX. DEPTH 56 FEET.  
TOTAL ALK. 152 P.P.M.  
VOLUME 656.29 ACRE FT.  
MAIN SHORELINE 2.22 MI.  
ISLAND SHORELINE 0 MI.
