EQUIPMENT RECORDING SONAR MAPPED JULY 1969

Source: Wisconsin Department of Natural Resources 608-266-2621  
McGee Lake - Langlade County, Wisconsin DNR Lake Map  
Date Jul 1969 - Historical Lake Map - Not for Navigation  
A Public Document - Please Identify the Source when using it.

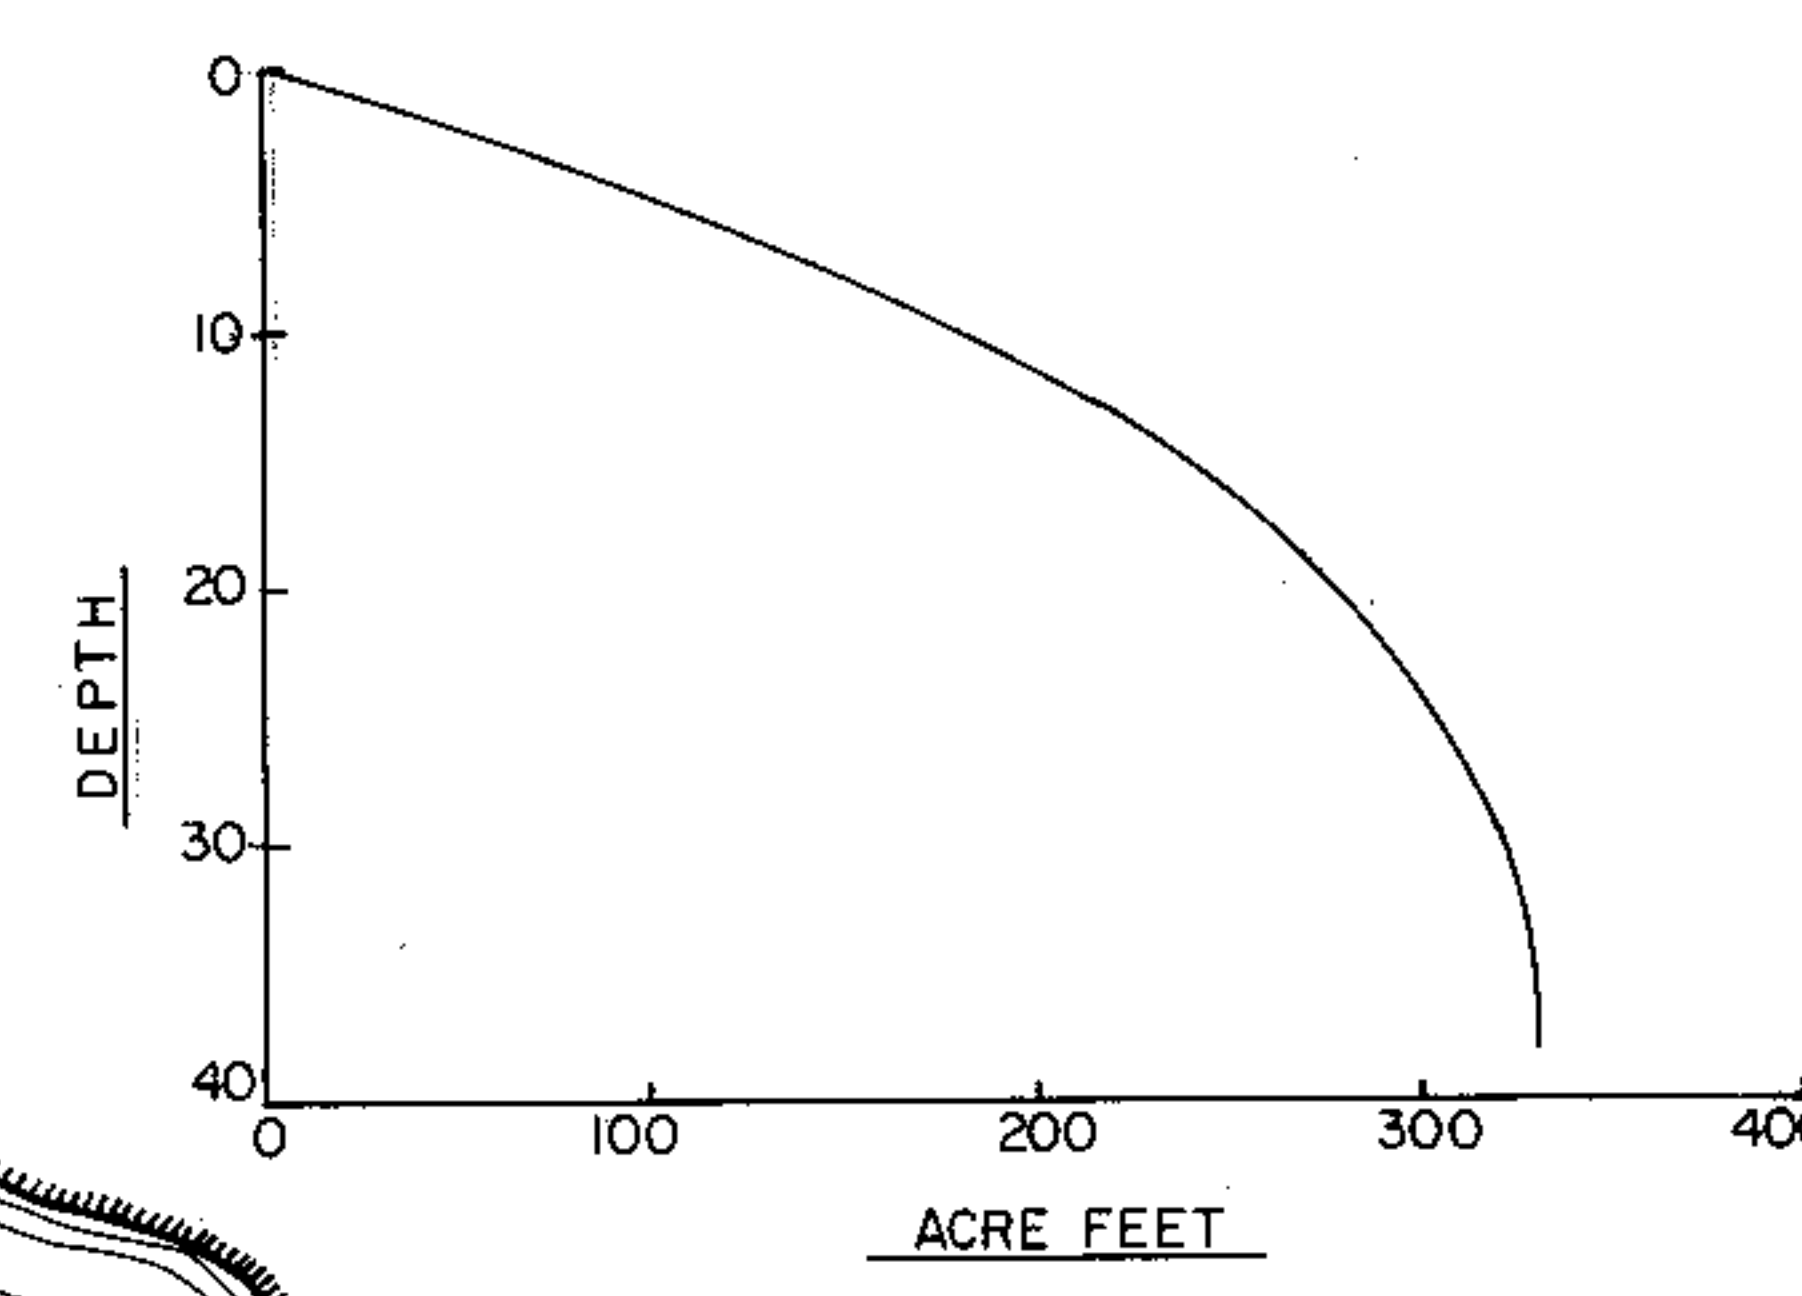
Department of Natural Resources Bench Mark 1541-A.  
2" Cut square in east end of concrete wall, approximately  
30' north of concrete silo.  
Assumed Elevation 100.00'  
Water Elevation 78.95' (July 1969)

WATER AREA 22.7 ACRES  
 UNDER 3 FT. 11 %  
 OVER 20 FT. 27 %  
 MAX. DEPTH 38 FEET.  
 TOTAL ALK. 134 P.P.M.  
 VOLUME 331.2 ACRE FT.  
 SHORELINE 95 MILES  
 .89 MILES OF SHORELINE EXCLUDING ISLAND
