WATER AREA 124 ACRES  
 UNDER 3 FT. 25 %  
 OVER 20 FT. %  
 MAX. DEPTH 23 FEET.  
 TOTAL ALK. 60 P.P.M.  
 VOLUME 1383.6 ACRE FT.  
 MAIN SHORELINE 3.1 MI.  
 ISLAND SHORELINE .2 MI.

Source: Wisconsin Department of Natural Resources 608-266-2621  
Waubesa Lake – Oconto County, Wisconsin DNR Lake Map  
Date - Jul 1975 - Historical Lake Map - Not for Navigation  
A Public Document - Please Identify the Source when using it.

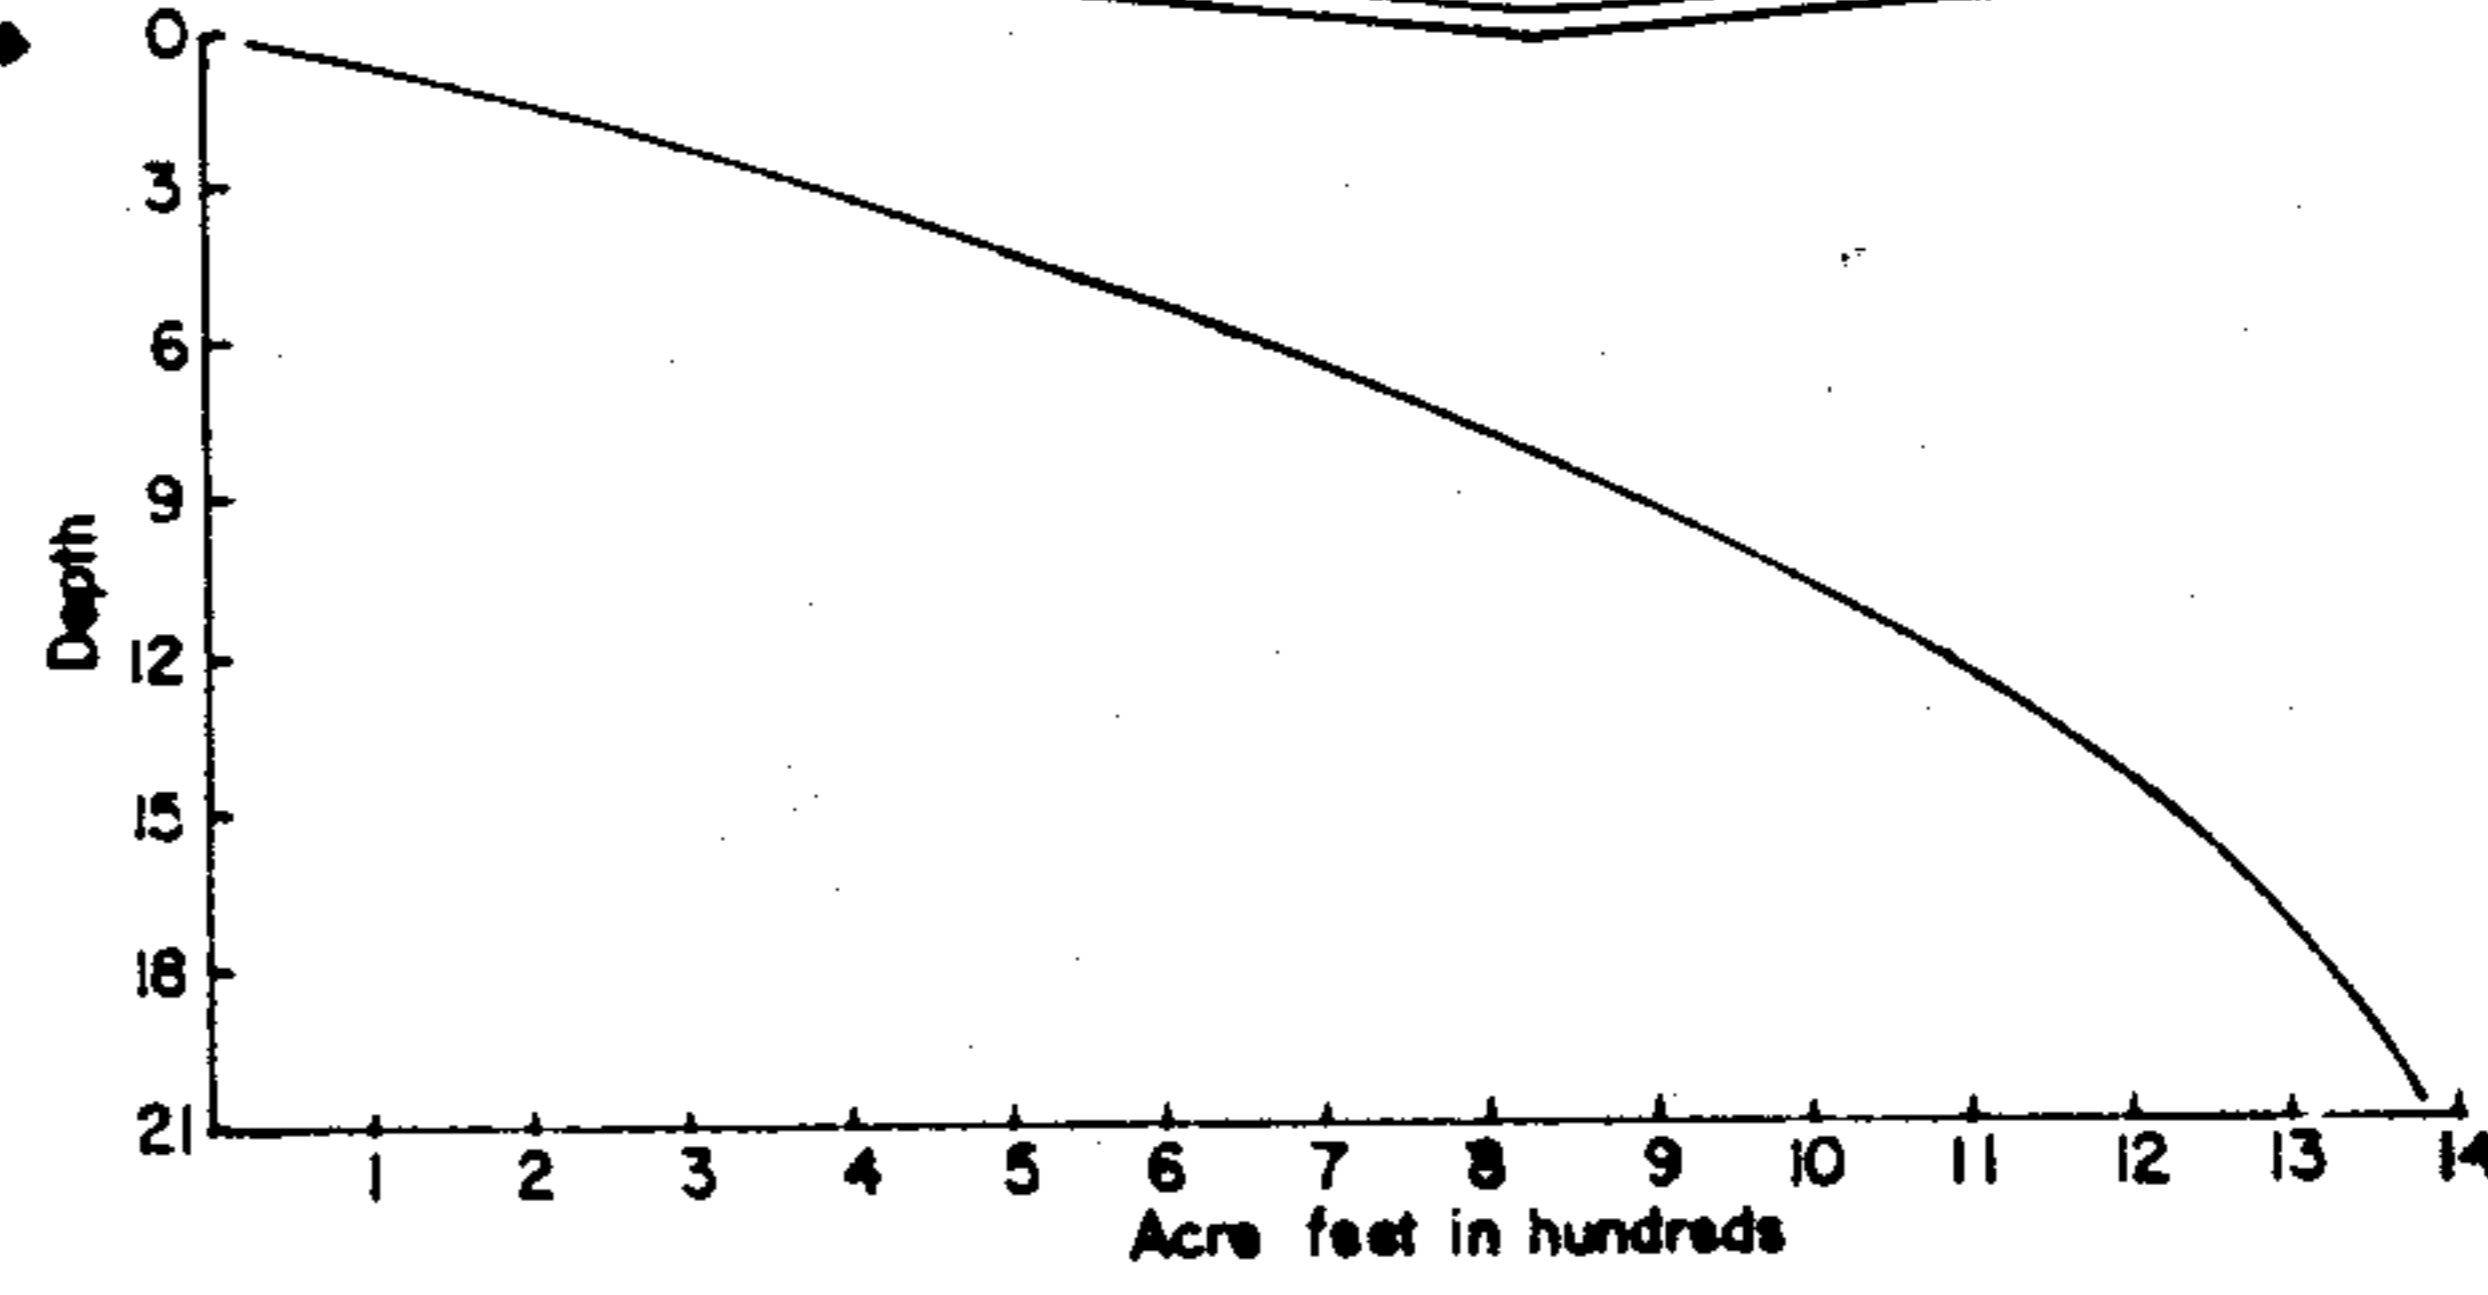
Bench mark (X) - top of town ordinance sign at public access on east side of lake.  
Assume elevation 100.0'  
Water elevation 93.4'
