LAKE SURVEY MAP

CROOKED LAKE
OGONTO COUNTY
SEC. 14, 15, 22, 23 T. 32 N. R. 17 E.

Source: Wisconsin Department of Natural Resources 608-266-2621
Crooked Lake – Oconto County, Wisconsin DNR Lake Map
Date - Jun 1968 - Historical Lake Map - Not for Navigation
A Public Document - Please Identify the Source when using it.

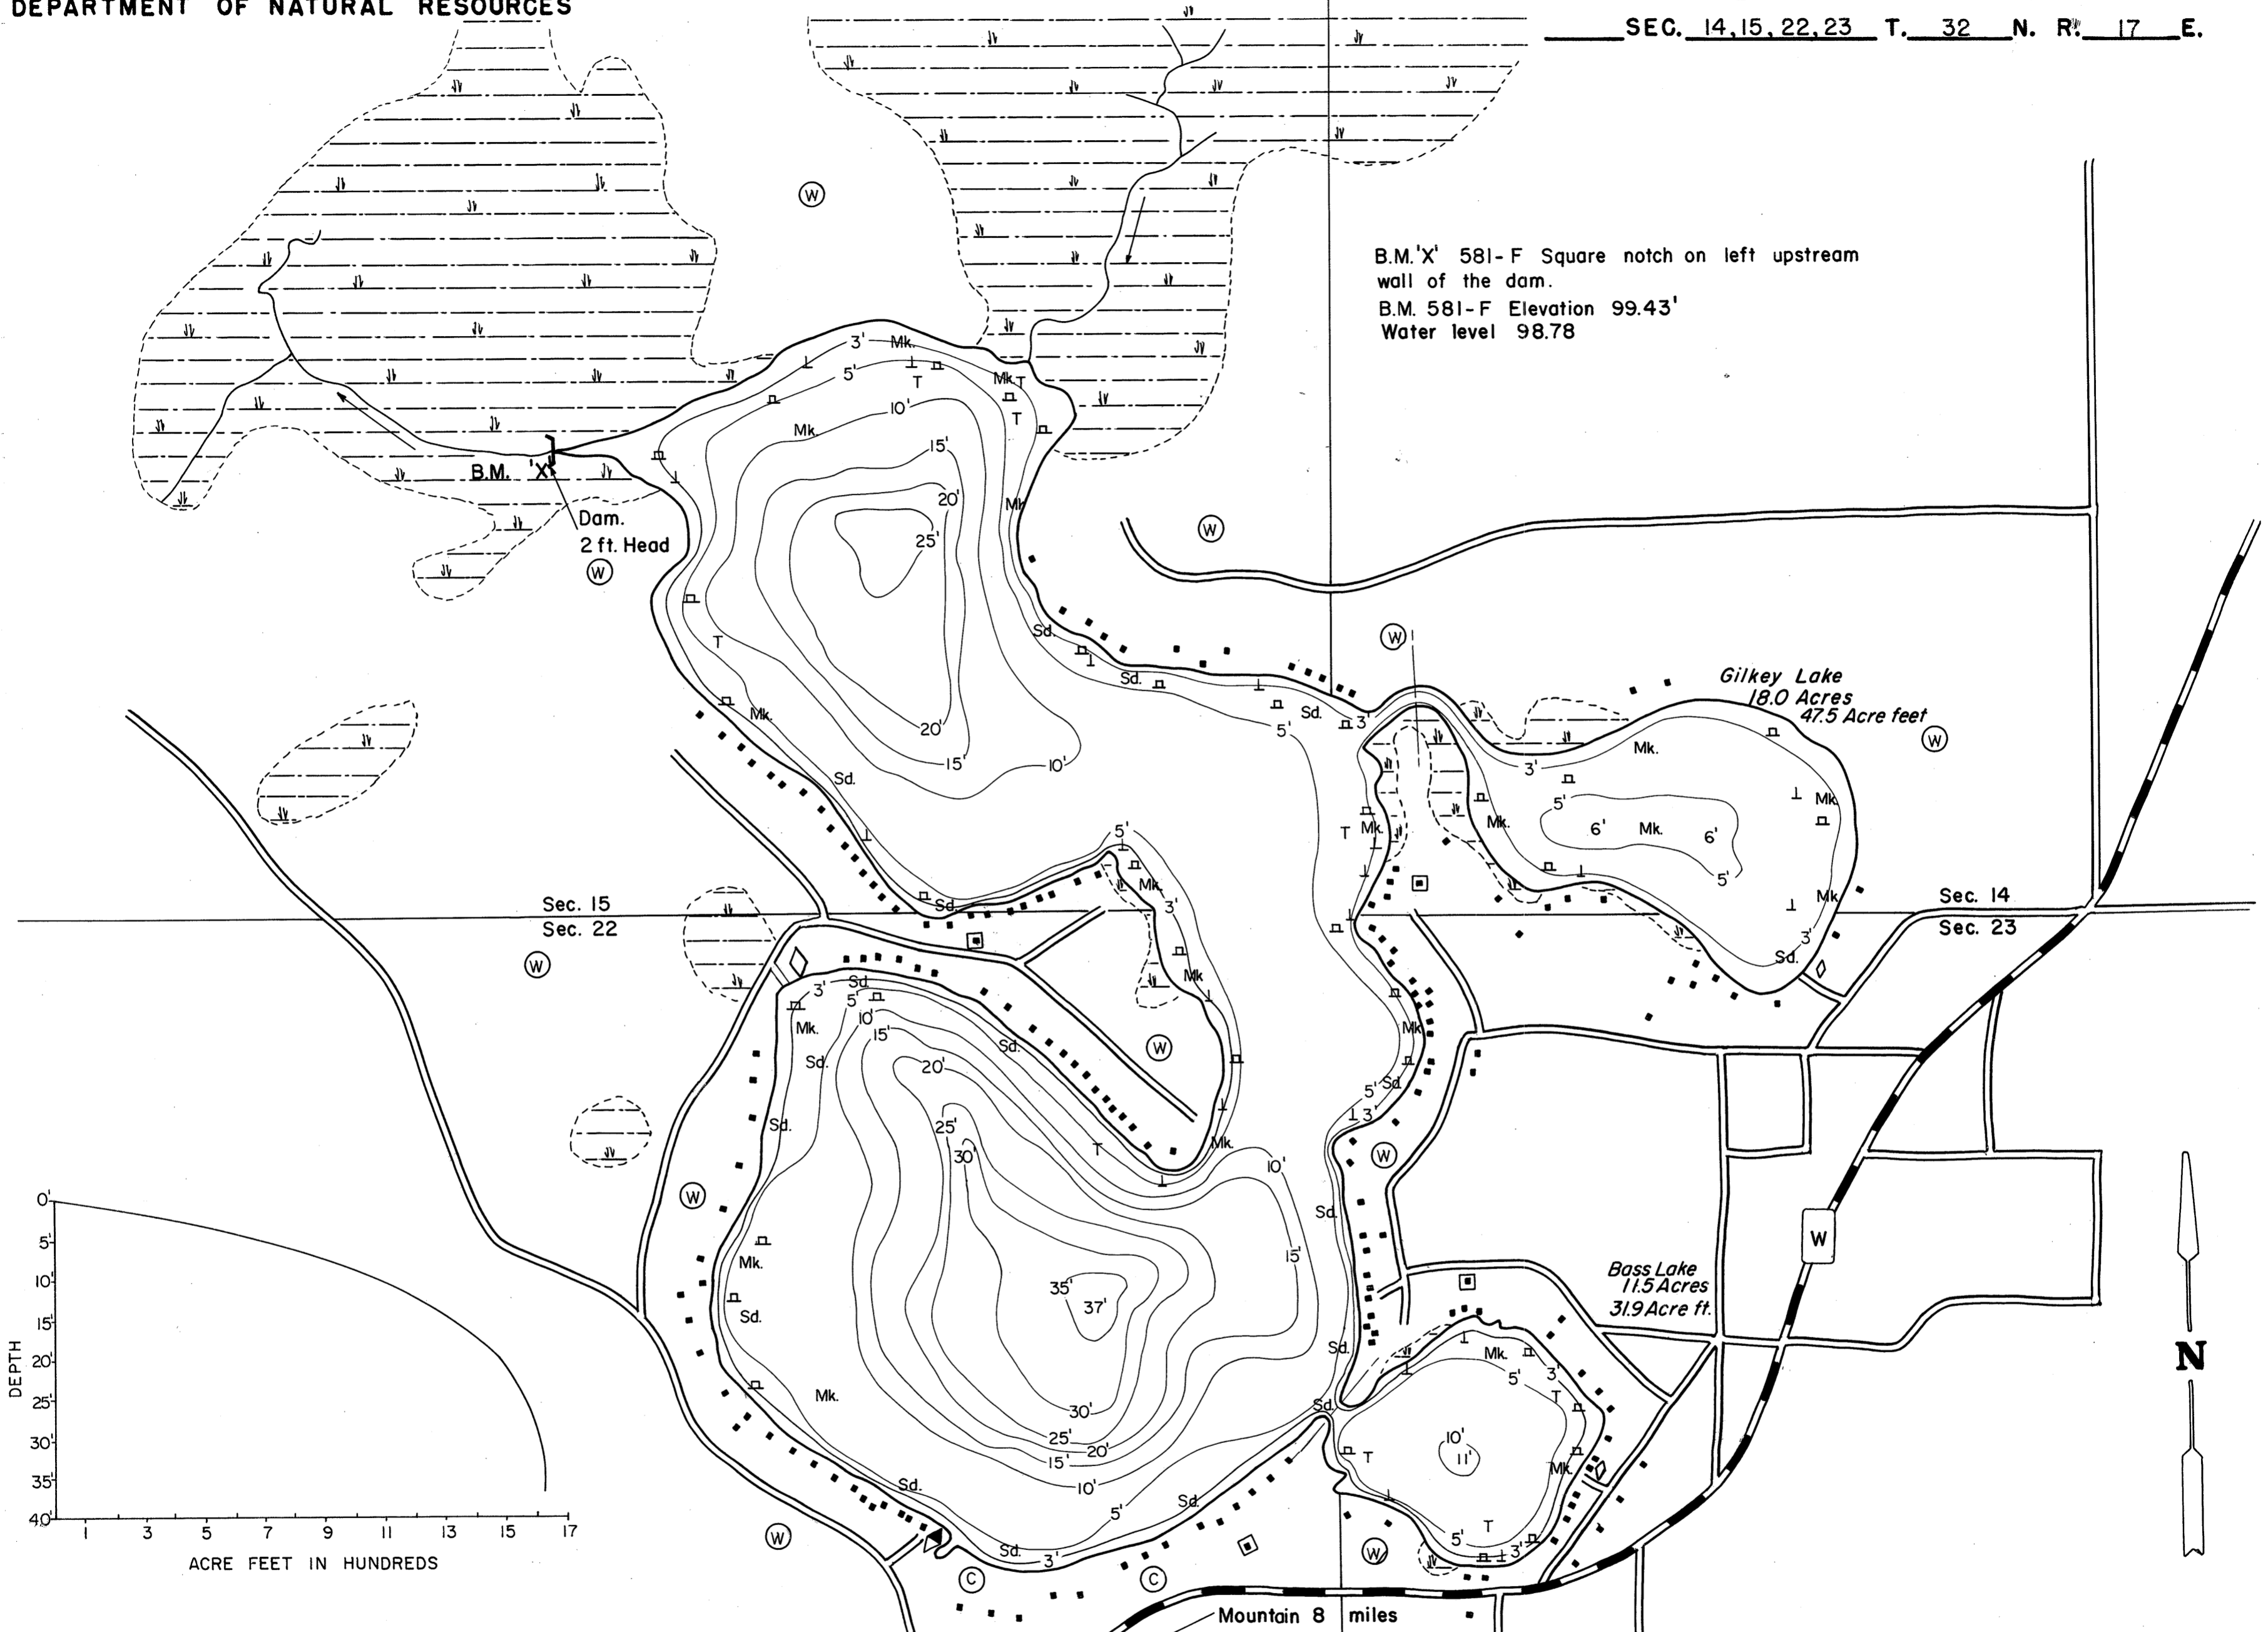
B.M. 'X' 581-F Square notch on left upstream wall of the dam.
B.M. 581-F Elevation 99.43'
Water level 98.78

WATER AREA 143.3 ACRES
 UNDER 3 FT. 9 %
 OVER 20 FT. 17 %
 MAX. DEPTH 37 FEET.
 TOTAL ALK. 53 P.P.M.
 VOLUME 1628.6 ACRE FT.
 SHORELINE 3.1 MILES
