LAKE SURVEY MAP

Source: Wisconsin Department of Natural Resources 608-266-2621
Townsend Flowage – Oconto County, Wisconsin DNR Lake Map
Date - May 1979 - Historical Lake Map - Not for Navigation
A Public Document - Please Identify the Source when using it.

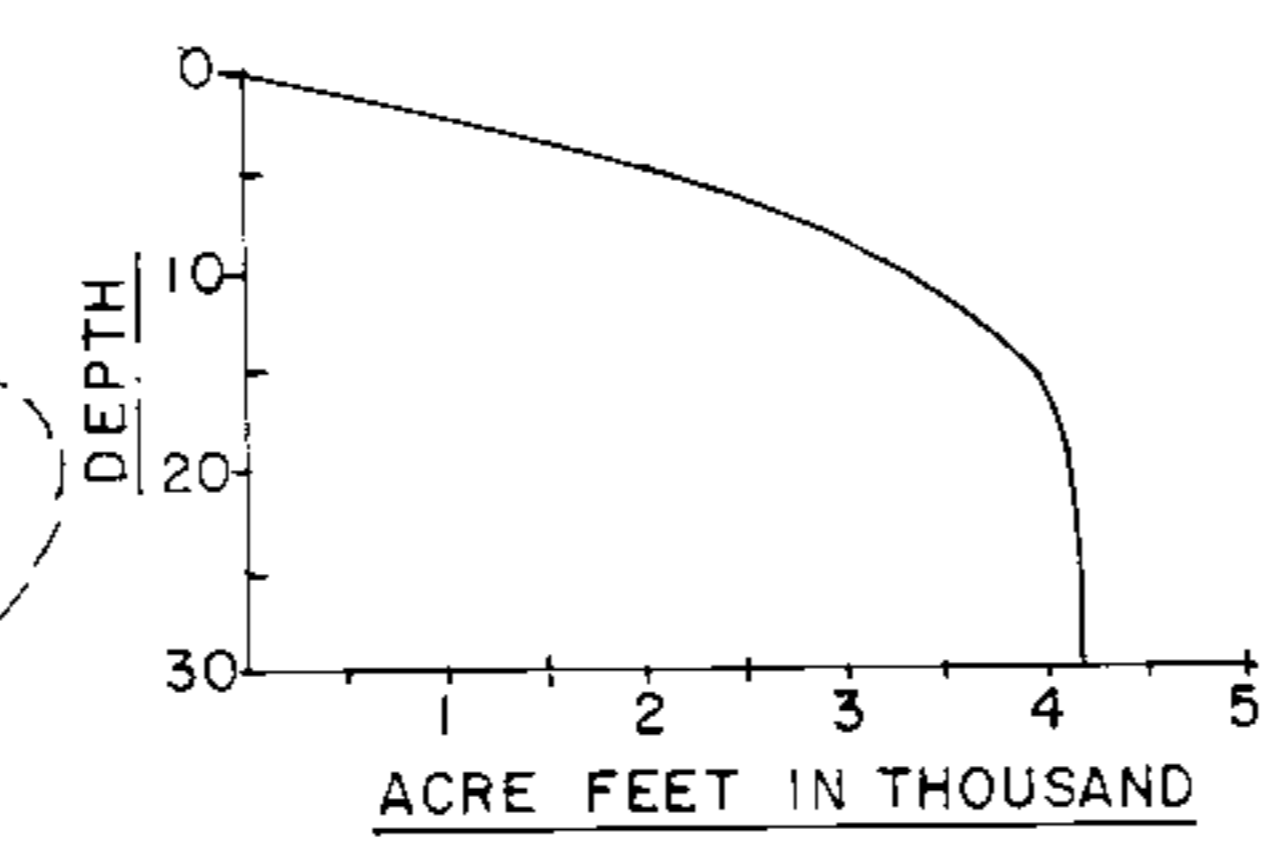
B.M. 'X' U.S.G.S. Tablet on top of right wing of dam
Assumed Elevation 100.00'
Water Level 96.00'

WATER AREA 476 ACRES
UNDER 3 FT. 15 %
OVER 20 FT. 2 %
MAX. DEPTH 30 FEET.
TOTAL ALK. 52 P.P.M.
VOLUME 4,157 ACRE FT.
MAIN SHORELINE 10.49 MI.
ISLAND SHORELINE 1.14 MI.
