Source: Wisconsin Department of Natural Resources 608-266-2621
Maiden Lake – Oconto County, Wisconsin DNR Lake Map
Date - Jun 1978 - Historical Lake Map - Not for Navigation
A Public Document - Please Identify the Source when using it.

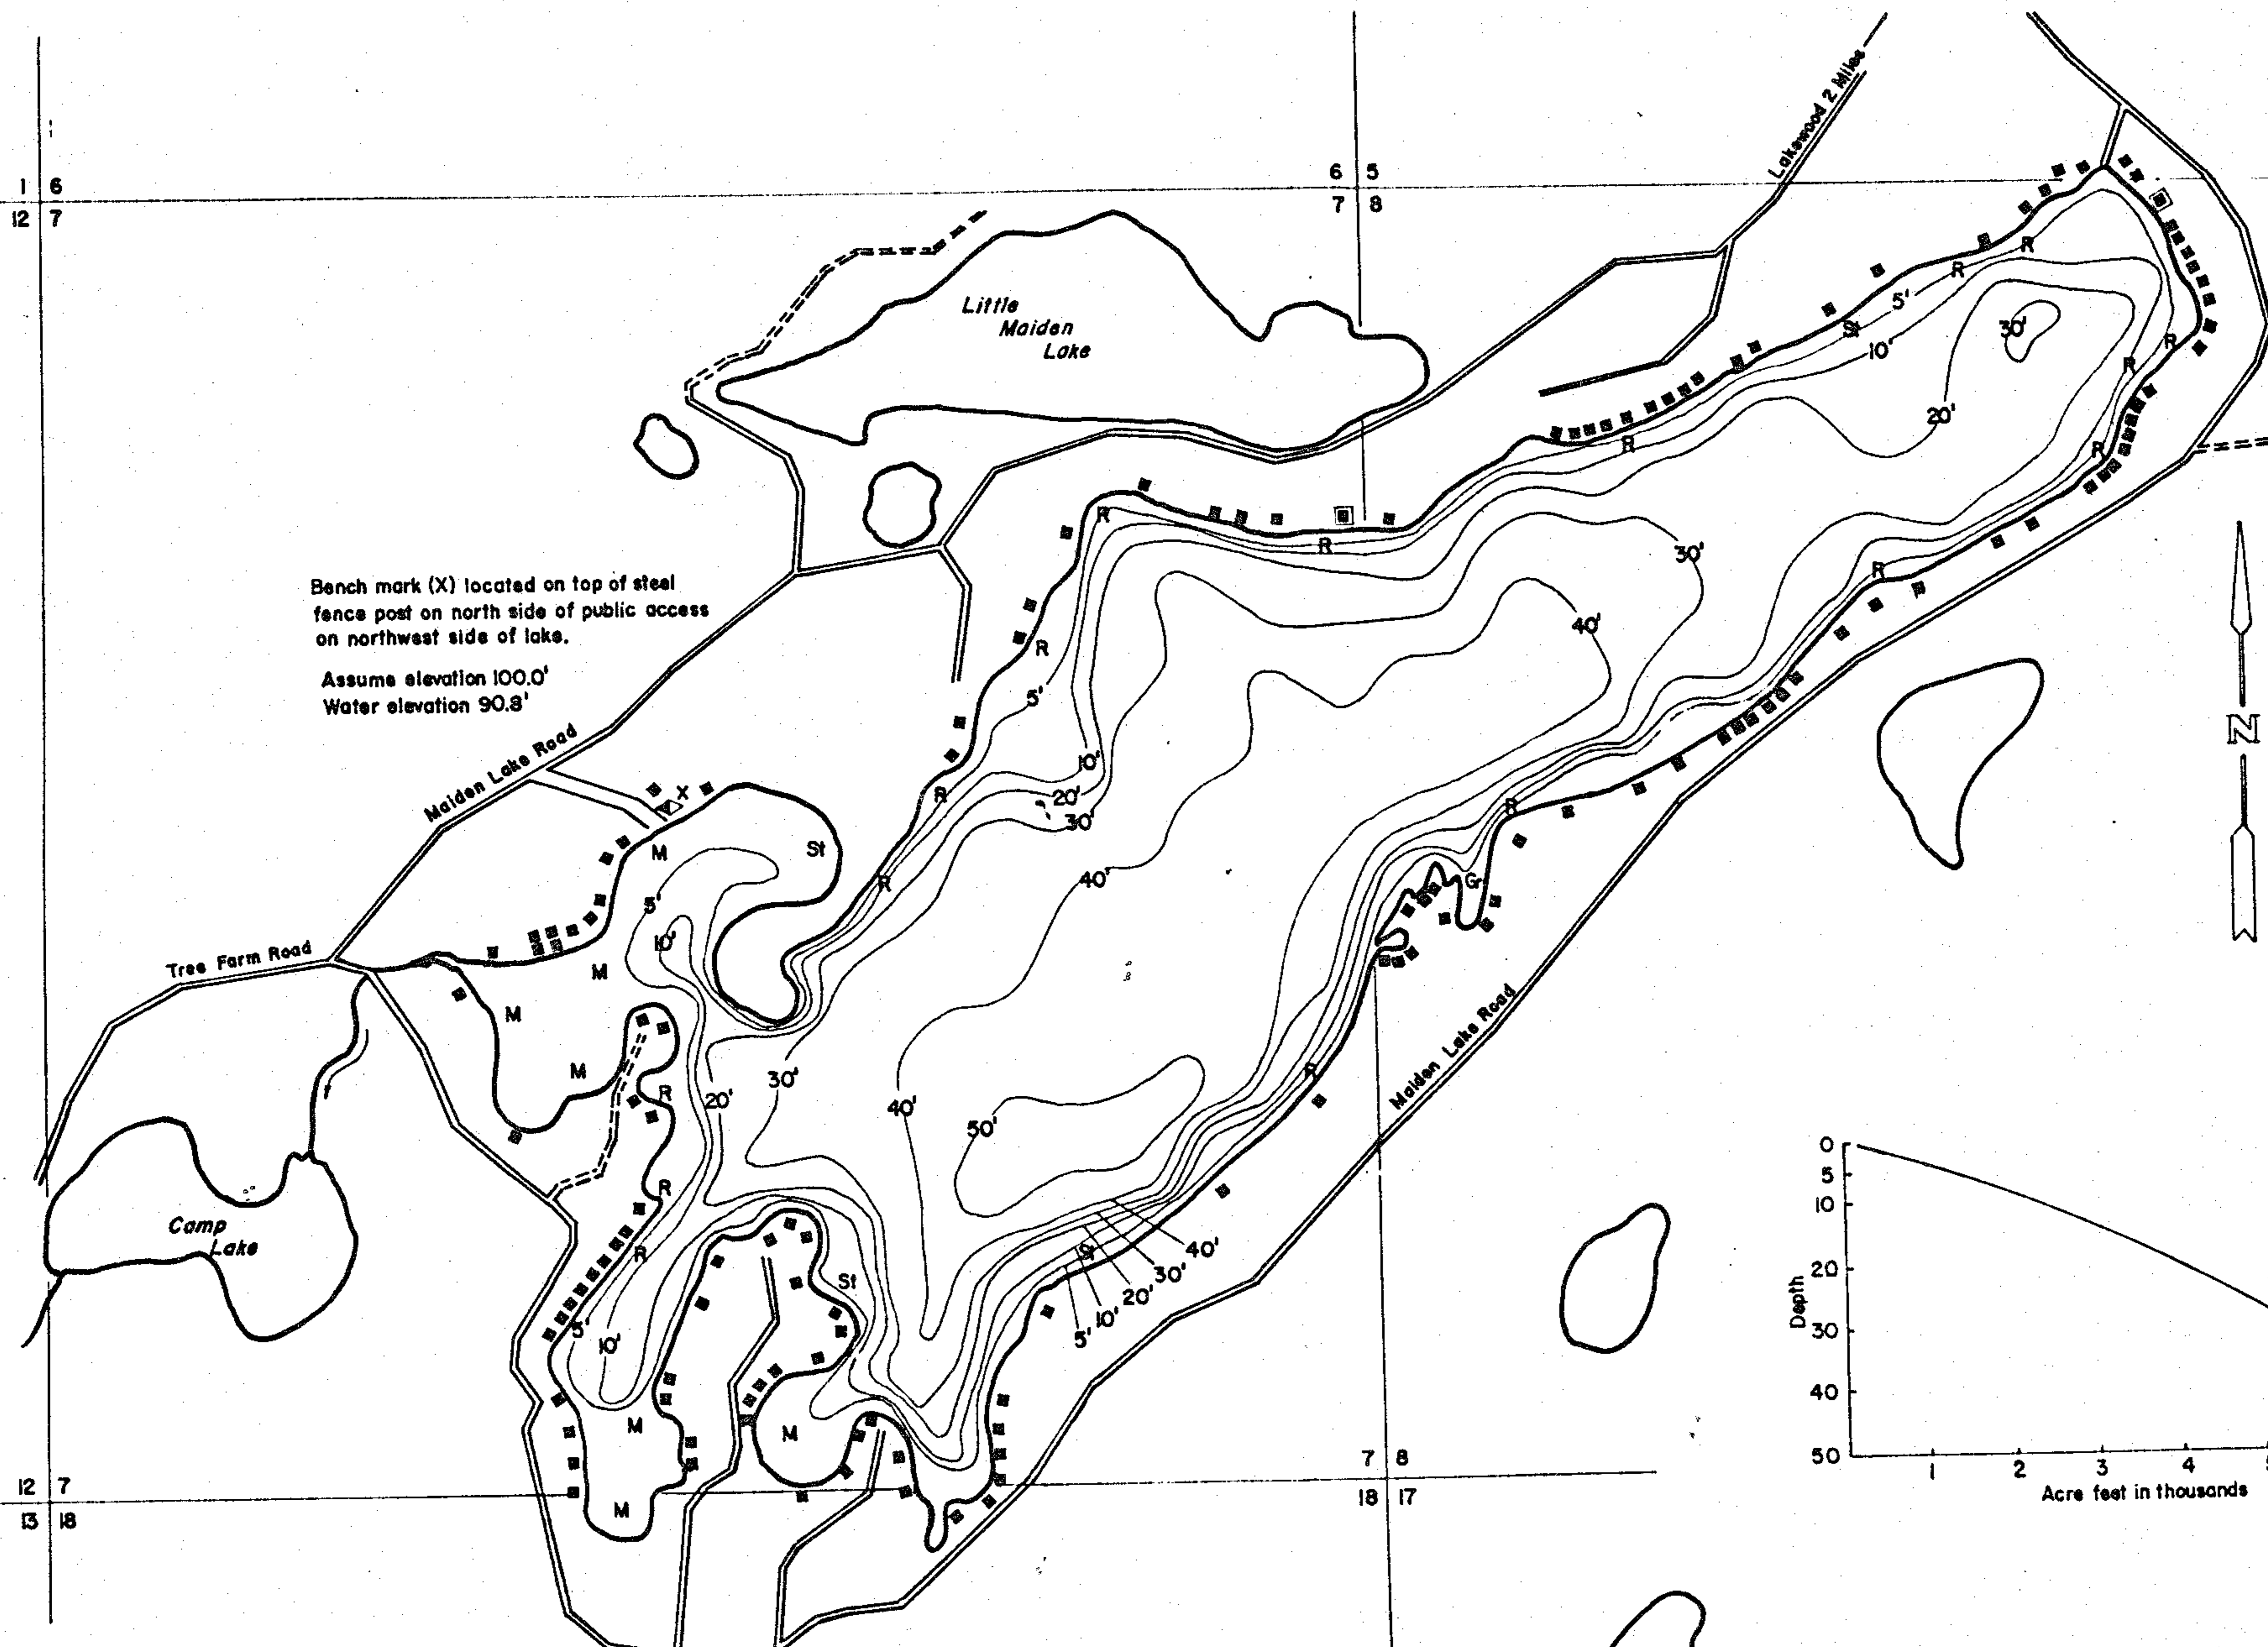
Bench mark (X) located on top of steel fence post on north side of public access on northwest side of lake.
Assume elevation 100.0'
Water elevation 90.8'

WATER AREA	269	ACRES
UNDER 5 FT.	19	%
OVER 20 FT.	39	%
MAX. DEPTH	52	FEET.
TOTAL ALK.	90.3	P.P.M.
VOLUME	6545.5	ACRE FT.
MAIN SHORELINE	5.6	MI.
ISLAND SHORELINE		MI.
