EQUIPMENT RECORDING SONAR MAPPED JUNE 1974  
MONTH YEAR

Lake Julia

Source: Wisconsin Department of Natural Resources 608-266-2621  
Lake Mary – Marinette County, Wisconsin DNR Lake Map  
Date – Jun 1974 - Historical Lake Map - Not for Navigation  
A Public Document - Please Identify the Source when using it.

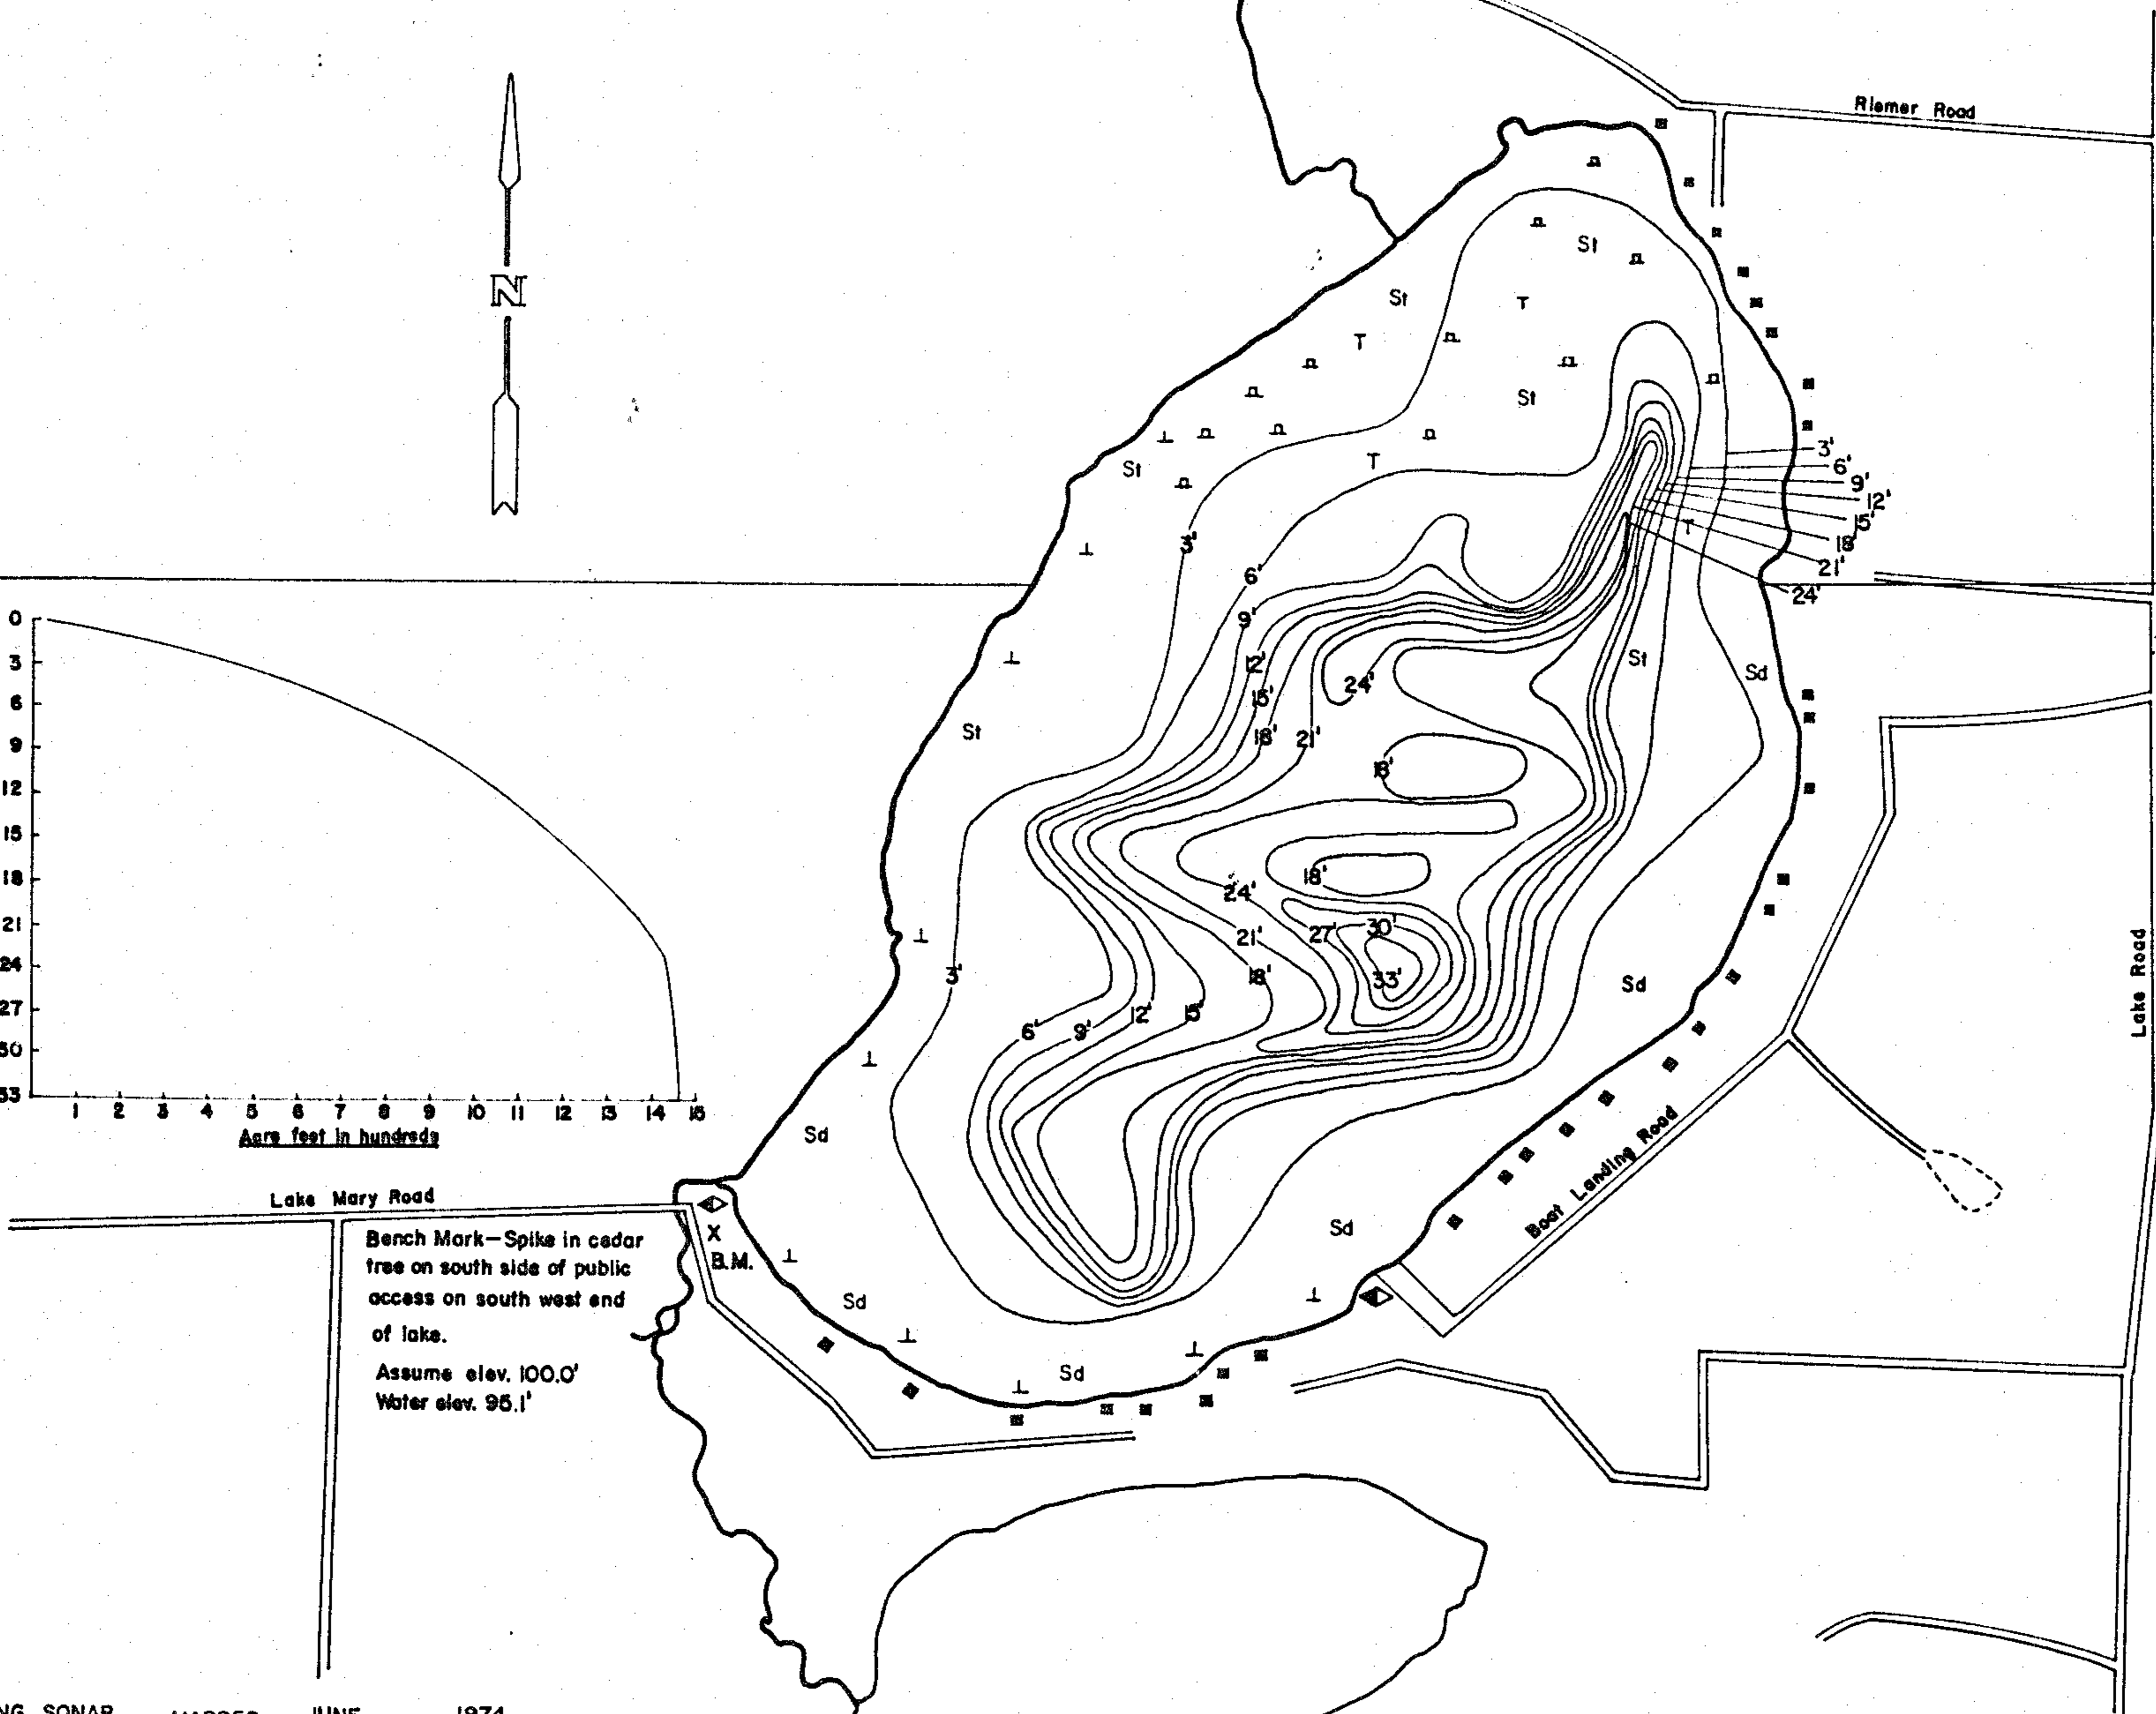
Bench Mark—Spike in cedar tree on south side of public access on south west end of lake.  
Assume elev. 100.0'  
Water elev. 95.1'

WATER AREA 175 ACRES  
UNDER 3 FT. 20 %  
OVER 20 FT. 5 %  
MAX. DEPTH 38 FEET.  
TOTAL ALK. 103 P.P.M.  
VOLUME 1464 ACRE FT.  
MAIN SHORELINE 2.07 MI.  
ISLAND SHORELINE MI.
