Source: Wisconsin Department of Natural Resources 608-266-2621
Hemlock Lake – Oneida County, Wisconsin DNR Lake Map
Date – Sep 1981 - Historical Lake Map - Not for Navigation
A Public Document - Please Identify the Source when using it.

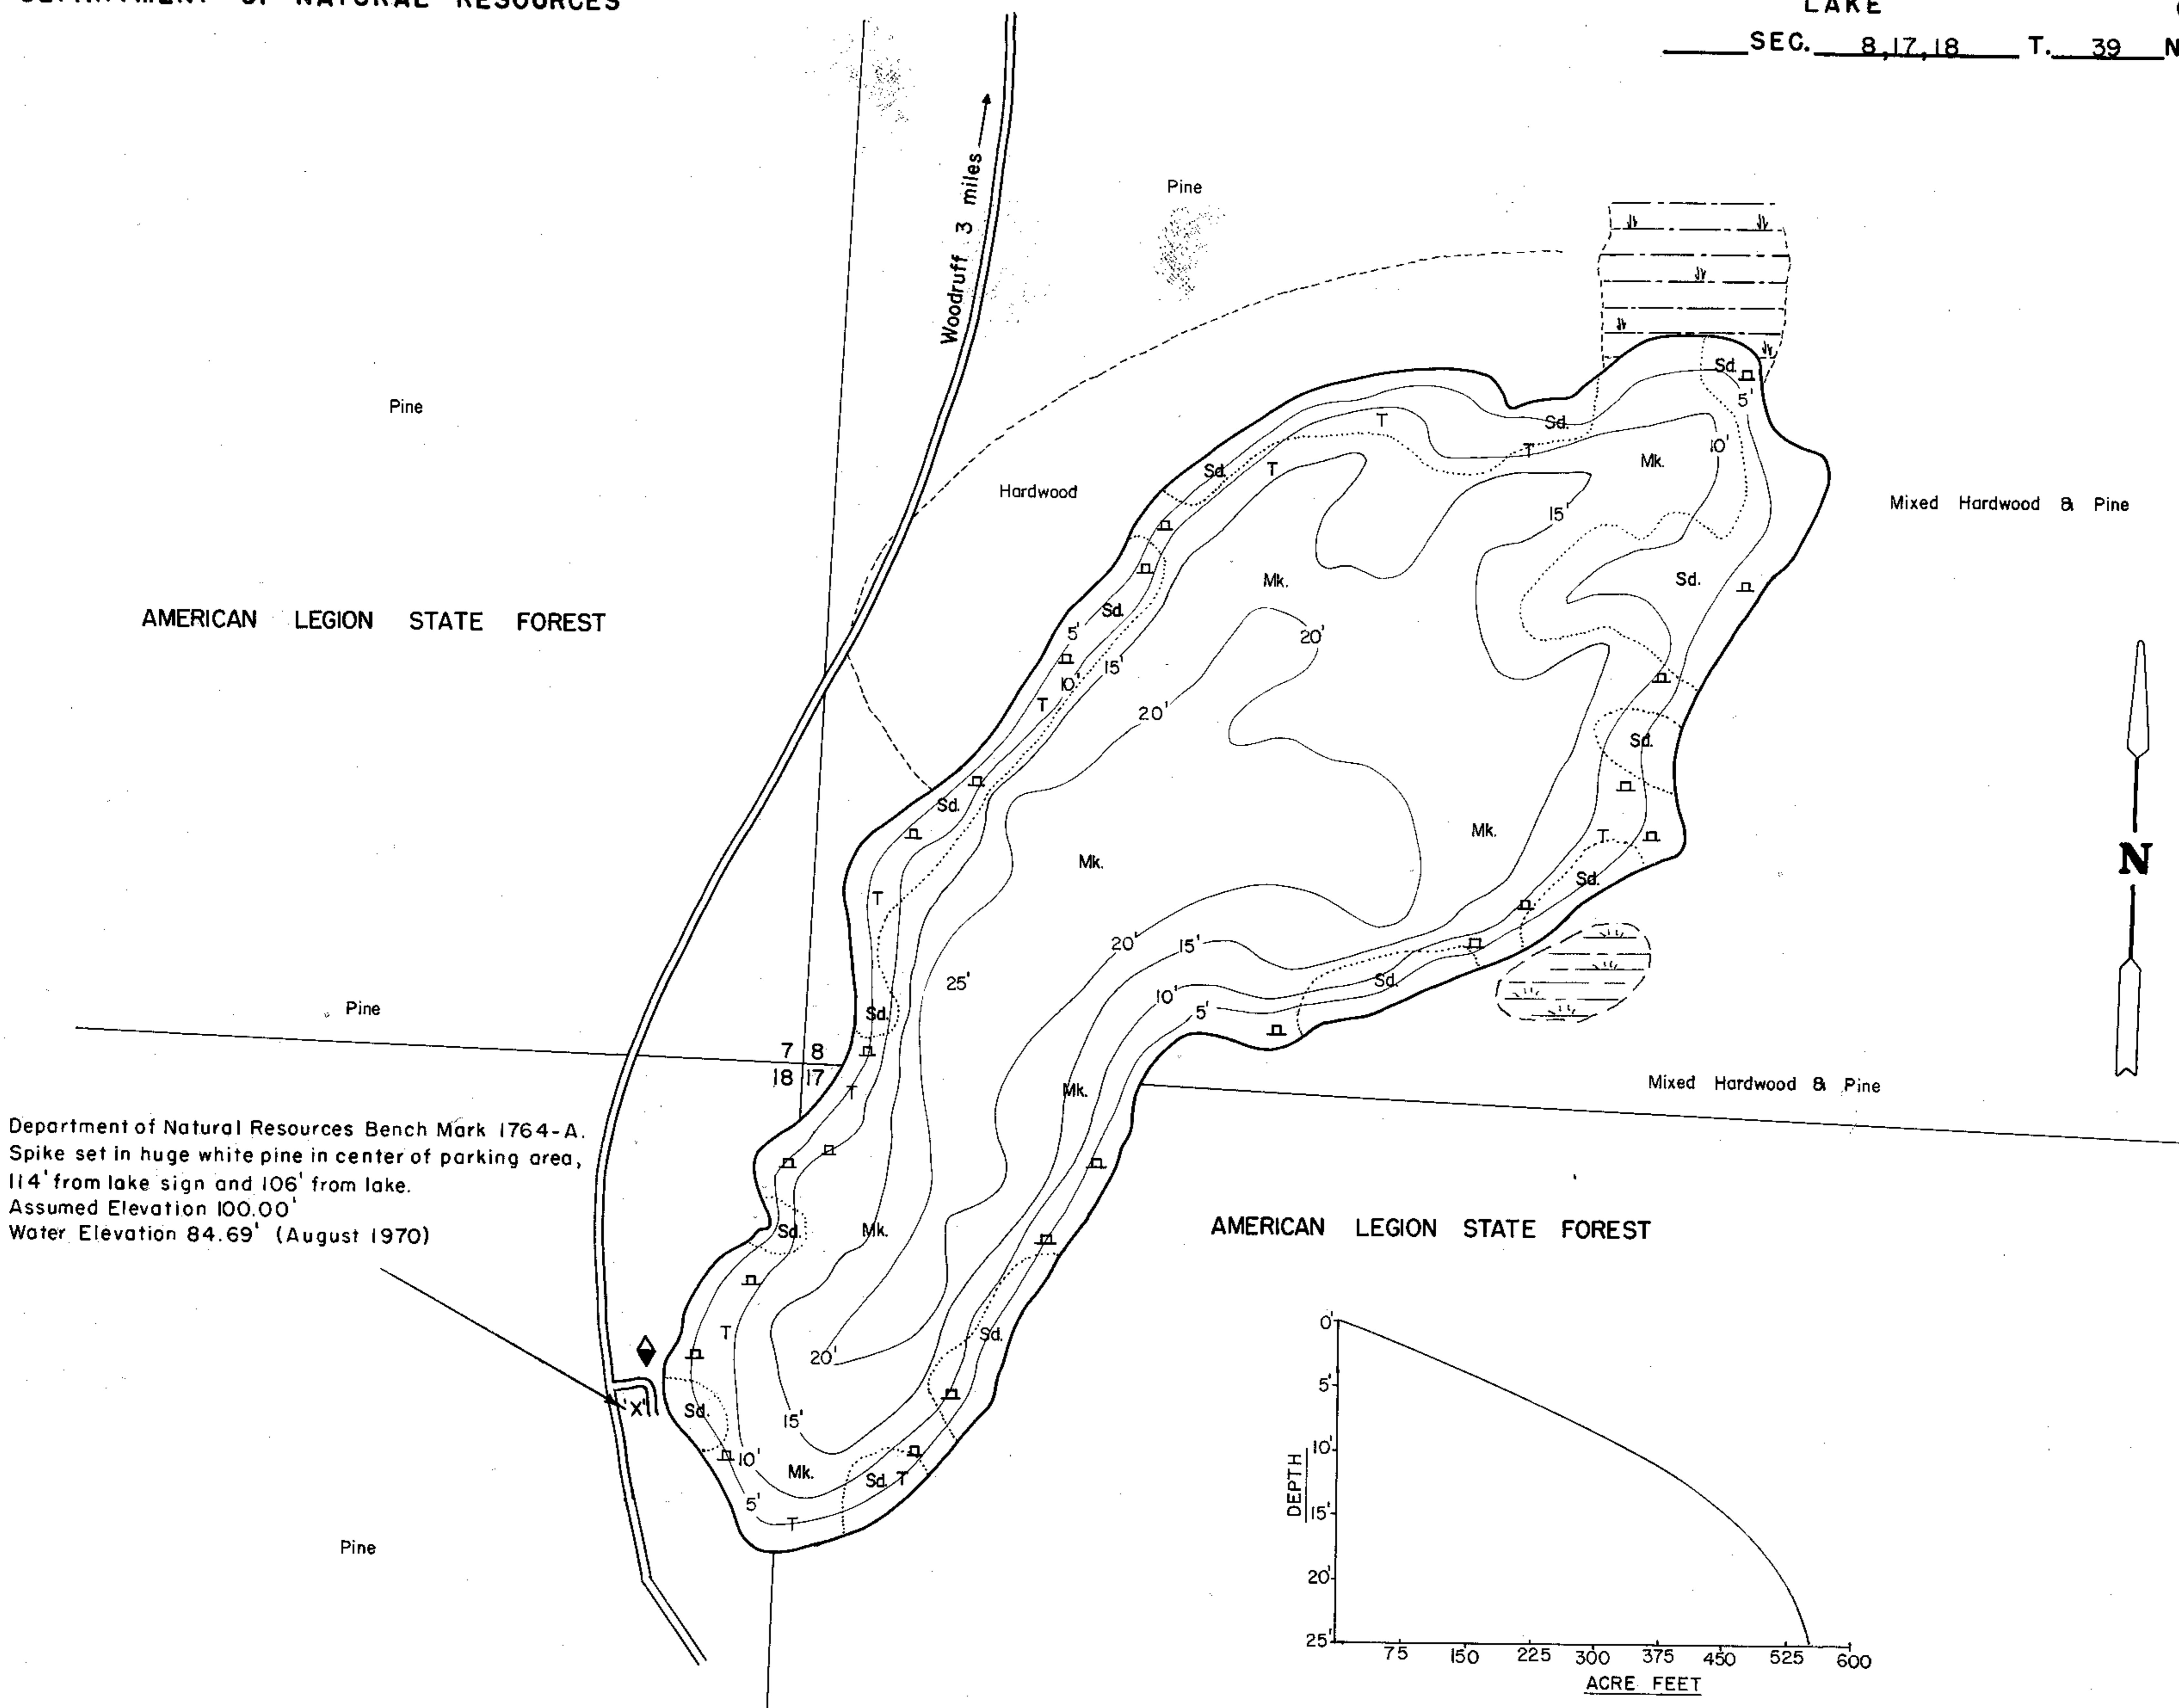
Department of Natural Resources Bench Mark 1764-A.
Spike set in huge white pine in center of parking area,
114' from lake sign and 106' from lake.
Assumed Elevation 100.00'
Water Elevation 84.69' (August 1970)

WATER AREA 40.4 ACRES
UNDER 3 FT. 10 %
OVER 20 FT. 20 %
MAX. DEPTH 25 FEET.
TOTAL ALK. 3 P.P.M.
VOLUME 551.24 ACRE FT.
SHORELINE 1.2 MILES
